July 30, 2001 Municipal Water Use Inspection - Report

MUNICIPAL WATER USE INSPECTION FORM

Date: 2001/07/30 Licensee Rep. (Name/Title): Micky Lyta / Municipal Garage Foreman
Licensee: Hamlet of Kimmirut Licence No.: N5L4-1441 (expired)

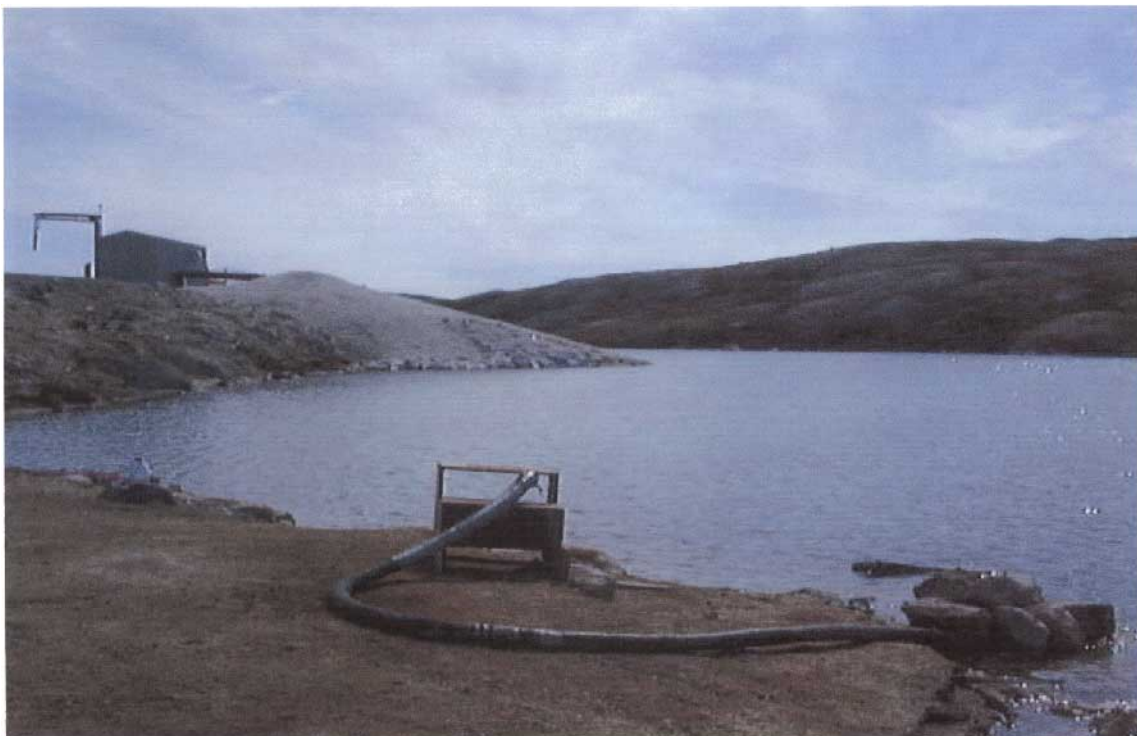
Comments: The water intake facility's generator has been out of service since springtime; direct truckfill station by the lakeshore currently utilized until specialized assistance comes in. Water delivery records kept. Manual chlorination (bleach) in use at the temporary truckfill station.

figure 1. Temporary water intake facility, Lake Fundo; 2001/07/30.

- **Water supply:** Due to the failure of its generator, the water intake facility has been bypassed for months. While the temporary truckfill station by the shoreline (figure 1) did not appear to create a negative impact on the water supply, the Inspector is glad to hear that maintenance work will proceed in a timely manner. This being said, the attached analytical results relating to a sample taken from the temporary truckfill station indicate that the raw water meets the *Guidelines for Canadian Drinking Water Quality* for all tested parameters.

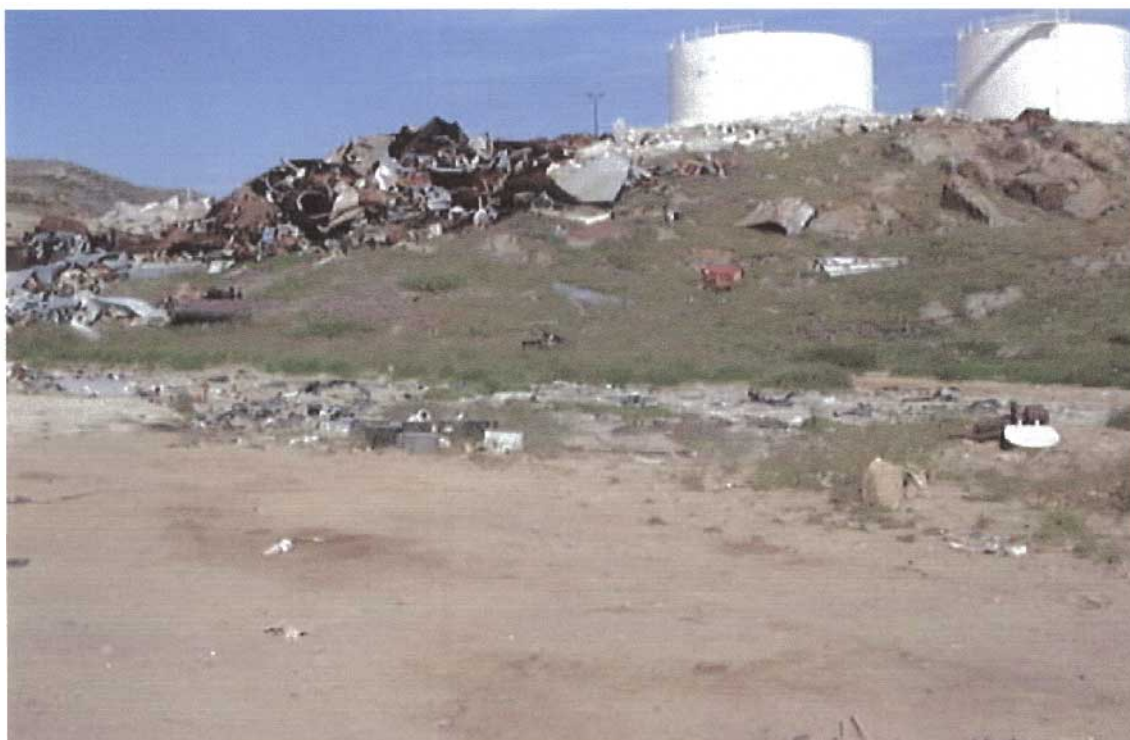
- **Waste disposal:** The sewage disposal area, essentially a truck dumping point (figure 2), provides no retention nor treatment time prior to the discharge of effluent. Further, although bulky metal wastes are segregated, waste oil and hazardous materials are still disposed of at the solid waste disposal facility. And while the household wastes appeared adequately managed (figure 3), a significant quantity of exposed wastes nonetheless line the toe of the dump, along the discharge path of the sewage effluent. Accordingly, the attached analytical results relating to a sample collected from Surveillance Network Program (SNP) station 1441-3 (figure 4) reveal that the level of total suspended solids (174 mg/L vs 120 mg/L) breaches the effluent quality standards set under the now expired Water licence N5L4-1441. In addition, concentrations of ammonia (103 mg/L vs 2.2 mg/L), phenols (200 µg/L vs 4 µg/L), cadmium (0.3 µg/L vs 0.017 µg/L), copper (56 µg/L vs 4 µg/L), iron (5.16 mg/L vs 0.3 mg/L), lead (16 µg/L vs 7 µg/L), and zinc (91 µg/L vs 30 µg/L) exceed the *Canadian Water Quality Guidelines for the Protection of Freshwater Aquatic Life*.

figure 2. Sewage disposal area, with bulky metal wastes in background; 2001/07/30.

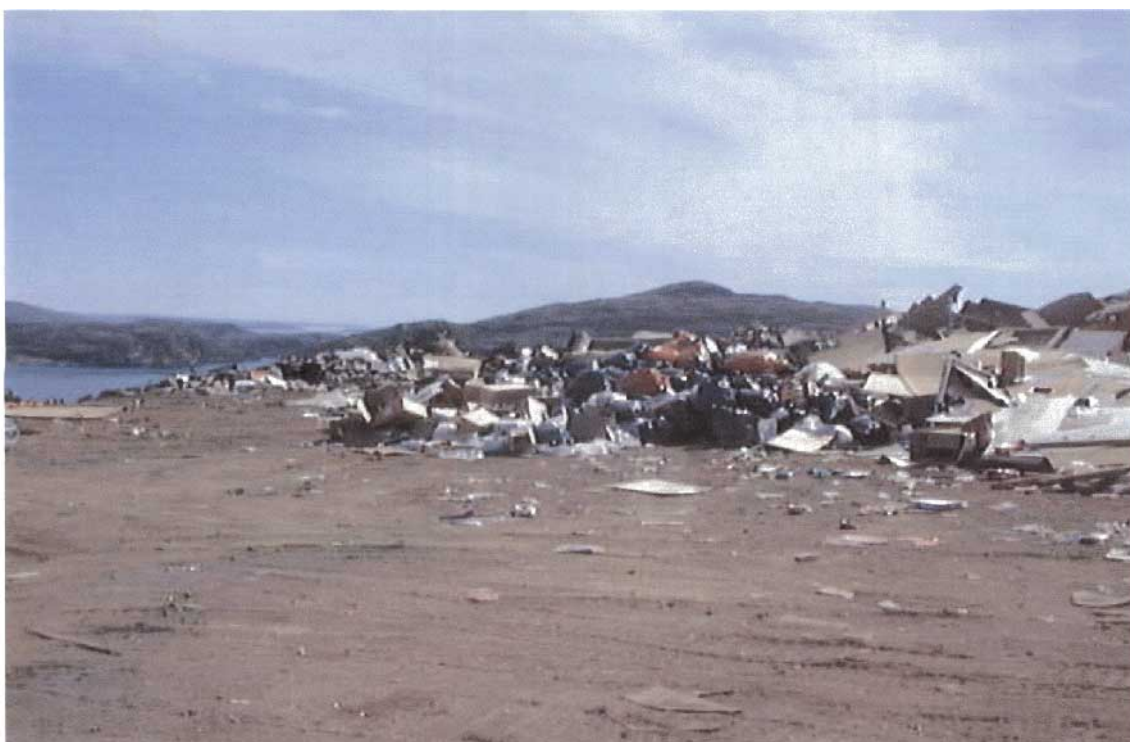
Comments: Sewage disposal area provides no retention/treatment time prior to the discharge of effluent. Minimal segregation of waste at the partly-fenced solid waste disposal site; windblown garbage noted far beyond the perimeter of the facility. Waste oil is still stored and disposed of at the dump; old burn area partially covered with fill material. No particular storage area for hazardous materials. Work has been undertaken on new solid waste and sewage disposal sites; little information provided beforehand. Operation and Maintenance (O&M) plan for the waste disposal facilities not submitted. No Abandonment and Restoration (A&R) plan yet submitted in regards to the current waste disposal facility.

figure 3. Solid waste disposal facility; 2001/07/30.

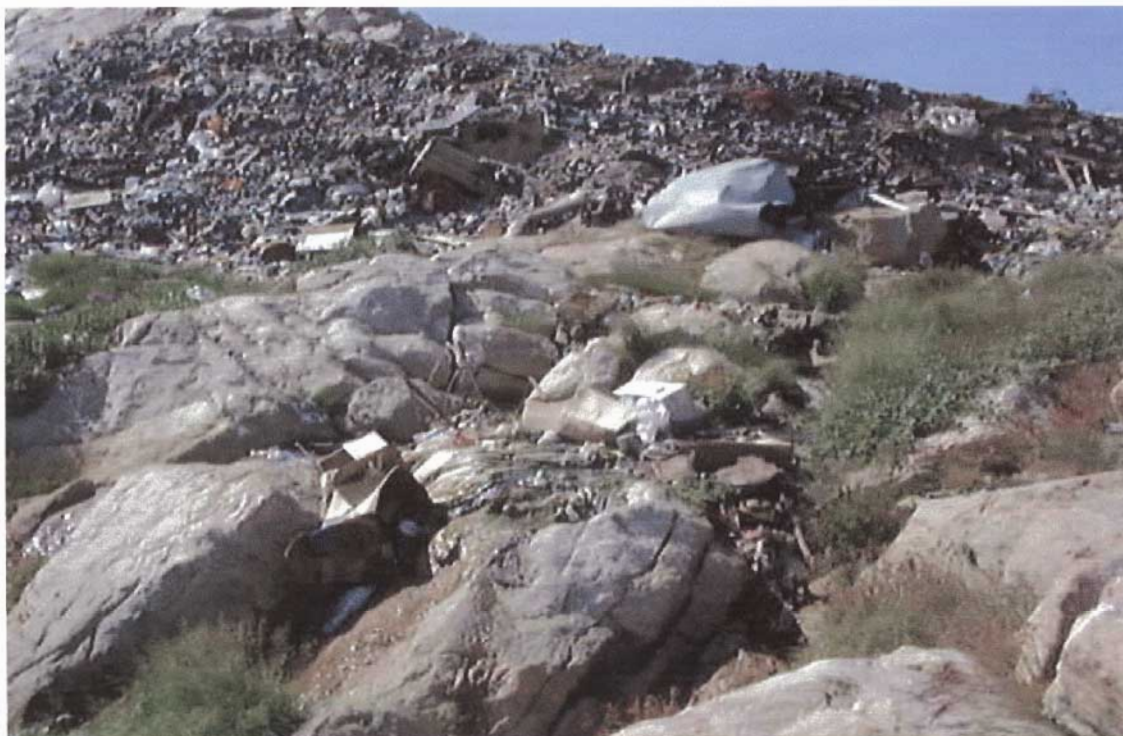
Moreover, the Microtox sample, which constitutes a reliable toxicity indicator (IC_{50}), shows that half of light-producing bacteria were inhibited by a sample concentration of 6.0%, whereas 50% and over is considered non-toxic. However, the considerable vegetation along the path of discharge from the waste disposal facility (figure 5) seemingly provides some means of effluent treatment. Unfortunately, due to flight scheduling limitations, bacteriological parameters could not be analysed.

figure 4. Discharge at the toe of the waste disposal facility; 2001/07/30.

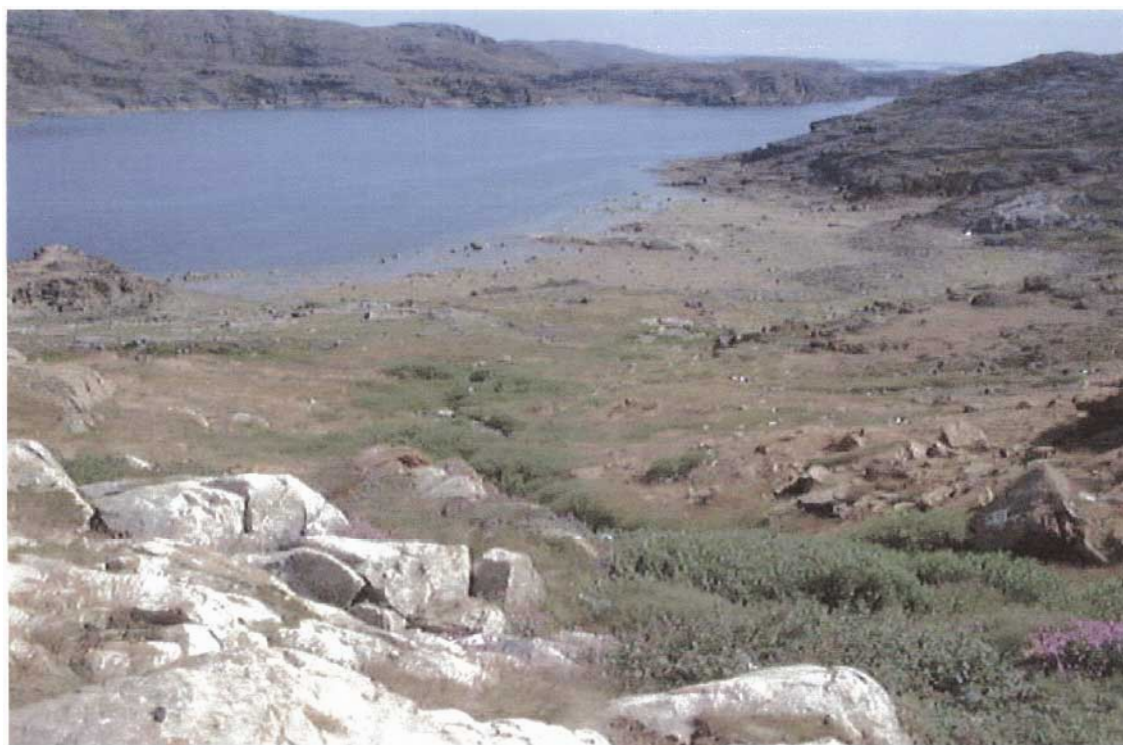
figure 5. Path of discharge from the waste disposal facility; 2001/07/30.

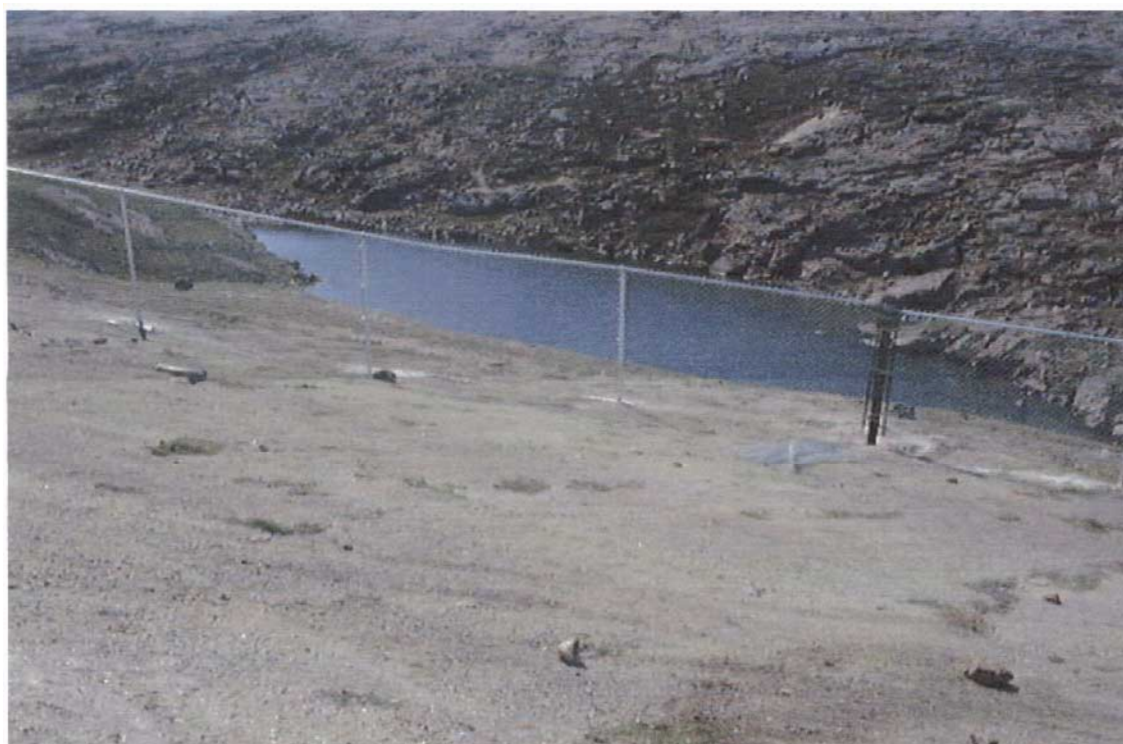
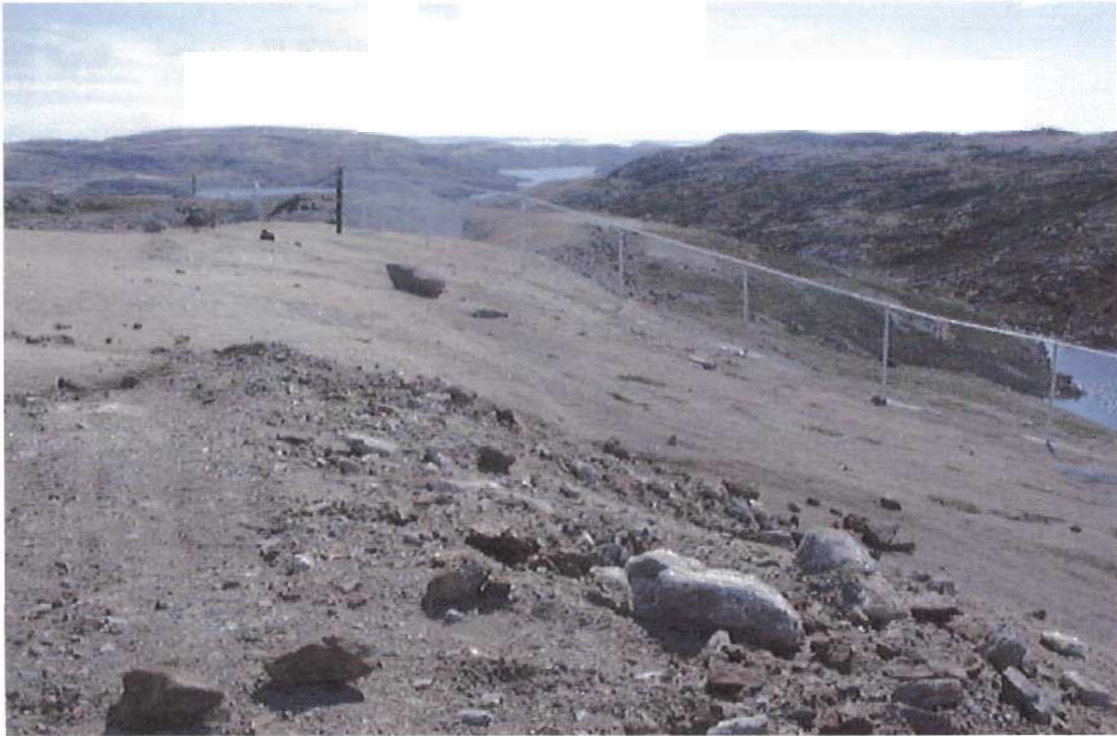
figure 6. Truck discharge point, new sewage disposal facility; 2001/07/30.

figure 7. Truck discharge and drainage valley, new sewage disposal site; 2001/07/30.

In related matters, the imminent commissioning of new sewage (figures 6-7) and solid waste (figures 8-9) disposal facilities implies additional considerations. Indeed, in light of their inherent potential for the deposit of waste into waters, the construction, operation and maintenance (O&M), and abandonment and restoration (A&R) of waste disposal facilities ought to previously be granted approval by the Nunavut Water Board (NWB).

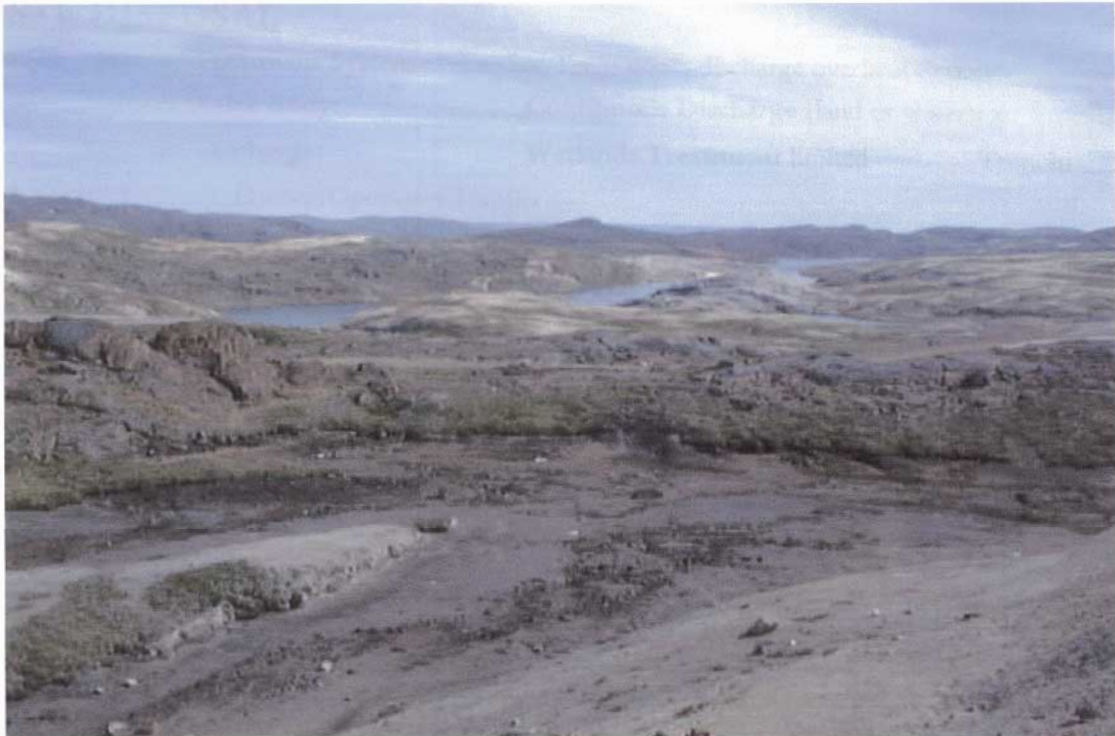
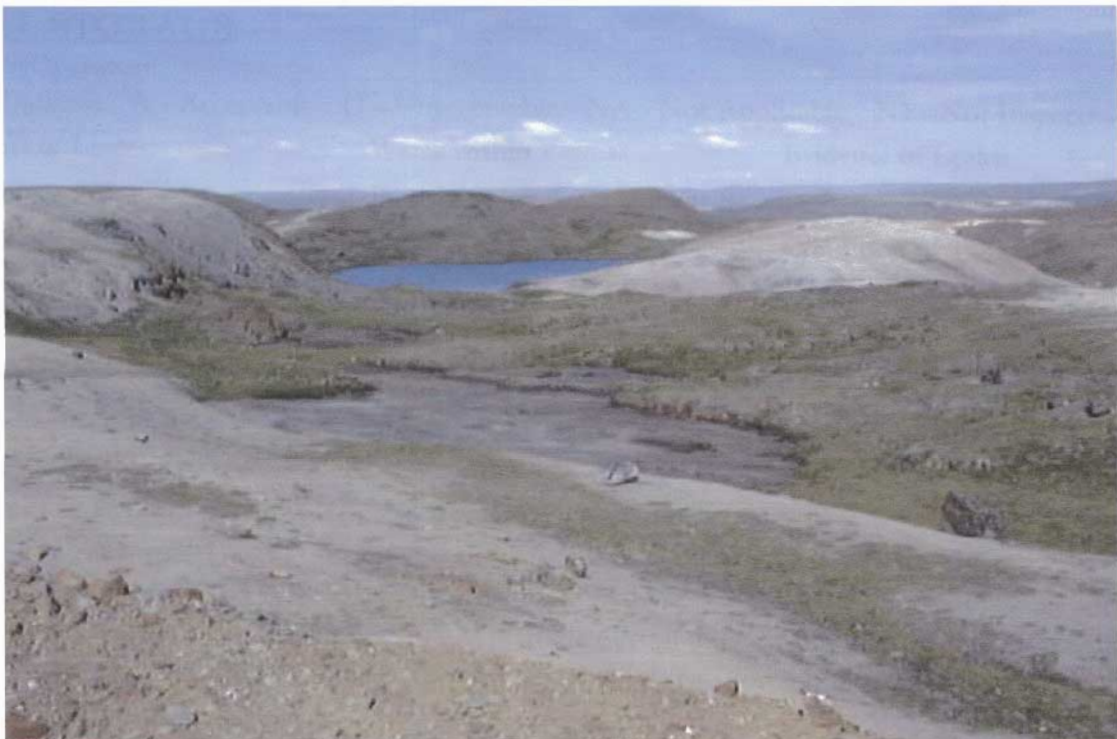
figure 8. New solid waste disposal facility, with Lake Fundo in background; 2001/07/30.

figure 9. New solid waste disposal facility; 2001/07/30.
