RE: August 1, 2002 Municipal Water Use Inspection - Report

MUNICIPAL WATER USE INSPECTION REPORT

Licensee: Hamlet of Kimmirut

Kimmirut Inspection pictures 2002

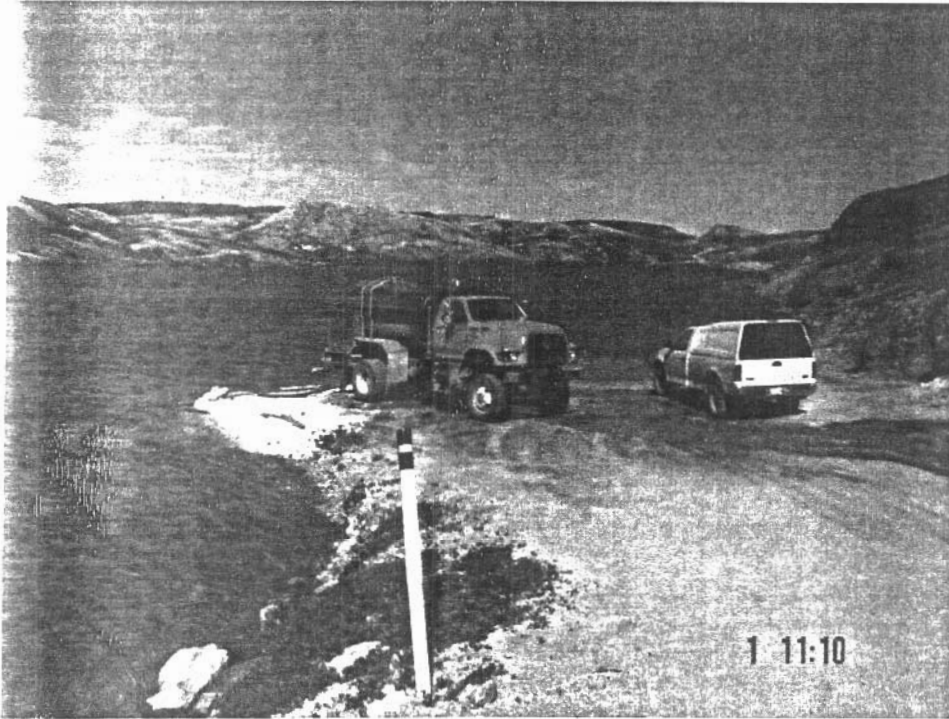
Photo # 1 Water truck shown at potable water supply filling up. Location of potable water supply sample. Chlorine bleach used to chlorinate potable water.

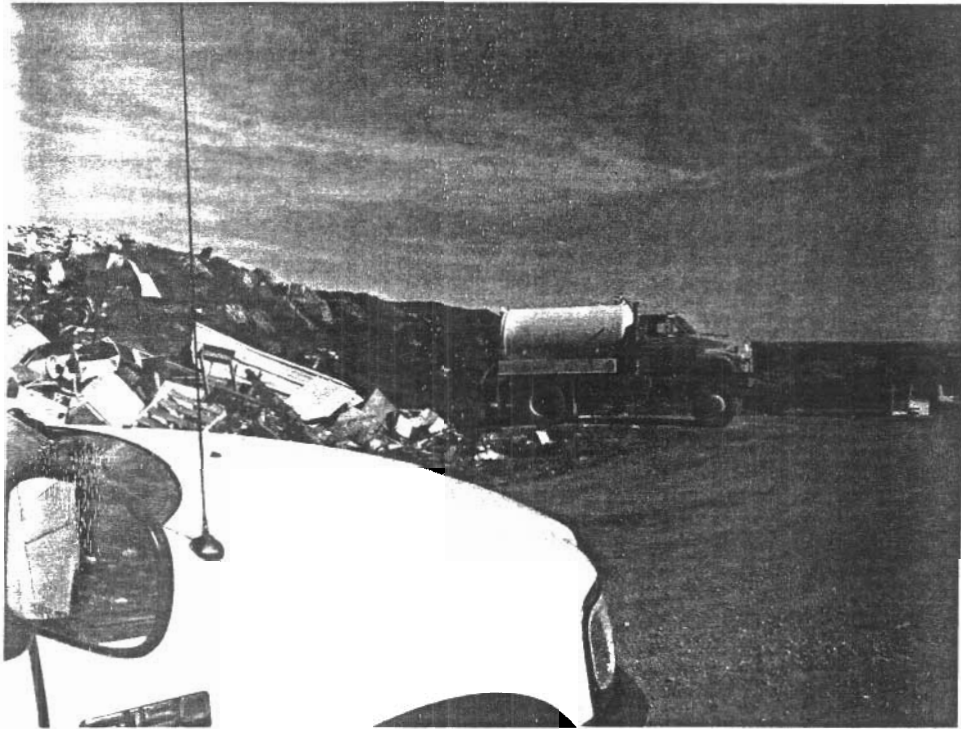
- ☐ **Sewage Disposal:** The Sewage Treatment Facility is located at the tipping face of the Solid Waste Disposal Facility (Photo 5). After flowing along the tipping

Comments: The Sewage Treatment Facility consists of discharging sewage at the Solid Waste Disposal Facility tipping face. The sewage then flows towards the ocean. The Solid Waste Disposal Facility has some of the bulky metal segregated from the general refuse. Some burning and covering of the refuse is practiced. However the discharging of sewage at the dump washes away some of the dump cover material.

Photo # 5 Sewage truck discharge at tipping face of Solid Waste Disposal Facility.

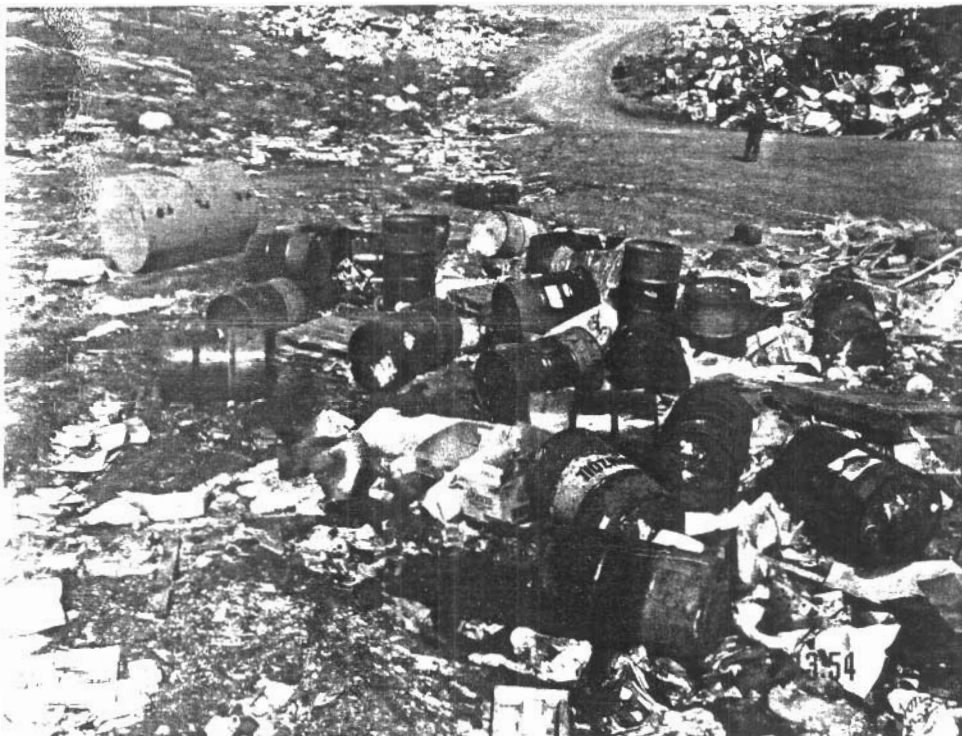
- ☐ **Waste Disposal:** The Solid Waste Disposal Facility was partly segregated with separation of bulky metal waste and general refuse (Photo 3). There was some burning of refuse at the dump. Hazardous materials (waste batteries and oil) require proper storage areas (Photo 6). Considerable bulky metal and oil waste are located along side the road above the dump (Photo 11 & 12). These materials should be relocated and properly stored at the Solid Waste Disposal Facility.

Photo # 6 Waste oil and drum storage area at Solid Waste Disposal Facility. Note that there is oil staining in the area.

- ☐ **Non-Compliance of Act or Licence:** The Water Resources Officer suggested that measures be undertaken to consolidate the waste oil in the Solid Waste Disposal Facility and waste storage area above the dump. In accordance with General Conditions, Part B of the *Water Licence*; Within 90 days of the first visit of the Inspector, all necessary signs including Surveillance Network Program (SNP) stations shall be posted in all official languages of Nunavut to the satisfaction of the Inspector.

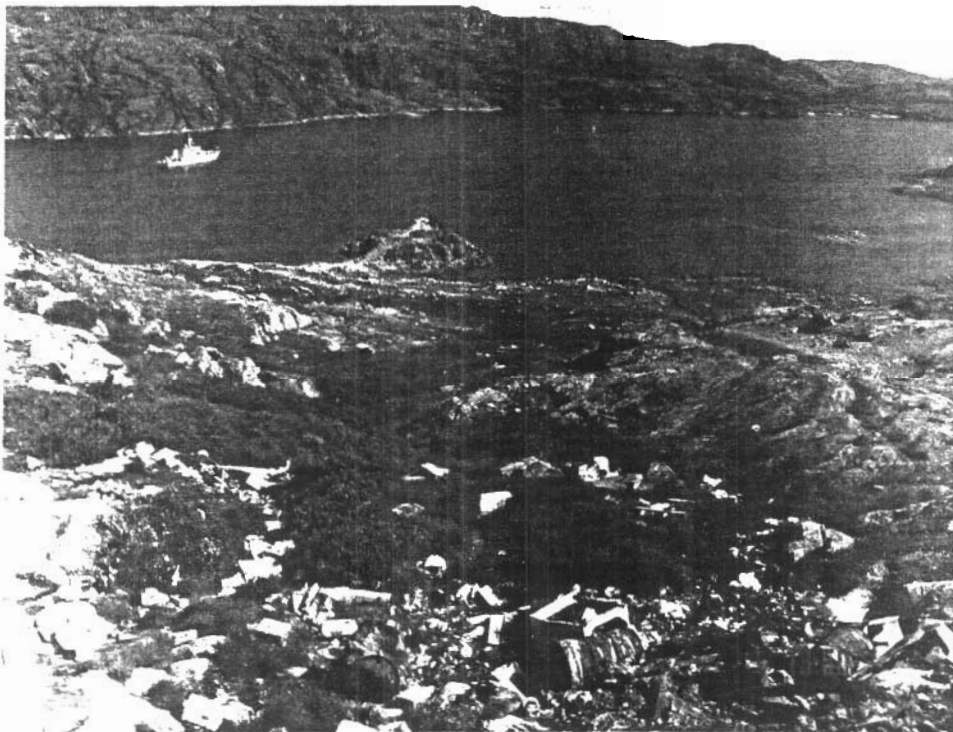
face of the dump the sewage flows down hill to the ocean (Photo 8 & 10). Some aeration and filtering out of large particles is accomplished before the effluent enters the ocean some 100 meters down stream. Attached analysis of sewage effluent (KIM-3) indicate pH (7.95 vs 6.5-9), Total Suspended Solids (8 mg/L vs 120 mg/L) and Biological Oxygen Demand (27 mg/L vs 100 mg/L) meet the *Municipal Wastewater Effluent Quality Guidelines*. However enclosed analysis indicate that Total Ammonia (21.3 mg/l vs 2.2 mg/L) and Nitrate + Nitrite (5.71 mg/L vs 3.2 mg/L) exceed the *Municipal Wastewater Effluent Quality Guidelines* Maximum Acceptable Concentrations.

Photo # 8 Flow path of sewage effluent flows through solid waste disposal facility. Note at front of photo refuse that sewage stream has carried from the tipping face.

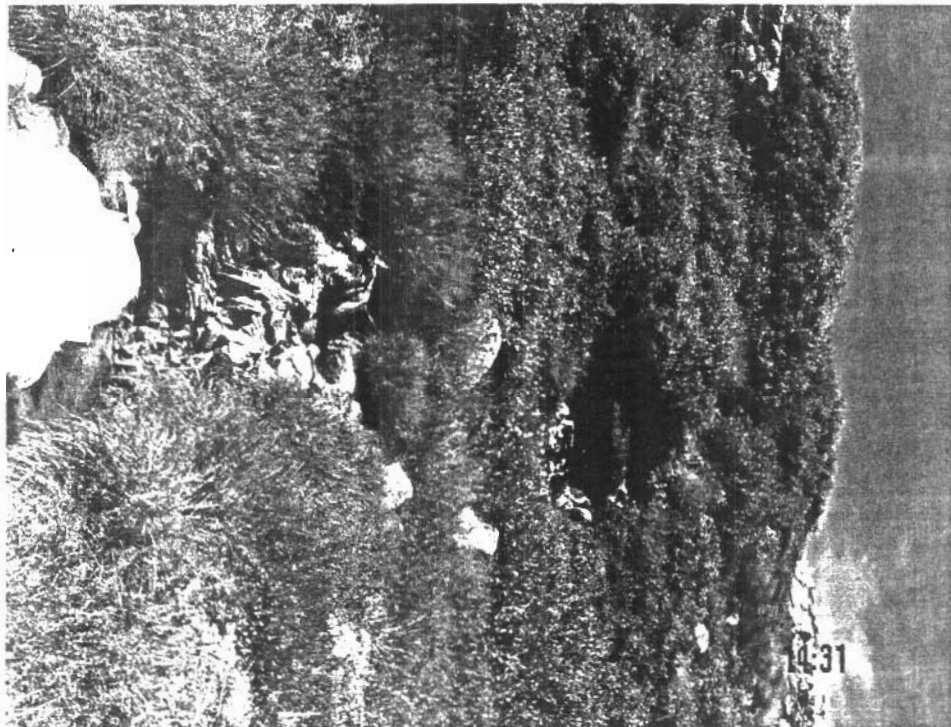
Photo # 10 Sewage discharge shown at centre of photo as effluent makes it's way to the ocean.

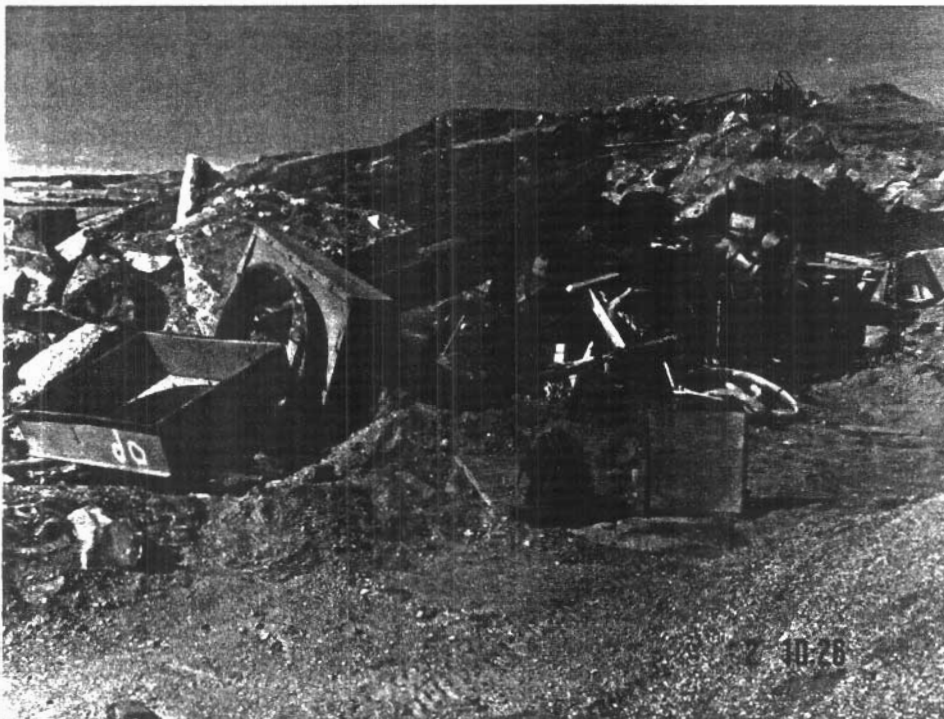
Photo # 12 Bulky metal waste, waste oil storage area located adjacent to road above current Solid Waste Disposal Facility.

Non-Compliance of Act or Licence: At the time of inspection the Water Licence for the Hamlet of Kimmirut had expired. The Water Resources Officer suggested to consolidate the waste oil from the road above the dump, and the waste oil from the Solid Waste Disposal Facility.
