WATER LICENCE INSPECTION FORM

Licensee		Licensee Representative	
Hamlet of Kimmirut		Bhabesh Roy	
Licence No. / Expiry		Representative's Title	
3BM-KIM		Regional Planning Engineer	
Land / Other Authorizations		Land / Other Authorizations	
None			
Date of Inspection		Inspector	
June 6, 2017		Jonathan Mesher	
Activities Inspected			
<input type="checkbox"/> Camp	<input type="checkbox"/> Drilling	<input type="checkbox"/> Mining	<input type="checkbox"/> Construction
<input checked="" type="checkbox"/> Roads/Hauling	<input checked="" type="checkbox"/> Other:		<input type="checkbox"/> Reclamation
			<input checked="" type="checkbox"/> Fuel Storage

On June 5, 2016, a water licence inspection was conducted at the Hamlet of Kimmirut, Qikiqtani Region, Nunavut. Sites inspected included the Raw water source, Solid waste disposal facility and the sewage dumping area.

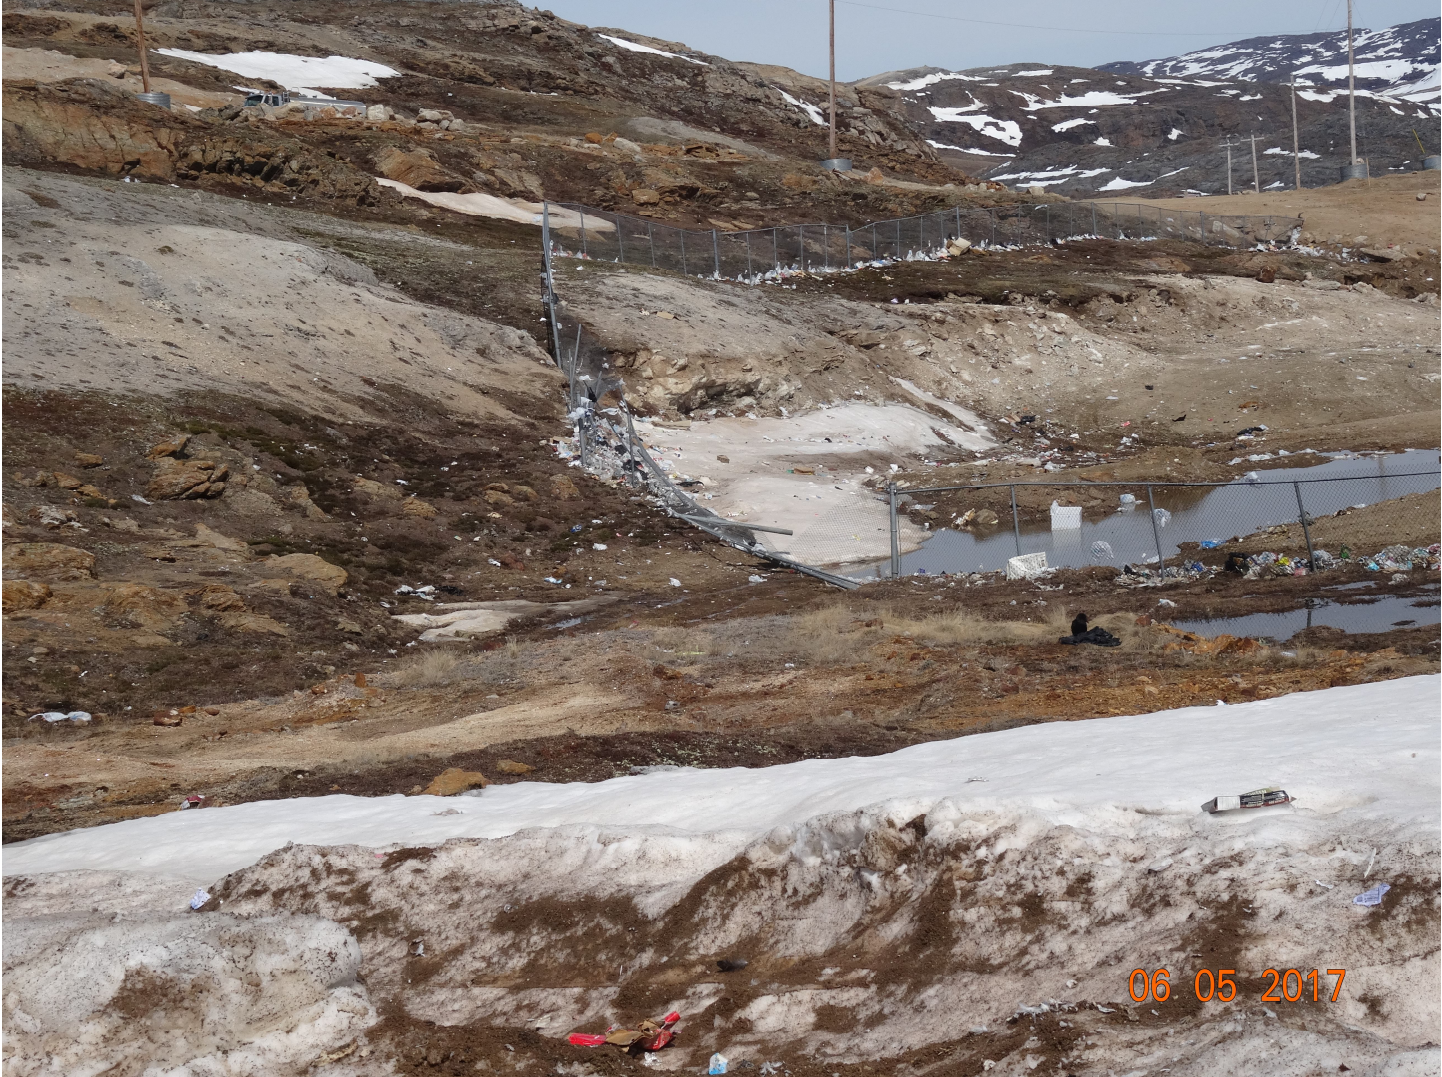
- c. Part D section 8 of the expired water licence 3BM-KIM0911 states, The Licensee shall implement measures to control wind-blown litter at the Solid Waste Disposal Facility. At the time of the inspection the fence around the facility was not properly maintained, it is recommended that the Hamlet of Kimmirut repair the fence to control wind-blown litter. See *Figure 1*.

Figure 1: wind-blown litter control

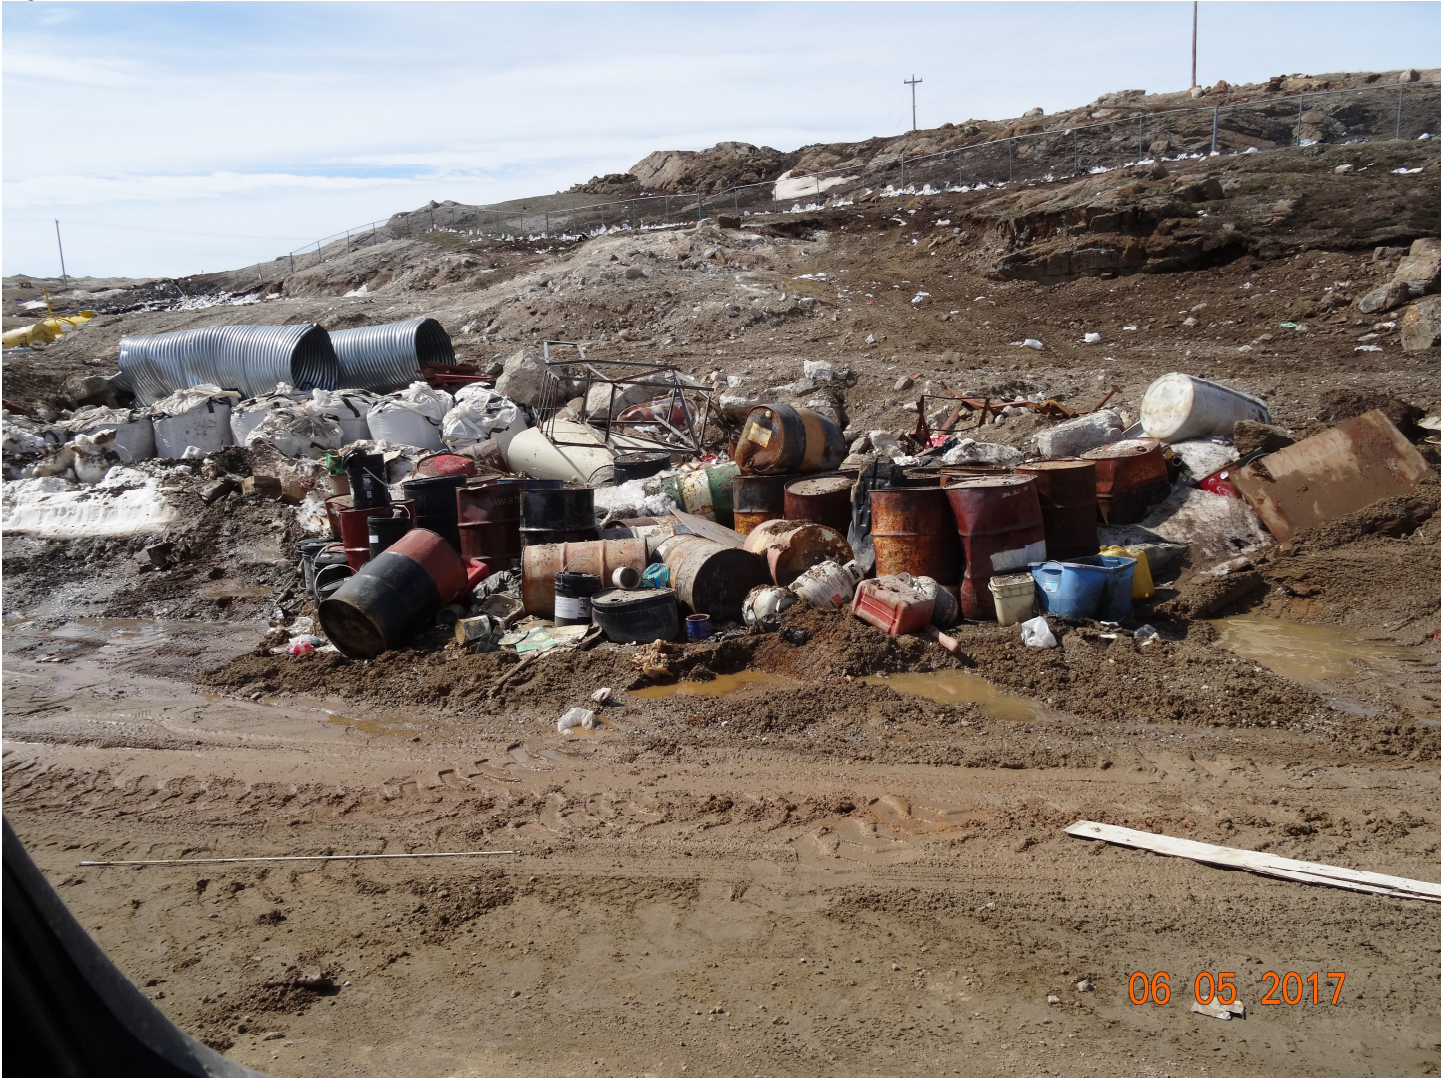
4. Hazardous Waste
  - a. The hazardous waste is currently stored within the solid waste disposal facility.
  - b. Part D section 7 of the expired water licence 3BM-KIM0911 states, The Licensee shall segregate and store all hazardous materials and/or hazardous waste, including waste oil, within the Solid Waste Disposal Facility in a manner as to prevent the deposit of deleterious substances into any water until such a time as proper disposal arrangements is made.

- i. The storage of Hazardous Waste does not appear to the inspector to be segregated, nor does it have the capability to contain contact water or to divert upstream flow around the Hazardous material. See Figure 2.

Figure 2: Hazardous Waste segregation

- ii. It is recommended that the Hamlet of Kimmirut properly store the Hazardous material such in a manner as to prevent the deposit of deleterious substances into any water, as required in the expired Water Licence 3BM-KIM0911.
