WATER LICENCE INSPECTION FORM

Licensee	Licensee Representative
Hamlet of Kimmirut	Bhabesh Roy
Licence No. / Expiry	Representative's Title
3BM-KIM0911 Expired January 2011	Municipal Engineer
Land / Other Authorizations	Land / Other Authorizations
Date of Inspection	Inspector
July 3, 2018	Joseph Monteith & Jonathan Mesher
Activities Inspected	
<input type="checkbox"/> Camp	<input type="checkbox"/> Drilling
<input type="checkbox"/> Roads/Hauling	<input type="checkbox"/> Mining
	<input checked="" type="checkbox"/> Other: Potable Water Source, Waste Water Treatment, and Solid Wastes
	<input type="checkbox"/> Construction
	<input type="checkbox"/> Reclamation
	<input type="checkbox"/> Fuel Storage
	<input type="checkbox"/> Other:

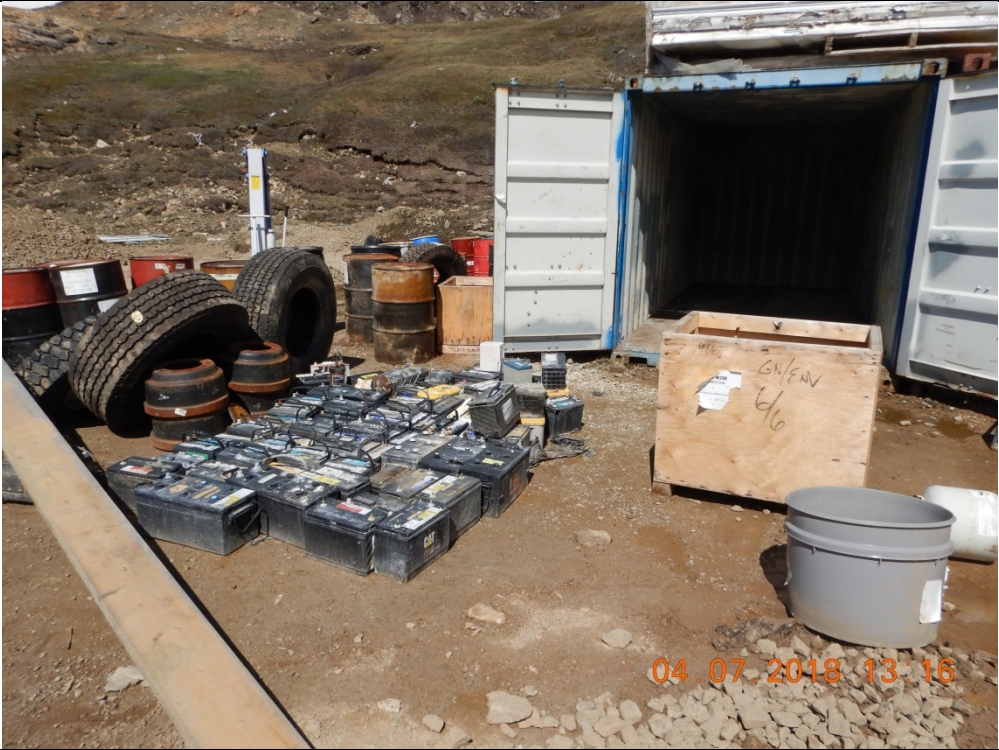
Photo Log
Photo 5

9. During the course of the inspection it was observed that the hazardous waste was located at two locations. The Solid waste facility which had the hazardous waste was exposed to the elements (Photo 4). This site is not lined, and has the potential to mix with fresh water during rainfall, and during the freshet, and at the Municipal Garage. At the municipal garage Hazardous Waste is stored within sea cans behind the municipal garage. At the time of the inspection some of the hazardous waste was taken out the sea cans, so that sea-cans can be cleaned (Photo 5).

Description: sea can being cleaned with hazardous waste batteries stored out in the elements – not a concern

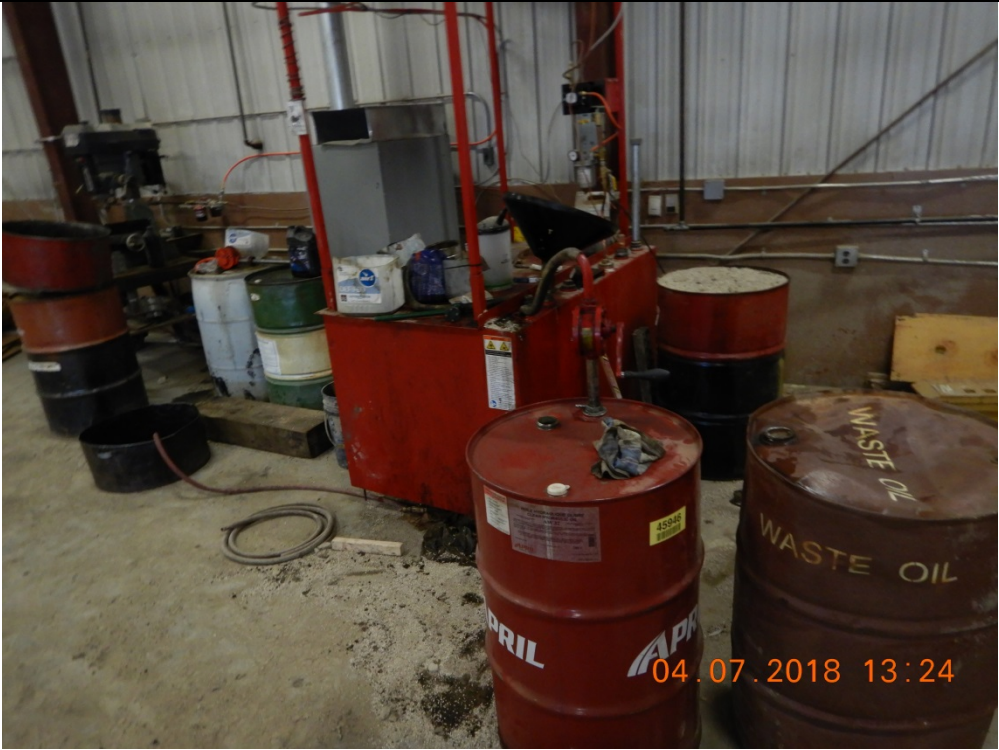
Photo Log
Photo 6

10. The Hamlet of Kimmirut uses a waste oil burner to heat up the municipal garage (photo 6).
11. Garbage blown from the Solid Waste Disposal Facility was observed within the drainage ditch of the Waste Water Discharge Location (photo 3).

Description: Waste Oil Burner used to heat up the municipal garage
