August 9, 2001 Municipal Water Use Inspection - Report

MUNICIPAL WATER USE INSPECTION FORM

Date: 2001/08/09 Licensee Rep. (Name/Title): Phillip Katak / Foreman
Licensee: Hamlet of Kugluktuk Licence No.: N7L4-1526

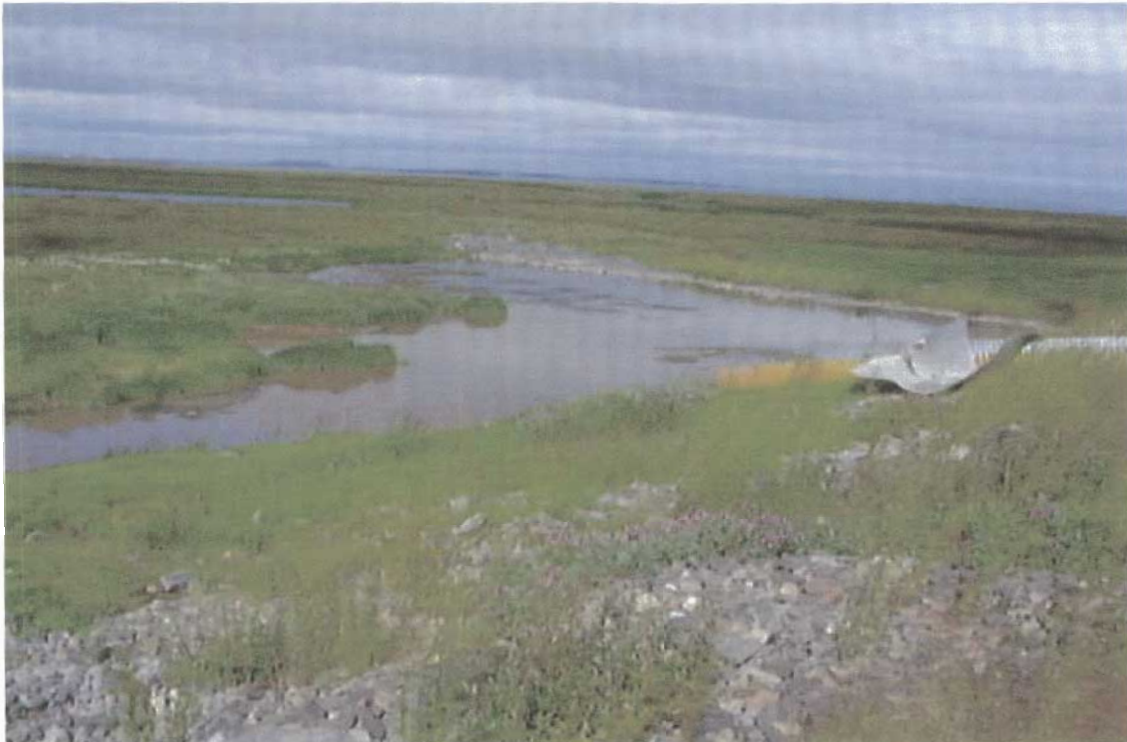
- **Sewage disposal:** The fairly limited capacity of the sewage disposal facility (figure 2) restricts the retention and treatment time provided to sewage effluent prior to its release to receiving waters. Accordingly, the attached analytical results relating to a sample collected from Surveillance Network Program (SNP) station 1526-2 (figure 3) reveal noteworthy levels of faecal coliform (1 470 000 CFU/100ml), as well as concentrations of ammonia (49 mg/L vs 2.2 mg/L) and phenols (100 µg/L vs 4 µg/L) exceeding the *Canadian Water Quality Guidelines for the Protection of Freshwater Aquatic Life*. Moreover, the Microtox sample, which constitutes a reliable toxicity indicator (IC₅₀), shows that half of light-producing bacteria were inhibited by a sample concentration of 6.4%, whereas 50% and over is considered non-toxic. In light of this, even if the abundant vegetation along the discharge path likely provides significant effluent treatment, efforts should be taken to increase the retention time prior to discharge from the sewage disposal facility.

figure 2. Sewage disposal facility; 2001/08/09.

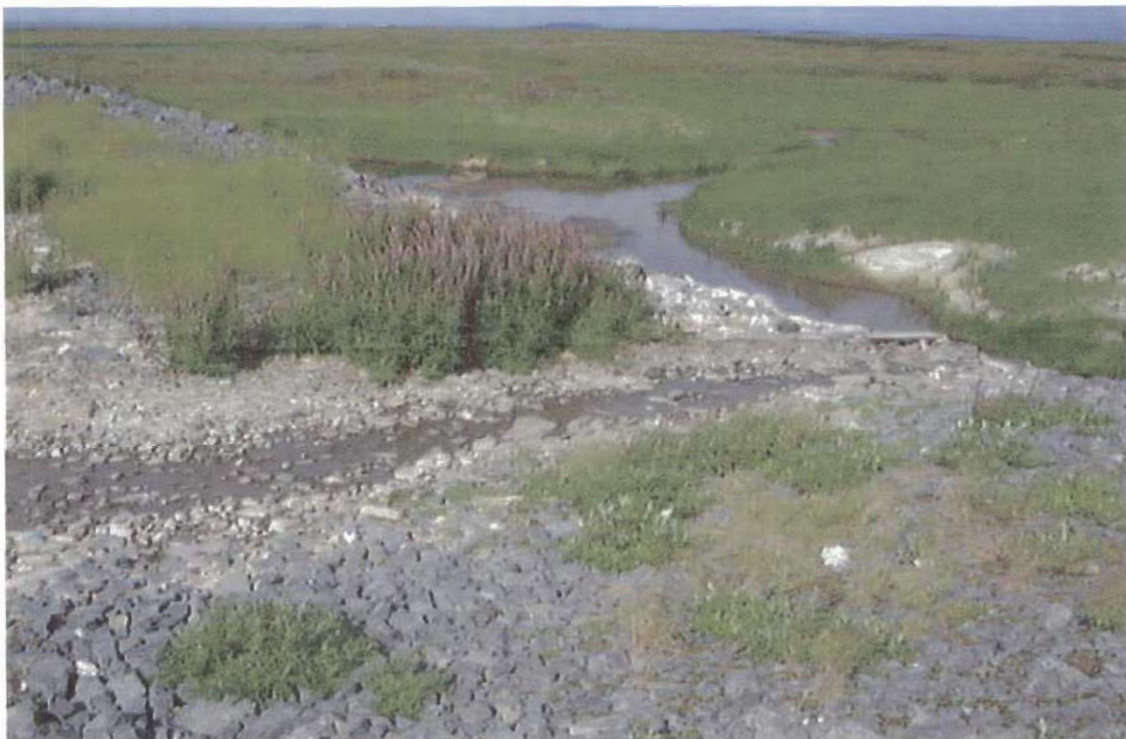
Comments: Sewage effluent flows over the gravel retention berm; abundant vegetation along the discharge path. Significant segregation of wastes at the solid waste disposal facility. Perimeter fence partly torn down; replacement awaited on the summer's sealift. Wastepile covered twice per year (spring and fall). Pooled water and marshy area along the toe of the dump.

figure 3. Discharge from the sewage disposal facility; 2001/08/09.

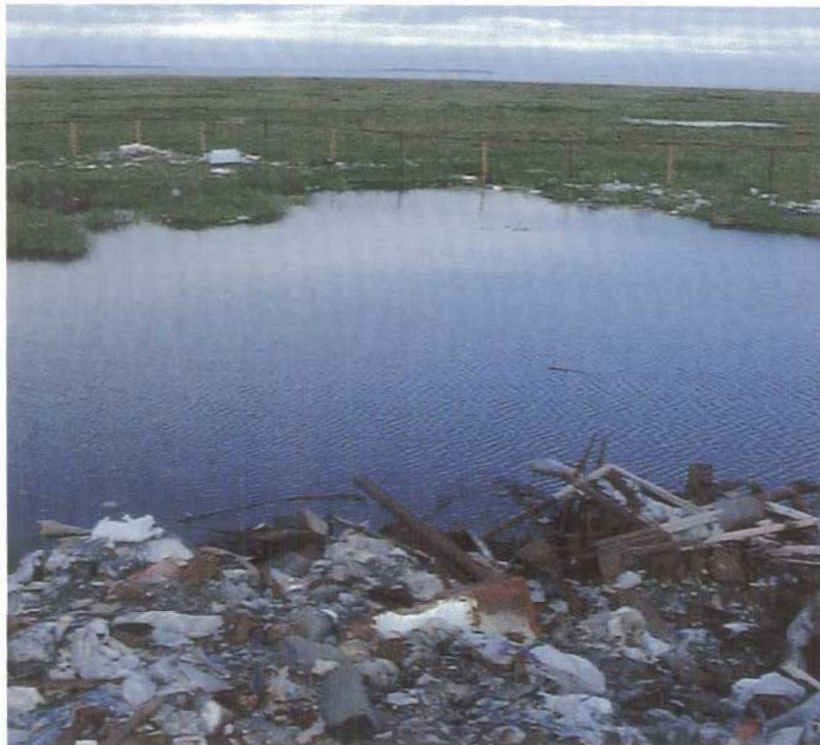
- **Solid waste disposal:** At the time of the inspection, runoff from the pooled water at the toe of the solid waste disposal facility (figure 4) was observed flowing onto the marshy area beyond. Thus, the attached analytical results relating to a runoff sample taken from SNP station 1526-4 indicate that concentrations of iron ($983 \mu\text{g/L}$ vs $300 \mu\text{g/L}$) and zinc ($79 \mu\text{g/L}$ vs $30 \mu\text{g/L}$) slightly exceed the *Canadian Water Quality Guidelines for the Protection of Freshwater Aquatic Life*; however the microtox sample did not attribute toxicity to the leachate. In related matters, waste undergoes considerable segregation; bulky metal wastes are set aside (figure 5), as are hazardous materials and waste oil (figure 6). In addition, above current storage practices, the Licensee is contemplating means of disposal for hazardous materials and waste oil.

figure 4. Pooled water at the toe of the solid waste disposal facility; 2001/08/09.

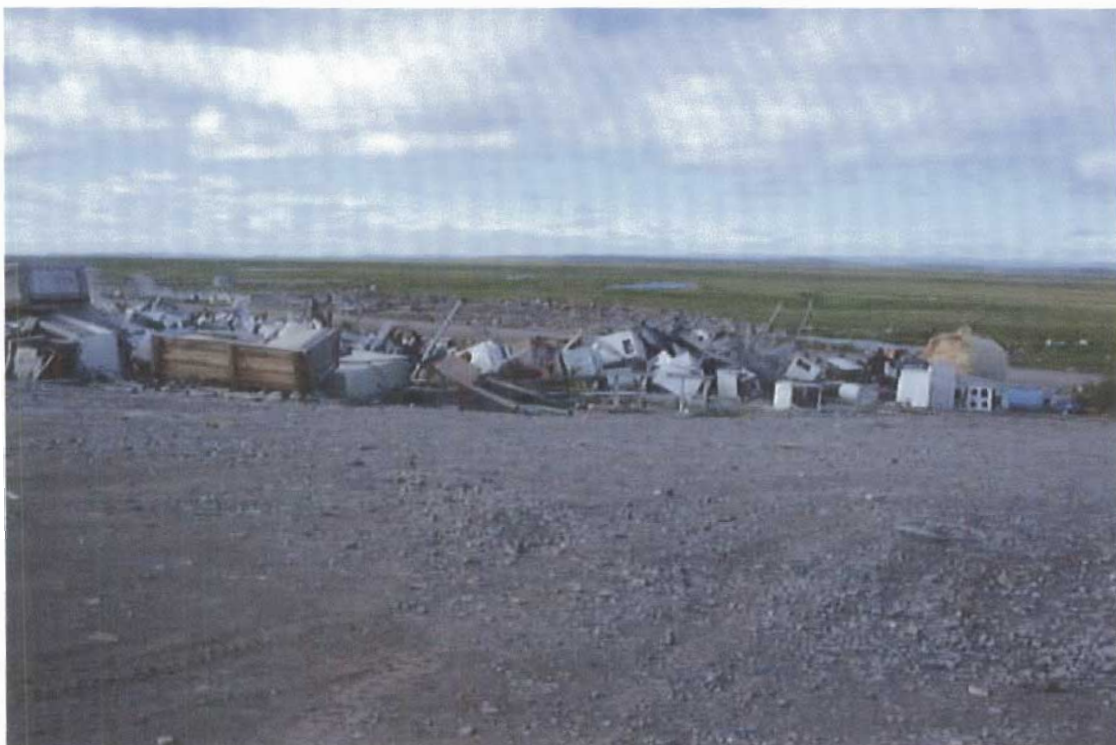
figure 5. Bulky metal wastes disposal site, with dump in background; 2001/08/09.

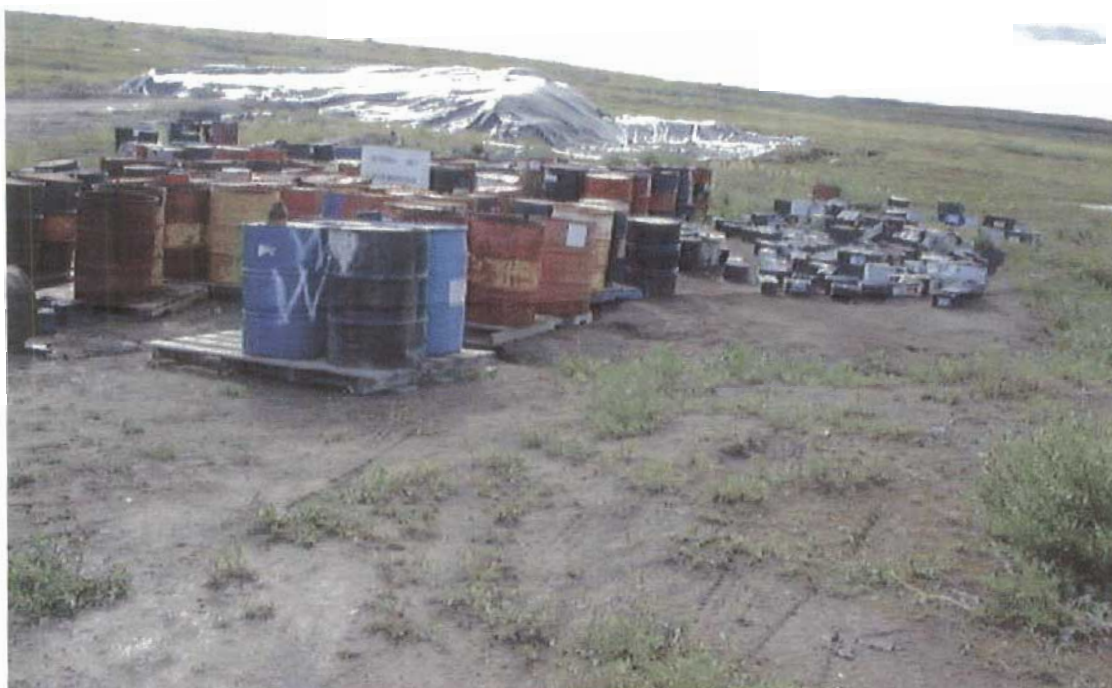
figure 6. Hazardous materials storage site, with landfarm in background; 2001/08/09.
