# ANNUAL REPORT FOR THE MUNICIPALITY OF KUGLUKTUK

YEAR BEING REPORTED: 2024

The following information is compiled pursuant to the requirements of Part B, Item 1 of Water License No. 3BM-KUG2030 issued to the Municipality of Kugluktuk.

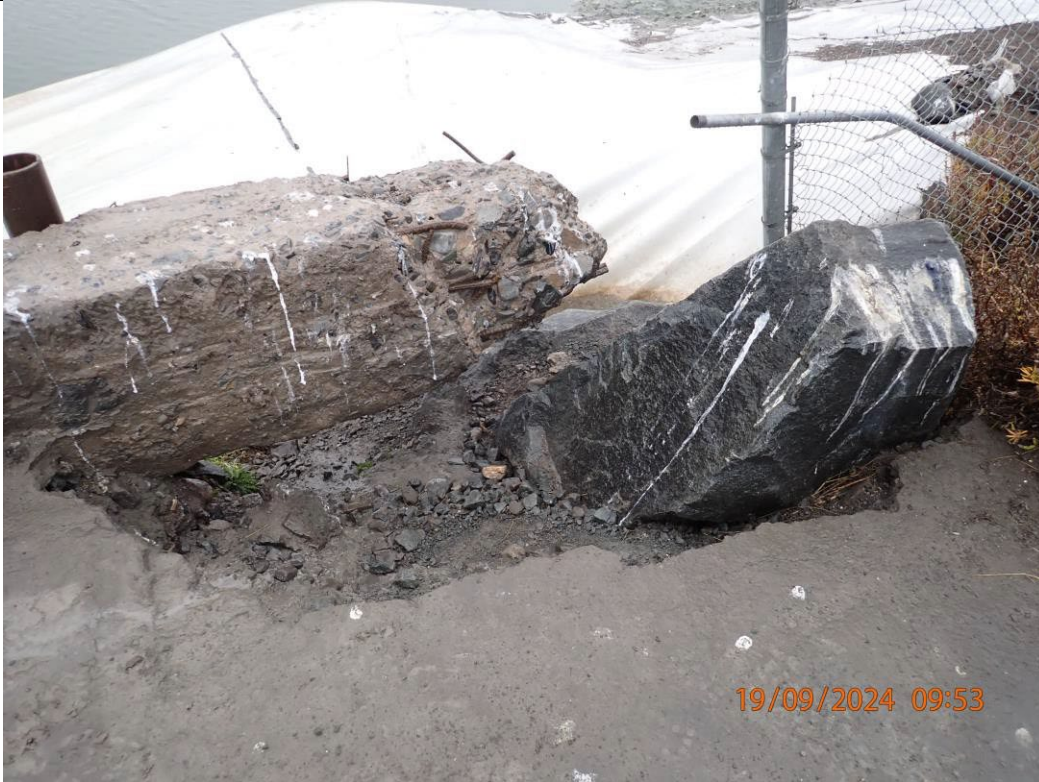
Photo #2

Another view of the erosion extent and the loss of berm structure under the concrete barrier.

In regards to non-compliance issue #1: Part D Item #6 of the issued water license states: *"The sewage disposal facility shall be maintained and operated, to the satisfaction of an Inspector and in such a manner as to prevent structural failure"*. Please ensure that discharged sewage is not causing erosion of the truck pad on the east side of the lagoon.

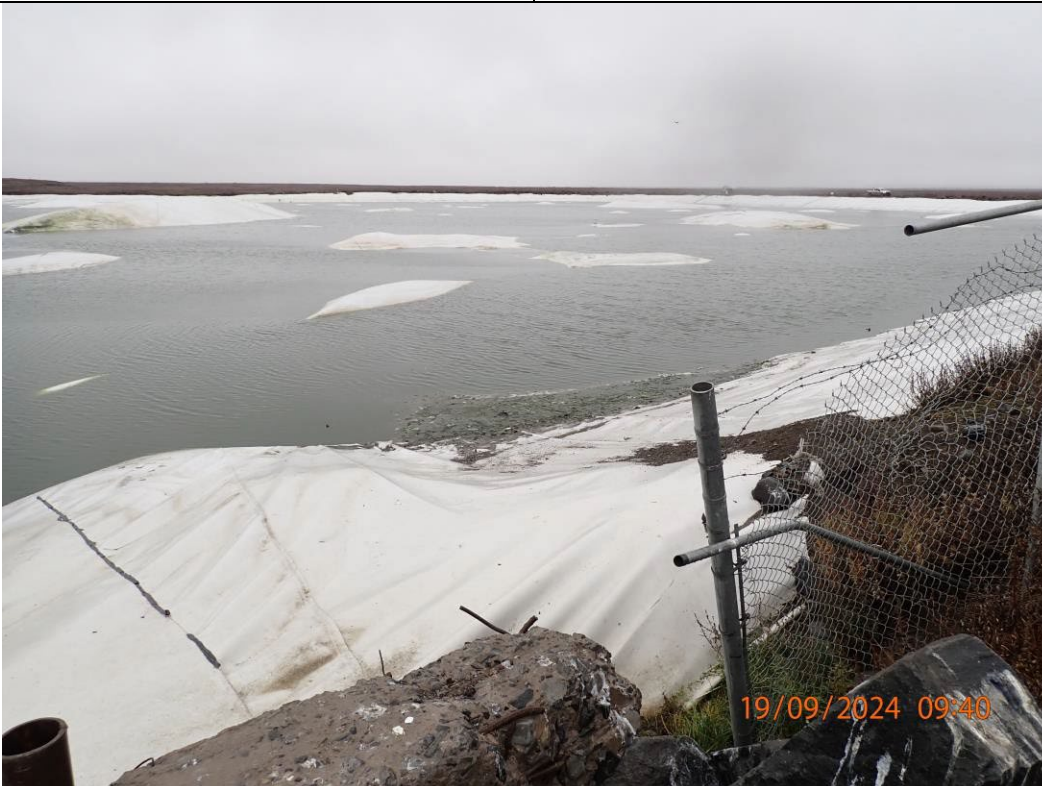
Photo #3

The image shows the broken and sunken fence and the “toe” caused by material slumping into the lagoon under the liner.

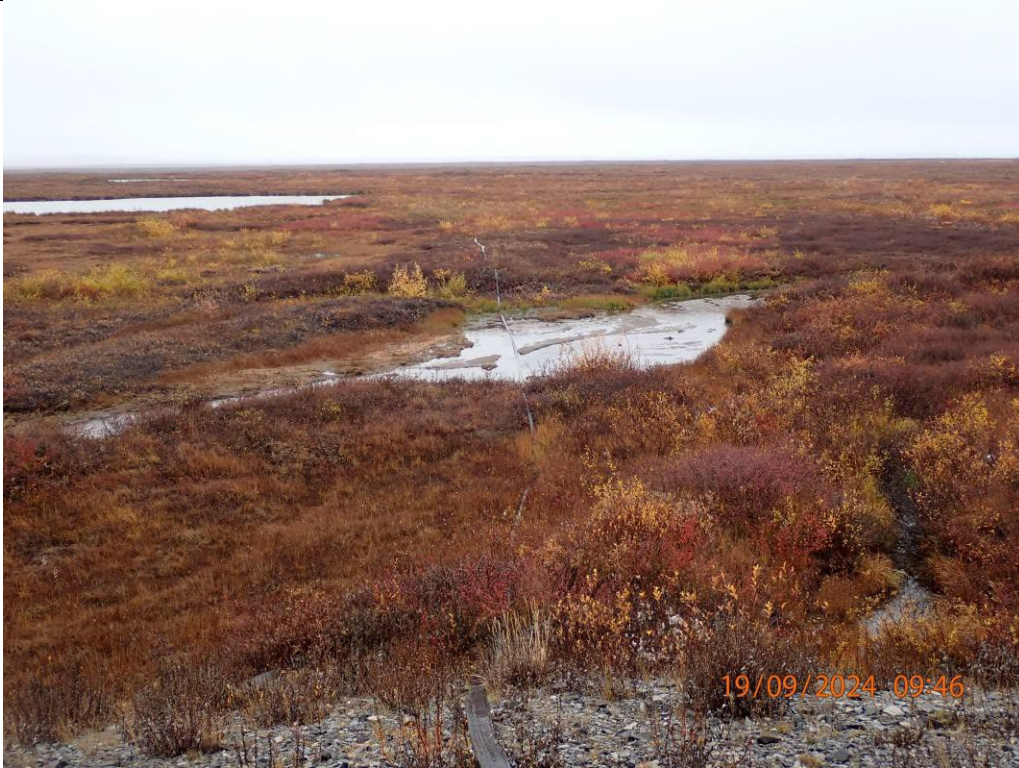
Photo #4

Decanting hose is placed into the receiving environemnt far away from the lagoon. No issues noted.

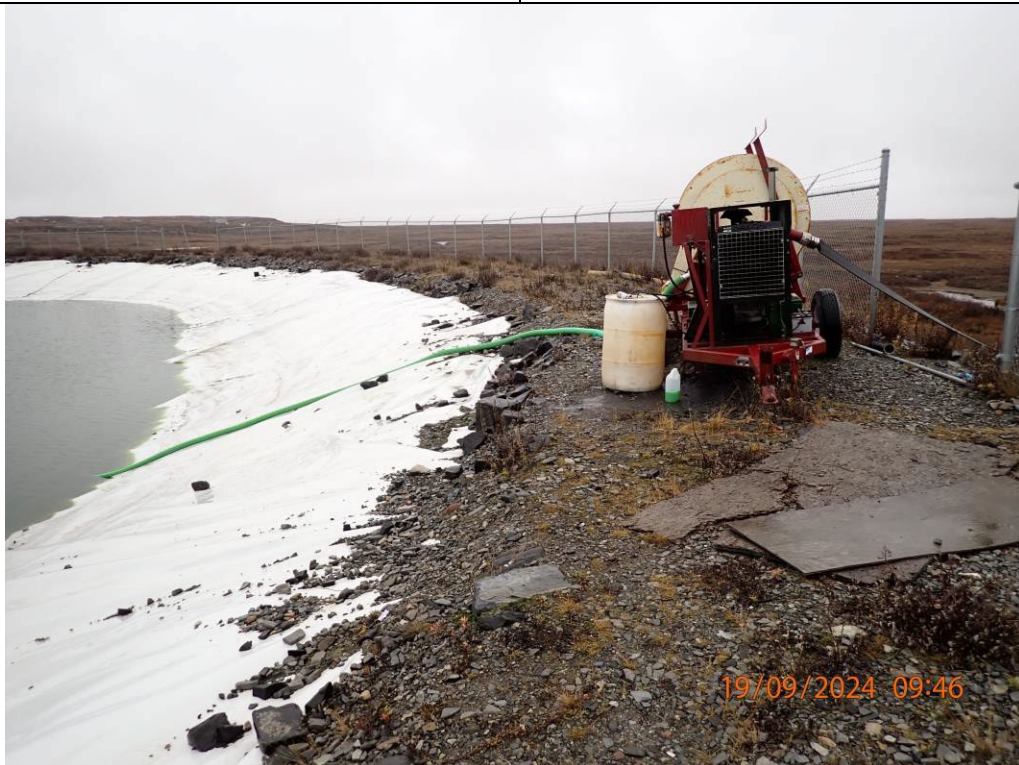
Photo #5

Water pump used to decant.

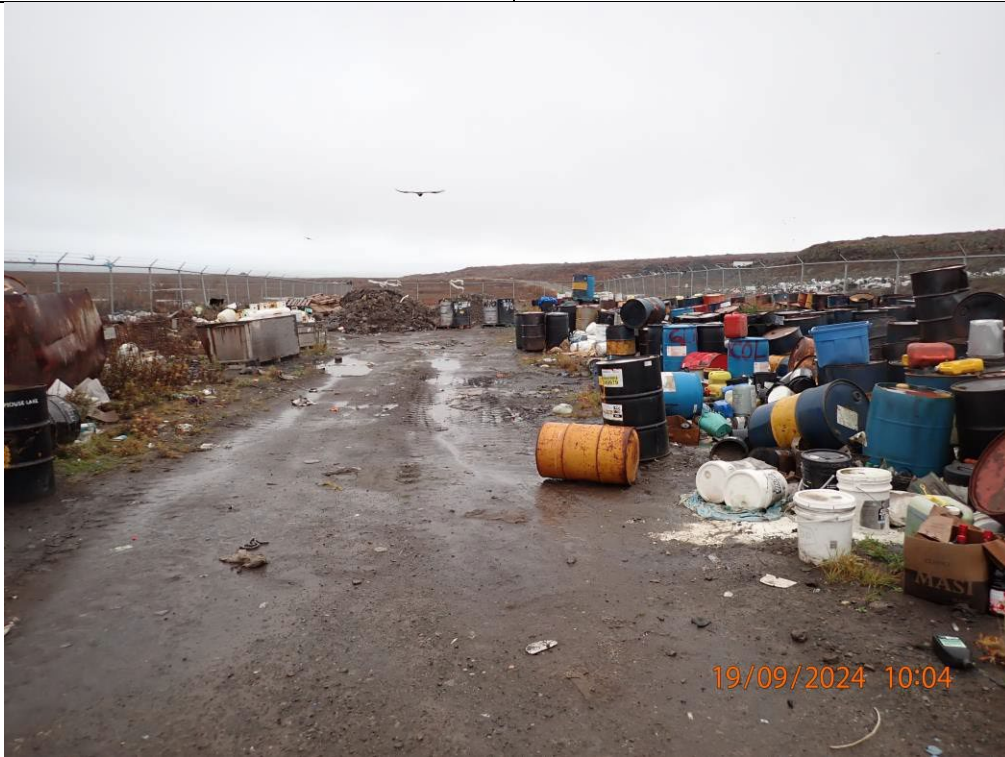
9. (Photo #10) is of the "Landfarm" area. The south east corner of the solid waste facility (open burn area). This area has not been cleaned as per the inspectors request in pervious years reports and is still being used as an "hazardous waste" section. Piles of contaminated soil are present in the middle of this area. These piles are creating an obstacle which hinders the hamlets ability to access the back portion of the landfarm. This greatly reduced the available usable space of the landfarm. (Photo #11) shows the backside of these piles.

Landfarm, with various hazardous waste

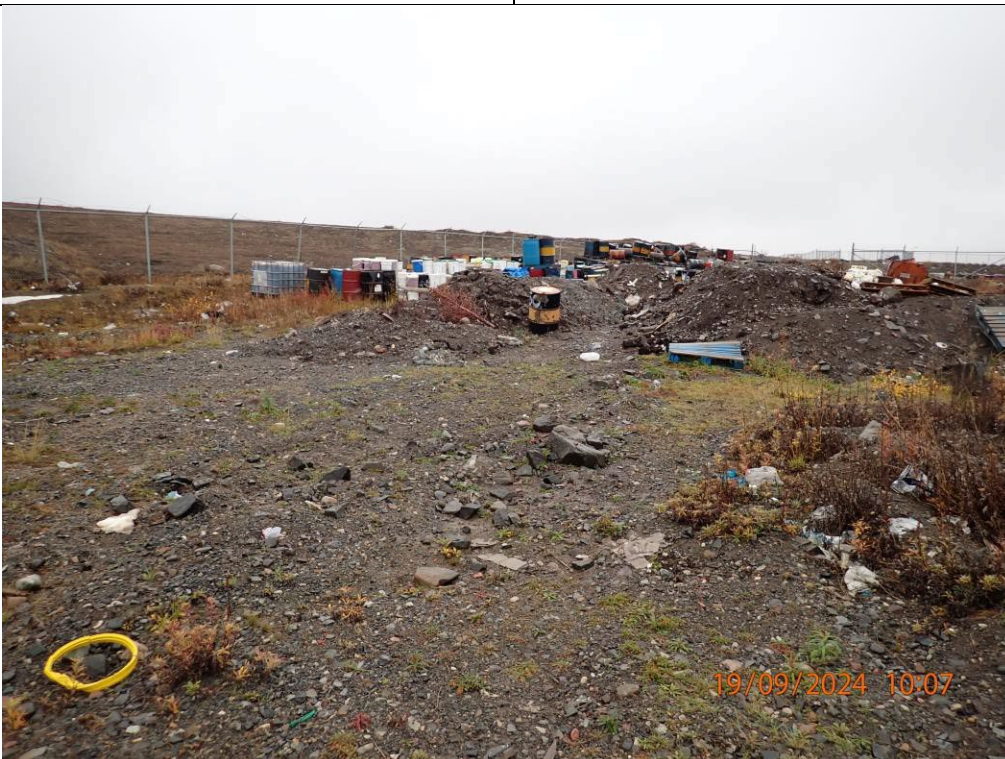
Backside of the landfarm showing contaminated soil piles blocking access.

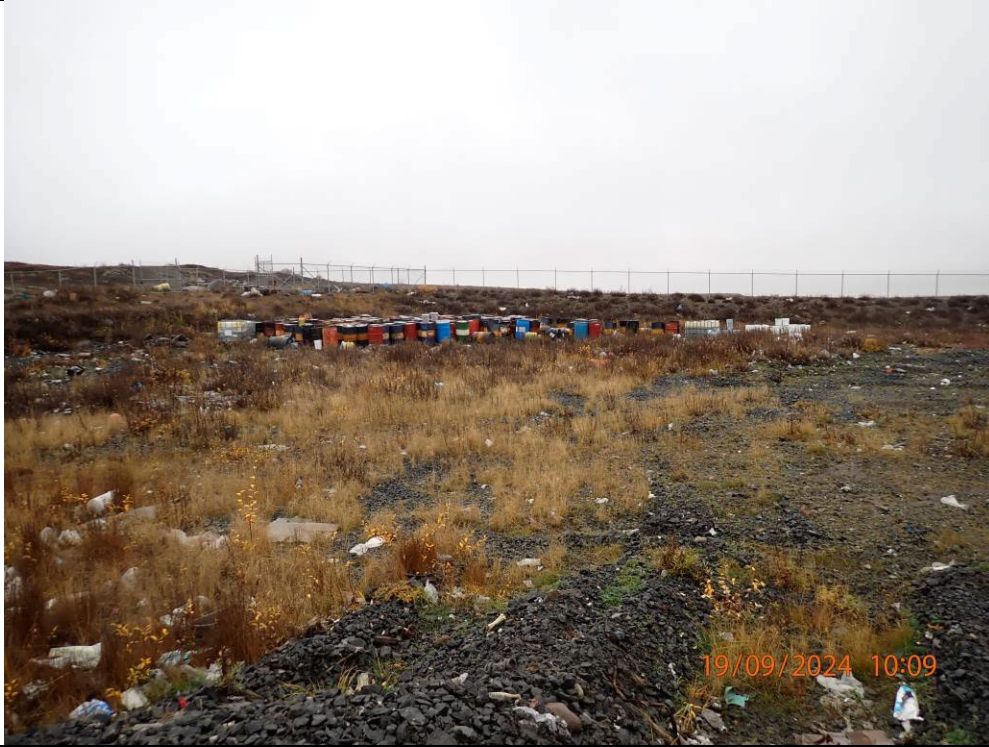
12. (Photo #14) shows "un-burnable" product such as glycol and other hazardous material stored away from the oil burner. These drums were tested and deemed unfit for burning. These barrels should be placed into the Hazardous waste section (south west side of the solid waste facility)

Un-burnable waste drums shown stored away from the oil burner. This product was tested and deemed unfit for burning.

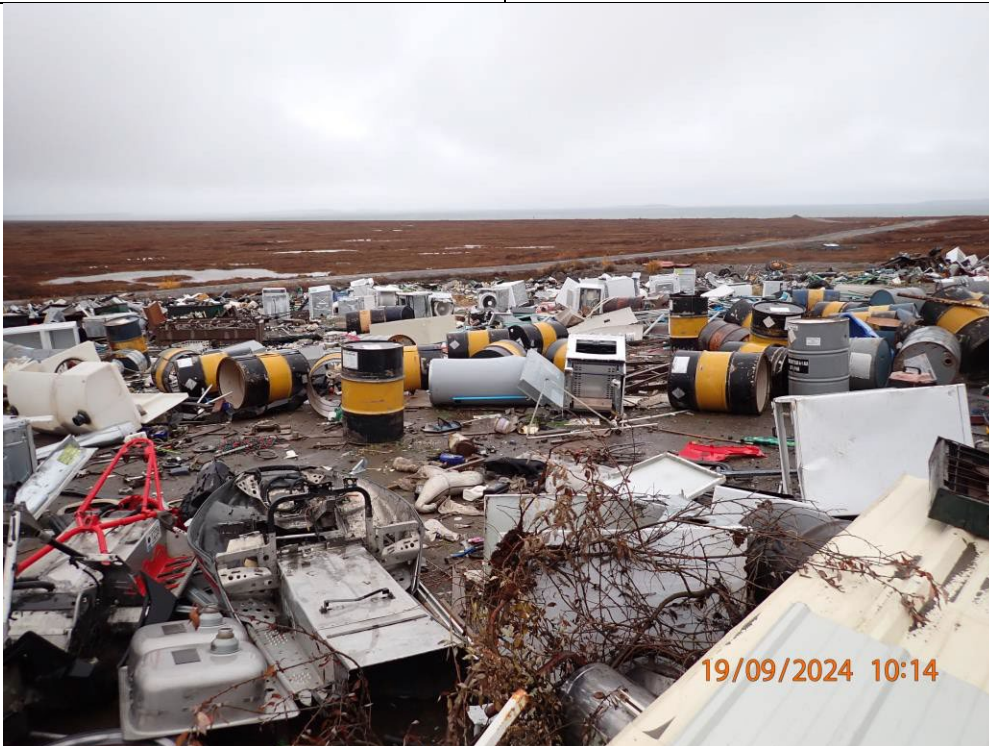
Used oil drums found found inside the bulk metal facility.

In regards to non-compliance issue #3: -Propane bottles stored on the ground should be placed in boxes and stored for shipment. -Batteries stored on the ground should be placed in the appropriate boxes and stored for shipment. -Hazardous waste/waste fuels stored in the Landfarm should be consolidated and placed in the appropriate hazardous waste section (South West corner of the solid waste facility). -Batteries stored in the landfarm should be consolidated with the rest of the batteries and placed in appropriate boxes and stored for shipment. -White wastes and fuel drums mixed in with bulk metals should be sorted and separated from bulky metals and placed in their appropriate areas.

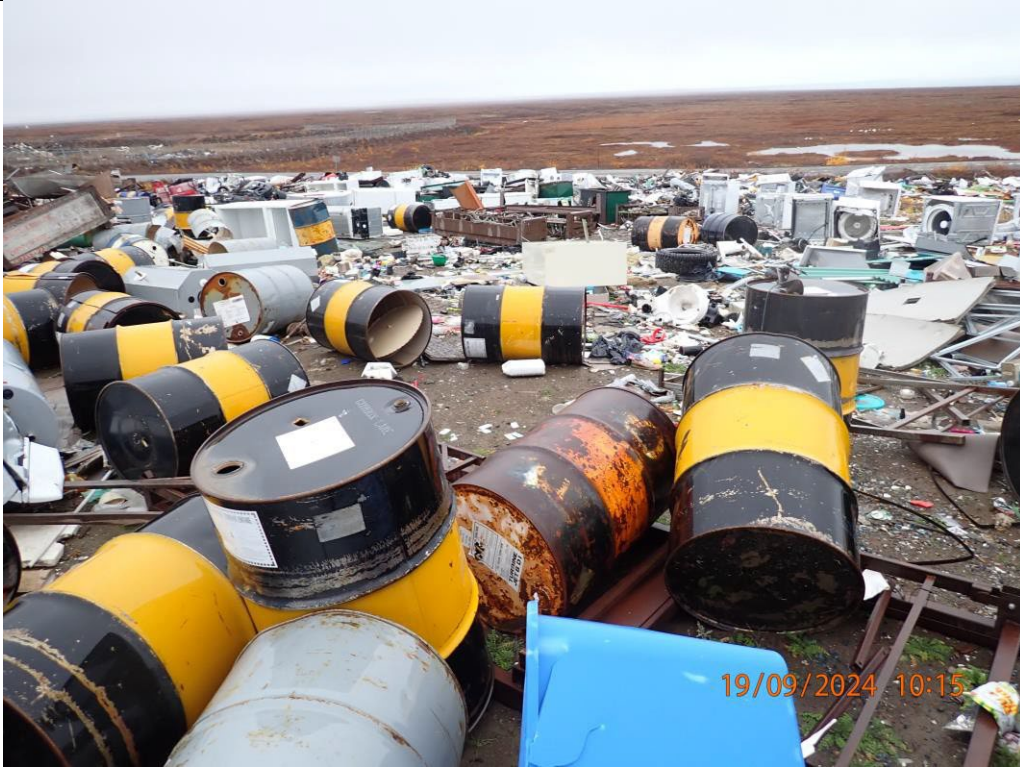
Photo #16

13. (Photo #15 and #16) The bulky metal facility was observed to have old fuel drums and white waste (fridges and freezers) mixed in with various bulky metals. Some of these used fuel drums were cut up and dismantled while others were observed to have holes poked into them and are leaking small amounts of Diesel fuel into the metal dump. The drums that are not cut up should be moved to the hazardous waste storage, dismantled drums that are shown to be clean may stay within the bulky metal facility.

White wastes and fuel drums amongst bulk metal

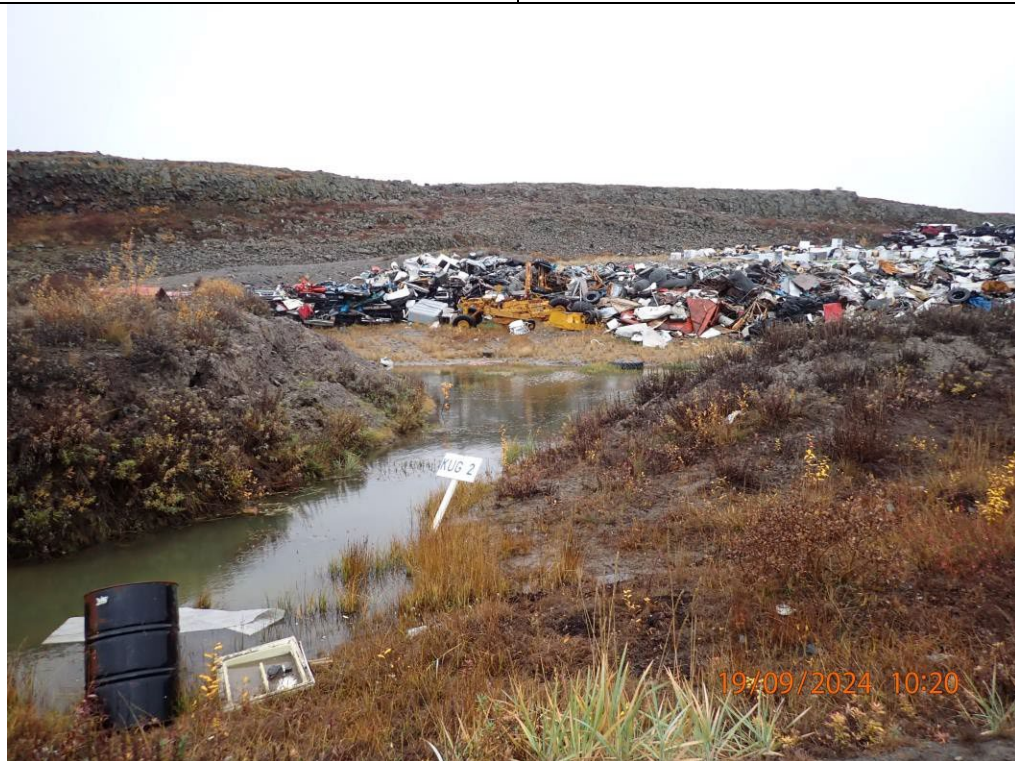
Photo #17

Kug 2 sample location at bulk metal facility. Showing stagnant water.

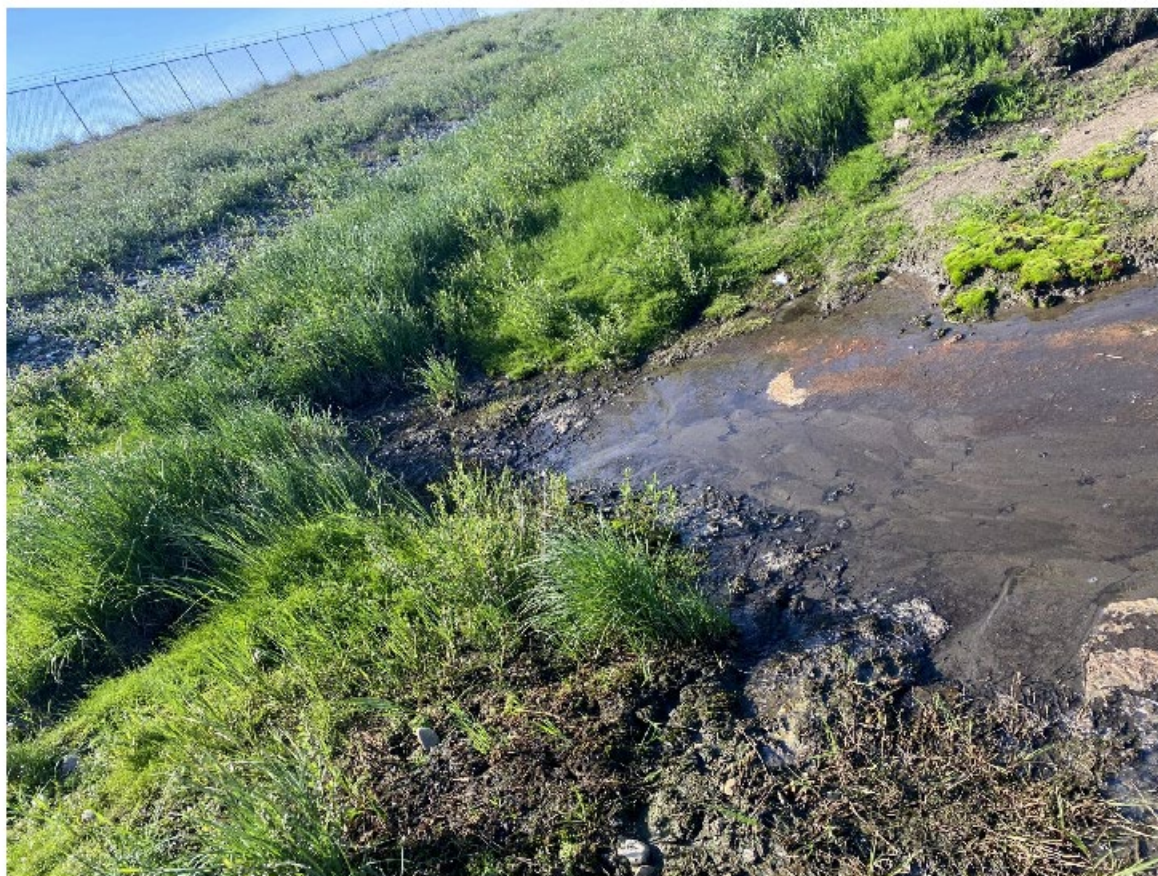
**Figure 1: Potential leak site below the north-east side berm July 17, 2024.**

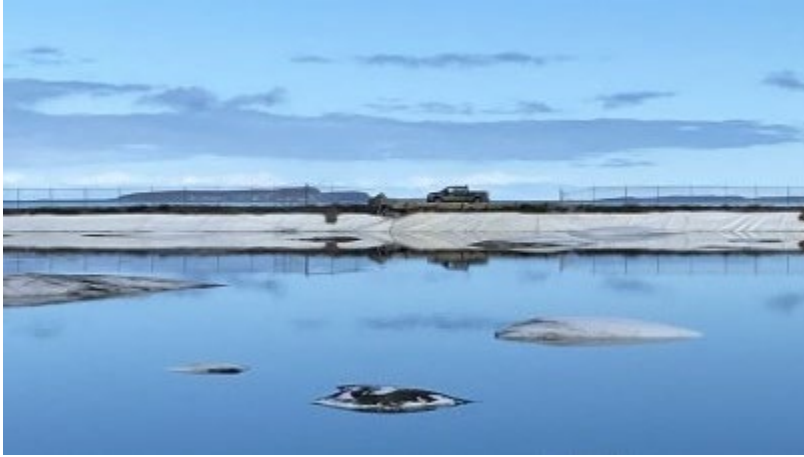
The erosion at the truck discharge site is not unilaterally imparted, suggesting either a more dynamic force or multiple sources. Possibly related to progressive slumping and increased sites of leaks noted by the Inspector. A Planning project has been approved to develop a business case to determine if rehab or relocation of the lagoon is the correct approach. The two-year planning project is anticipated to begin summer 2025. Further updates are anticipated to be provided in the 2026 Annual Report. Additional photos of the erosion are included in Appendix G.

Figure 1: View of the truck fill site erosion from the opposite side of the Lagoon July 17, 2024.

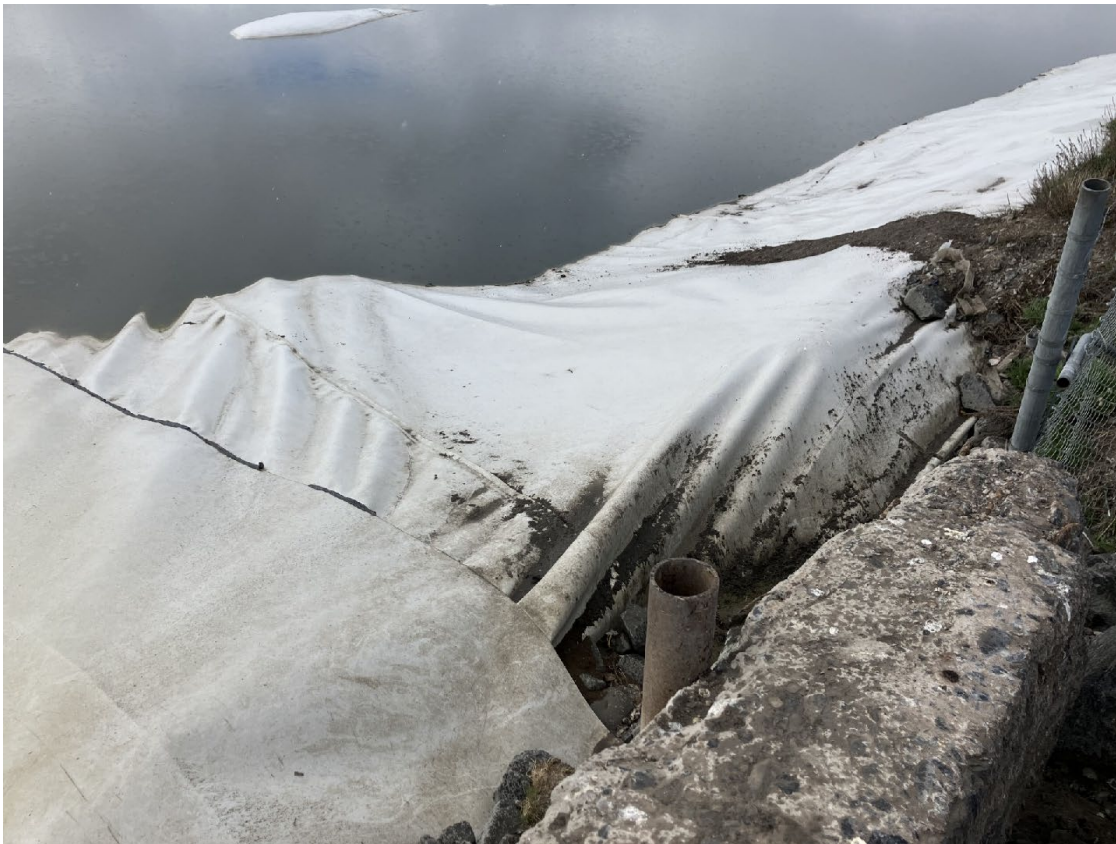
Figure 2: View of the truck fill erosion from above July 17, 2024.

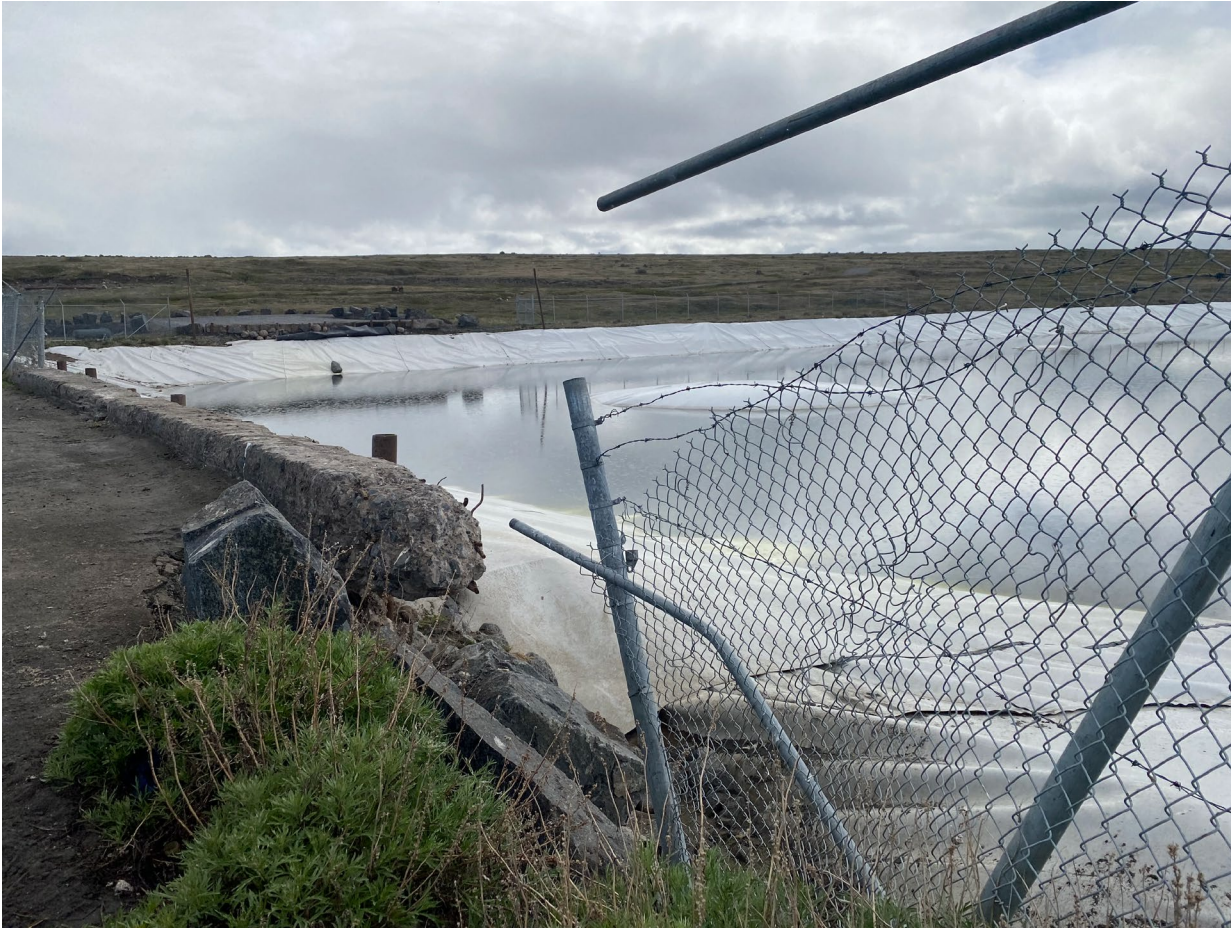
**Figure 3: View of truck fill site erosion from the north.**
