**Wetlands Assessment, Sewage Treatment  
Wetlands, Hamlet of Repulse Bay, NU**

Type of Document  
Final

Project Number  
OTT-00207086-A0

Date Submitted  
October 18, 2012

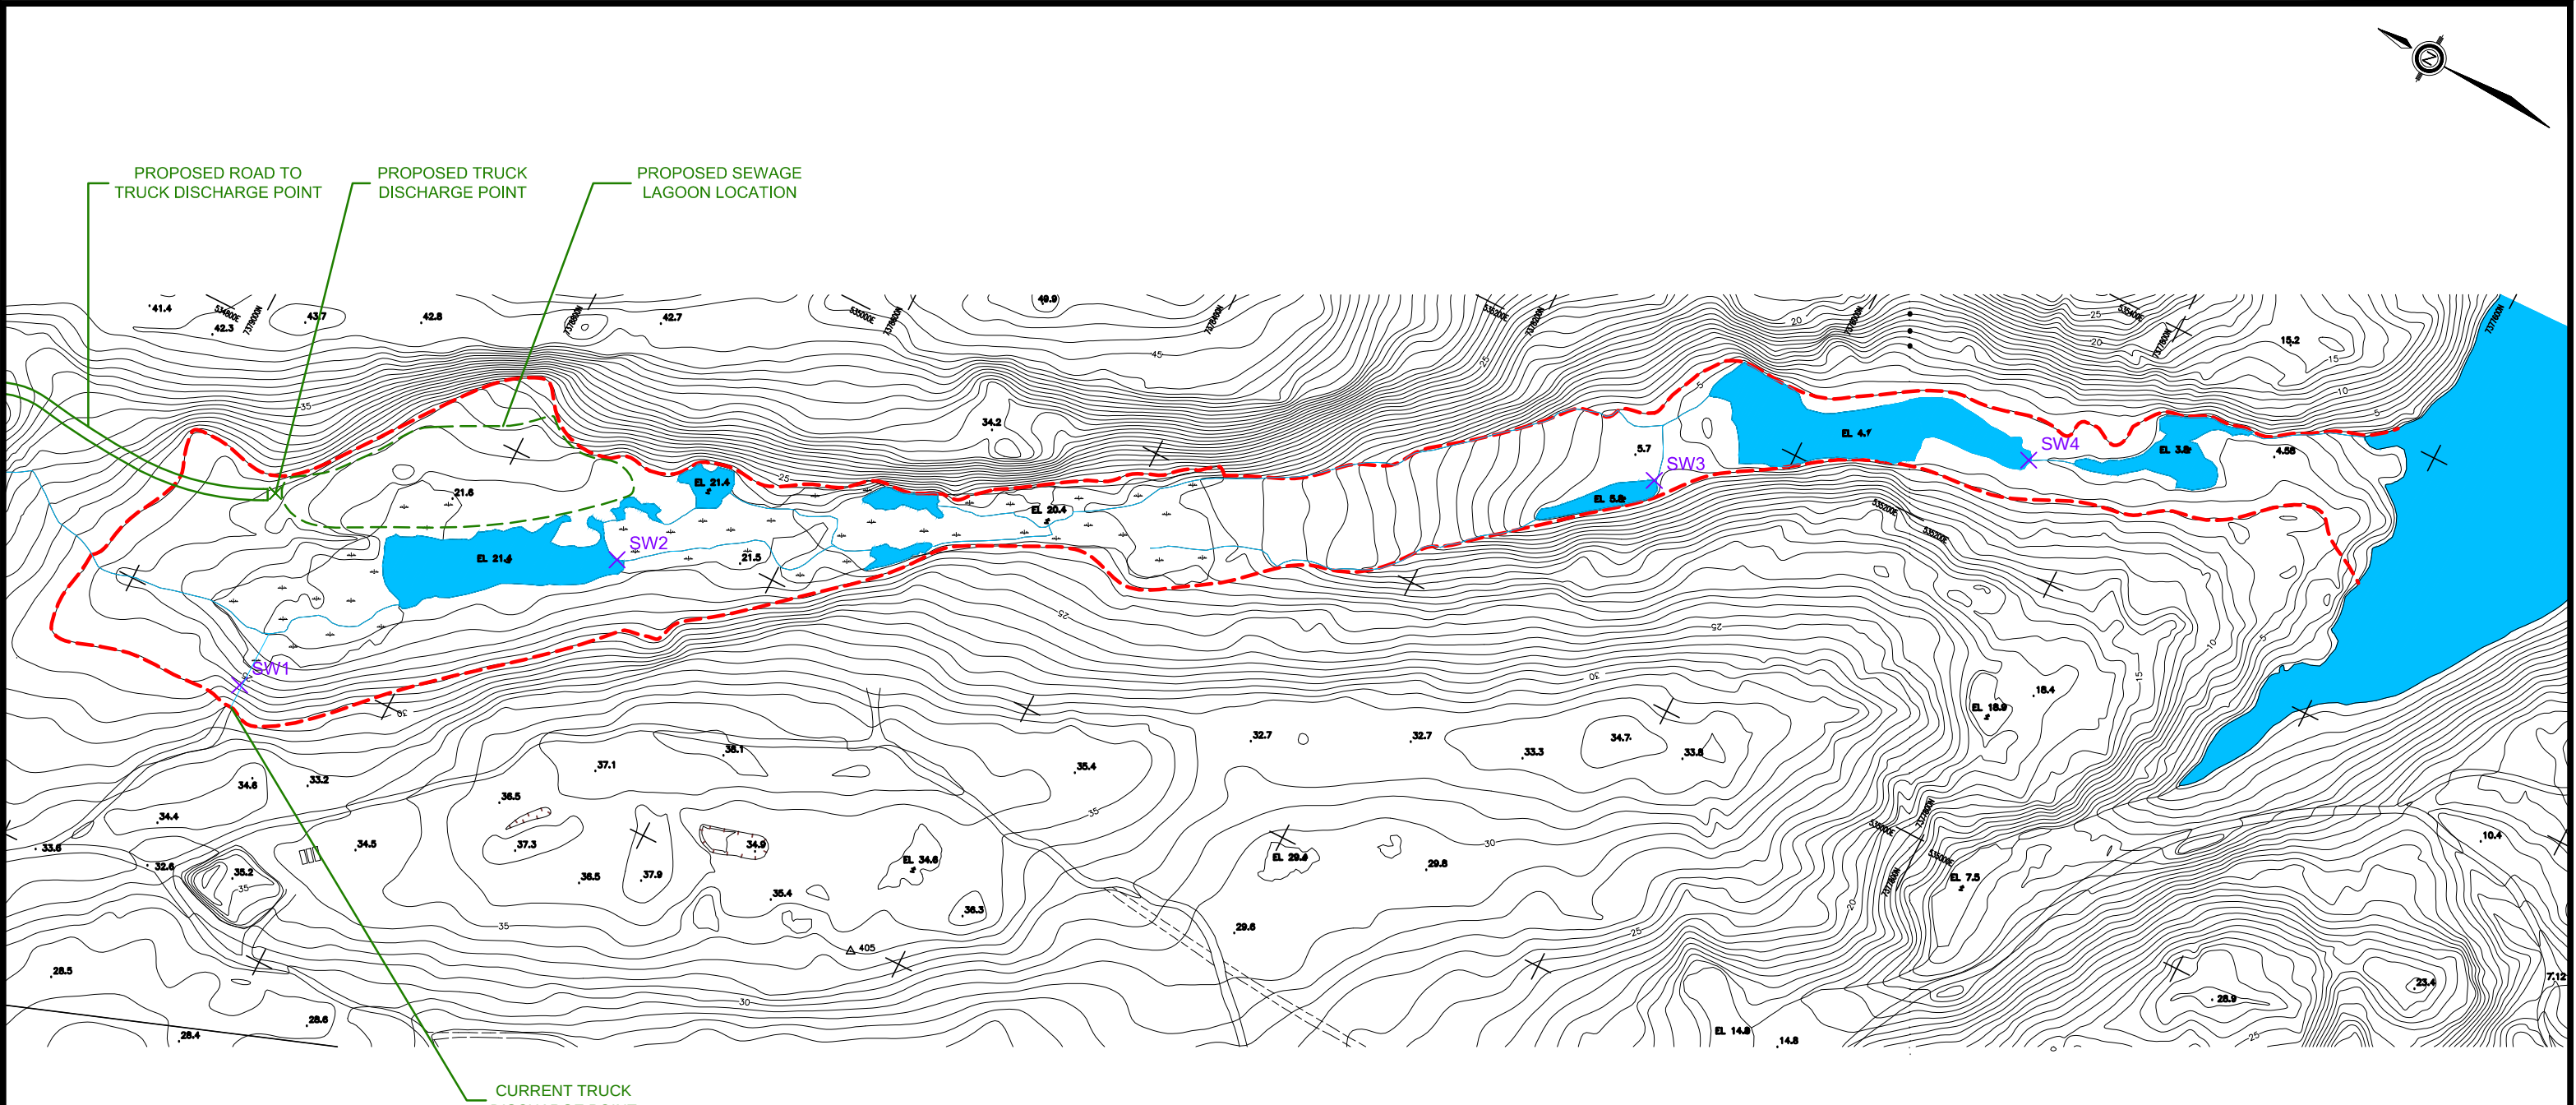
A Site visit was undertaken by exp staff in September 2012 to collect surface water samples from various locations of the sewage treatment system, which include:

- One (1) at the sewage truck discharge point (SW1);
- One (1) at the outlet of the first natural treatment pond (SW2);
- One (1) at the outlet of a natural treatment pond near the middle of the Site (SW3); and,
- One (1) at the outlet of a natural treatment pond near the discharge point (SW4).

The surface water sampling locations are presented in Figure 3, in Appendix A.
