August 29, 2001 Municipal Water Use Inspection - Report

MUNICIPAL WATER USE INSPECTION FORM

Date: 2001/08/29 Licensee Rep. (Name/Title): Steven Kopak / acting-Senior Administrative Officer
Licensee: Hamlet of Repulse Bay Licence No.: unlicenced

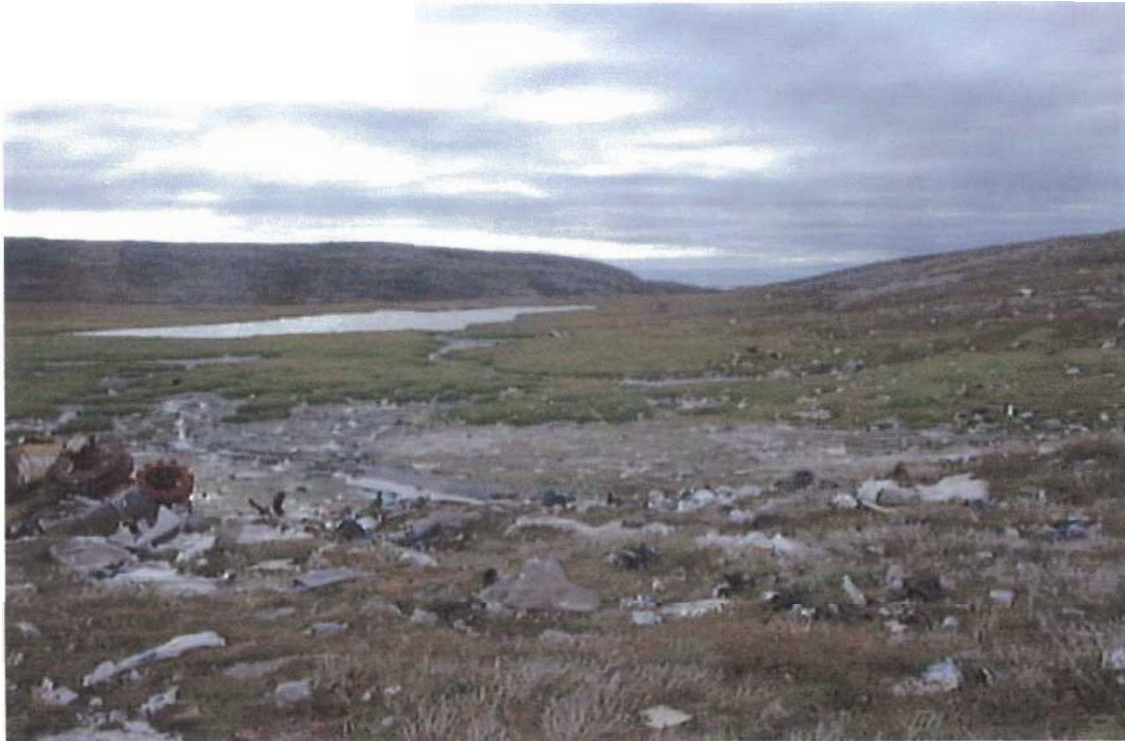
- **Sewage disposal:** As sewage effluent discharged at the truck dumping point (figure 1) flows through a series of lakes draining along a densely vegetated valley, it would seem that the sewage disposal facility provides adequate effluent treatment. However, the attached analytical results relating to a sample collected from the outlet of the first sewage lake (figure 2) reveal that the concentration of ammonia (30.4 mg/L vs 2.2 mg/L) significantly exceeds the *Canadian Water Quality Guidelines for the Protection of Freshwater Aquatic Life*. Moreover, the Microtox sample, which constitutes a reliable toxicity indicator (IC₅₀), attributed borderline toxicity to the sewage effluent discharge; half of light-producing bacteria were inhibited by a sample concentration of 50.5%, whereas 50% and under is considered toxic. Unfortunately, due to flight scheduling limitations, bacteriological parameters could not be analysed. Accordingly, in an attempt to determine if an initial retention structure prior to the discharge of sewage effluent to receiving waters is required to ensure sufficient treatment, a wider range of parameters will be sampled during the next water use and waste disposal inspection.

figure 1. Sewage discharge point along the toe of the solid waste disposal site;2001/08/29.

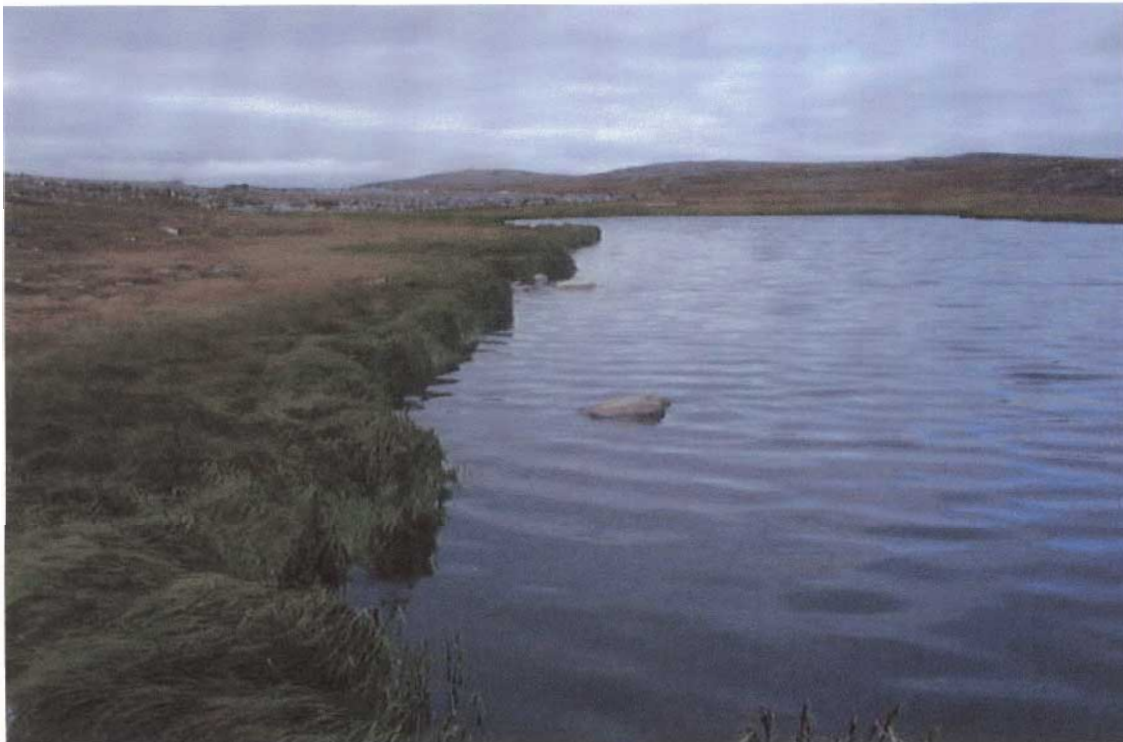
figure 2. Waste disposal facility from the outlet of the first sewage lake; 2001/08/29.

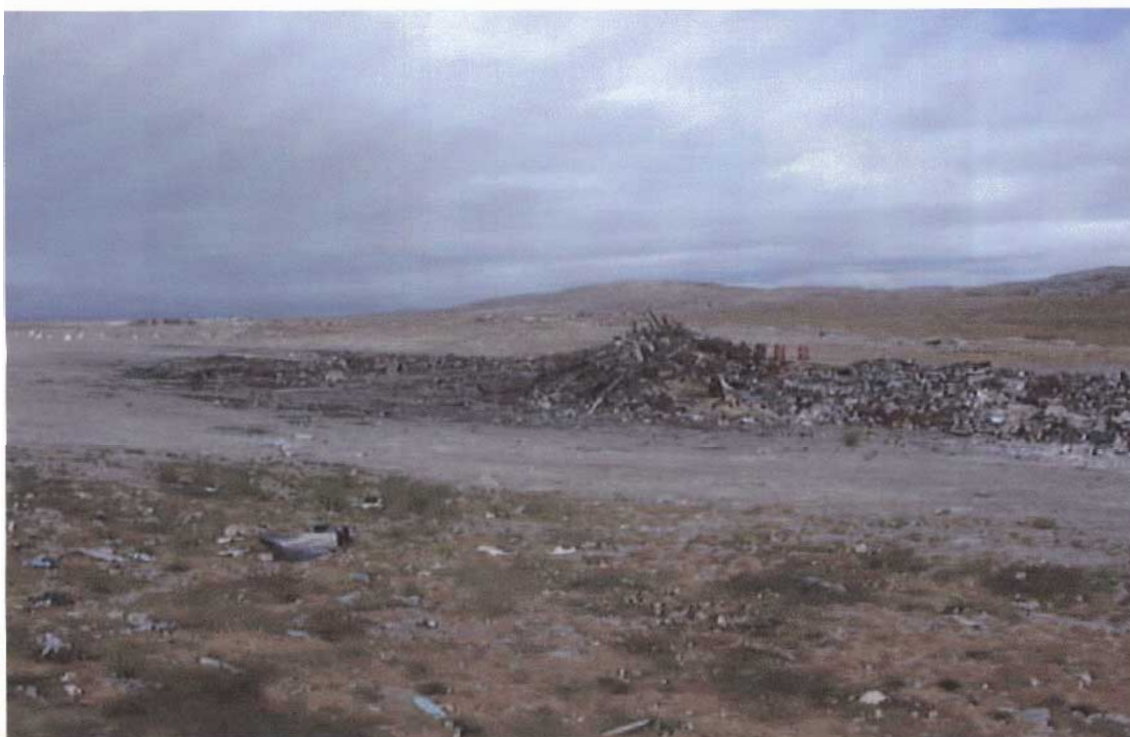
- **Solid waste disposal:** While combustible wastes at the solid waste disposal facility appear fairly well compacted and covered (figure 3), a considerable amount of windblown waste was nonetheless noted beyond the perimeter of the unfenced site. In this regards, it was mentioned during the inspection that a fenced in facility would practically solve this issue. In addition, leachate from the solid waste disposal facility was observed flowing along the toe of the wastepile before mixing with the sewage effluent and following the same path of discharge. As such, the attached analytical results relating to a sample taken at the toe of the facility (figure 4) indicate that concentrations of ammonia (5.65 mg/L) and iron (5.89 mg/L vs 0.3 mg/L) exceed the *Canadian Water Quality Guidelines for the Protection of Freshwater Aquatic Life*. Nevertheless, the associated Microtox sample did not denote toxicity.

figure 3. Burnpile at the solid waste disposal facility; 2001/08/29.

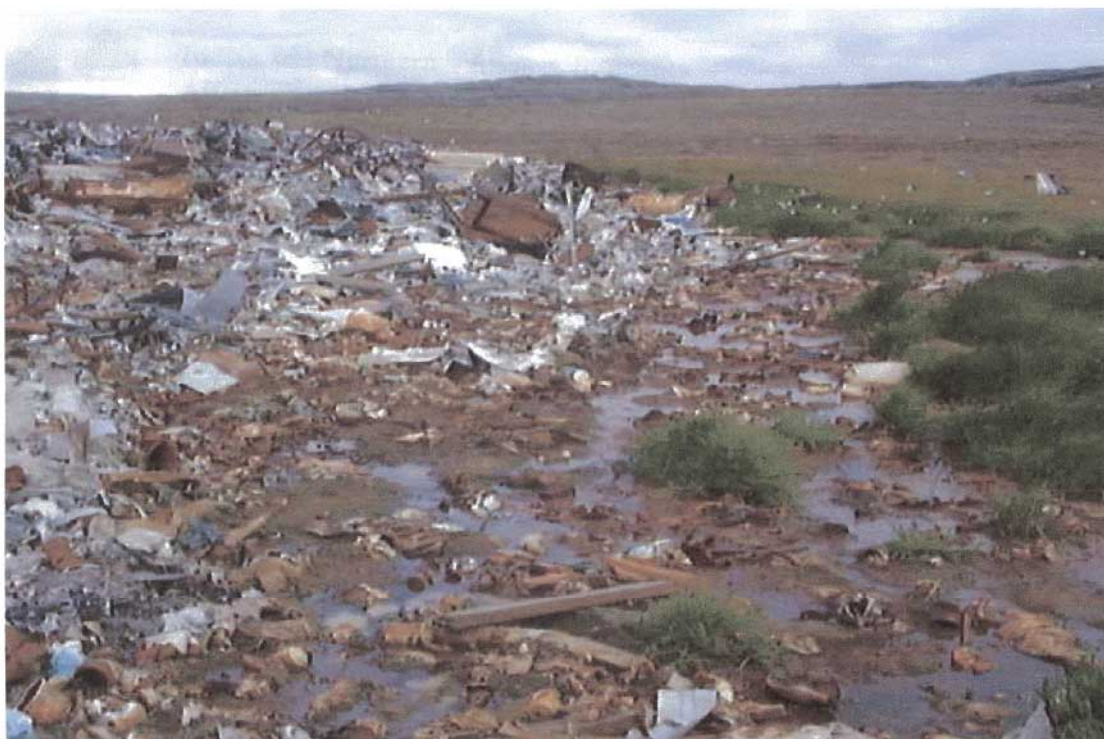
Indicate: A - Acceptable U - Unacceptable NA - Not Applicable NI - Not Inspected
Discharge Quality: sampled Decant Structure: NA Erosion: A
Discharge Meas. Device: none Dyke Inspection: NA Seepages: A
Dams, Dykes: NA Freeboard: NA Spills: none reported
Construction: NA O&M Plan: NA A&R Plan: NA
Periods of Discharge: A Effluent Discharge Rate: not measured
Comments: Sewage disposal facility consists of a series of lakes draining along a densely vegetated valley. Considerable quantity of windblown waste noticeable beyond the perimeter of the unfenced solid waste disposal facility. Bulky metal wastes segregated from the combustible wastes, which are regularly burnt and pushed towards the toe of the wastepile; accumulated waste is covered on an annual basis. Signs of hydrocarbon contamination noted at the waste oil storage site. No particular treatment or containment is provided for batteries and other hazardous materials. Leachate flowing from the toe of the wastepile mixes with the sewage effluent and basically follows the same path of discharge.

figure 4. Leachate at the toe of the solid waste disposal facility; 2001/08/29.

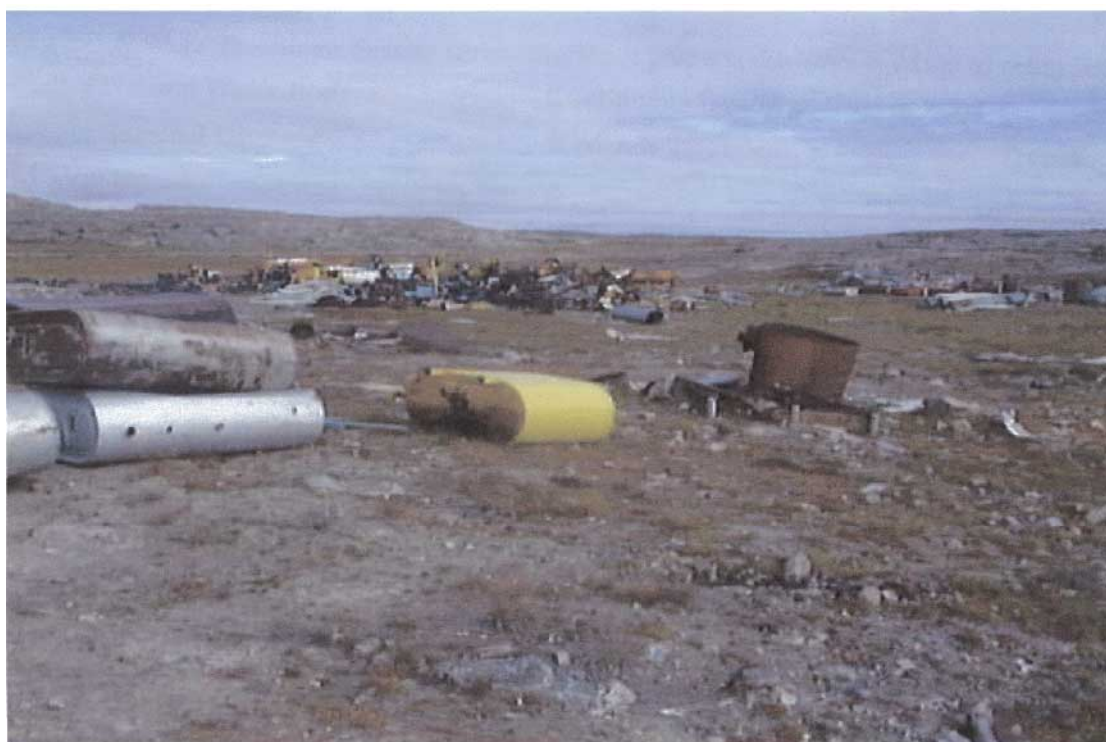
In related matters, although bulky metal wastes are segregated from the combustible wastes (figure 5), no particular treatment or containment is provided for batteries and other hazardous materials. Consequently, it was suggested that a sealift container be designated for that purpose until the Hamlet can see to the proper disposal of its stockpiled hazardous materials. Lastly, evidence of hydrocarbon contamination was noted at the waste oil storage site (figure 6). Since the soil in the immediate vicinity will likely have to be considered contaminated due to the spillage, and that further leaks are likely to occur, the Hamlet may wish to consider either acquiring a means of on-site disposal or dispatching the waste oil to facilities outside of the community.

figure 5. Bulky metal wastes disposal site; 2001/08/29.

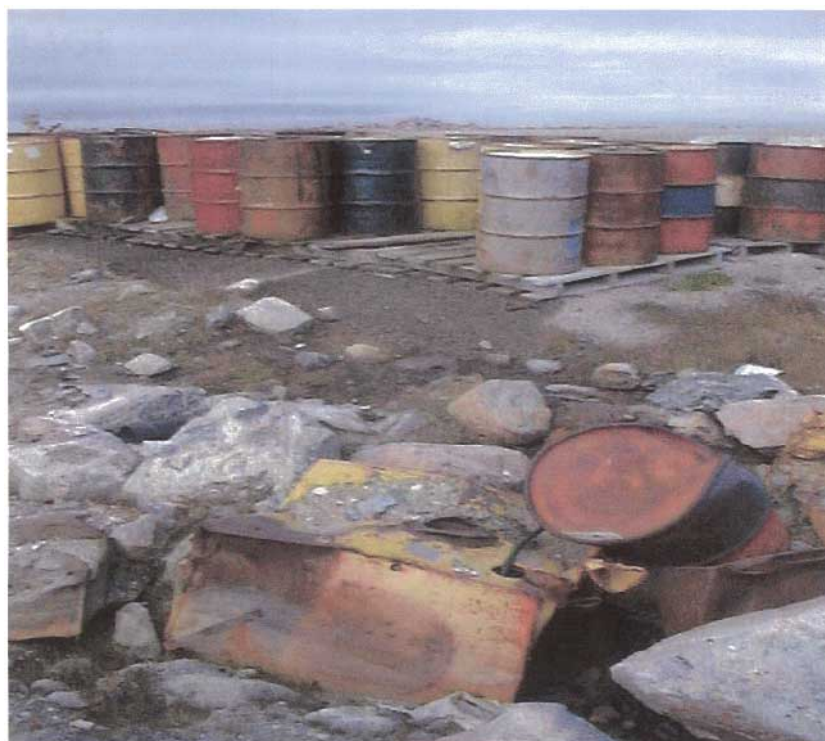
figure 6. Hydrocarbon contamination at the waste oil storage site; 2001/08/29.
