November 29, 2002

Re: September 3, 2002 Municipal Water Inspection - Report

MUNICIPAL WATER USE INSPECTION REPORT

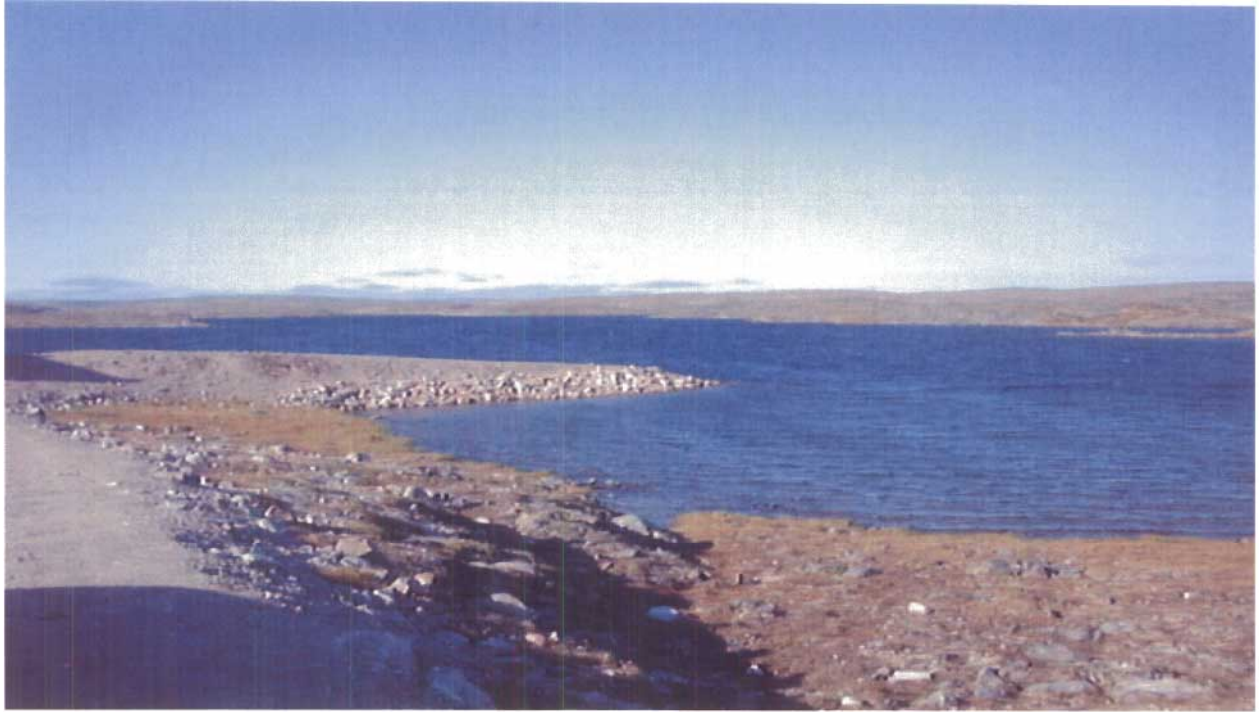
(Figure 1)

- 1. Water supply:** No concerns were noted regarding the water intake and supply facility. Further, the attached analytical results relating to samples taken in the vicinity of the intake station indicate that all tested parameters meet the *Guidelines for the Canadian Drinking Water Quality*. Please find attached analytical results. (Figure 1-2 Refers to Water Supply)

- Repulse Bay, Water Supply (Water Reservoir) Site: N66 33 47.1 W86 15 07.1

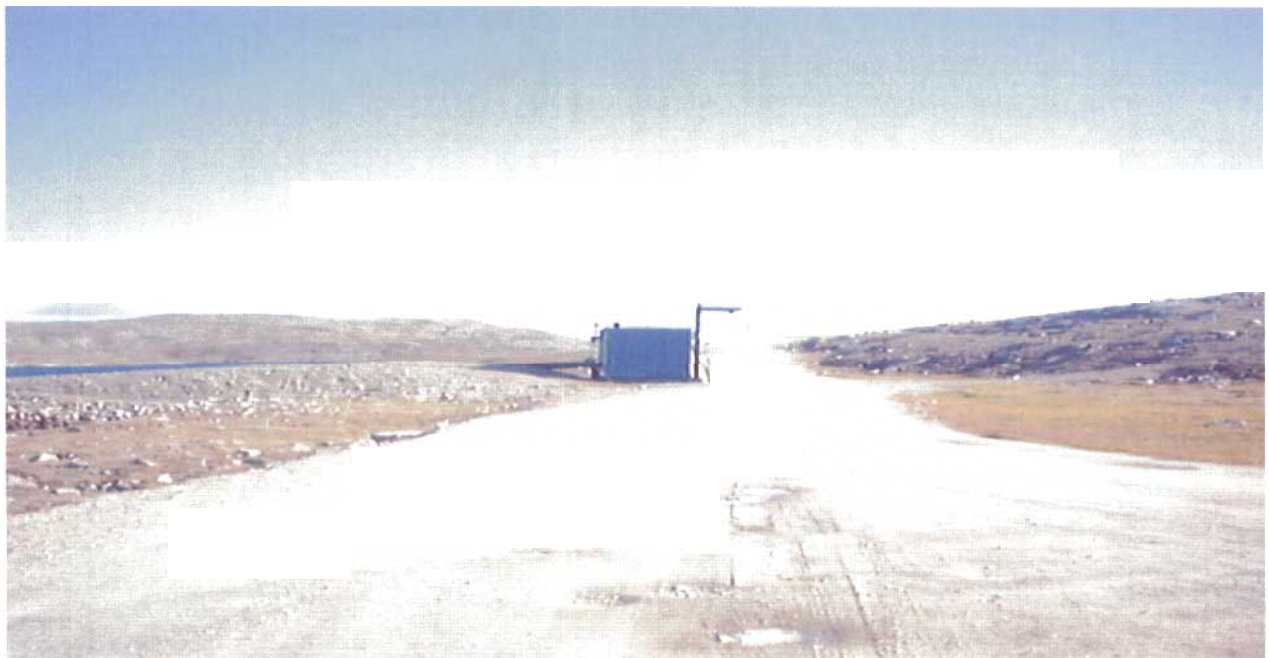
(Figure 2)

- Repulse Bay, Water Pump Station, Site: N66 33 47.1 W86 15 07.1

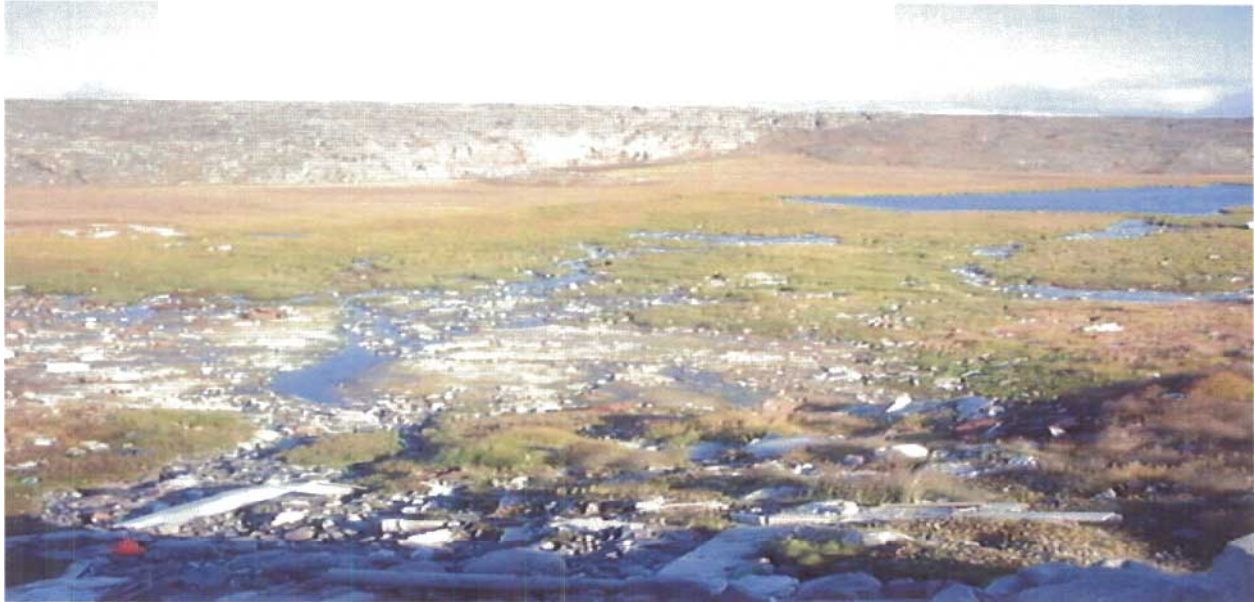
(Figure 3)

- 2. Sewage disposal:** Sewage effluent is discharged at a dumping point, which flow through series of small water bodies that lead to the ocean. Samples were collected within 92 meters from the drop point. Further, the attached analytical results indicate that the level of ammonia (3.28 mg/l vs 2.2 mg/l) is a little high. This community is within the municipal waste water guideline. Please find attached analytical results. (Figure 3-4 Refers to the Sewage Disposal)

- Repulse Bay, Sewage Disposal, Discharge Point, Site: N66 31 37.0 W86 13 22.0

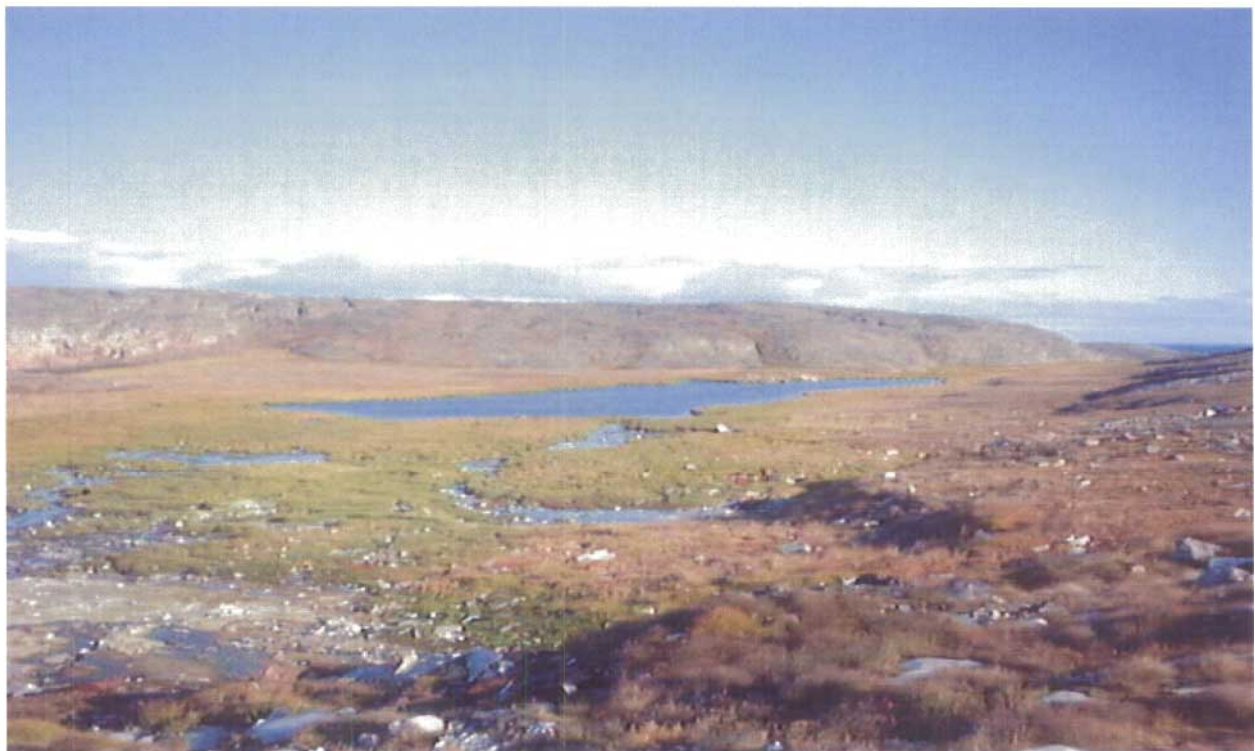
(Figure 4)

- Repulse Bay, Sewage Disposal (Sewage Lagoon), Site: N66 31 34.7 W86 13 12.9

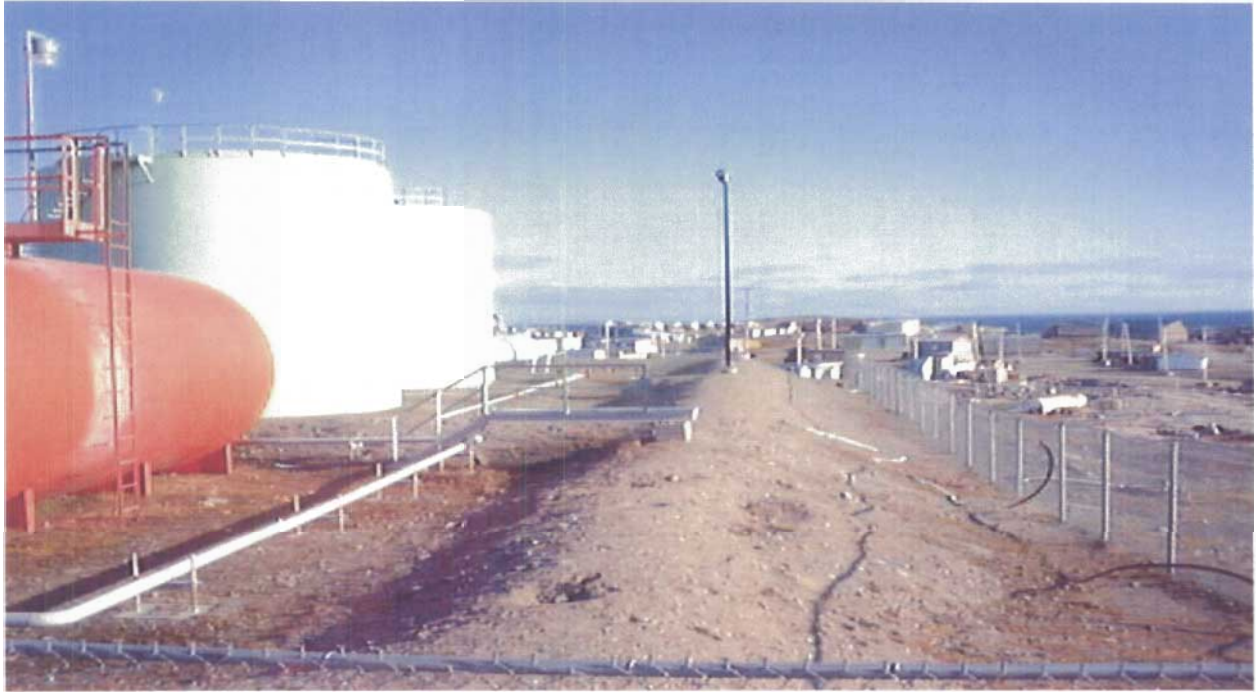
(Figure 7)

- Repulse Bay, Community Tank Farm

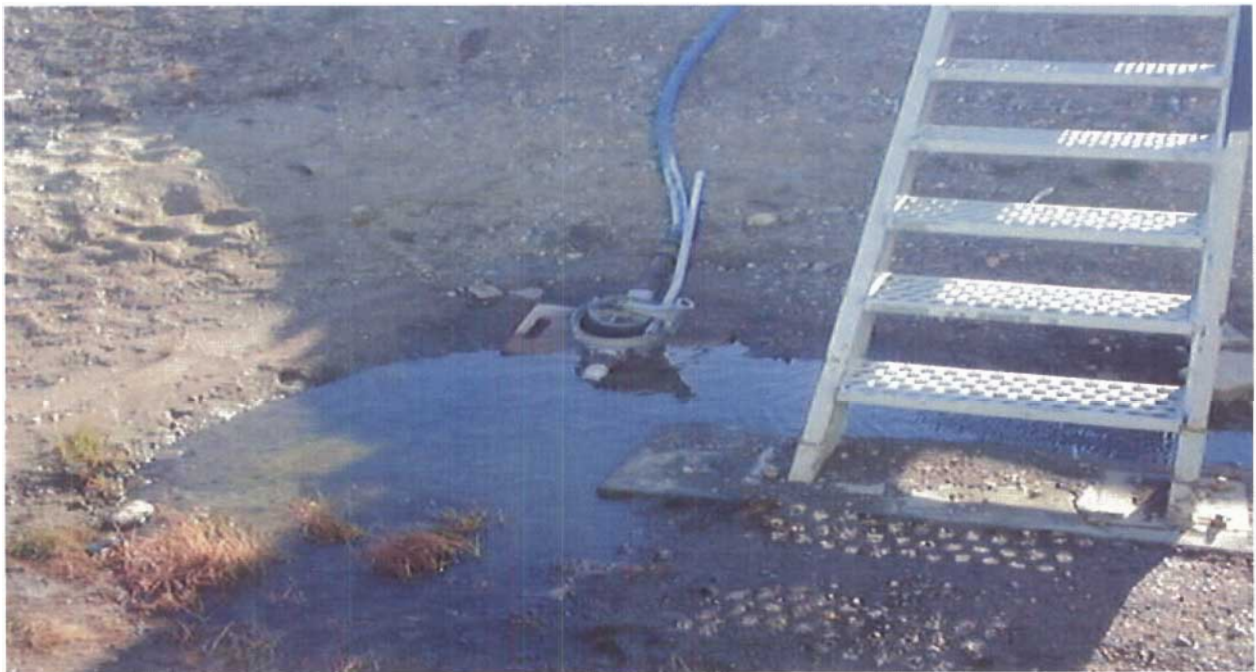
(Figure 8)

- Repulse Bay, Community Tank Farm, Drainage Pump

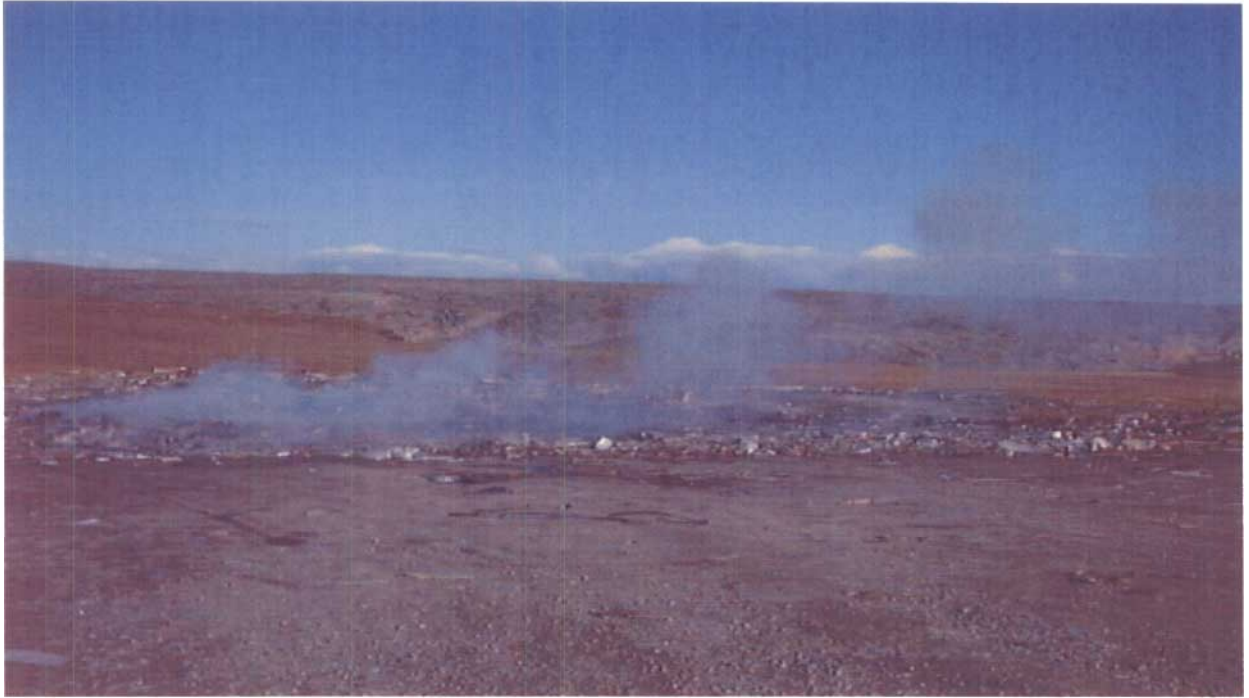
(Figure 5)

- 3. Solid waste disposal:** The inspector recommended that some sort of retaining wall be built or fencing set up to limit, windblown waste from entering the sewage / disposal area. A new location has been picked to have the new solid waste disposal site well away from the main community. (Figure 5-6 Refers to the Solid Waste Disposal)

- Repulse Bay, Solid Waste Disposal (Main Dump) Site: N66 31 40.1 W86 13 30.7

Comments: No major issue to note with respect to the sewage system, only concern was the amount of garbage that has blown from the waste disposal site into the streams that flow out towards the ocean, mixture of both. Recommendation was made to try and keep the two apart, possibly fencing. As for the waste oil storage site, 110 barrels of waste oil was shipped out the sealift, very few drum are left at the site and some clean up is still required within the ground area

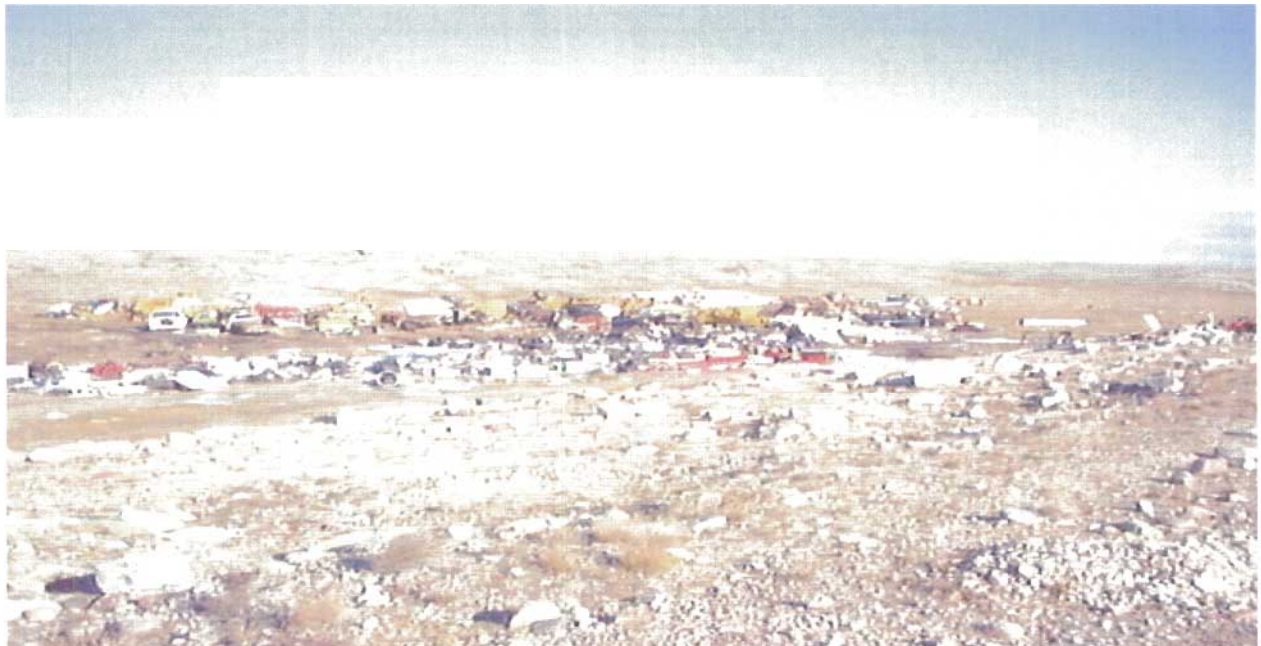
(Figure 6)

Bulky metal waste: During the site inspection the inspector observed numerous hazardous materials, (e.g. fuel storage tanks, drums, batteries) in the metal dump. The inspector suggested that all hazardous waste be kept together to minimize the chances of contaminating a larger area.

- Repulse Bay, Solid Waste Disposal (Metal Dump) Site: N66 31 46.8 W86 13 46.2

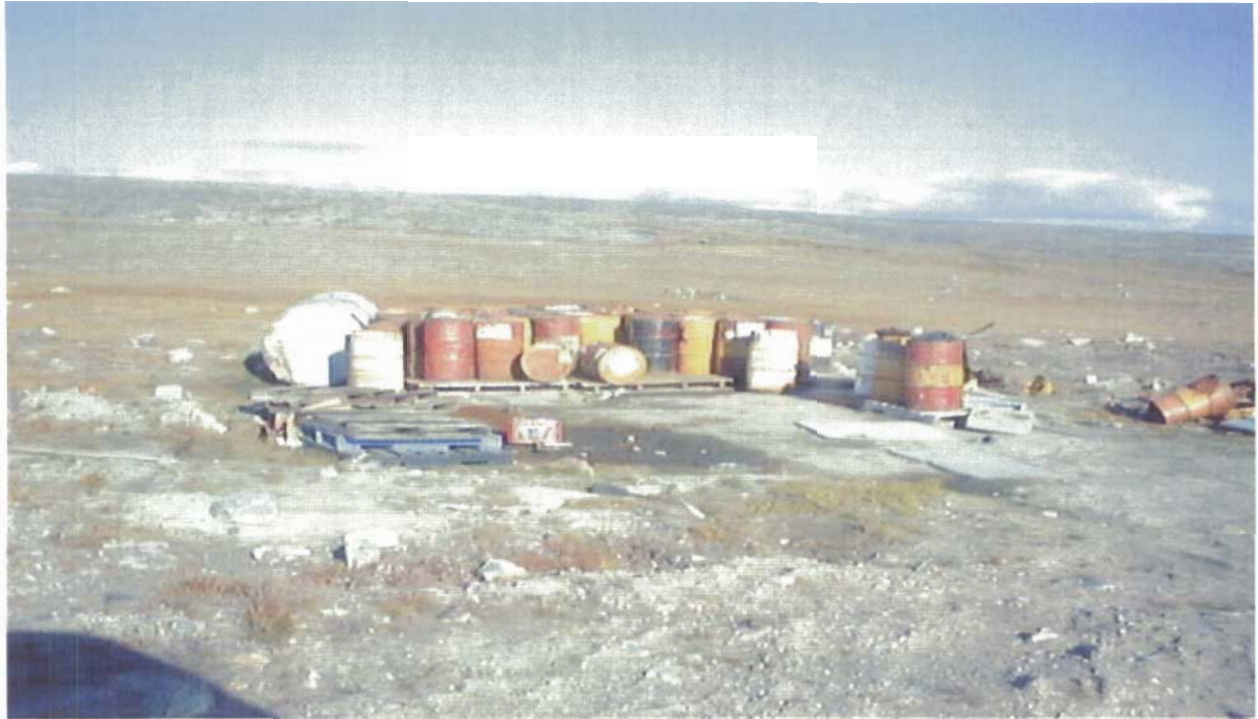
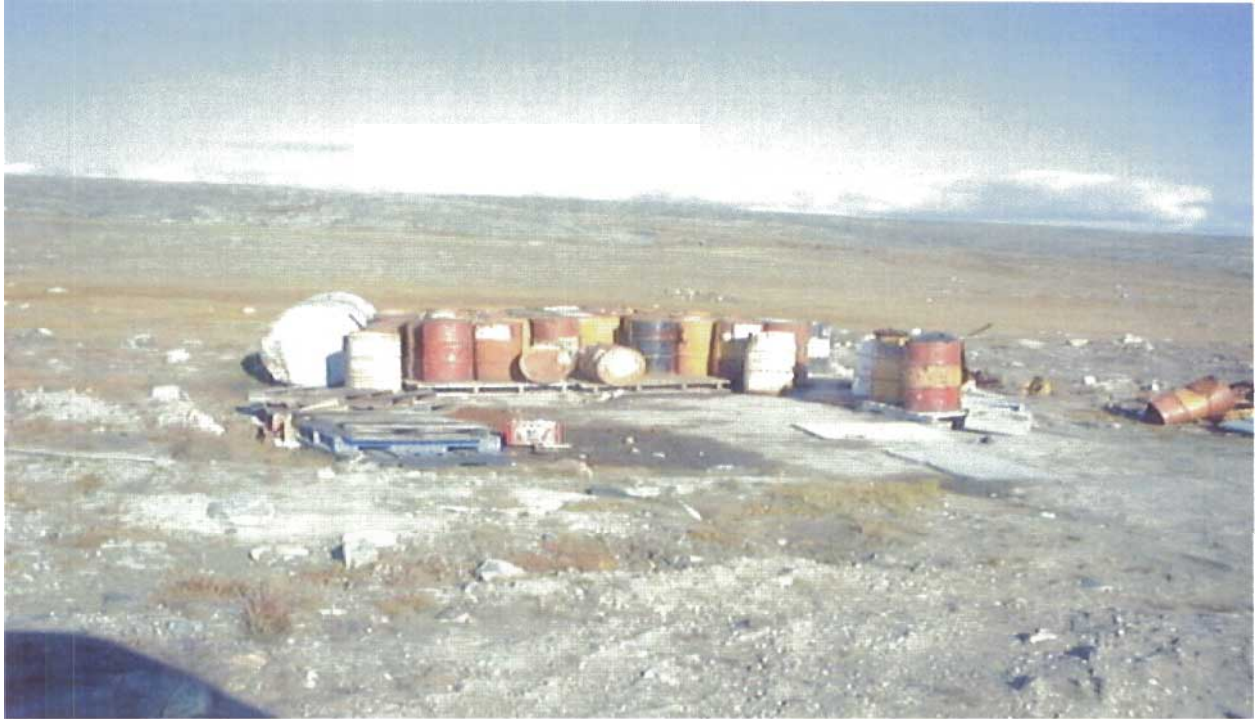
(Figure 9)

The inspector was also advised that 110 barrels of waste oil were shipped out during the sealift season. Evidence of hydrocarbon contamination was still noted at the waste oil site. The inspector recommended that the site be cleaned. (Figure 9-10 Refers to Waste Oil Site)

- Repulse Bay, Waste Oil Site, Evidence of Leaks, Site:N66 31 43.5 W86 13 40.0

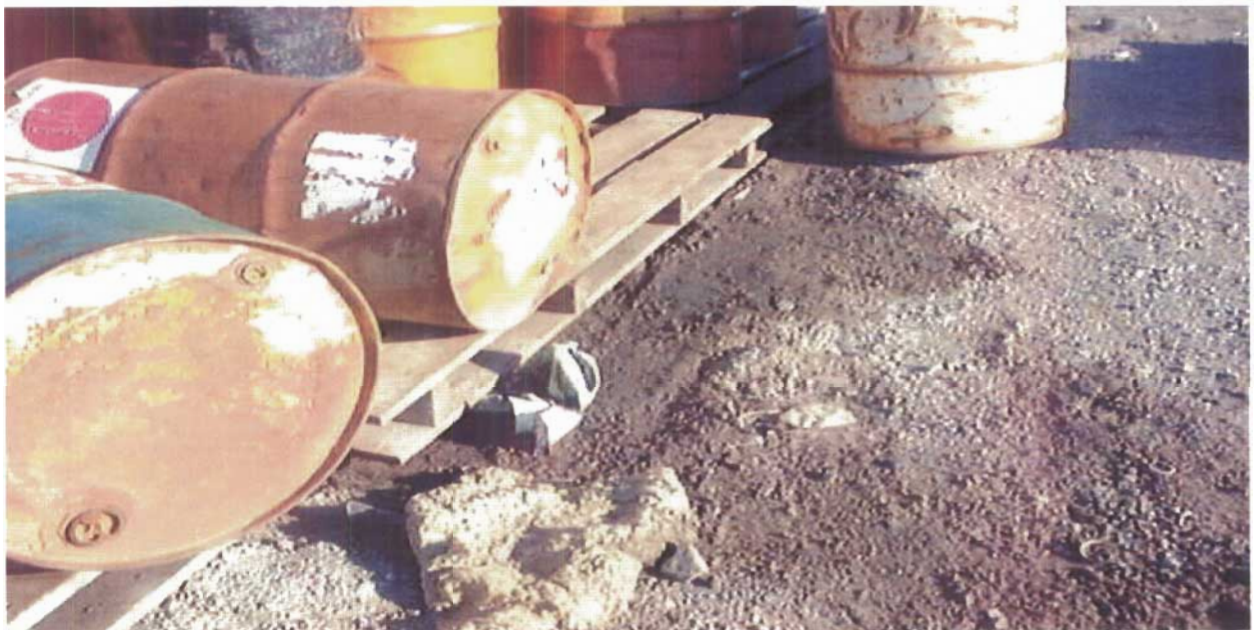
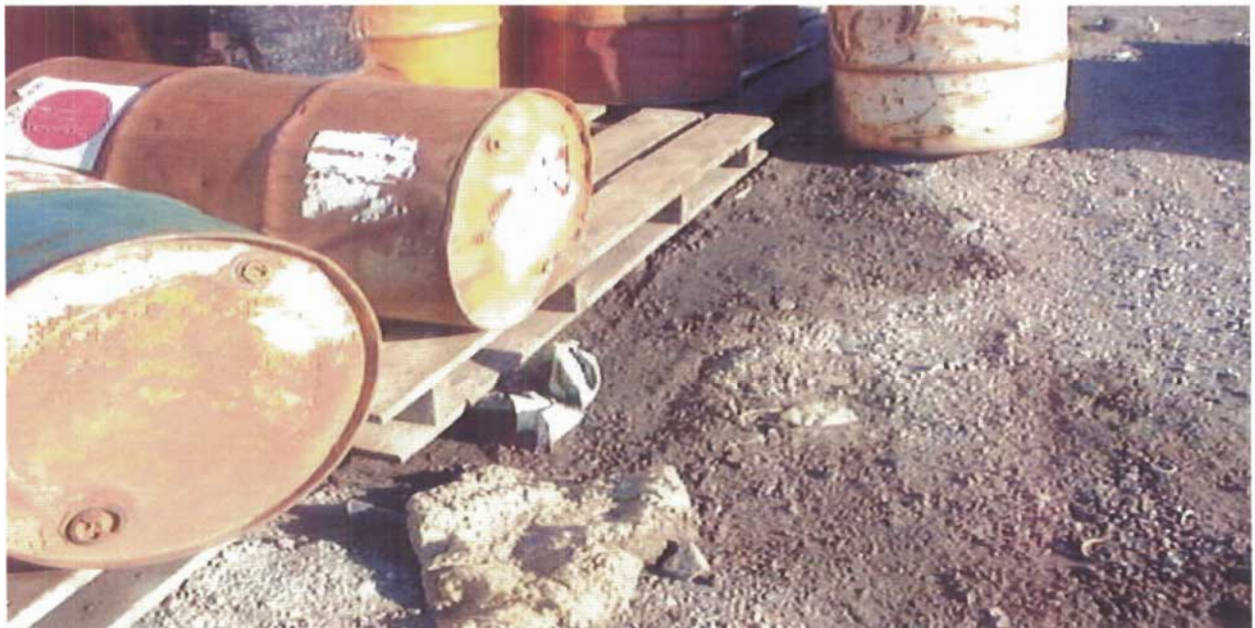
(Figure 10)

- Repulse Bay, Waste Oil Site, Evidence of Leaks, Site: N66 31 43.5 W86 13 40.0
