Appendix B: Photographs of the Project area

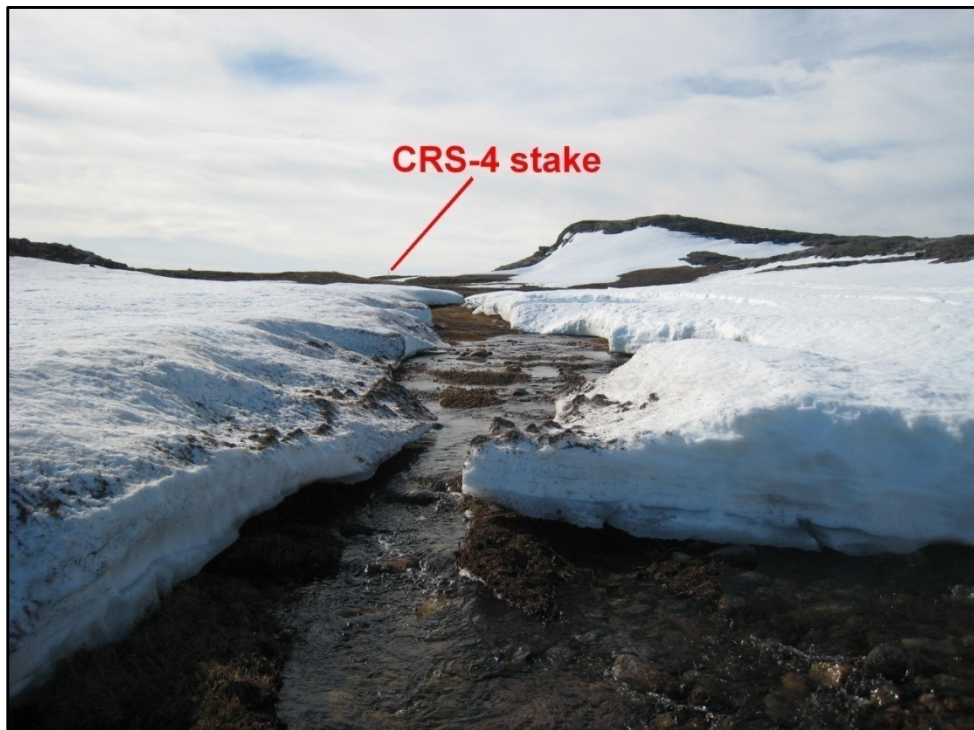
Photo 15 Stream reach downstream of CRS-4 crossing with large snowpack still present; north aspect.

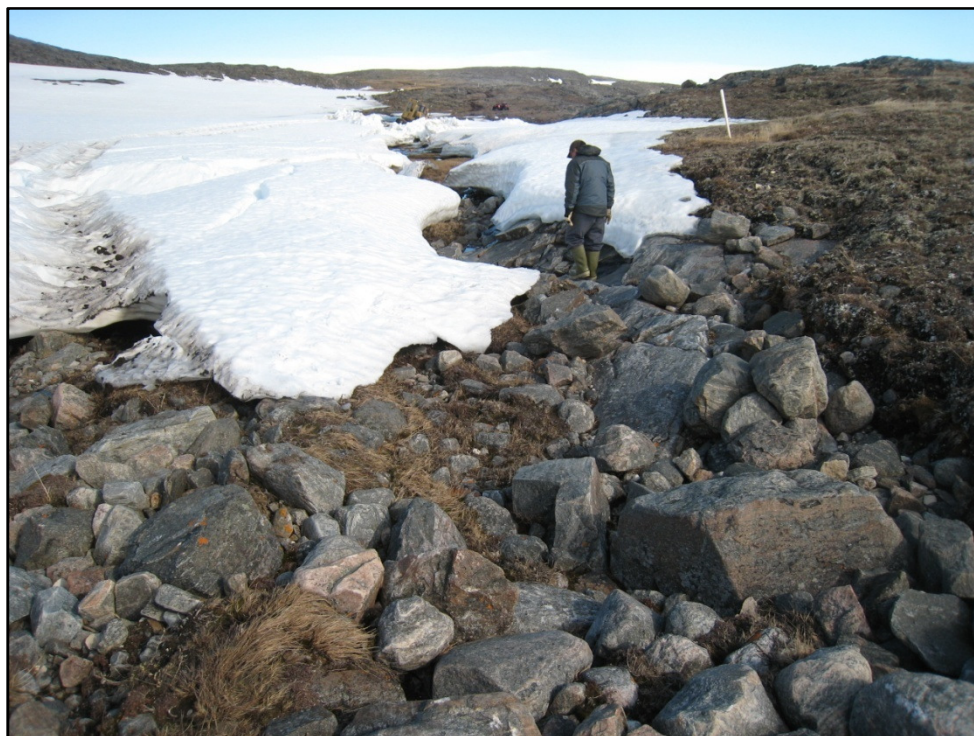
Photo 16 North of CRS-4 crossing stake located at Km 4.4 of the proposed access road route, note snowpack and boulders; south aspect.

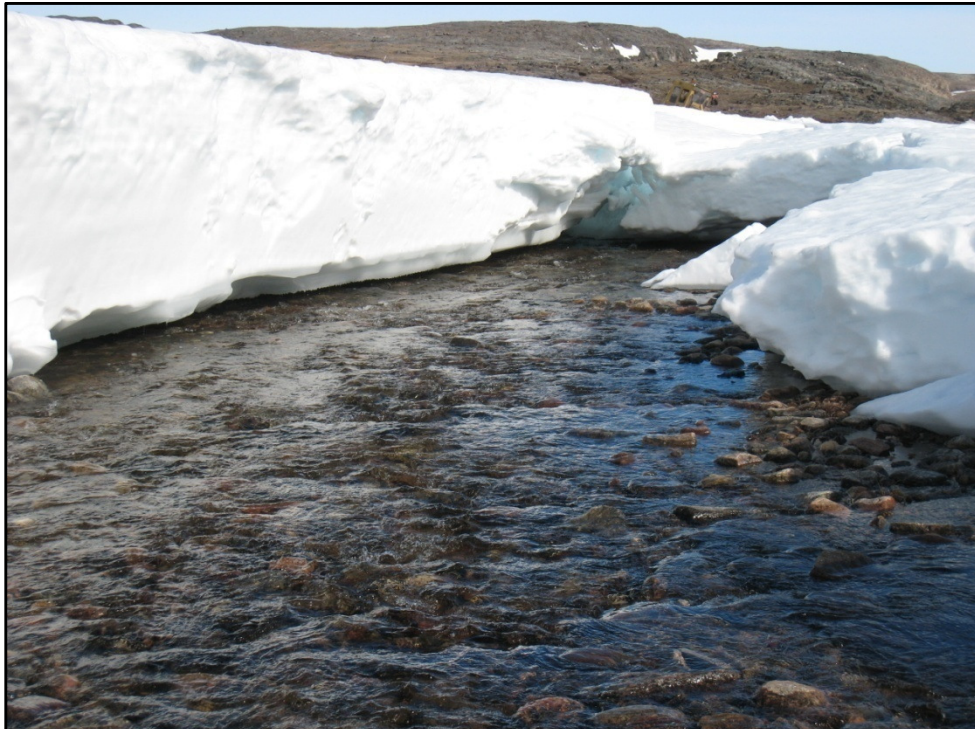
Photo 17 Large snowpack along stream, and stream substrate downstream of CRS-4 crossing; southeast aspect

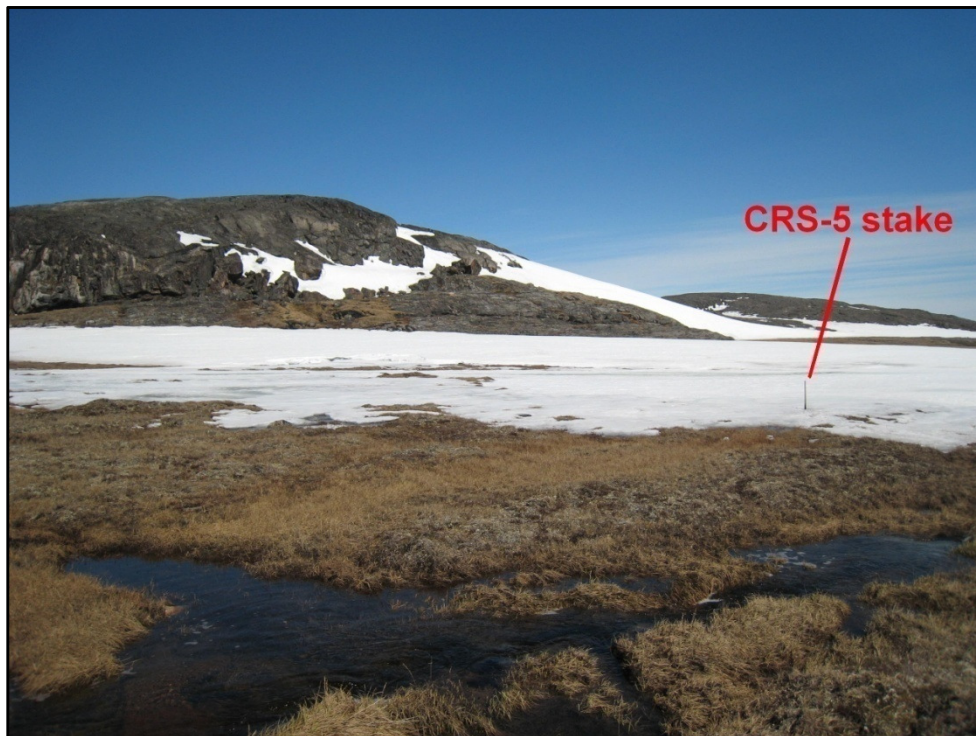
Photo 18 CRS-5 crossing located at Km 5.0 of the proposed access road route, note snow cover and bedrock ridges; southeast aspect.

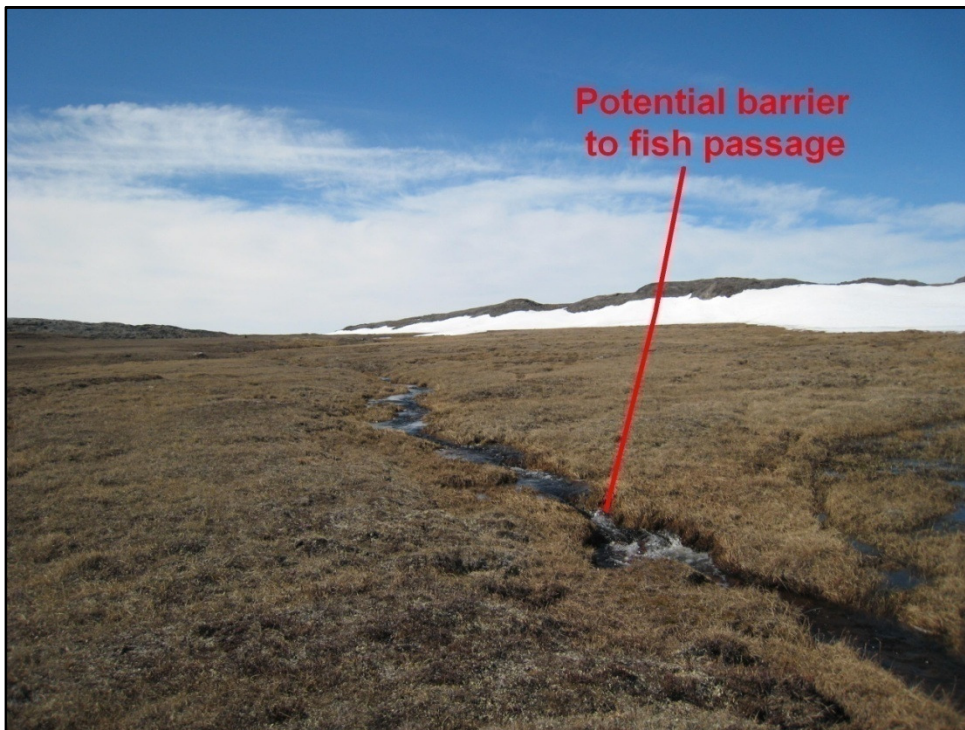
Photo 19 Stream reach upstream of CRS-5 crossing with potential barrier to fish passage, northeast aspect.

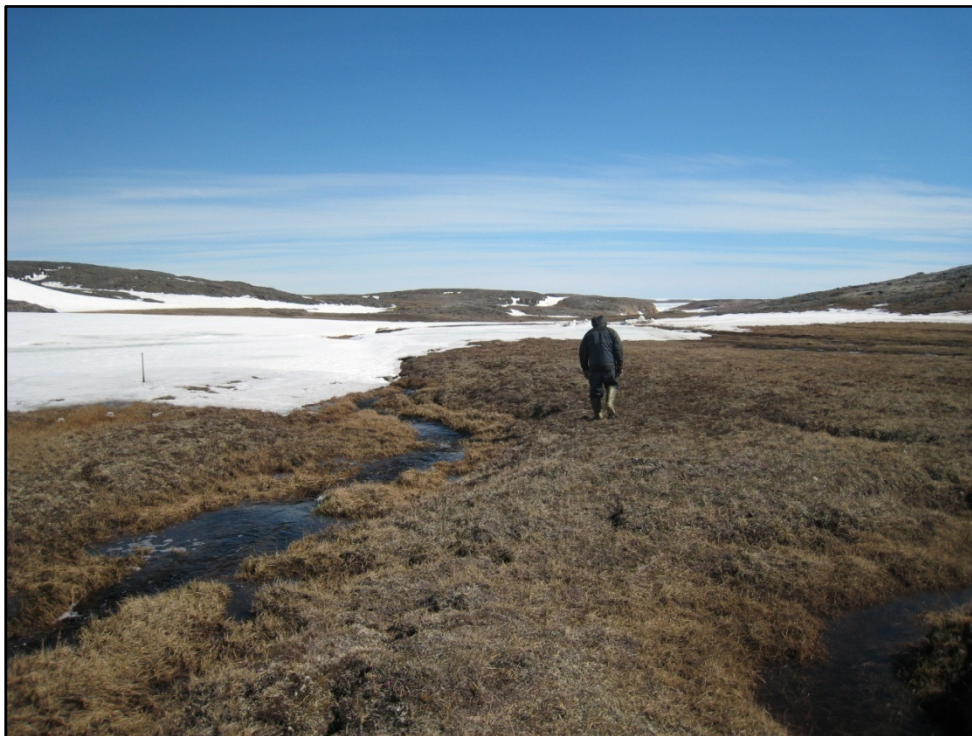
Photo 20 Stream reach downstream of CRS-5 crossing, note snow cover, vegetated valley bottom and bedrock ridges to east and west; south aspect.

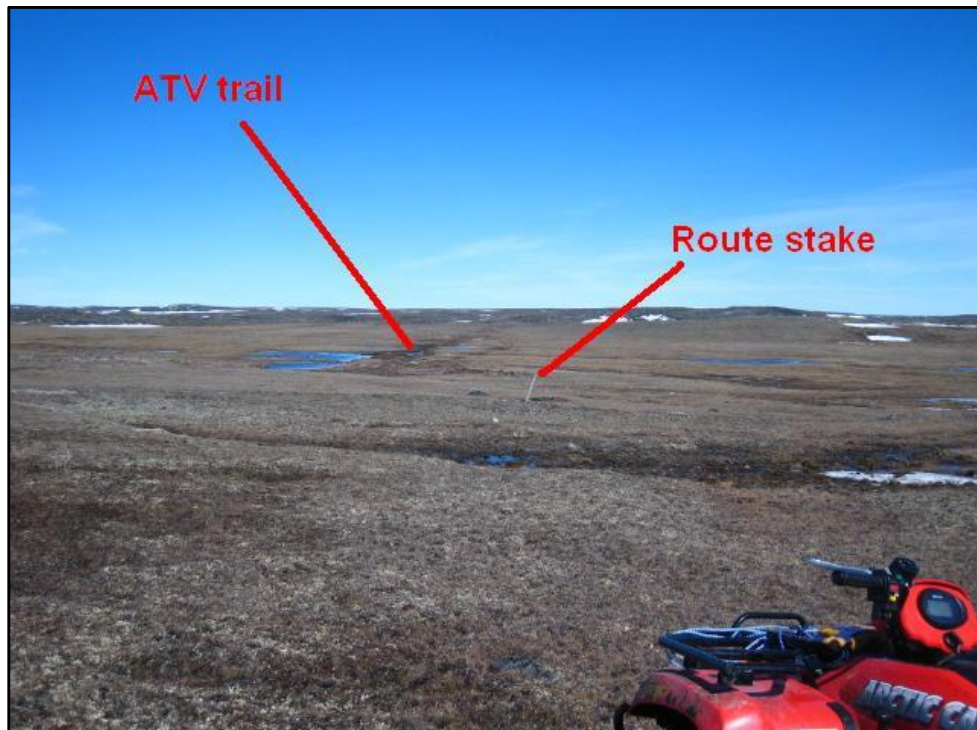
Photo 21 Proposed access road route near Km 5.7 with route stake and ATV trail, note terrain and standing water; east aspect.

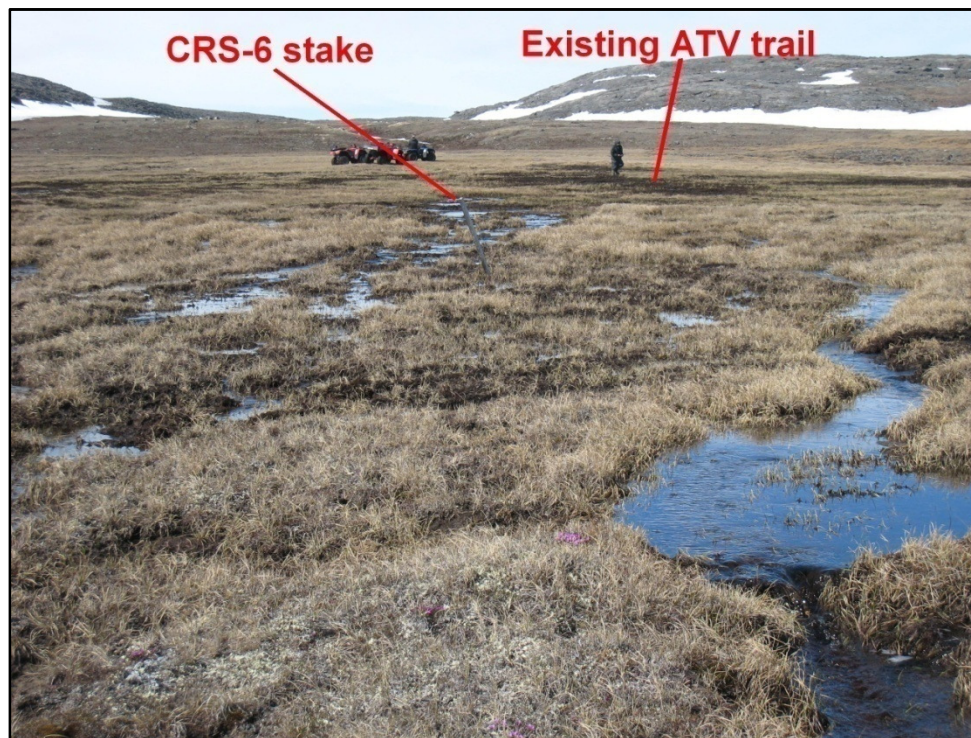
Photo 22 CRS-6 crossing stake located at Km 6.2 of the proposed access road route, note lack of defined channel at crossing and existing ATV trail in background; north aspect.
