Appendix B: Photographs of the Project area

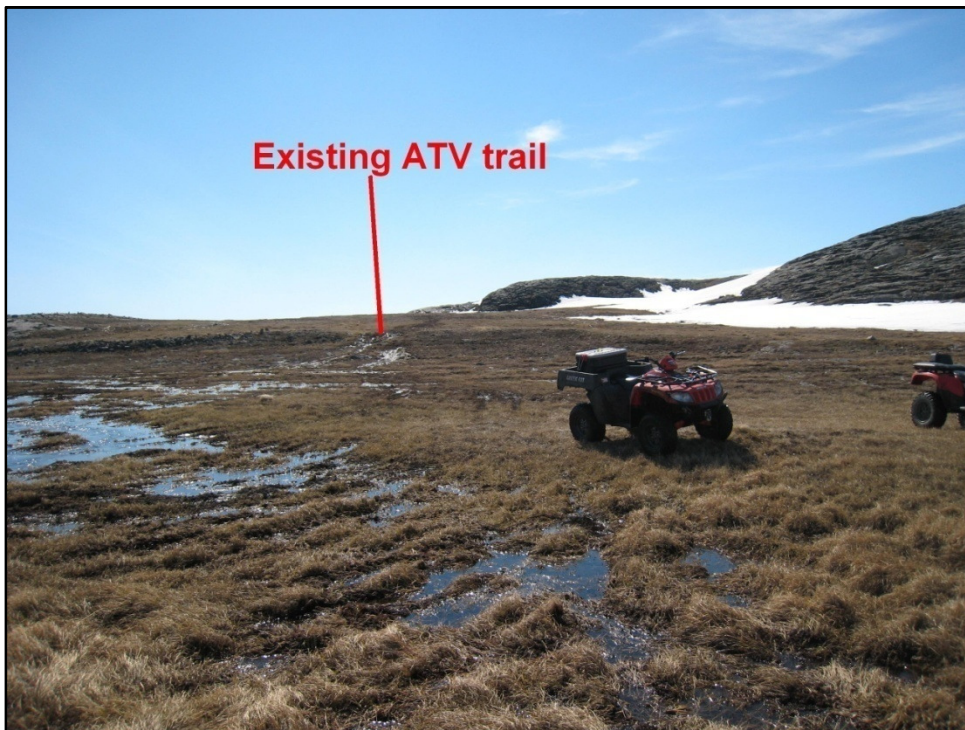
Photo 23 Wide spread flow pattern with ATV tracks across flow upstream of the CRS-6 crossing, existing ATV trail in background; southwest aspect.

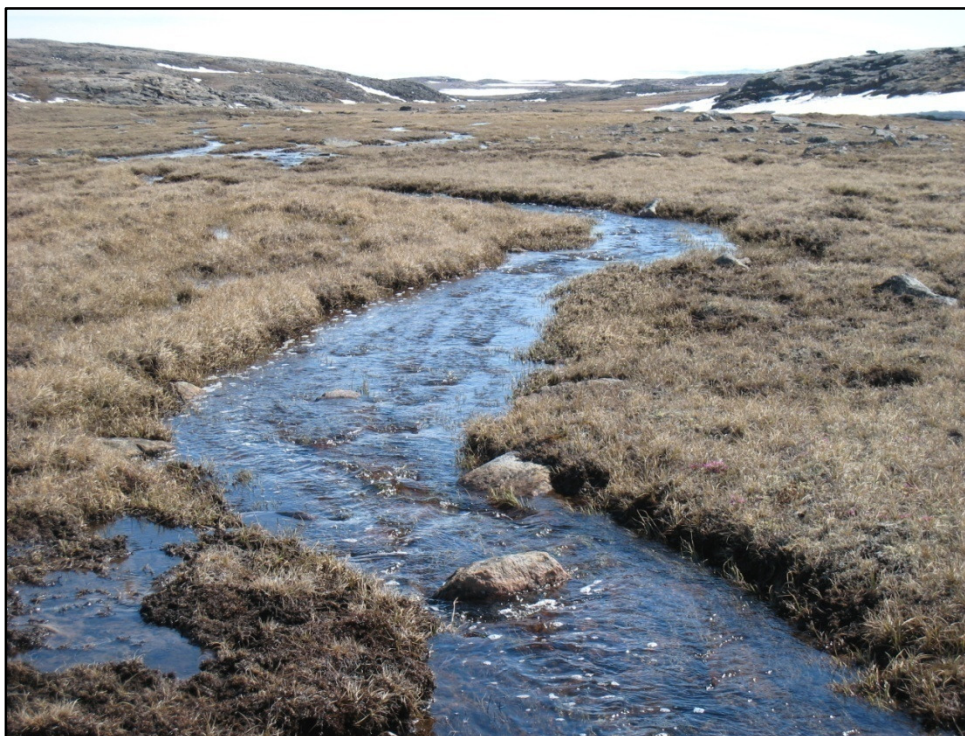
Photo 24 Stream reach downstream of CRS-6 crossing site with defined channel, note bedrock ridges to east and west; south aspect.

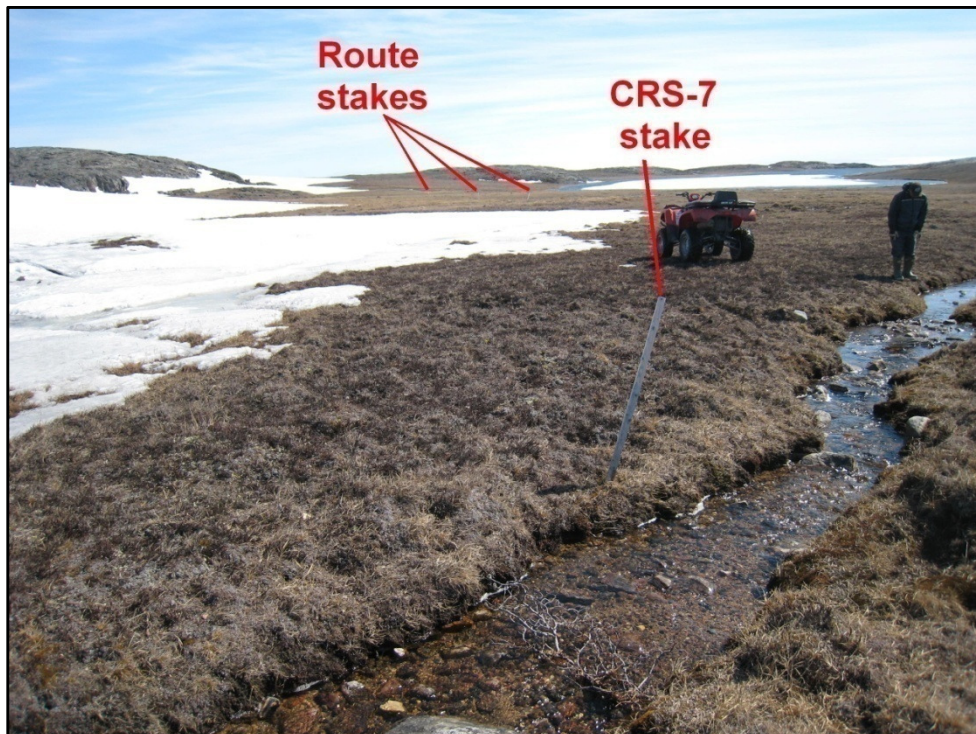
Photo 25 Stream reach at the CRS-7 crossing site, note vegetated banks and snow cover with other route stakes in background; south aspect.

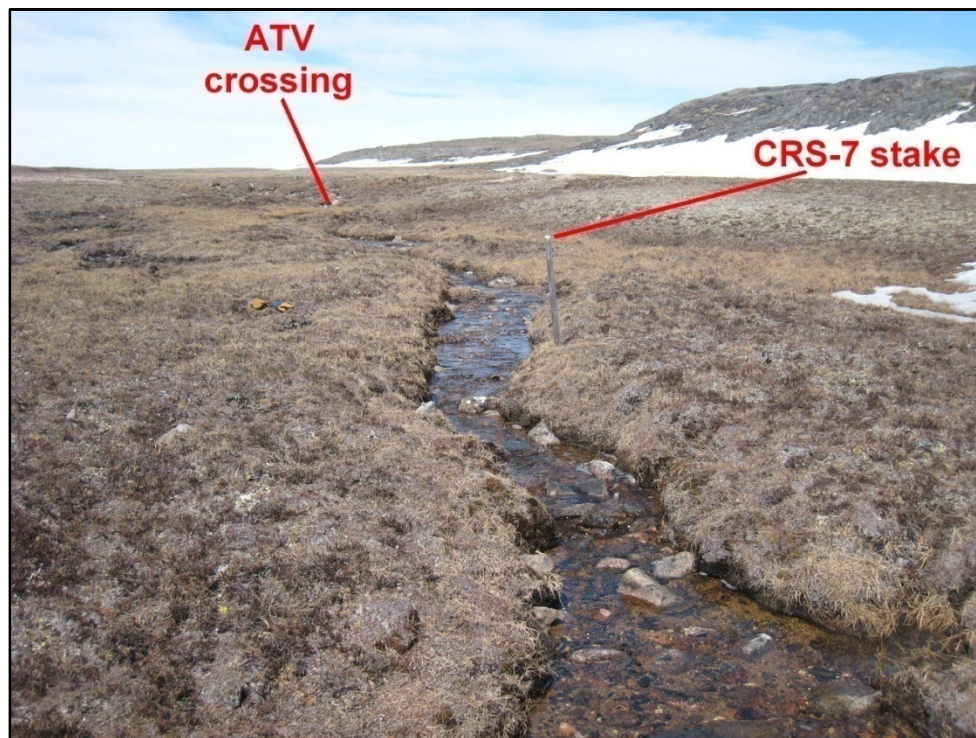
Photo 26 CRS-7 crossing located at Km 7.2 of the proposed access road route; north aspect.

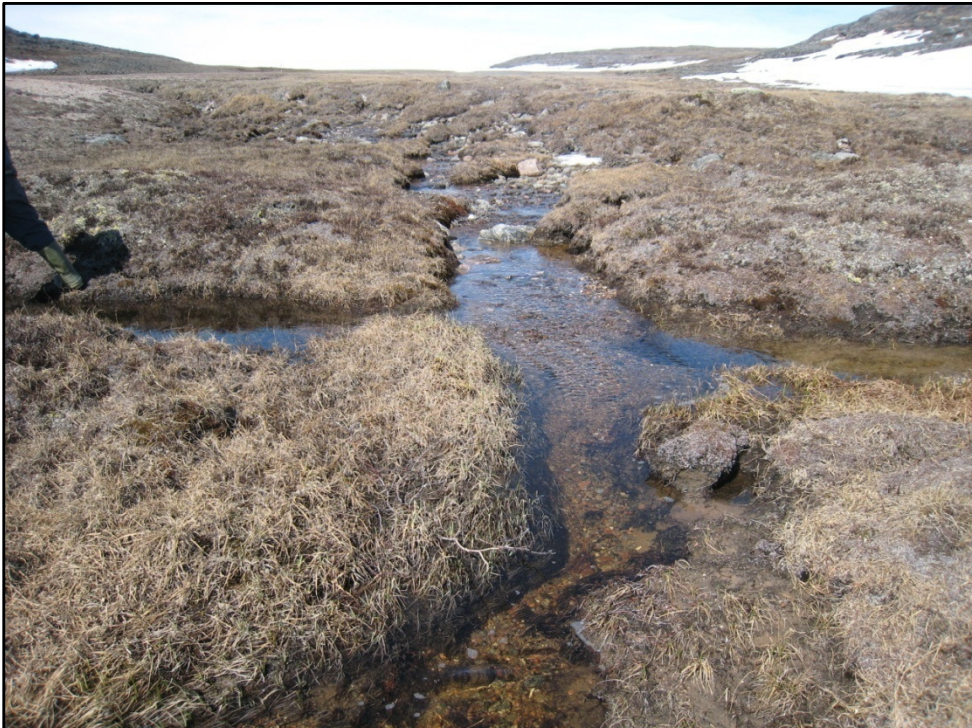
Photo 27 ATV crossing site upstream of CRS-7, note altered substrate, widened channel and bedrock ridges to east and west; north aspect.

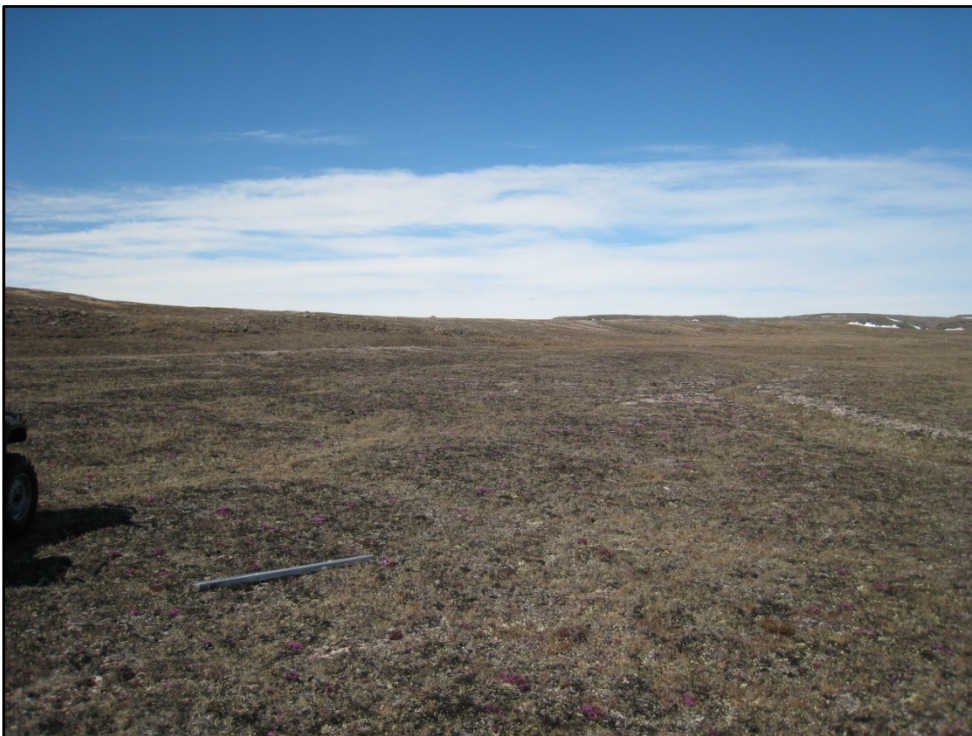
Photo 28 Terrain at the end of the proposed access road route, note route stake on ground and gravel/sandy substrate; north aspect.

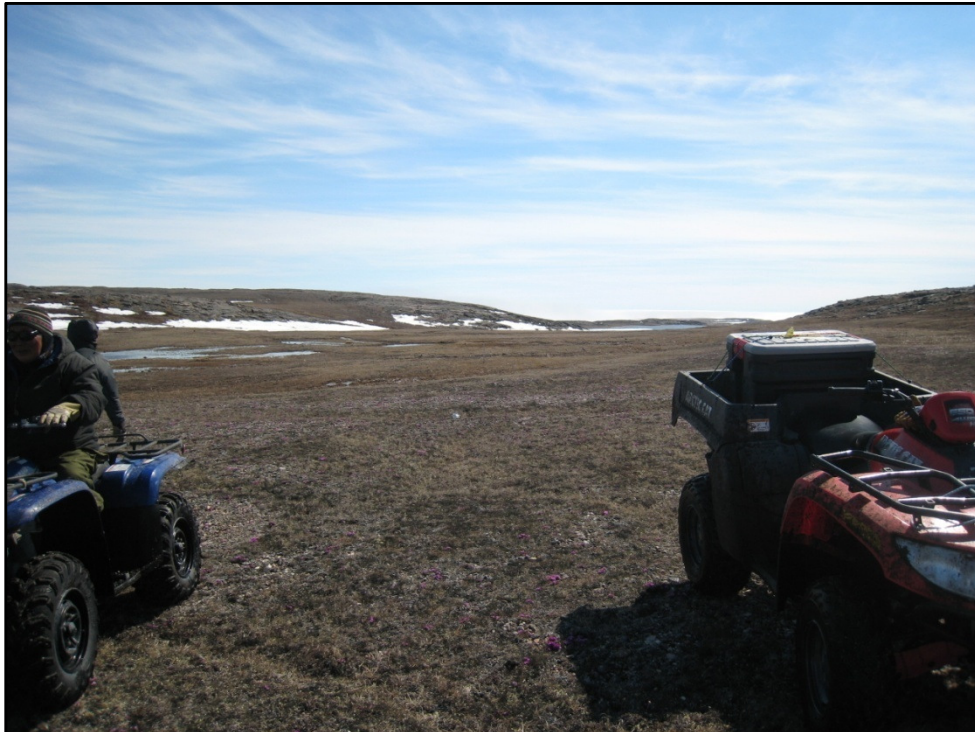
Photo 29 Terrain at the end of the proposed access road route, note small pond adjacent to area and bedrock ridges to east and west; south aspect.
