July 6, 2001 Water Licence Inspection - Report

MUNICIPAL WATER USE INSPECTION FORM

Date: 2001/07/06 Licensee Rep. (Name/Title): Etienne Kakkianun / acting-Foreman
Licensee: Hamlet of Kugaaruk Licence No.: NWB3PEL9803

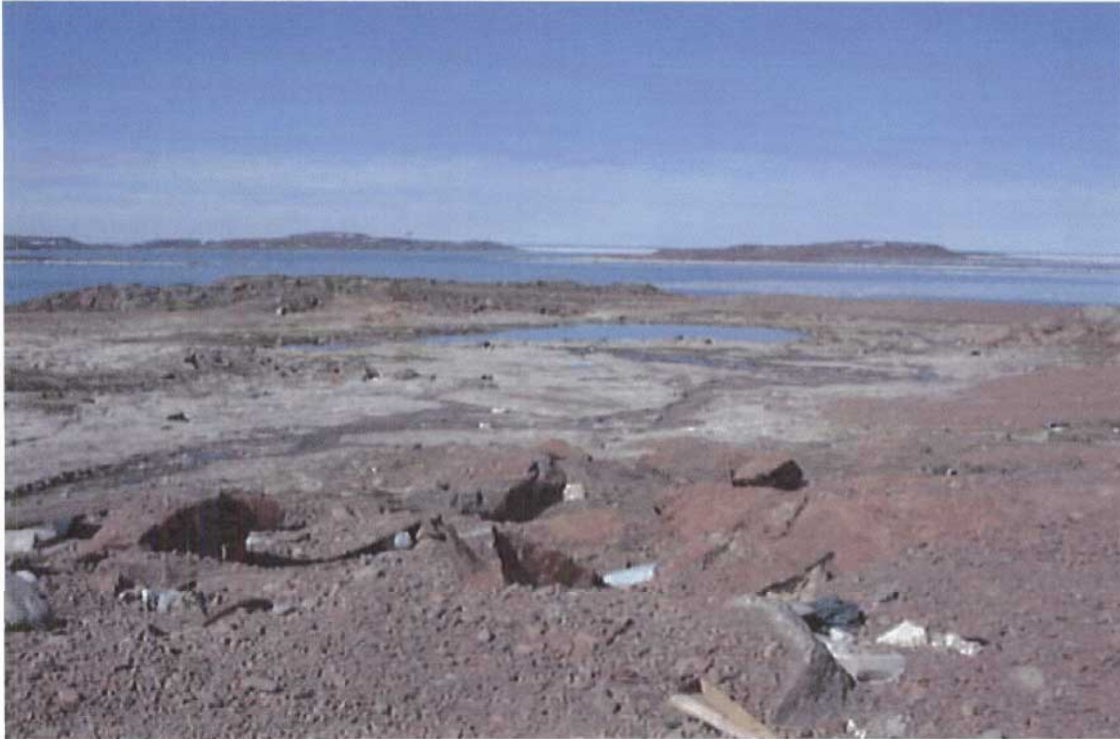
- **Sewage disposal:** As recurring breaches have occurred in recent years at the sewage disposal facility (figure 1), the Licensee consequently raised the permeable retention berm (figure 2). However, this summer an event of excessive seepage, regarding which spill report 01-193 was filed, prompted the Licensee to fortify the base of the retention berm with the material at its crest. Therefore at the time of the inspection, the extent of seepage was found to be acceptable. Nonetheless, since the facility is practically emptied of its contents, adequate retention and treatment time is not likely to be provided to sewage effluent prior to its discharge to receiving waters. As such, the attached analytical results relating to a sample collected ten metres downslope of the berm (figure 3) indicate that levels of faecal coliform (264 000 CFU/100ml vs 10 000 CFU/100ml) potentially breach the effluent quality standards (part D, item 2) set under Water licence NWB3PEL9803. Also, concentrations of ammonia (40.2 mg/L vs 2.2 mg/L) and phenols (21 µg/L vs 4 µg/L) exceed the *Canadian Water Quality Guidelines for the Protection of Freshwater Aquatic Life*. Moreover, the Microtox sample, which constitutes a reliable toxicity indicator (IC₅₀), shows that half of light-producing bacteria were inhibited by a sample concentration of 36.9%, whereas 50% and over is considered non-toxic.

figure 1. Sewage disposal facility from the truck dumping point; 2001/07/06.

In light of this, the Inspector trusts that Community Government and Transportation (CG&T) will respond to the Licensee's requests, and will be able to provide guidance and/or assistance in regards to an appropriate manner of addressing this outstanding issue.

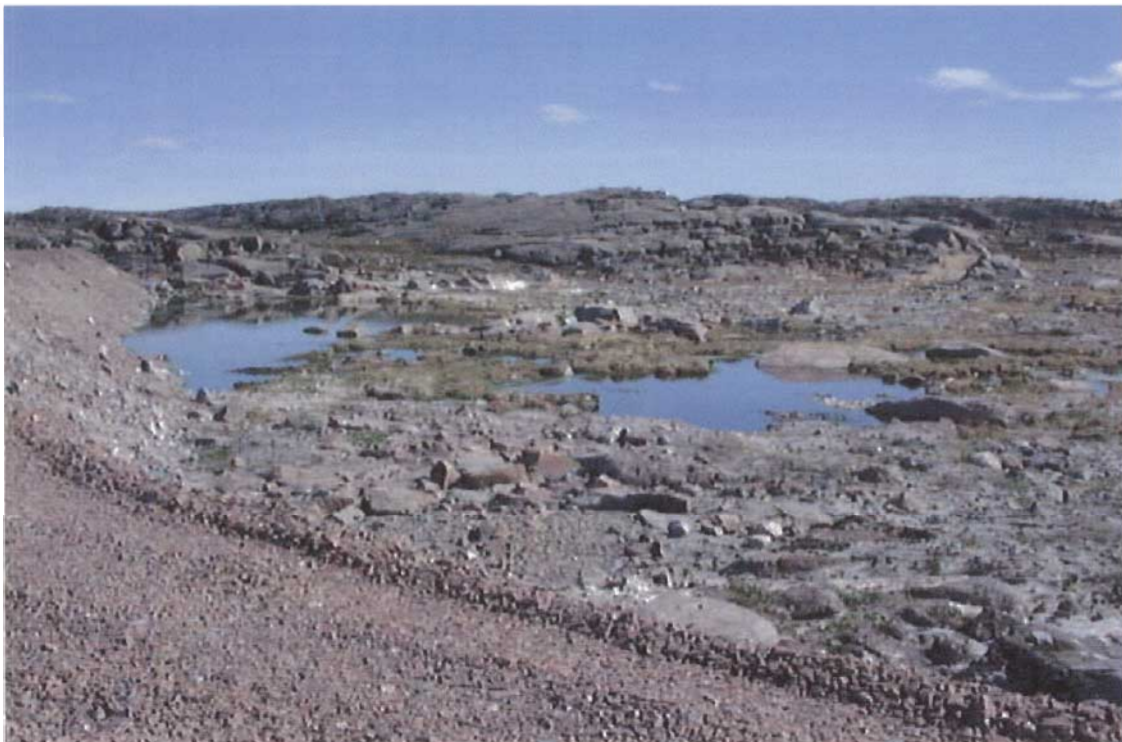
Comments: Sewage disposal facility reportedly overflowed last year; downslope retention berm then raised. Excessive seepage noted this spring/summer; upper berm material packed along the outer toe of the retention berm. Sewage disposal facility almost emptied of contents at time of inspection; signs of prior seepage of larger scale. No more housing units rely on honeybags. Solid waste disposal facility is fenced, but frail fencing appears inefficient at preventing windblown waste. Considerable amount of exposed waste despite the fact that the wastepile is reportedly burnt/compacted regularly and covered yearly. Minor hydrocarbon spillage at the waste oil storage site; idle furnace at the Hamlet garage. Leachate trickles along the roadside, but mainly seeps through the site's containment berm. Batteries observed at the metal wastes disposal site although supposed to be segregated and stored at the Hamlet garage.

figure 2. Downslope retention berm of the sewage disposal facility; 2001/07/06.

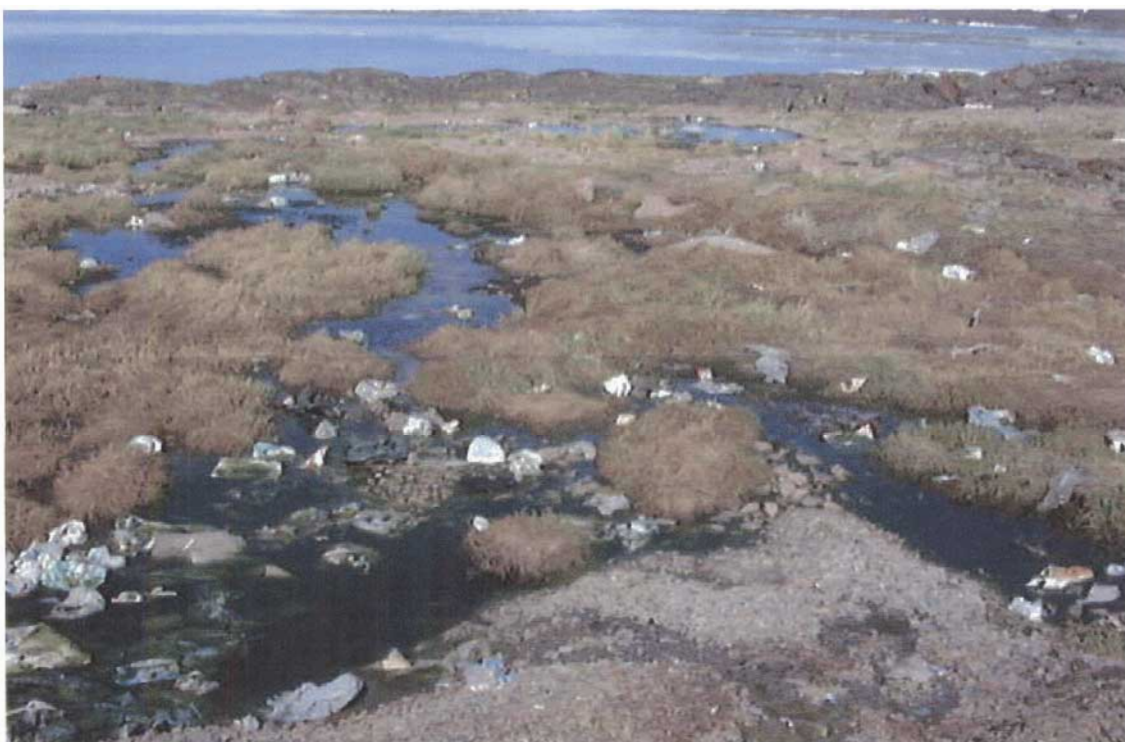
figure 3. Main vein of seepage from the sewage disposal facility; 2001/07/06.

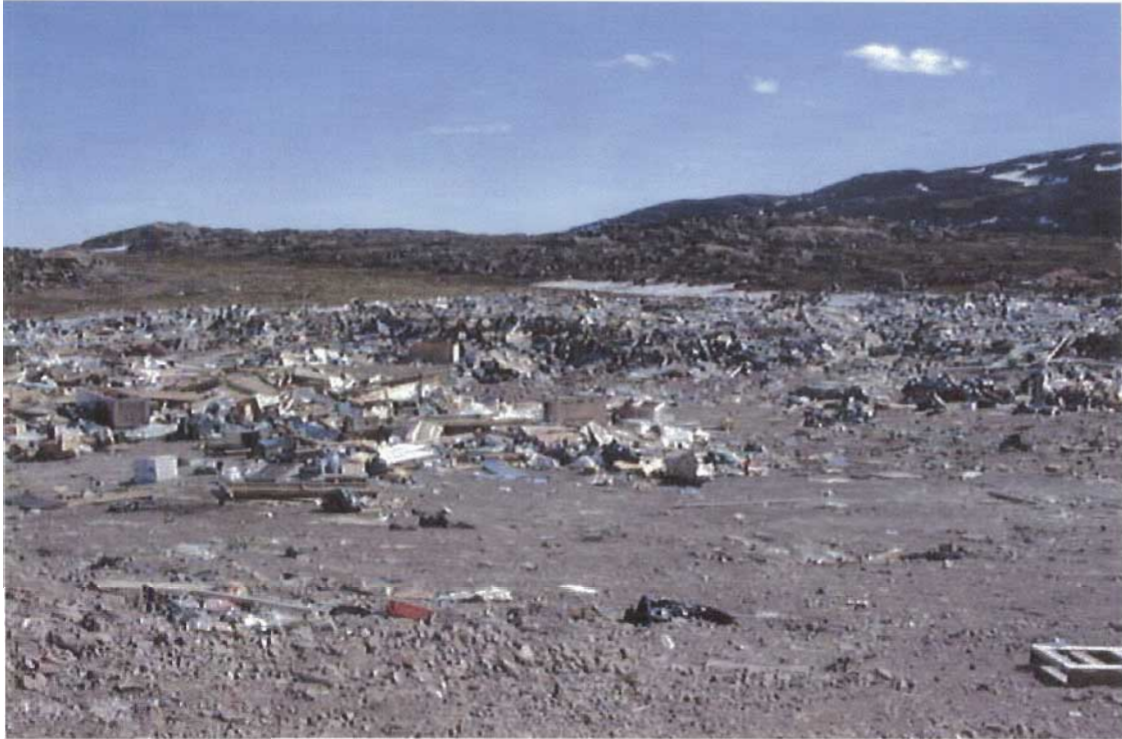
- **Solid waste disposal:** Although combustible wastes are reportedly burnt/compacted regularly and covered on an annual basis, a considerable quantity of exposed waste was nevertheless noticeable at the solid waste disposal facility (figure 4). Furthermore, the frail fencing does not appear to efficiently contain windblown waste within the perimeter of the site. This being said, the attached analytical results relating to a leachate sample collected along the main vein of runoff from the facility (figure 5) reveal levels of ammonia (5.01 mg/L), phenols (12 µg/L), cadmium (1.0 µg/L vs 0.017 µg/L), copper (48 µg/L vs 4 µg/L), iron (2.52 mg/L vs 0.3 mg/L), and zinc (248 µg/L vs 30 µg/L) exceeding the *Canadian Water Quality Guidelines for the Protection of Freshwater Aquatic Life*. Regardless, the associated Microtox sample did not attribute toxicity to the leachate. In parallel, no flow of water could be observed in the vicinity of the well segregated bulky metal wastes disposal facility. In related matters, since signs of hydrocarbon contamination were noted at the waste oil storage site (figure 6), it was strongly suggested during the inspection that the Licensee see to utilizing its waste oil furnace now idle at the Hamlet garage.

figure 4. Solid waste disposal facility; 2001/07/06.

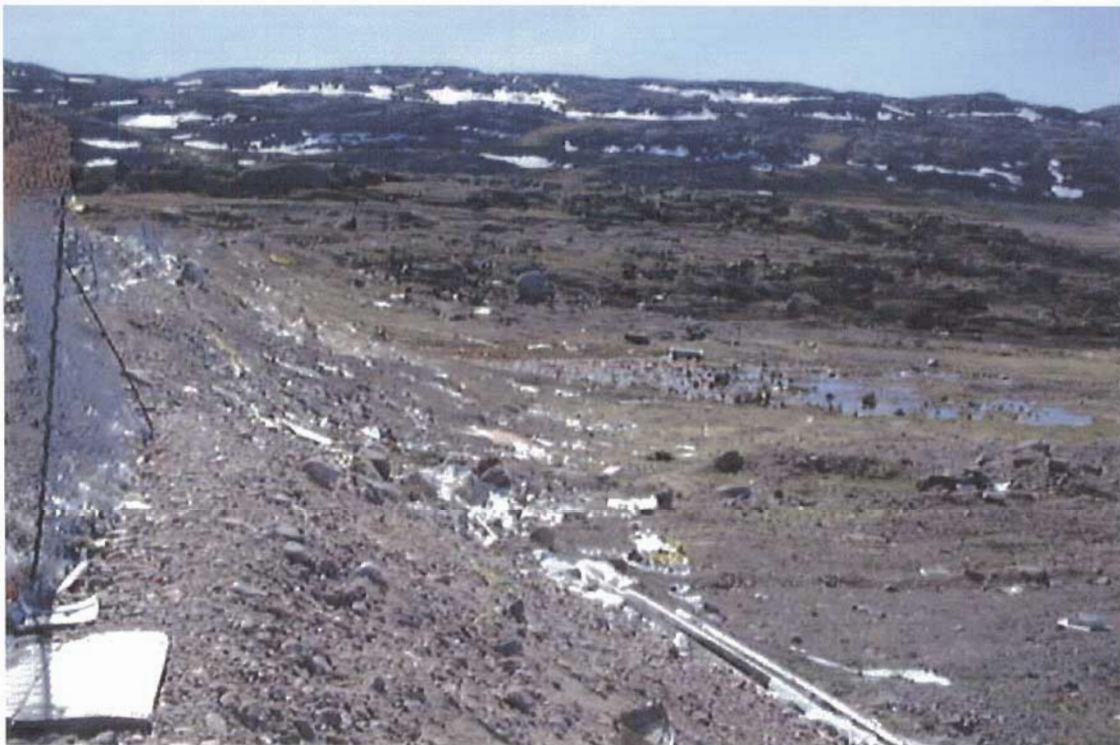
figure 5. Leachate runoff from the solid waste disposal facility; 2001/07/06.

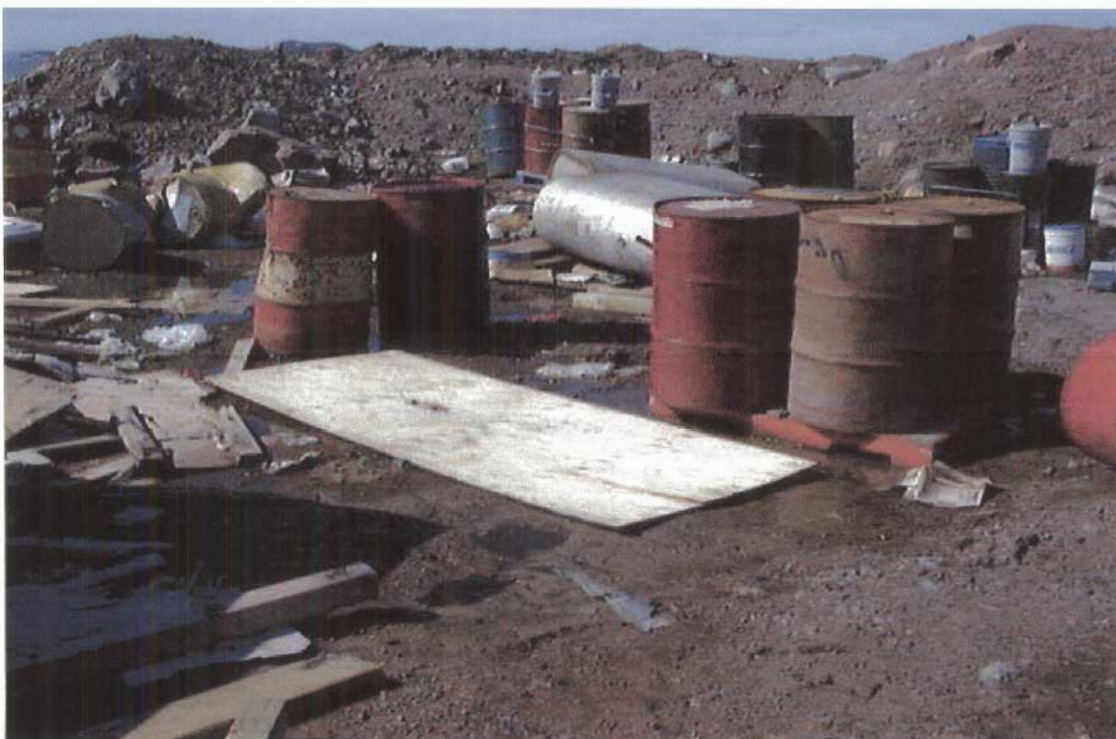
figure 6. Hydrocarbon contamination at the waste oil storage site; 2001/07/06.
