**Nunavut District Office
Field Operations
P.O. Box 100
Iqaluit, NU, X0A 0H0**

RE: September 11th 2007 Kugaaruk Municipal Water Inspection

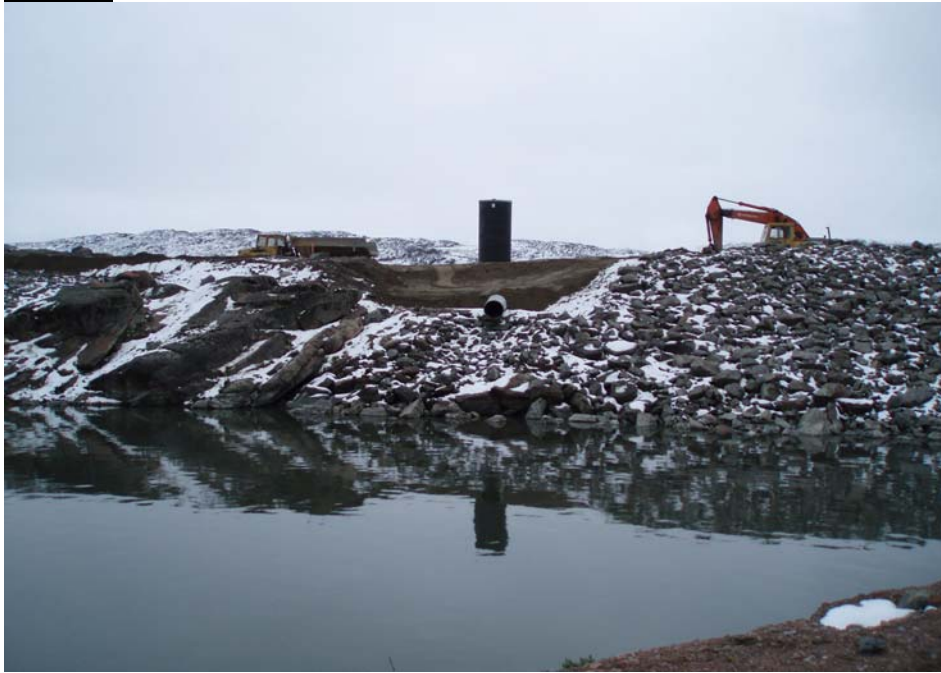
Picture 1. Construction of new lagoon located above old lagoon.

At the time of the inspection the hamlet had already begun constructing a new sewage lagoon just above the old lagoon. In speaking with the hamlet staff it was understood that the old lagoon would be used as a back-up. A sample was taken at the first discharge point after the old lagoon.

At the time of the inspection, the Hamlet of Kugaaruk had almost finished the construction of the new lagoon located just above the old one. In conversations with the SAO the old lagoon will be used as a back up system.

An abandonment and restoration plan should be developed for the old sewage lagoon.

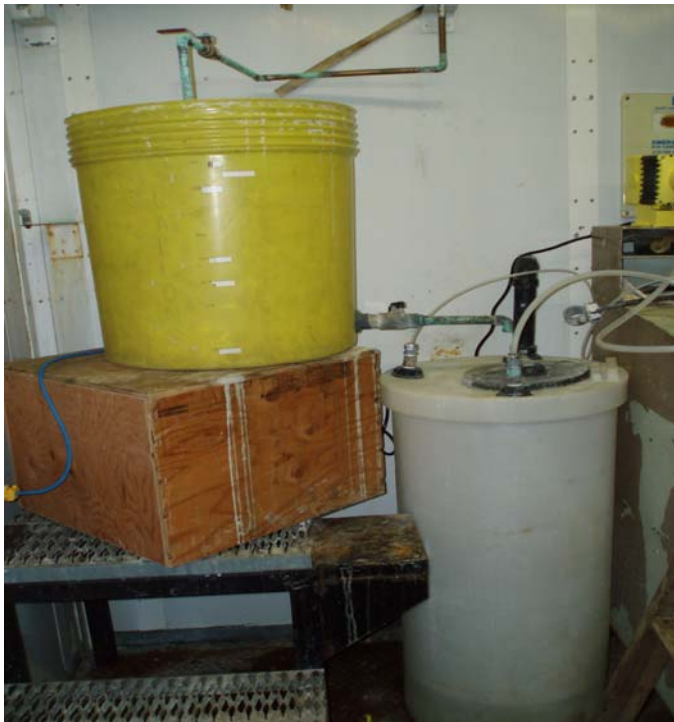
Picture 2. Chlorine being added to the tanks before it gets distributed to the community.

Raw water for the hamlet is taken from the Kugaaruk River. It is then pumped to a pumping station where delivery trucks transfer it to the hamlet. Chlorine is added to the water before it is transferred to the water trucks. Records for chlorine are kept up to date and stored in the pumping station. There are no signs identifying the hamlets drinking water source. A water sample was taken at the river near the pumping station.

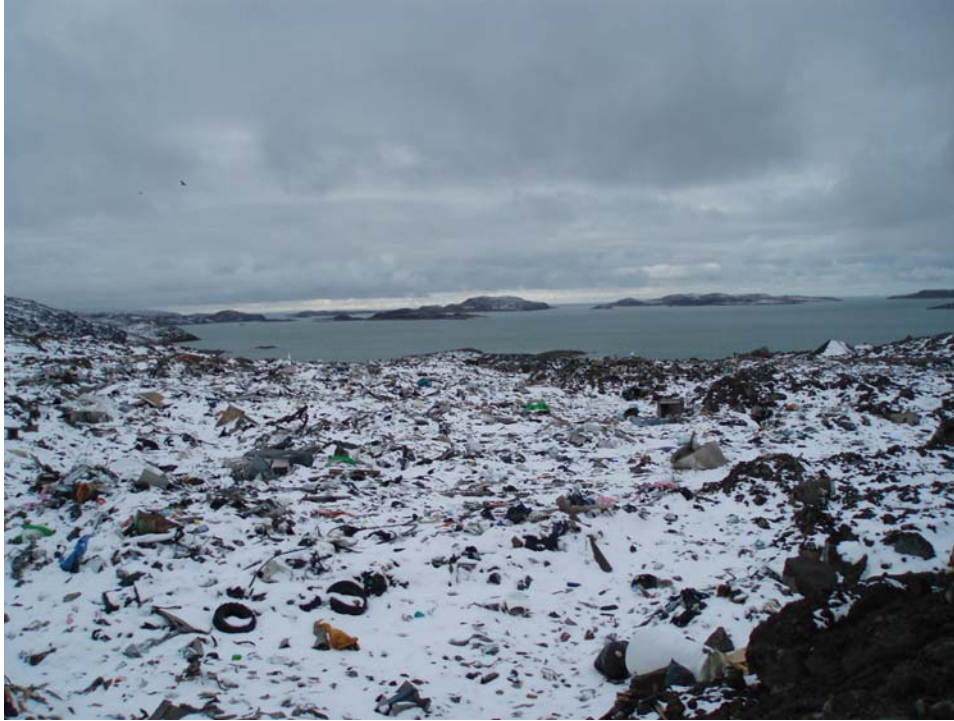
The landfill for the Hamlet is located adjacent to the sewage lagoon. The landfill is a burn and bury facility that should be better segregated. The landfill is not fenced in and there is wind blown garbage all over the place. A sample was taken in standing water at the toe of the landfill.

Photo 3. No fence surrounding the solid waste facility and little segregation.

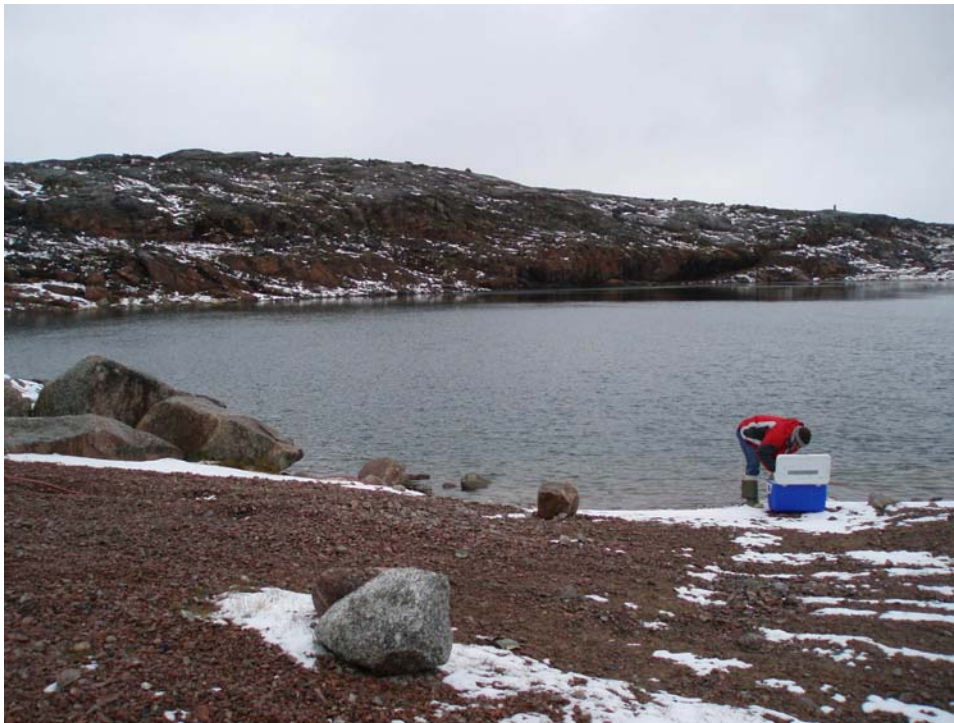
Photo 4. Raw water sampling point next to pumping station.
