WATER LICENCE INSPECTION FORM

Licensee		Licensee Representative	
Hamlet of Kugaaruk		Chantal Dowden	
Licence No. / Expiry		Representative's Title	
3BM-PEL1929		Senior Administrative Officer	
Land / Other Authorizations		Land / Other Authorizations	
Date of Inspection		Inspector	
2020 August 14		Baba Pedersen	
Activities Inspected			
<input type="checkbox"/> Camp	<input type="checkbox"/> Drilling	<input type="checkbox"/> Mining	<input type="checkbox"/> Construction
<input type="checkbox"/> Roads/Hauling	<input type="checkbox"/> Other:	<input checked="" type="checkbox"/> Other: Municipal	<input type="checkbox"/> Reclamation
<input type="checkbox"/> Fuel Storage

PHOTO LOG

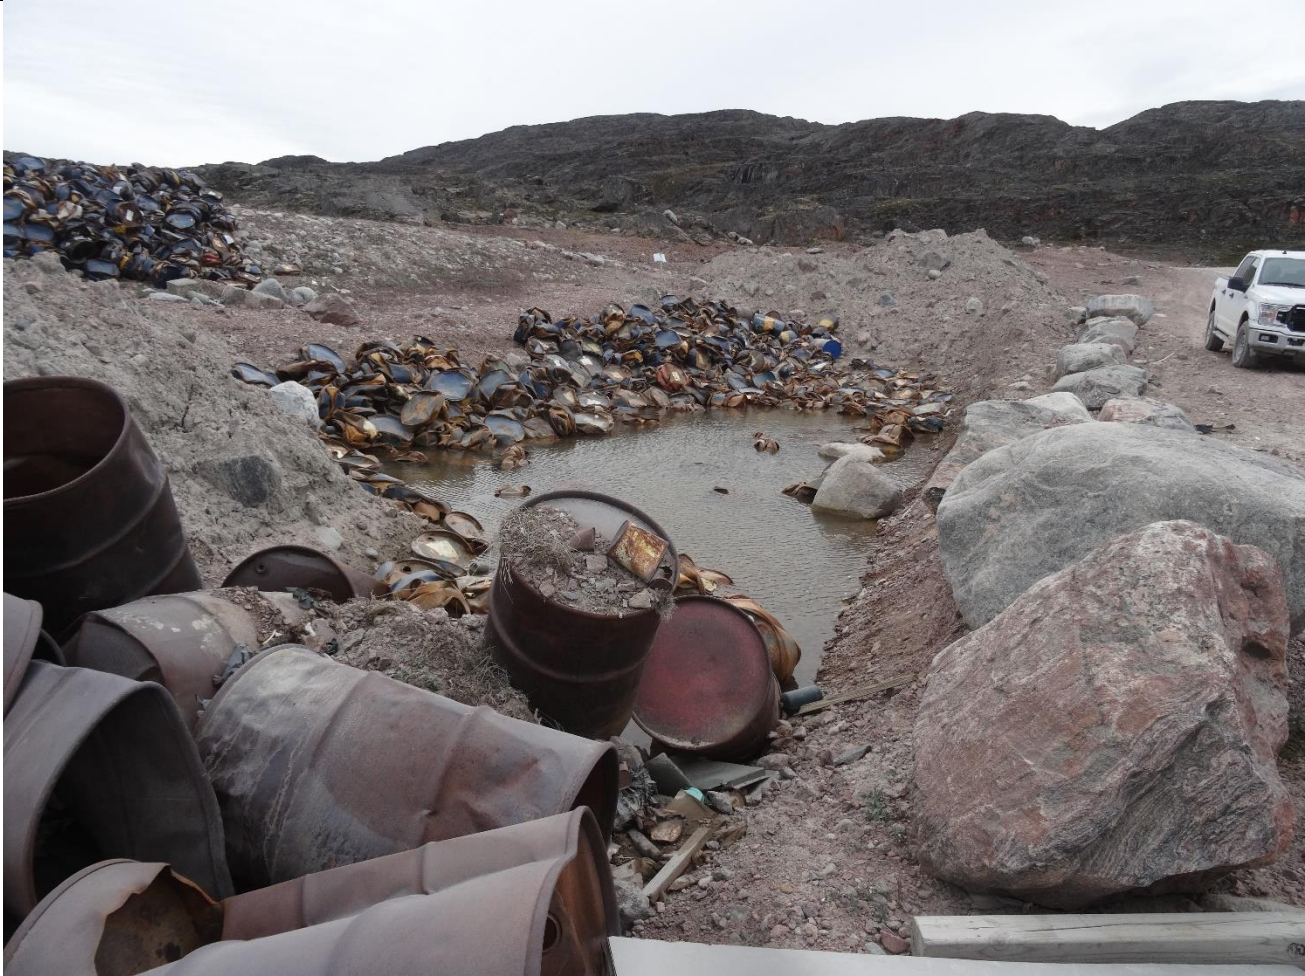
Photo 1

Description: Lower Cell of Used Oil Drum Bermed Area showing Rain Water to be transferred into the Sewage Lagoon

SECTION 3	<input type="checkbox"/> Comments	<input type="checkbox"/> Non-Compliance with Act or Licence	<input checked="" type="checkbox"/> Action Required
<ol style="list-style-type: none">1. The Licence Holder shall remove the Rain Water from the Lower Cell into the Sewage Lagoon BEFORE FREEZE-UP, and place all Crushed Drums into the Lower Cell PRIOR TO March 31, 2021. Then the Licence Holder Shall place all Drums of Used Oil within the 3 Upper Bermed Areas PRIOR TO March 31, 2021.2. The Licence Holder shall push back all Debris encroaching onto the Road from the Metal Dump PRIOR TO March 31, 2021.3. The Licence holder shall IMMEDIATELY restart the Burn Program of Non-Hazardous Material in the Garbage Dump to reduce the volume of Waste Piles.

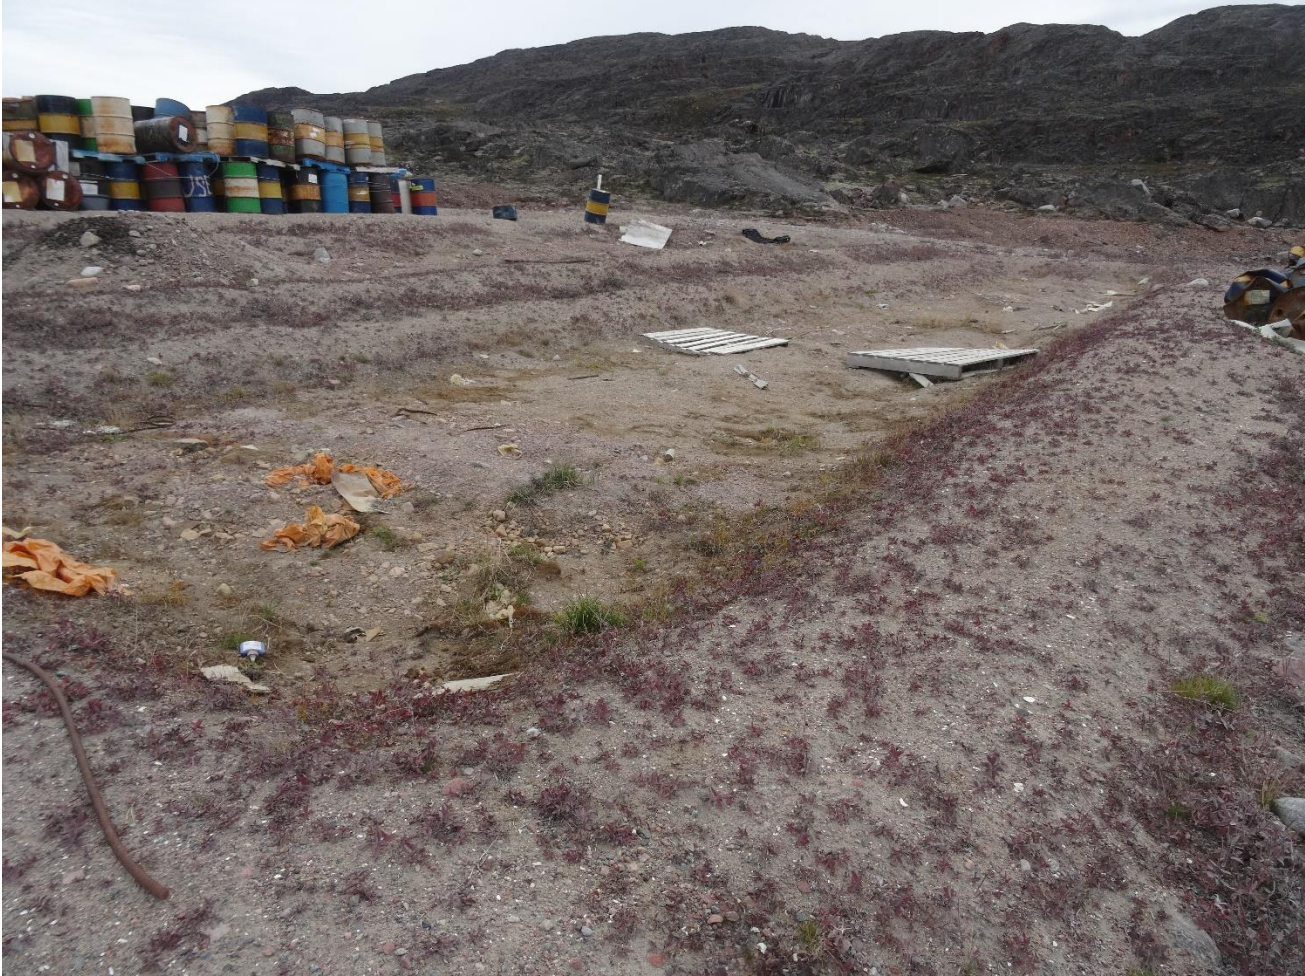
Photo 2

Description: Upper Bermed Area where All Drums of Used Oils should be stored

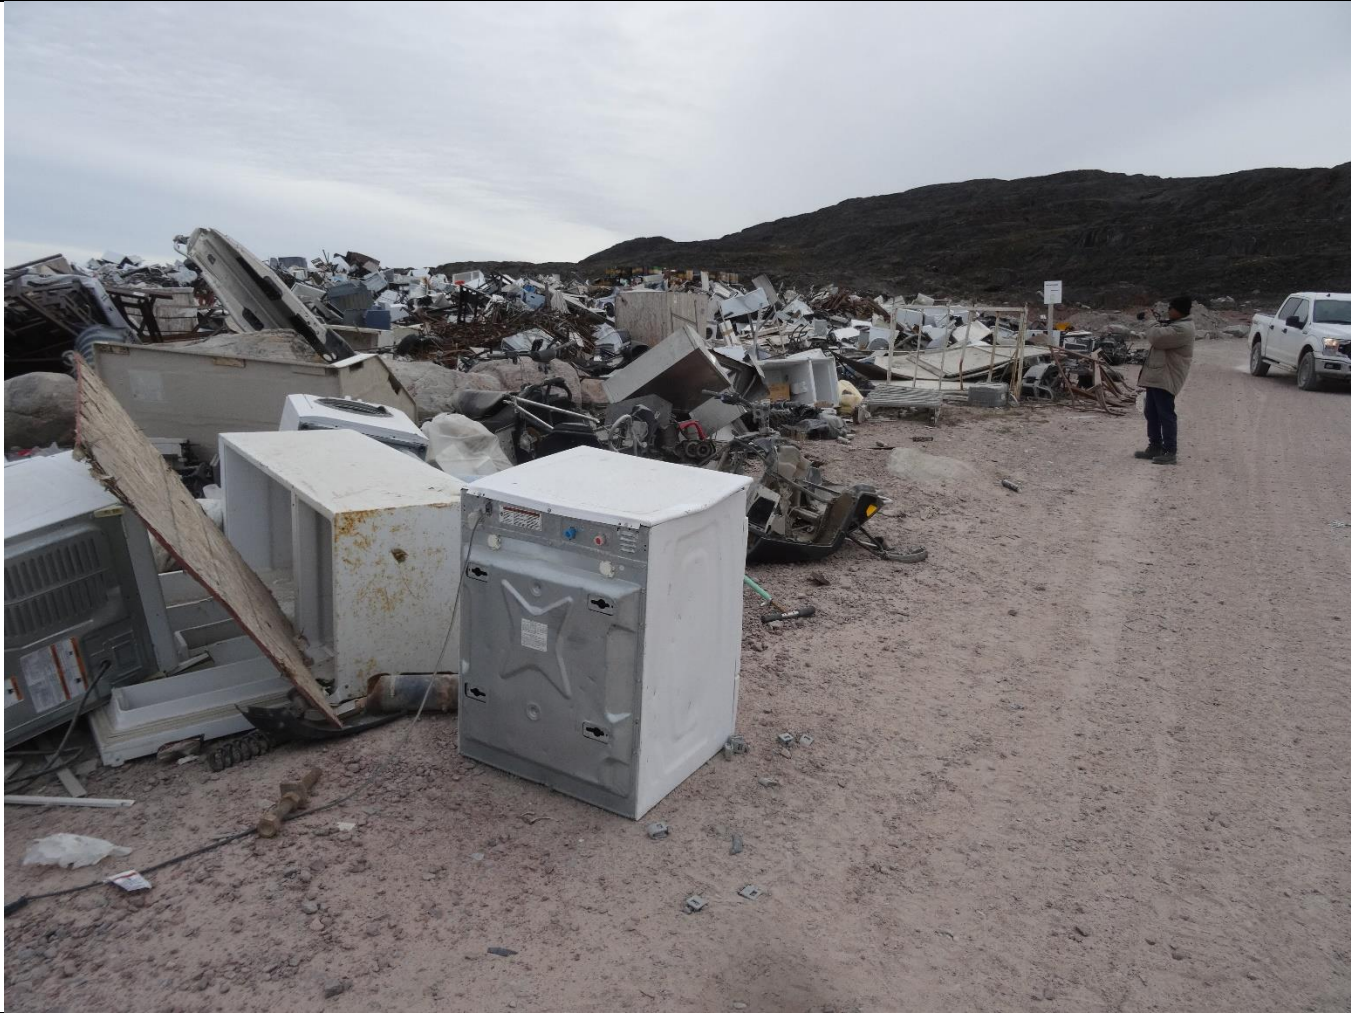
Photo 3

Description: Debris from the Metal Dump encroaching onto the Road requires to be pushed back away from the road

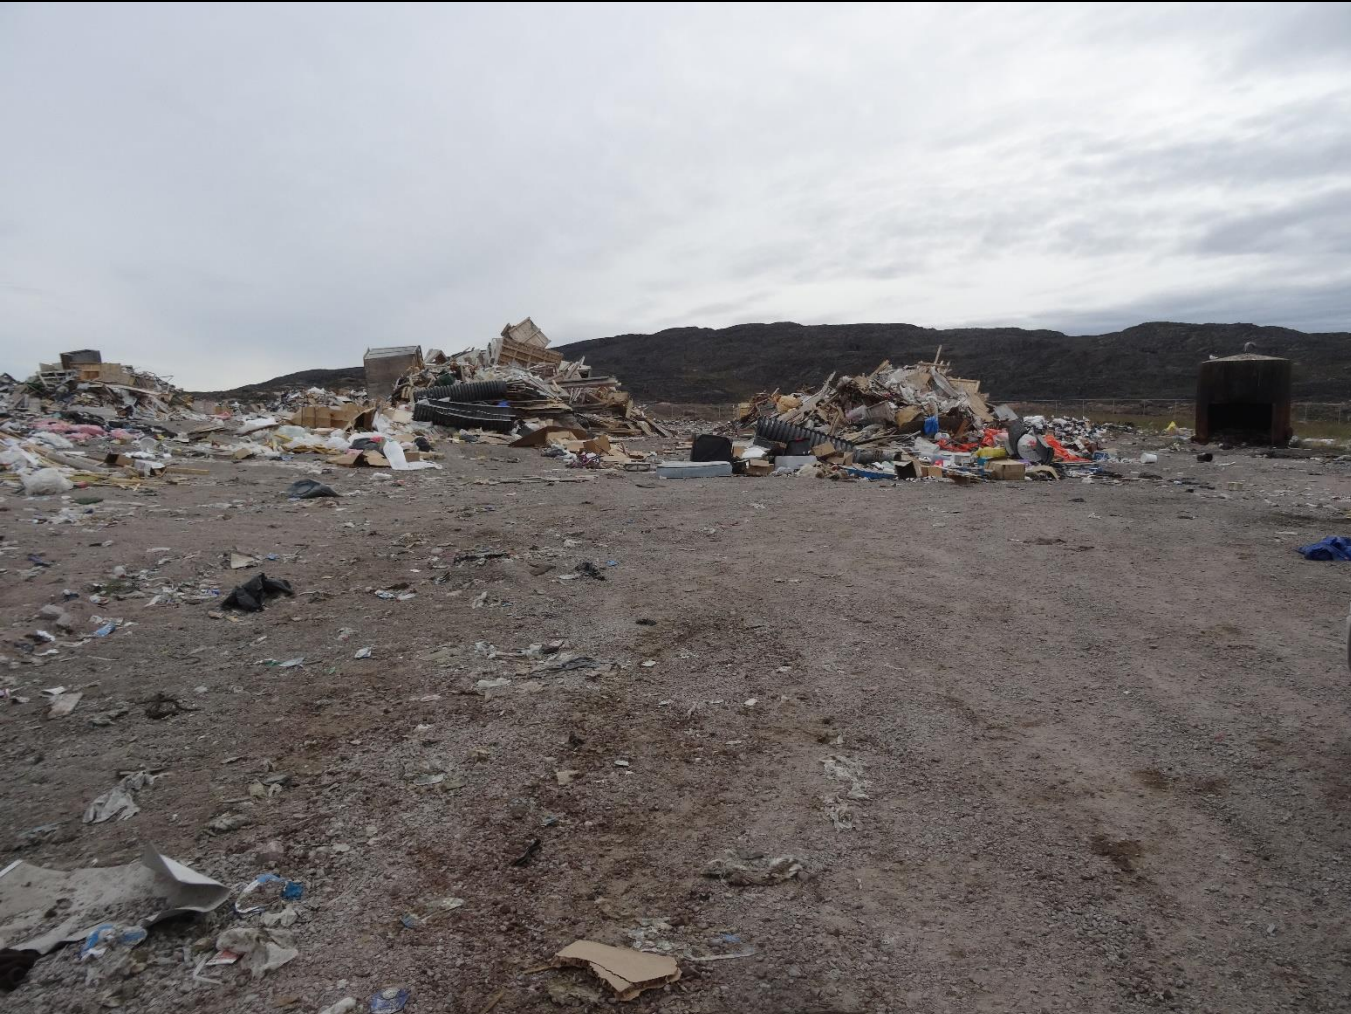
Photo 4

Description: Excessive Piles of Non-Hazardous Waste within the Garbage Dump requiring routine Burning to control volumes

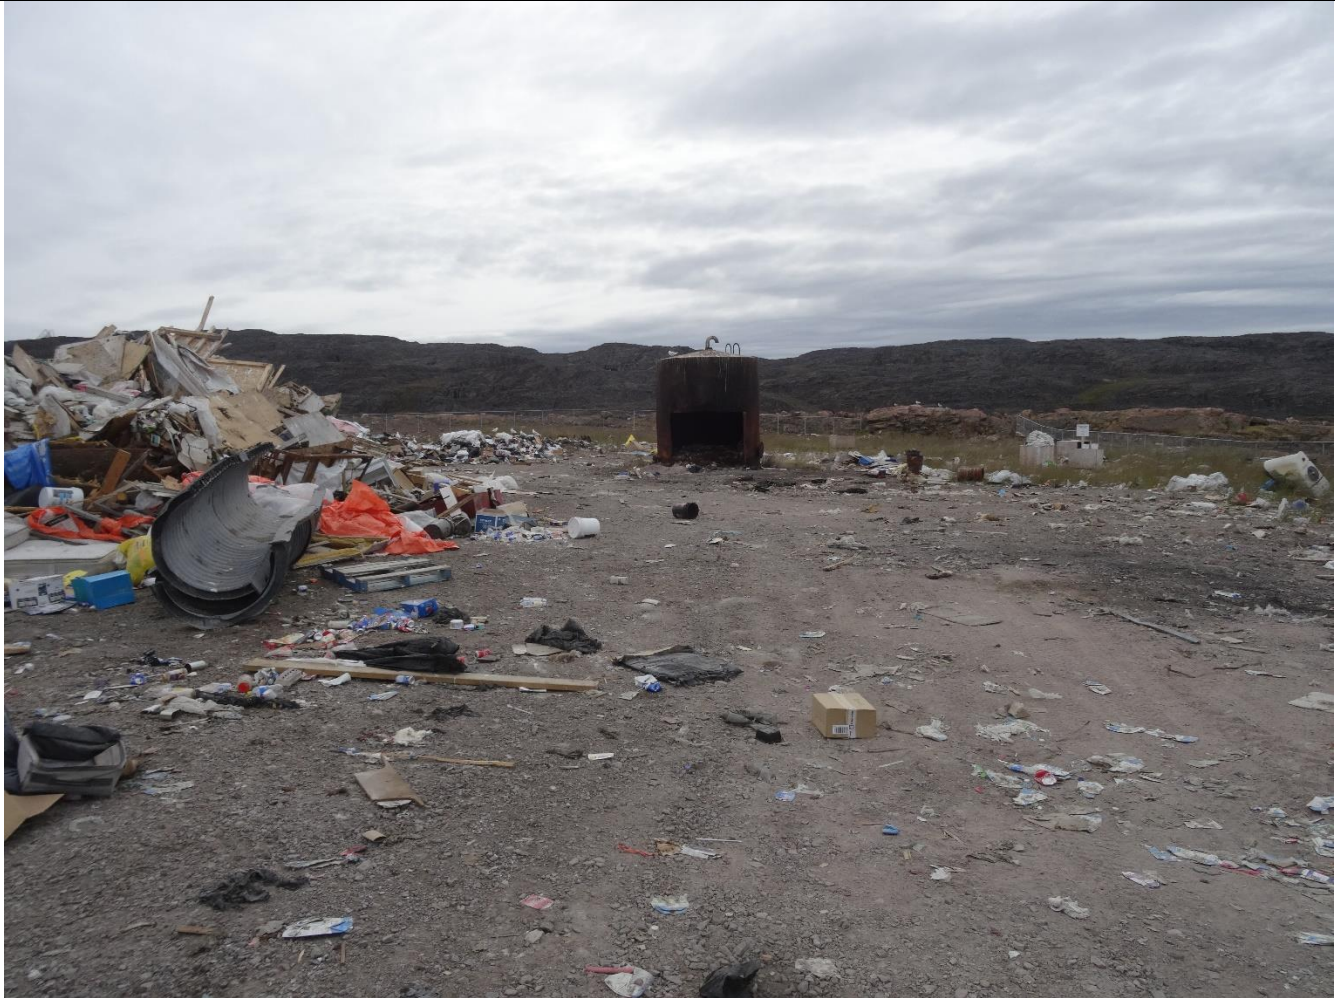
Photo 5

Description: Large Metal Debris shown on Left Side of Photo should be moved and stored within the Metal Dump

The Licence Holder Shall remove the large metal debris in the Garbage Dump and place it in the Metal Dump PRIOR TO Freeze-up.
5.

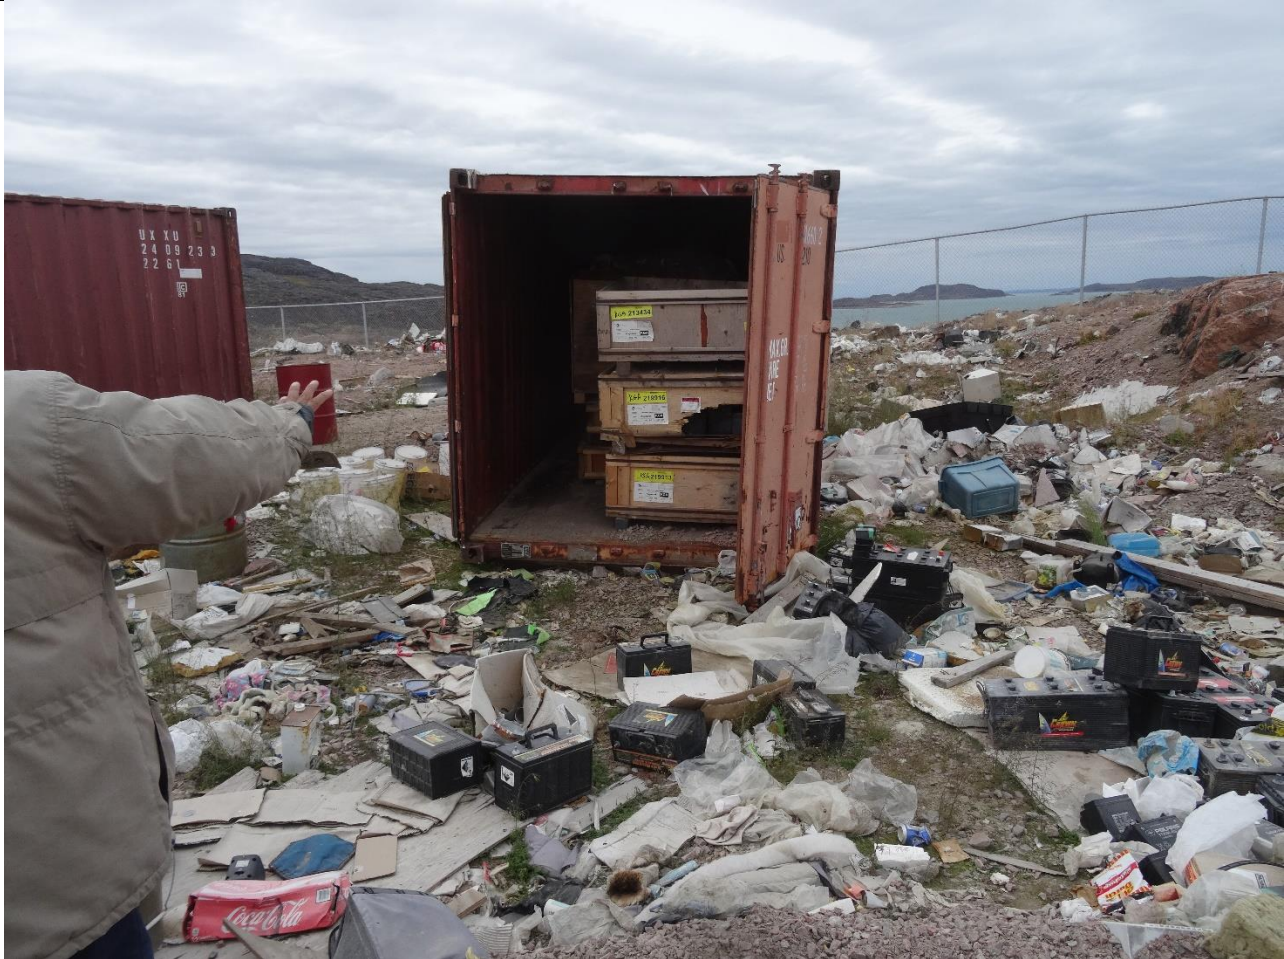
Photo 6

Description: Used Batteries waiting to be Crated Up should be stored in an open wooden crate, not directly on the ground

The Licence Holder shall Temporarily Store all Used Batteries waiting to be Crated within a Wooden Crate EFFECTIVE IMMEDIATELY.
7.

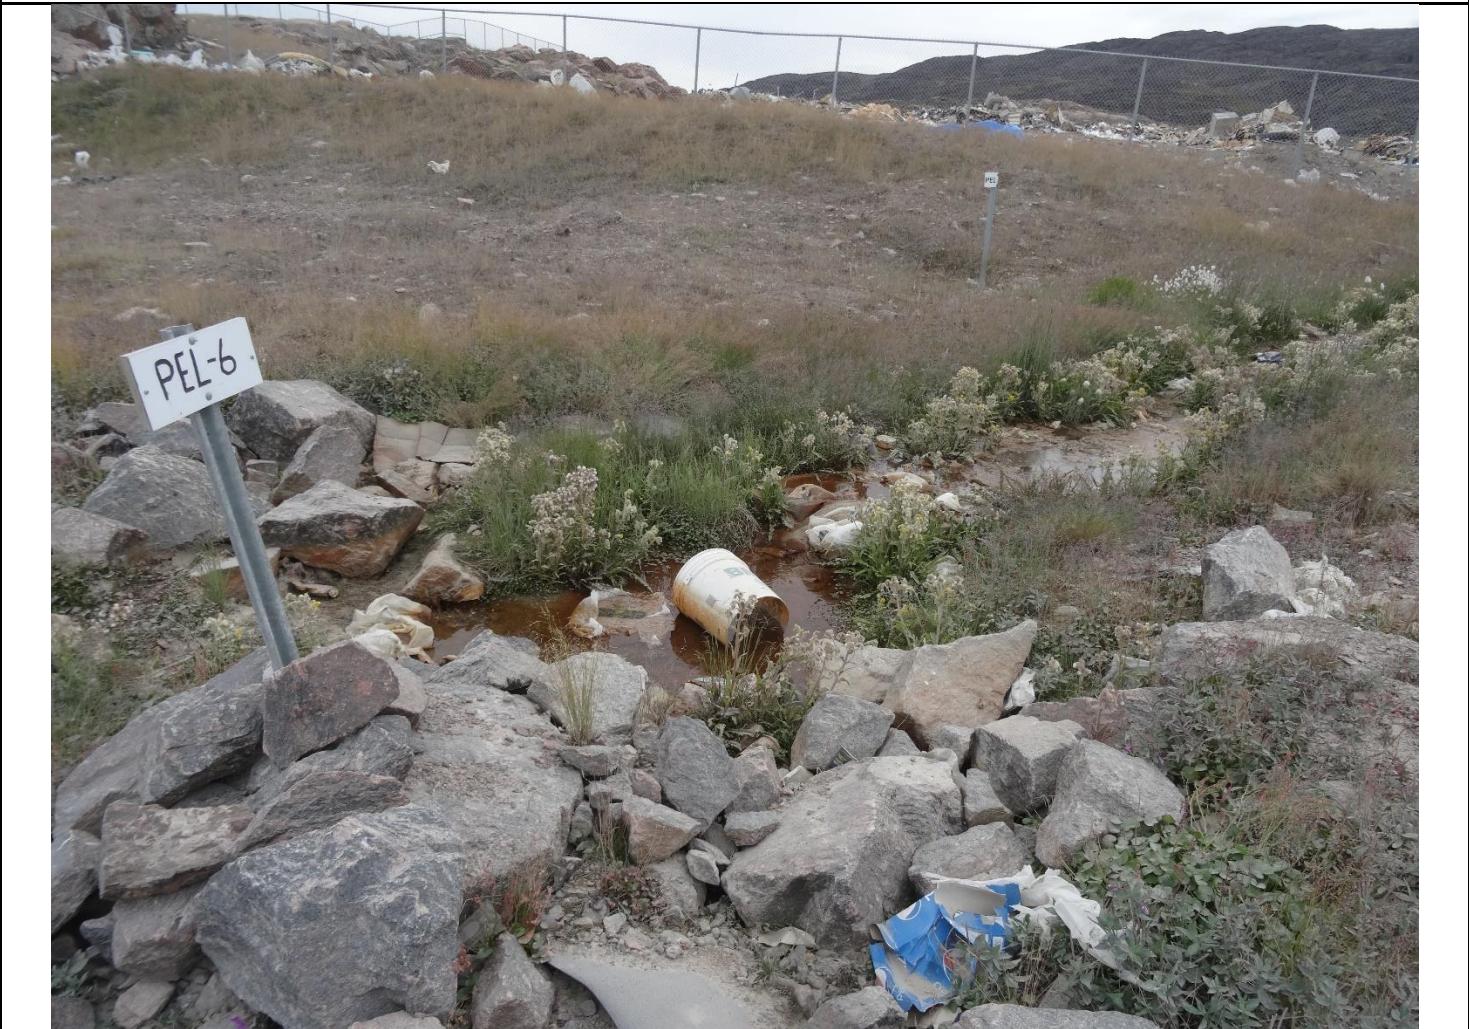
Photo 7

Description: All Debris in the Ditch near Sample Station PEL-6 needs to be removed and placed within the Garbage Dump

The Licence Holder shall remove all Debris from within the Ditch around the PEL-6 Sample Station PRIOR TO Freeze-up.
8.

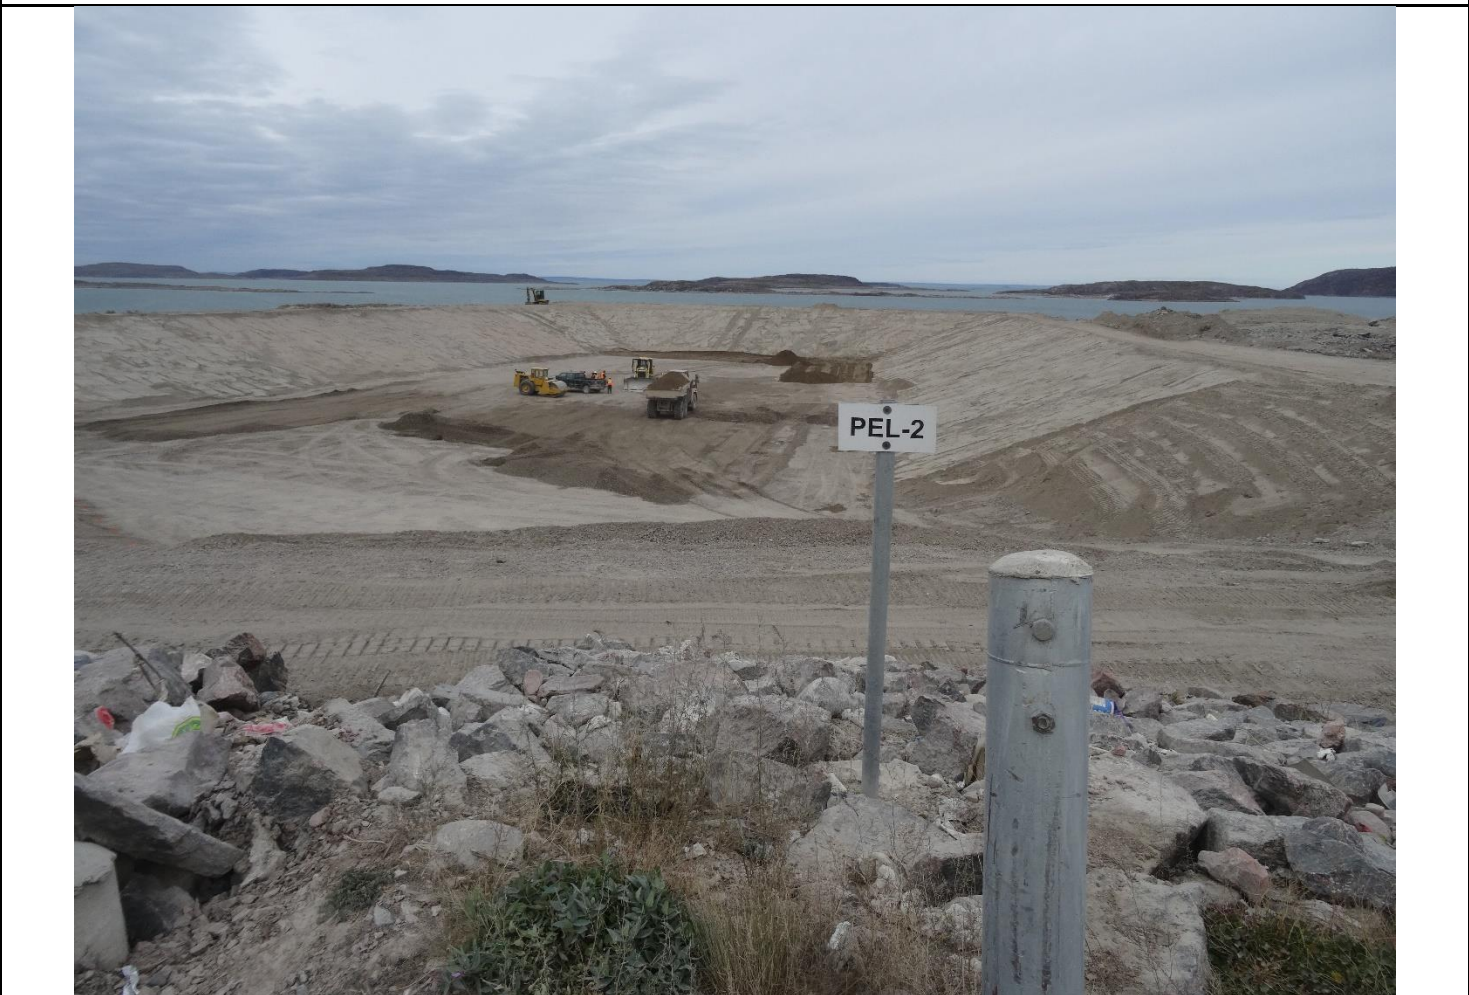
Photo 8

The Licence Holder along with the Gov't of Nunavut have a Contractor rebuilding the Sewage Lagoon which is expected to be in operation before Freeze-up this year. The Inspector has no concerns with this at this time.
9.

Description: Contractor Rebuilding the Sewage Lagoon which is expected to be in use before freeze-up this season

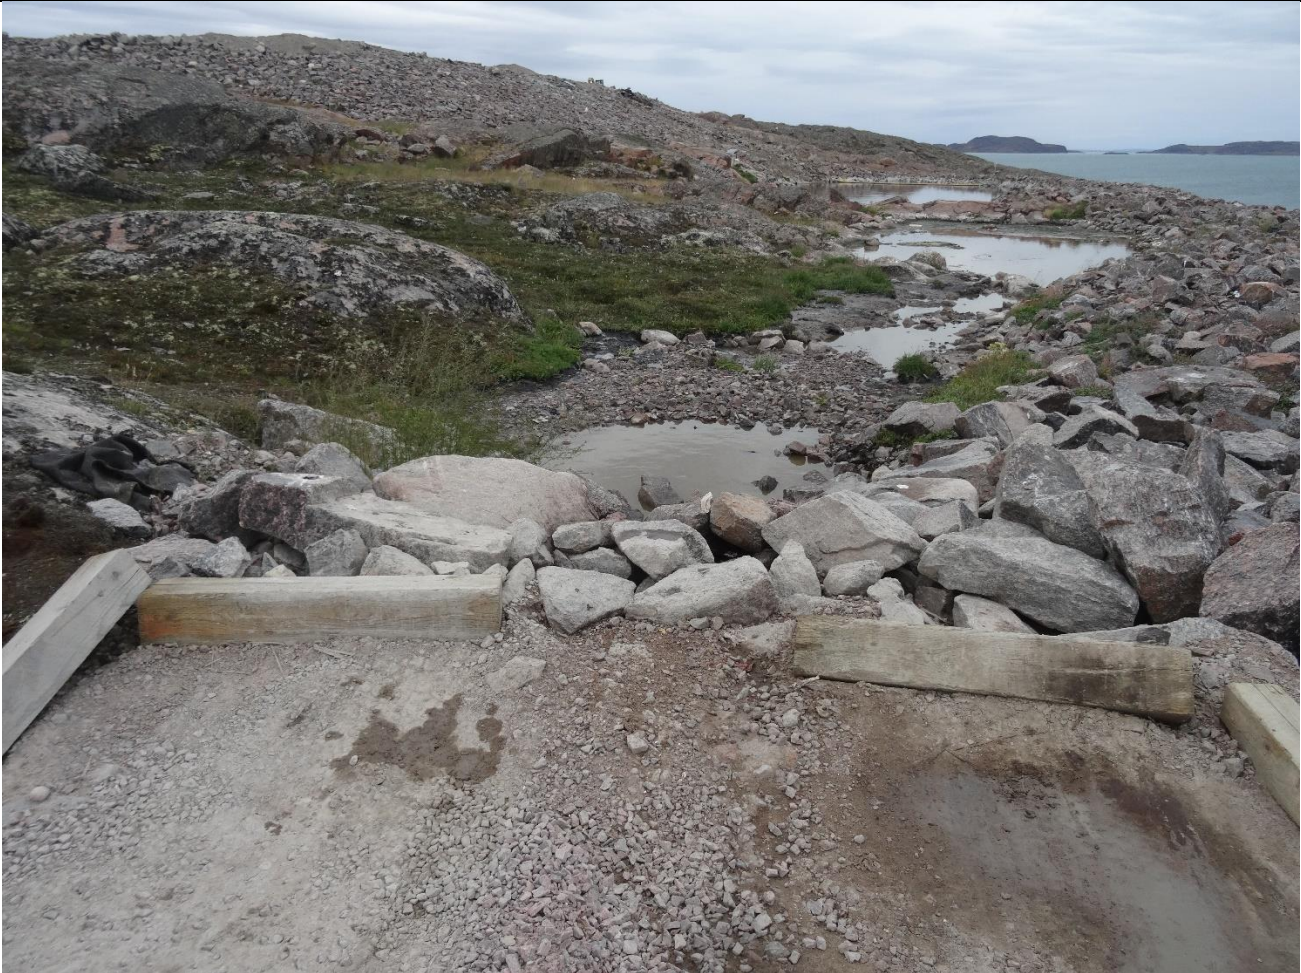
Photo 9

The Licence Holder is using the Lower Cell of the Sewage Lagoon System as the Main Cell during the Construction Phase for the New Main Cell of the Sewage Lagoon. The Inspector has no concerns with this at this time.
10.

Description: Lower Cell of the Sewage Lagoon being used as the Main Cell during the rebuilding Construction period

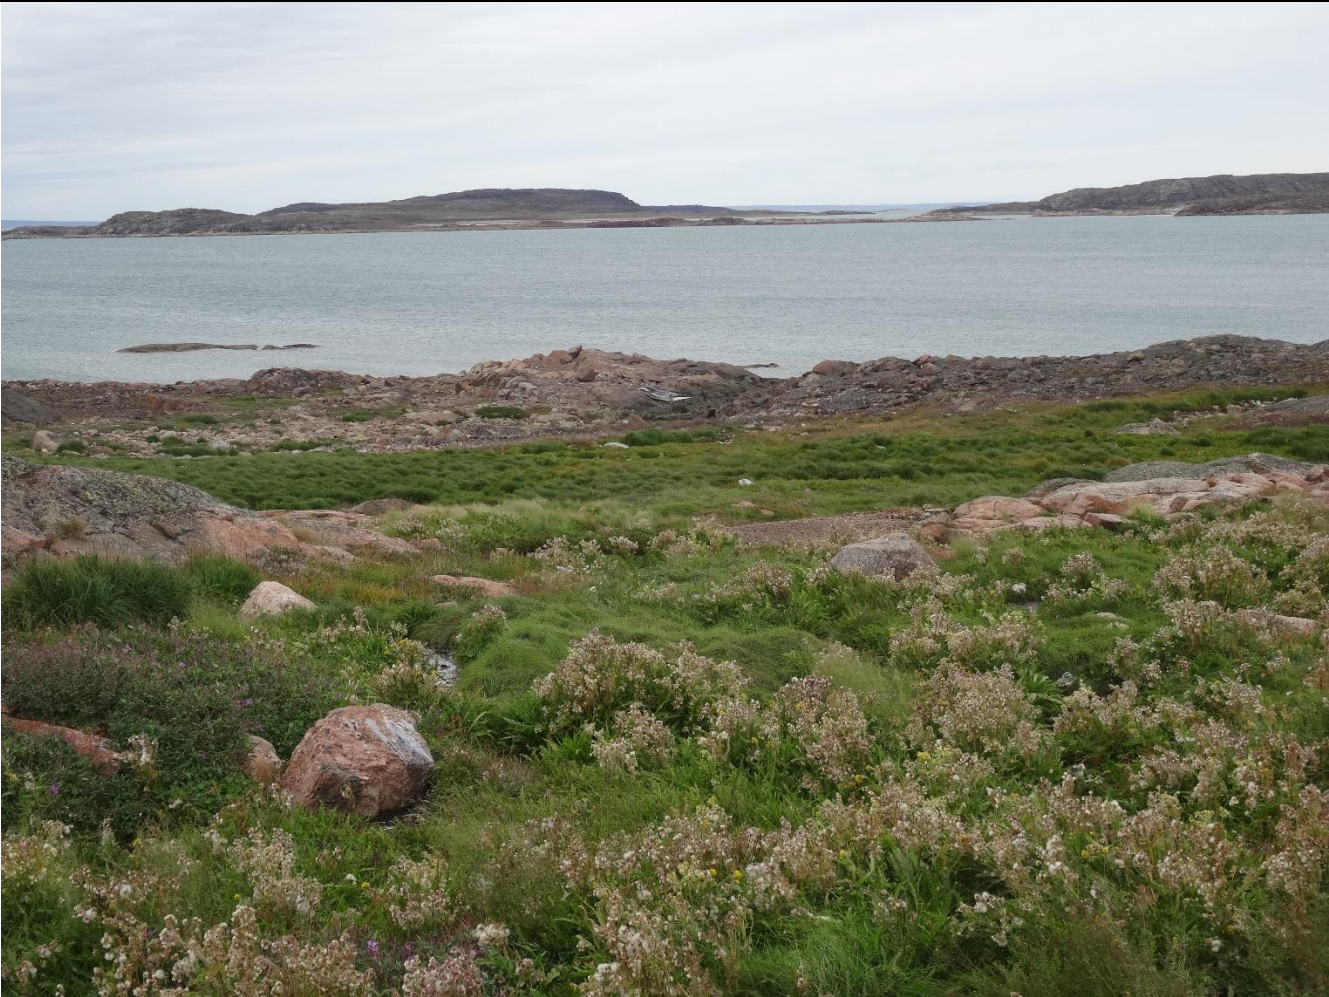
Photo 10

Description: Top view of the Decant Area for the Sewage Lagoon
