YEAR BEING REPORTED: 2021

The following information is compiled pursuant to the requirements of Part B, Item 1 of Water License No. 3BM-PEL1929 issued to the Municipality of Kugaaruk.

Appendix F: Notice of Leak

Re: Kugaaruk Lagoon Leak

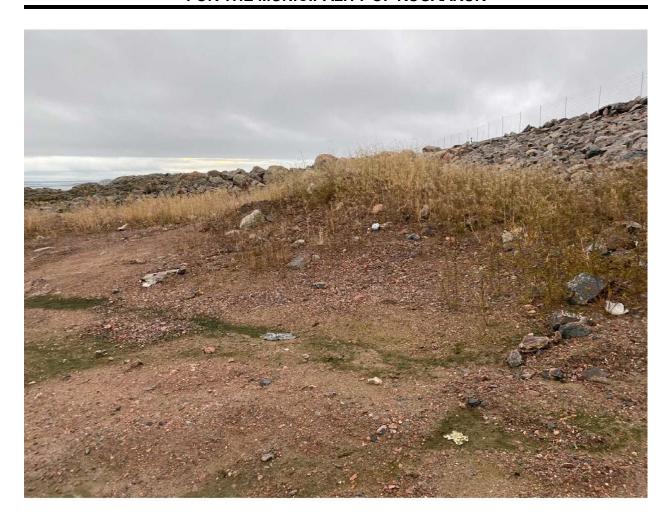
On September 21, 2021, a leak with some pooling was observed below the southwest berm of the Kugaaruk sewage lagoon by municipal staff. Samples were taken on September 22^{nd} and sent to Taiga Laboratory in Yellowknife.

The preliminary sample results and a photograph of the area of the leak taken October 4, 2021 are attached to this letter. The leak had dried at the time of the photograph, but the discoloration and lab results suggest that the leak contains wastewater effluent. The lagoon was upgraded and commissioned in 2020 and is still under warranty. The contractor is currently on site investigating the issue and the design consultant will be onsite next week.

- Municipal staff identified a leak coming from the southwest berm of the sewage lagoon on September 21, 2021. Samples were taken and sent to Taiga Laboratory and results indicated that it was likely sewage. The leak had dried by October 4th. The lagoon was still under warranty at the time the leak was identified so the CGS project Team is working with the consultant to determine a solution. The notice of the leak submitted to NWB is included in Appendix F.

CGS will follow-up with the consultant's recommendations once available.
