Re: Kugaaruk Lagoon Leak

On September 21, 2021, a leak with some pooling was observed below the southwest berm of the Kugaaruk sewage lagoon by municipal staff. Samples were taken on September 22nd and sent to Taiga Laboratory in Yellowknife.

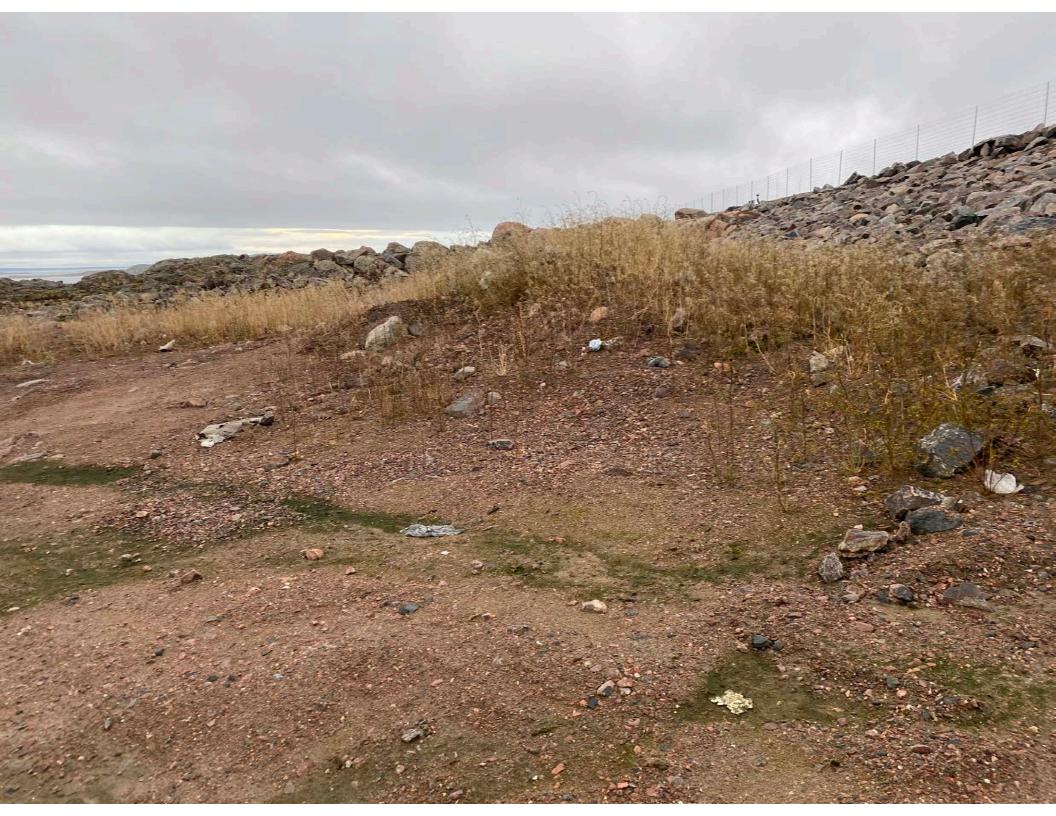
The preliminary sample results and a photograph of the area of the leak taken October 4, 2021 are attached to this letter. The leak had dried at the time of the photograph, but the discoloration and lab results suggest that the leak contains wastewater effluent. The lagoon was upgraded and commissioned in 2020 and is still under warranty. The contractor is currently on site investigating the issue and the design consultant will be onsite next week.

CGS will follow-up with the consultant's recommendations once available.
