## **Response to Inspector's Report**

### **Water Licence # NWB 0409 Renewal Application for the Municipality of Pond Inlet**

#### **Seepage from the Sewage Lagoon:**

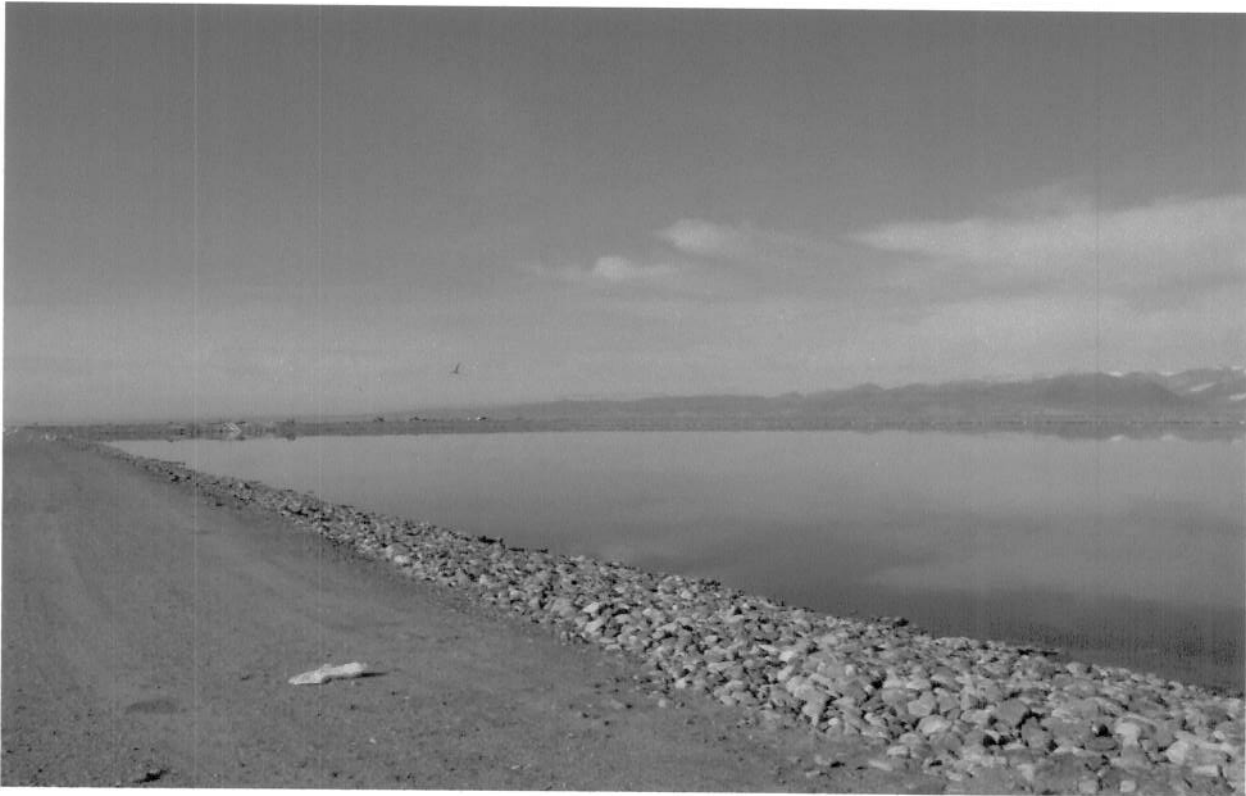
Fig. 1

This is a single cell sewage lined lagoon with gravity decanting system. This was designed to function as a containment retention structure. The facility has been in operation since 2005.

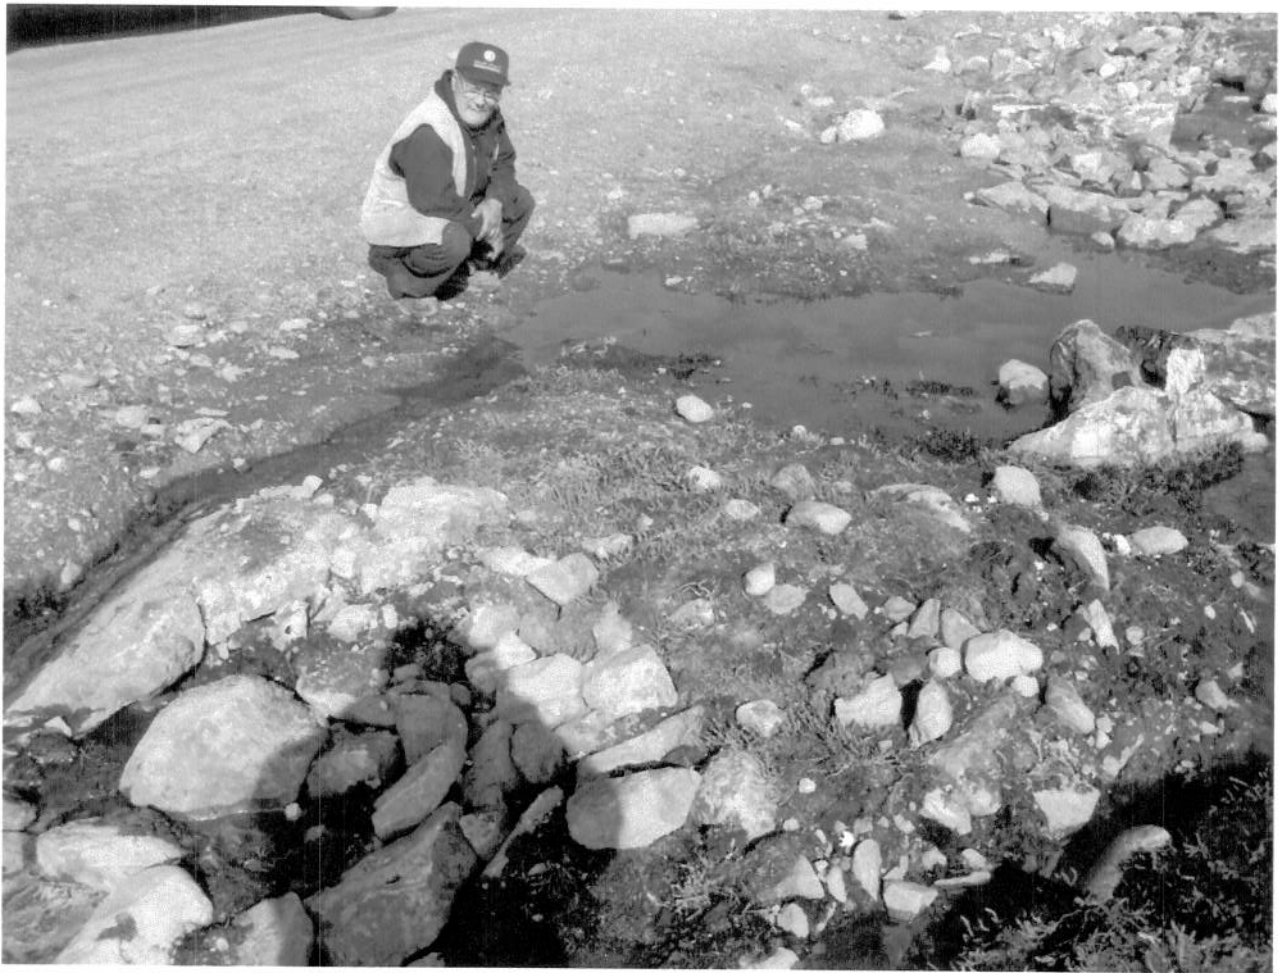
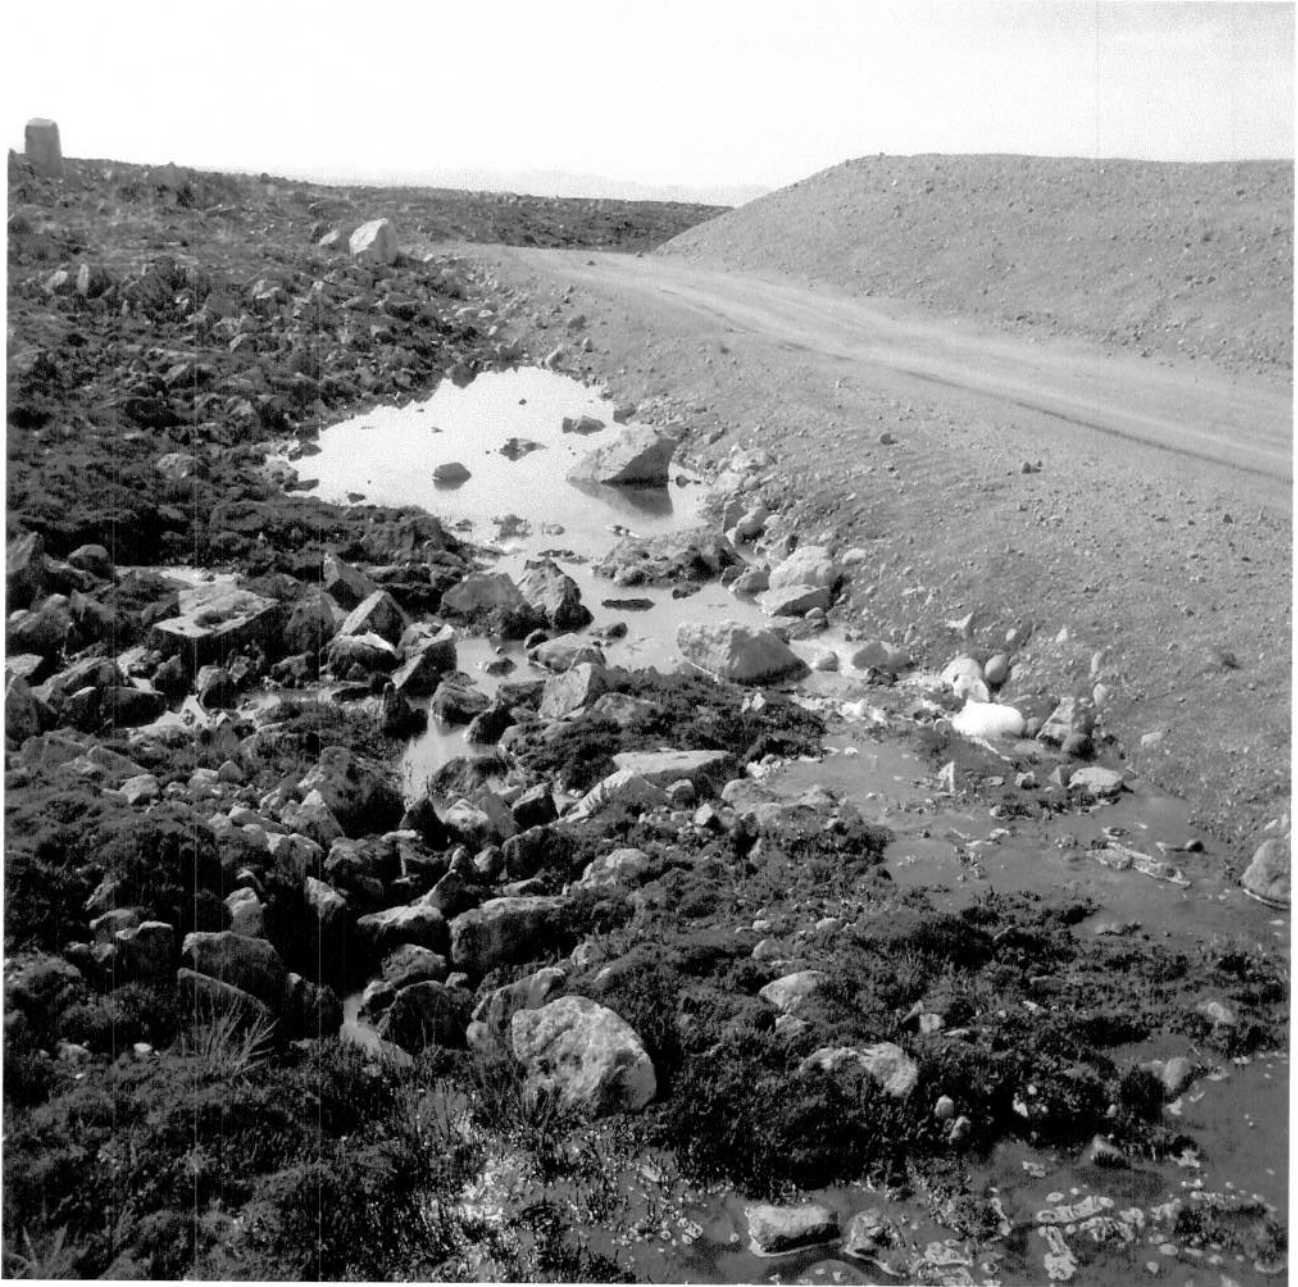
Fig. 2

After heavy rainfall during summer each year, there was a sign of leakage water next to the East berm. Water used to bubble out from the ground. It was observed during the event since the lagoon started operation. In 2007, samples were collected and tested in the accredited lab in Ottawa and the results are attached. The results does not proof that this bubble was leaking out from inside of the lagoon. It means this might not be sewage water coming out from the Lagoon. After few days of the rain, the bubble does not continue. This water might come from the upper hill nearby which penetrated during the heavy rainfall and leaked to the down slope and ran along the Eastern berm of the lagoon as shown in the Picture below.

At the end of the Easter berm slope of the Lagoon, the ground elevation is lower and acts like a shallow ditch. This allows accommodating surface runoff from the surroundings. At the same time, the rain water penetrated in the upper hill during the rainfall try to bubble out at this ditch shown in this picture.

We are planning to hire a geotechnical consultant this summer 2010 to thoroughly investigate the structural stability and integrity of the berms of this facility. We are also conducting a technical assessment on the containment nature of this facility.

At the same time we will continue sampling and testing water from inside of the lagoon and surroundings from the lagoon during decanting of the lagoon and also during rainfall.

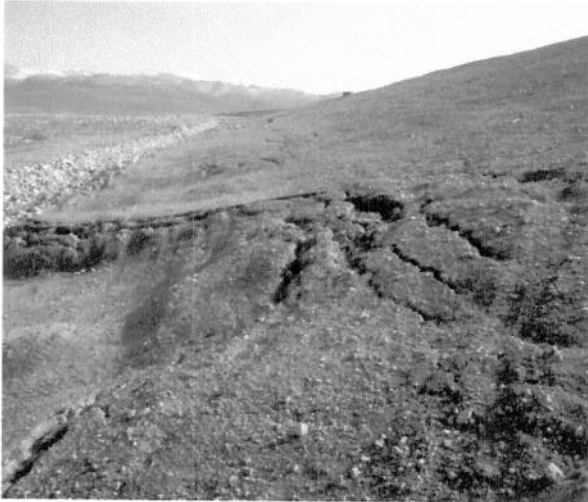
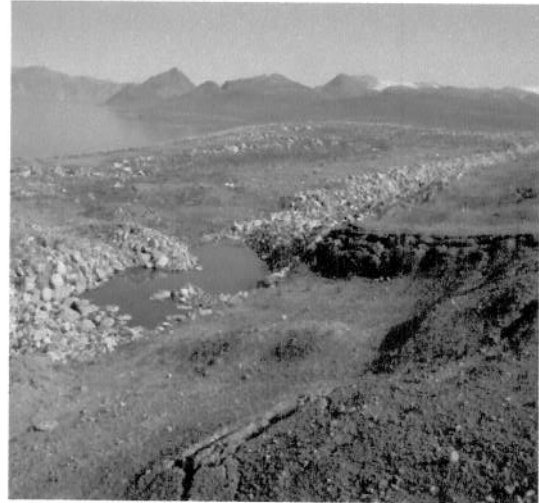
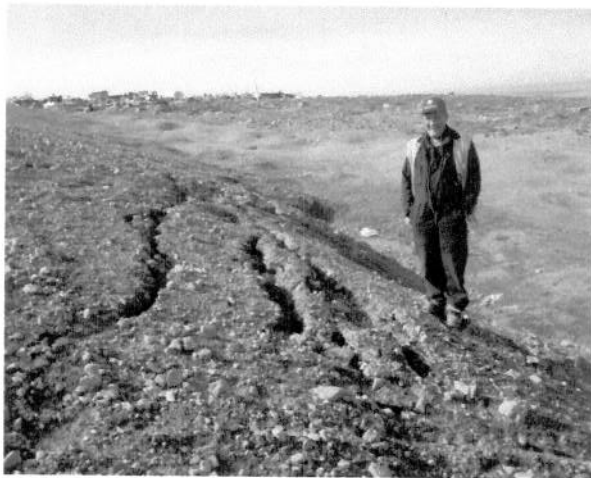
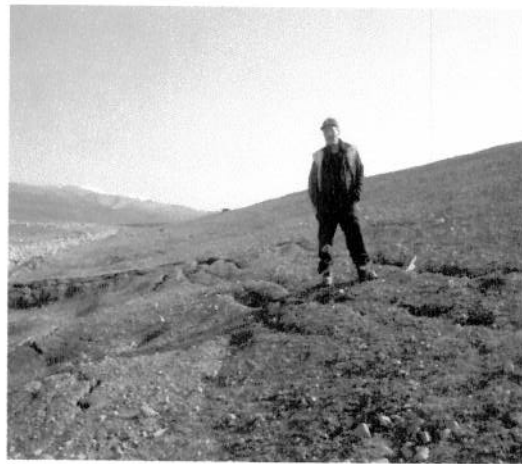
Fig. 4

Last summer 2009 there was a sign of berm failure at the northern part of this lagoon as shown in the pictures below.

We have recognized that there might be some geotechnical concerns inside the berms and their surroundings.

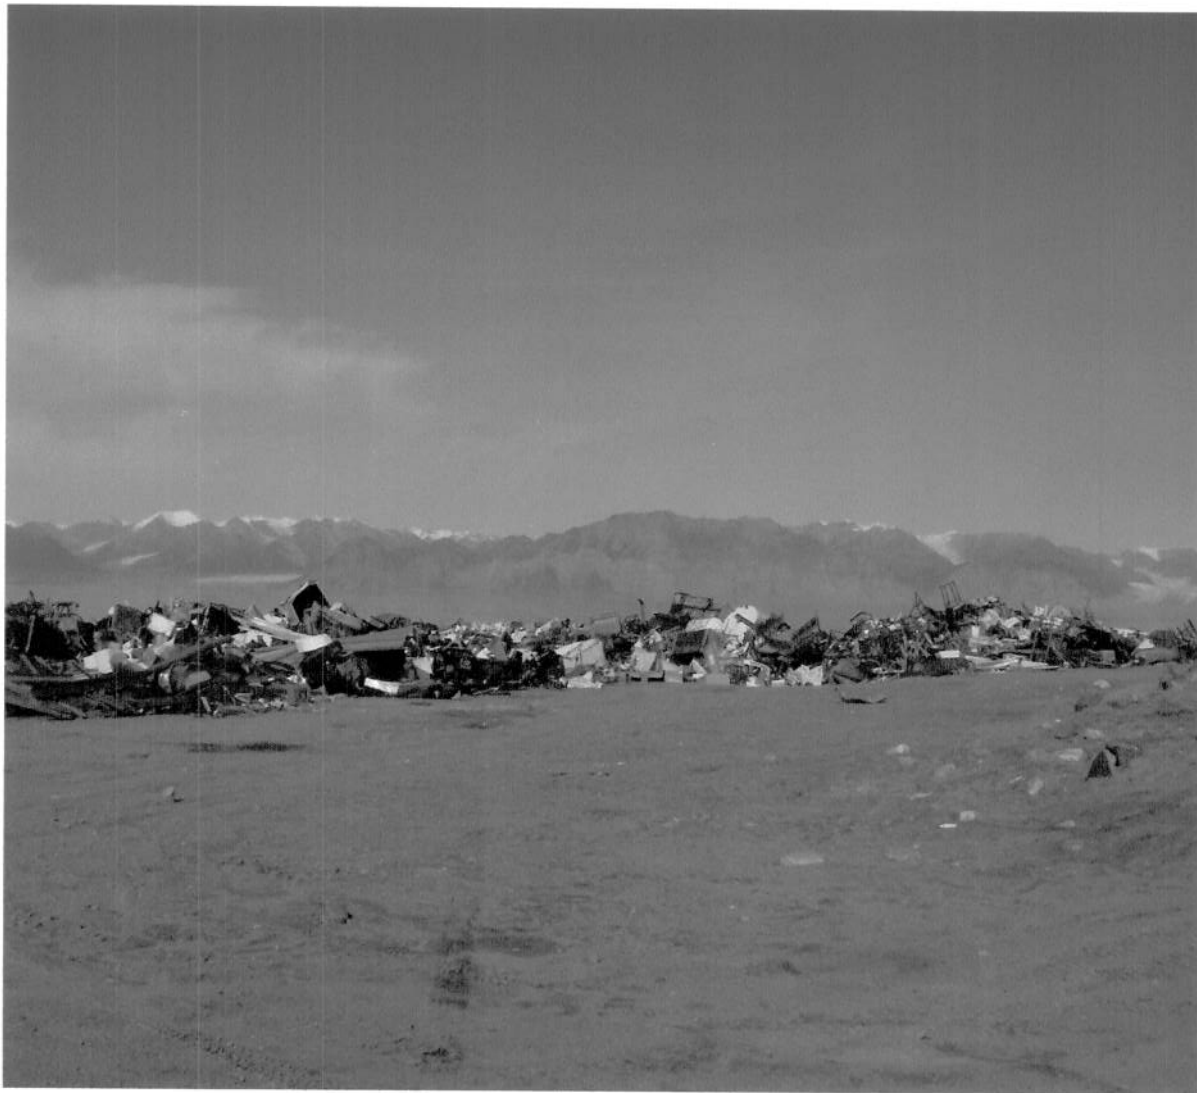
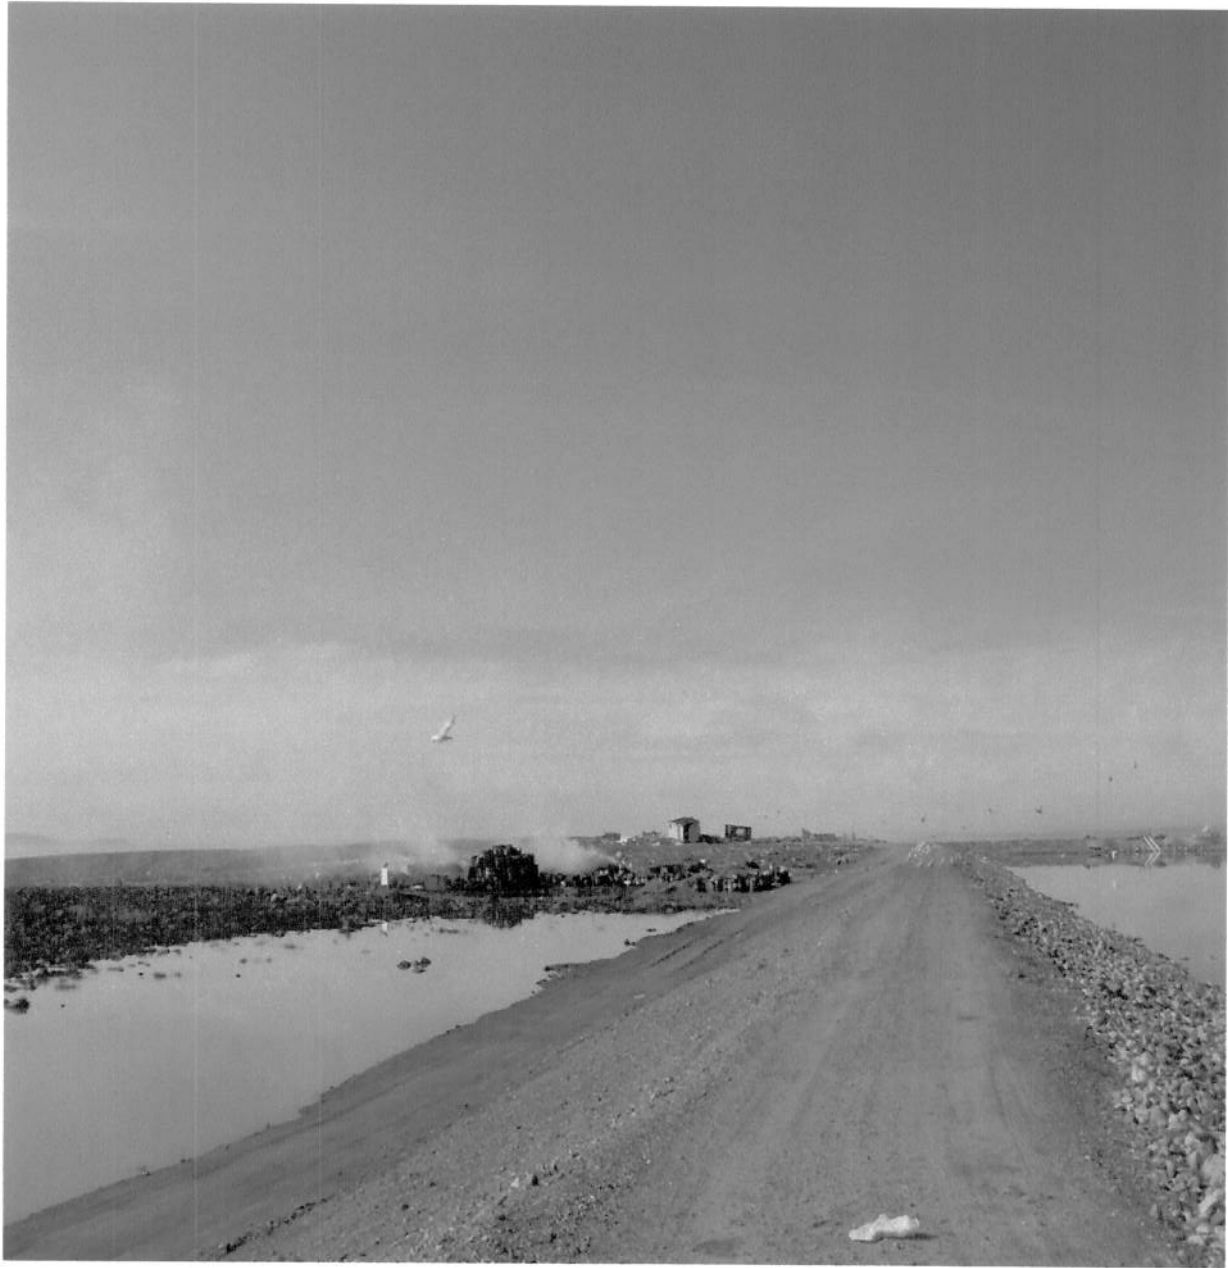
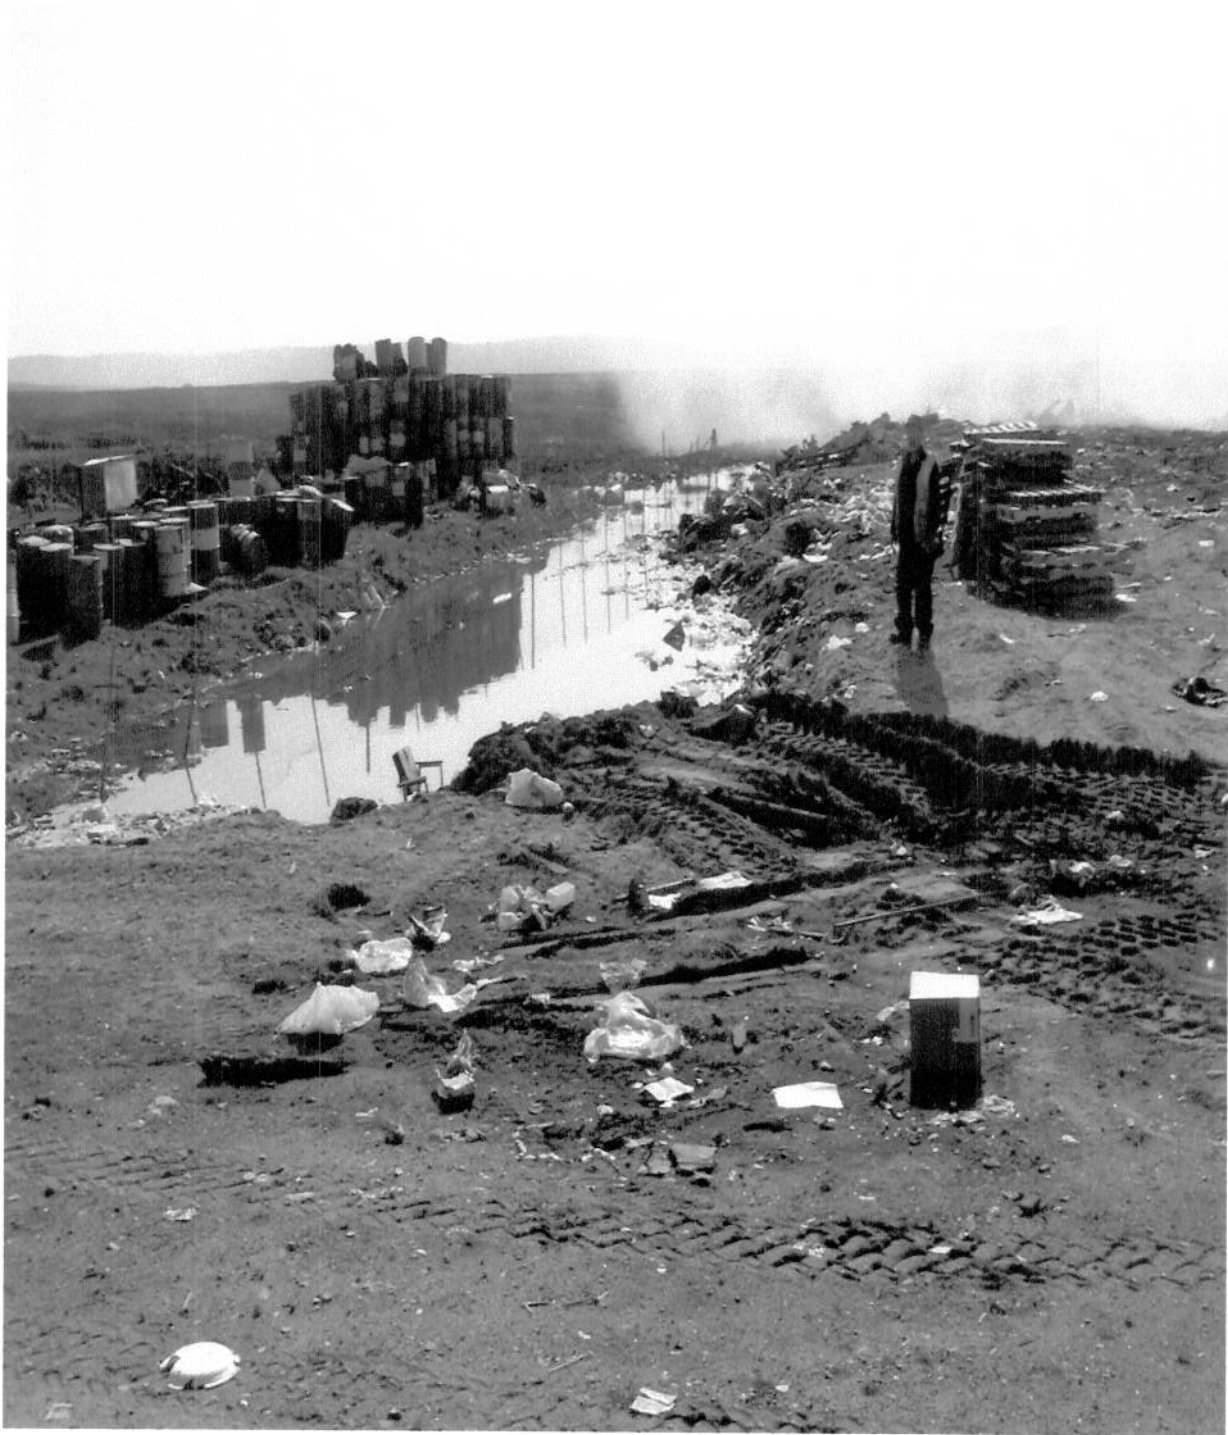
Fig. 8

**Waste oils leaching**  
**Improper storage of barrels**  
**Segregation of bulk metals and**  
**Segregation of hazardous wastes**

These all fall under waste management policy of the hamlet.

**Short term action Plan:** Hamlet will hire a consultant/contractor for managing waste oils leaching of the site and proper storage of barrels this summer 2010. CGS will be providing technical support where necessary to implement this action plan.

**Medium term action Plan:** CGS is hiring an Environmental consultant to assist GN in developing a long term strategy for managing community solid wastes site accommodating all different wastes. It is in the RFP stage and going to be advertised at the end of March, 2010. The outcome of the strategy will determine the future designs for the community solid wastes site.

**Long Term action Plan:** Following this technical assessment, a future consultant will be hired for detail design and construction of a new facility. As-built drawings and a Standard O&M manual satisfying the guidelines of NWB will be developed to operate and manage the new waste management facility once commissioned. This project is in substantiation stage and expected GAS TAX funding in 2011. This is scheduled for design and built by 2012.
