Review of Wastewater Treatment Facility

Pond Inlet, Nunavut

Project No: OTT-00020662-A0 Report date: January 21, 2011

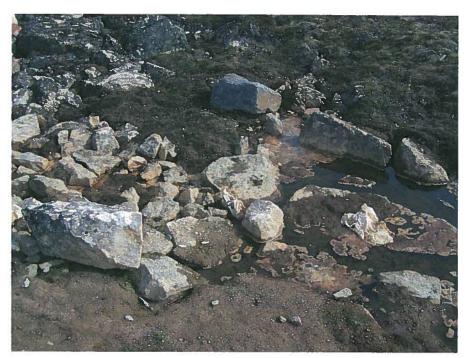
Photo #1
Water seepage under east berm close to north end of the berm.

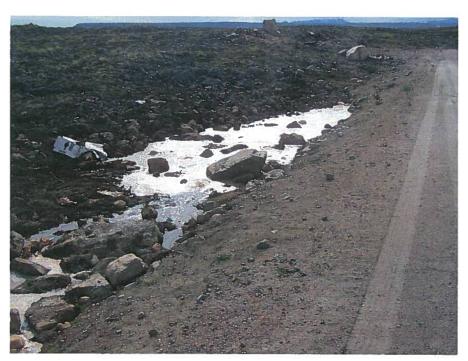
Photo #3
Water flowing along the south berm to the ponded area.

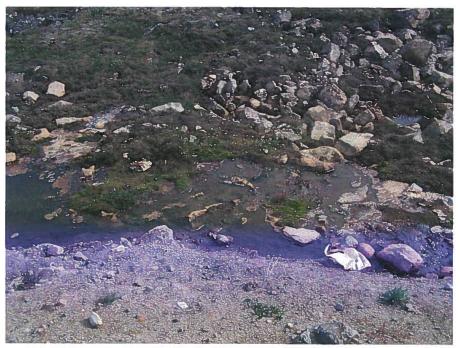
Photo #4
Water ponding south of the south berm close to the east end of the berm.

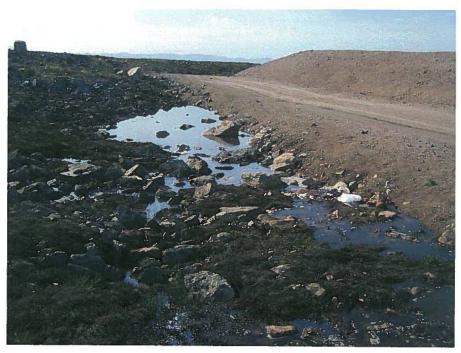
Photo #5

Another view of water ponding adjacent to the south berm.

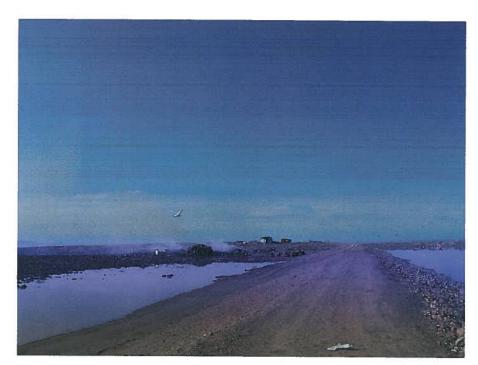
Photo #6
Ponded water south of south berm of the lagoon.
