Re: Pond Inlet Lagoon Dye Test Technical Report (GN Project #10-2008)

The Government of Nunavut, Department of Community and Government Services (GN-CGS) contracted ARKTIS Piusitippaa Inc. (ARKTIS) to complete a tracer study, and associated analysis and reporting, on the sewage lagoon in the Hamlet of Pond Inlet (GN Project #10-2008: Pond Inlet Sewage Lagoon Dye Test). The location of the sewage lagoon in relation to the community is shown in **Appendix B, Map 1**. The purpose of the tracer study was to identify potential leakage through the lagoon berm. The study involved the following main components:

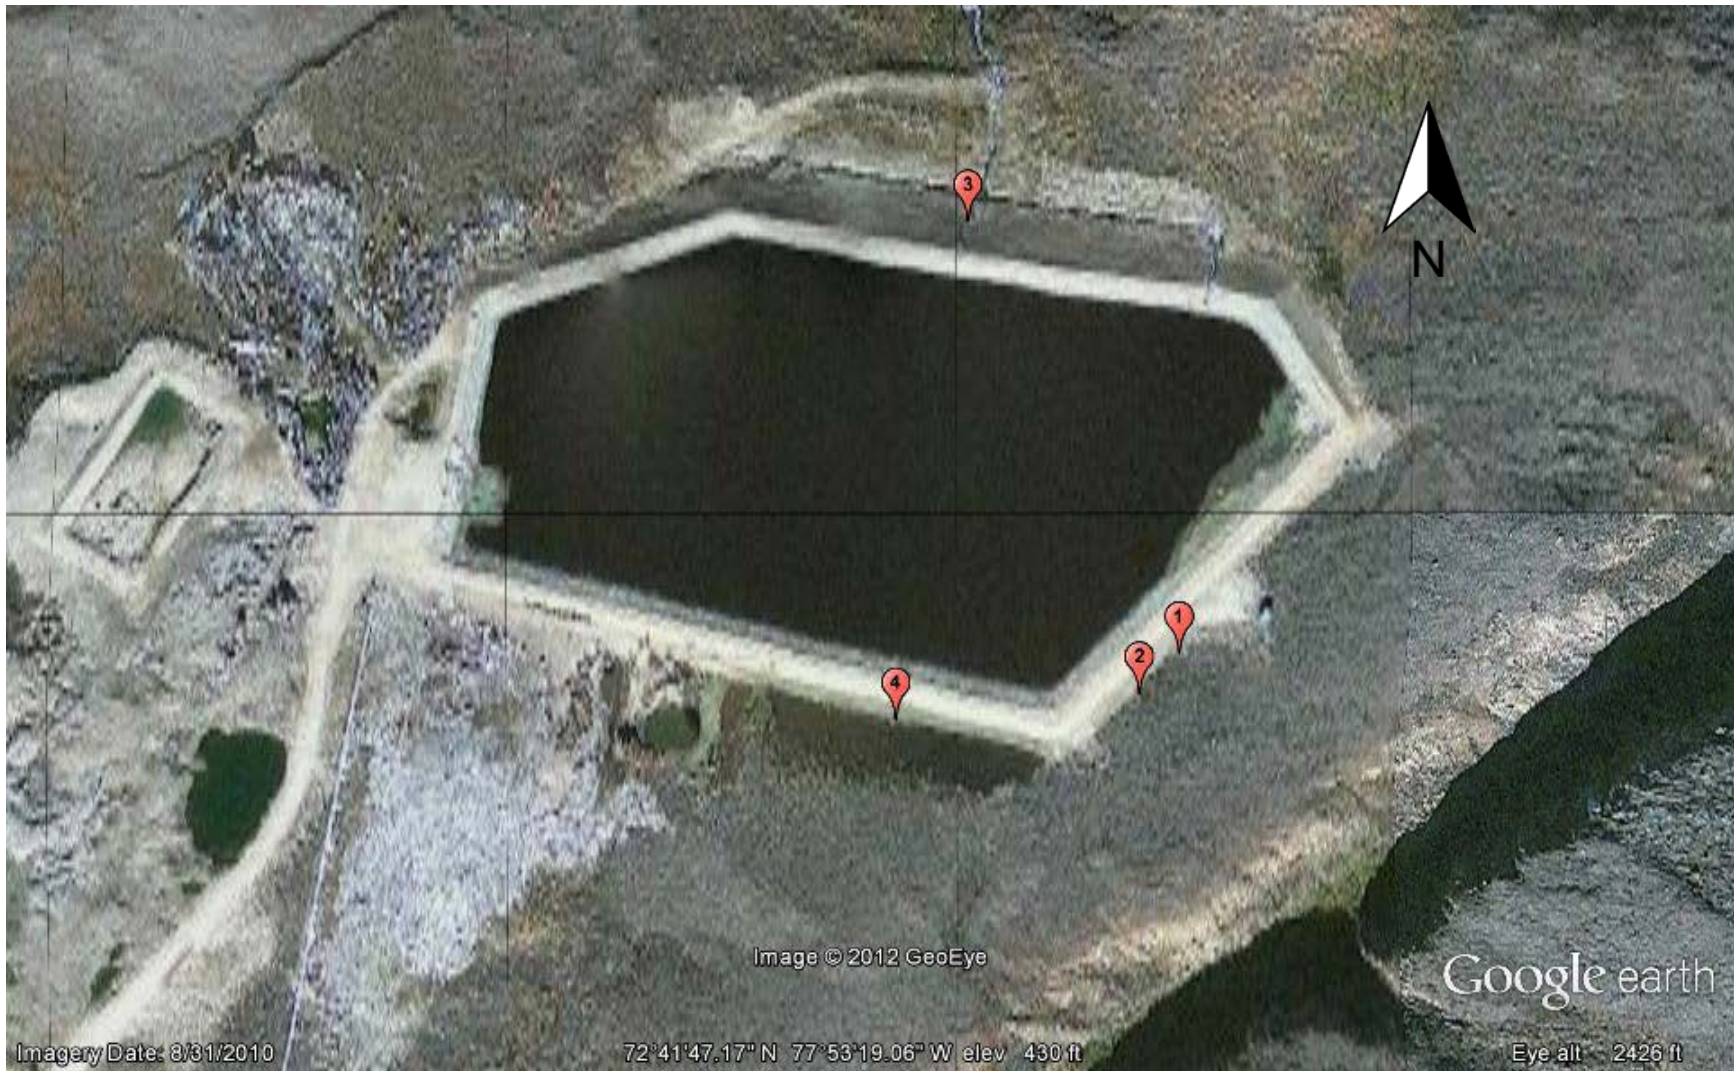
Map 2 – Locations of interest noted during the start-up meeting and site inspections.

A follow-up site inspection was undertaken on 23 August, at which time it was noted that there had been some accumulation of water at the points of interest outside of the lagoon and adjacent to the berm toe identified during the start-up meeting. The liquid level within the lagoon was noted at this time to have not changed perceptibly since the last inspection.

Location	Comments	Photograph Reference
Point 1	Identified during the start-up meeting as the primary point of interest; visible signs of settlement across the berm and access roadway in this area	Appendix C, Photographs 1 and 2
Point 2	Surface water accumulation approximately 15m south of Point 1	Appendix C, Photograph 7
Point 3	Toe of northernmost berm; no standing water present	N/A
Point 4	Large pond to the south of the lagoon; determined to be comprised of run-off from the municipal dump site This point was later including in the sampling run partway through the dye test at the request of the GN-CGS	Appendix C, Photograph 8

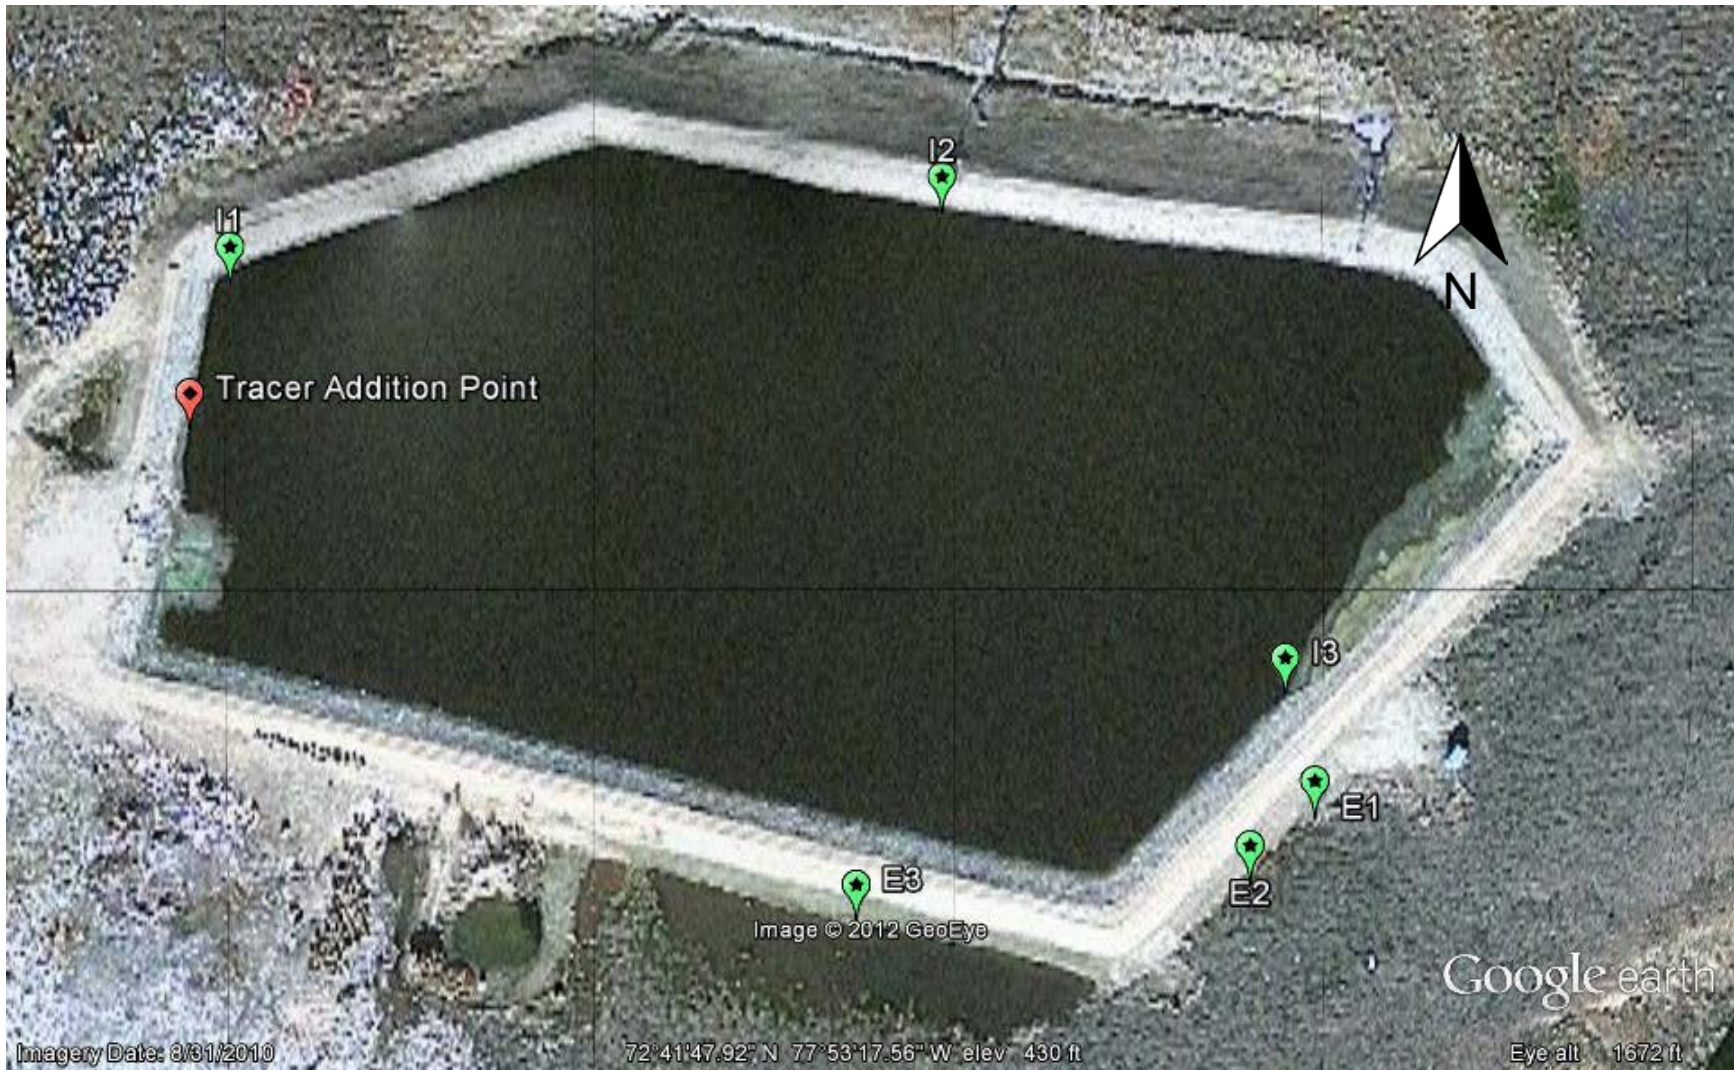
Map 3 – Points chosen for sampling during the tracer study, and the tracer addition point.

Based on the information gathered from the site inspection, background information provided by the GN-CGS, and information needed to conduct the tracer study, five locations were chosen for sampling. Three of these locations are located within the lagoon, in attempts to assess when the lagoon is fully mixed, and to provide a baseline for the source concentration of tracer. Two locations were selected along the toe of the westernmost berm, in the two potential leakage locations identified during the start-up meeting, and a third sampling location was selected along the toe of the southernmost berm, after the GN-CGS requested inclusion of this sample location partway through the test. **Appendix A, Table 2** lists the location, descriptions, and reference photographs for each of the selected sample points.

The locations of the sampling points are displayed in **Appendix B, Map 3**.

Designation	Description of Location	Photograph Reference
Interior 1 (I1)	Inside lagoon at northwestern corner	Appendix C, Photograph 3
Interior 2 (I2)	Inside lagoon midway along northernmost berm	Appendix C, Photograph 4
Interior 3 (I3)	Inside lagoon midway along easternmost berm	Appendix C, Photograph 5
Exterior 1 (E1)	Potential Leak #1: puddle of water adjacent to access roadway midway along easternmost berm	Appendix C, Photograph 6
Exterior 2 (E2)	Potential Leak #2: puddle of water adjacent to access roadway approximately 15m south of E1	Appendix C, Photograph 7
Exterior 3 (E3)	Pond located south of access roadway running parallel with the southernmost berm; sampling at this location requested by GN-CGS approximately 21 hours after dye release	Appendix C, Photograph 8
