## Application for Modification - Supporting Documentation

Water Licence NWB3PON9904

JOB TITLE  
**POND INLET  
 SEWAGE LAGOON**

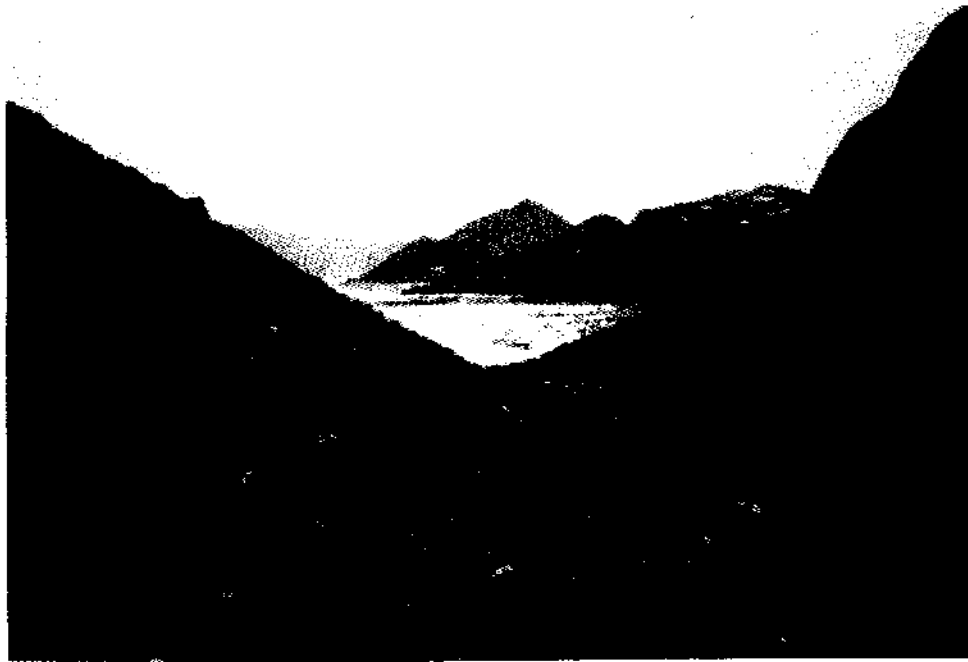
Photos 3 through 5 show "Qeetenujah". It drains a small area and has become a natural sink for organic material and nutrients as shown by the increased amount of vegetation. When this site was inspected, the odour of rotting vegetation was noticeable in several areas. Such odours indicate that the organisms that would treat sewage in this area are already present.

Photo 5 Lower area of "Qeetenujah."
