ANNUAL REPORT FOR THE MUNICIPALITY OF QIKIQTARJUAQ, 2022

WATER LICENCE INSPECTION FORM

On June 22, 2022, A water licence inspection was conducted by Water Resource Officer (WRO) Joseph Monteith at the Hamlet of Qikiqtarjuaq, Qikiqtani Region, Nunavut.

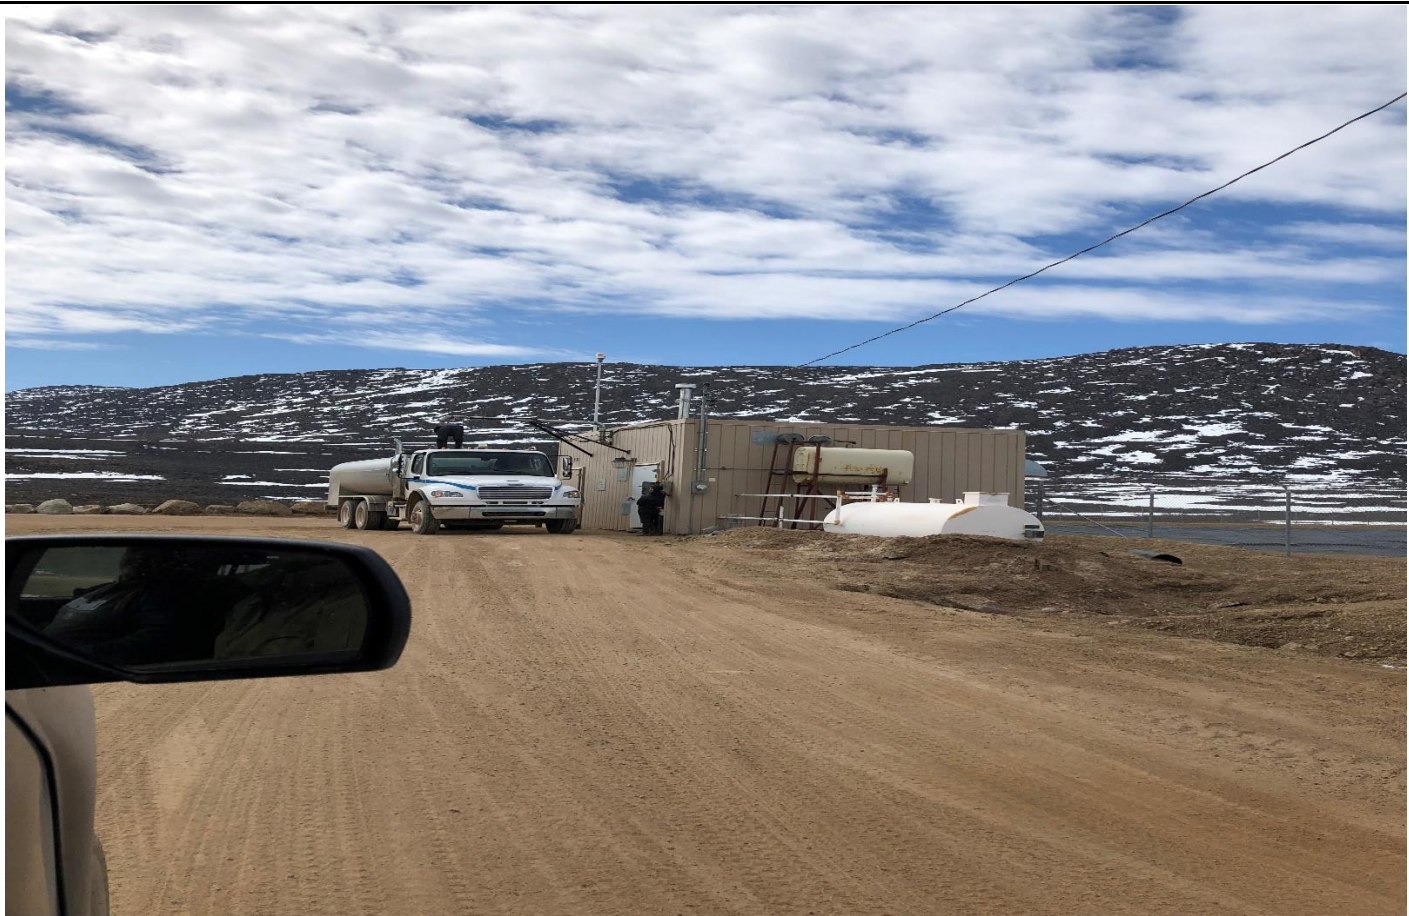
Photo Log #
Photo 4

Description: Water Treatment Facility/Truck Pumping House. Samuel Nuqingaq

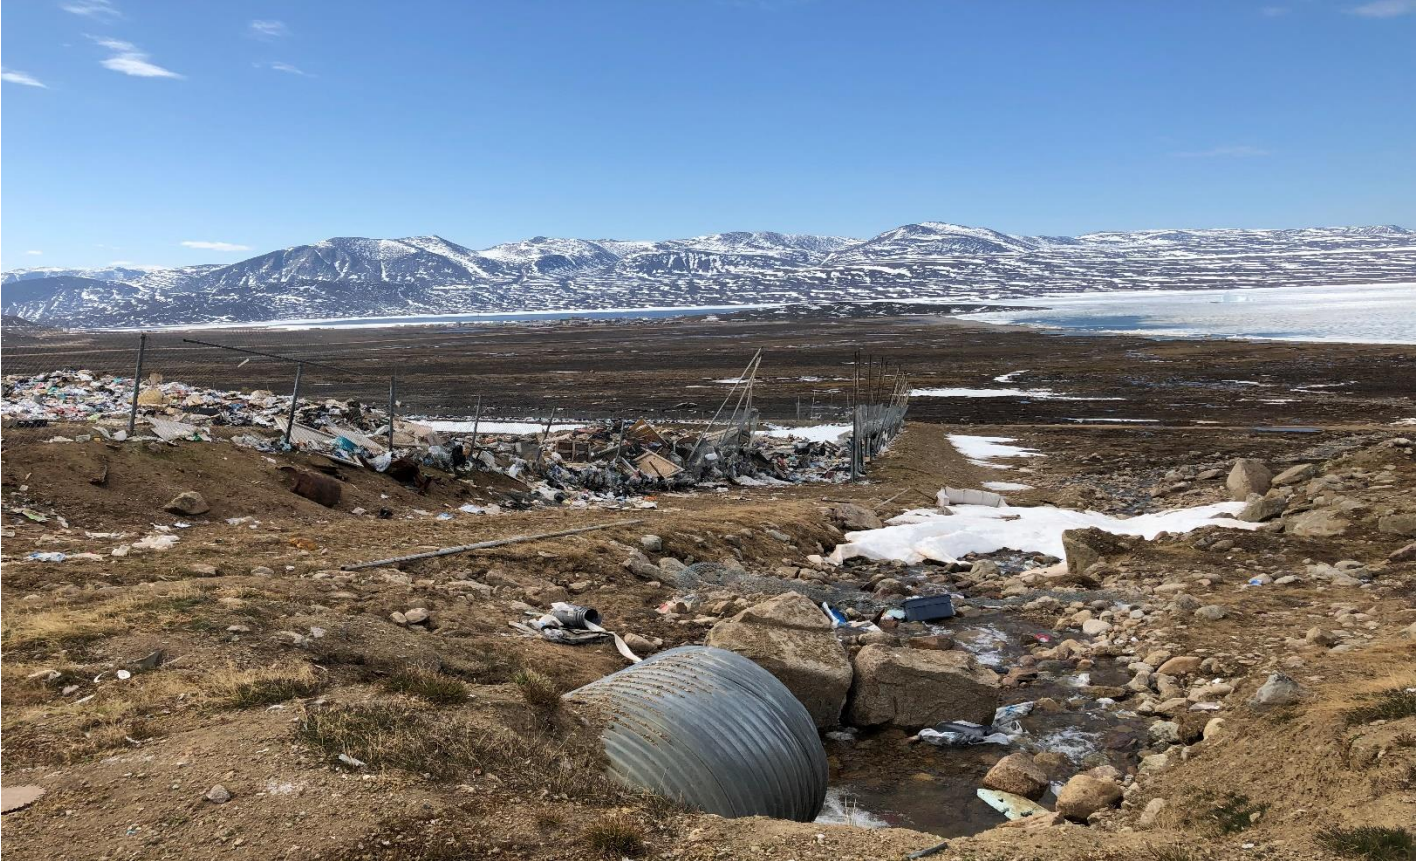
Photo 11

Description: Fence requires repair on the North East side of burn and cap facility

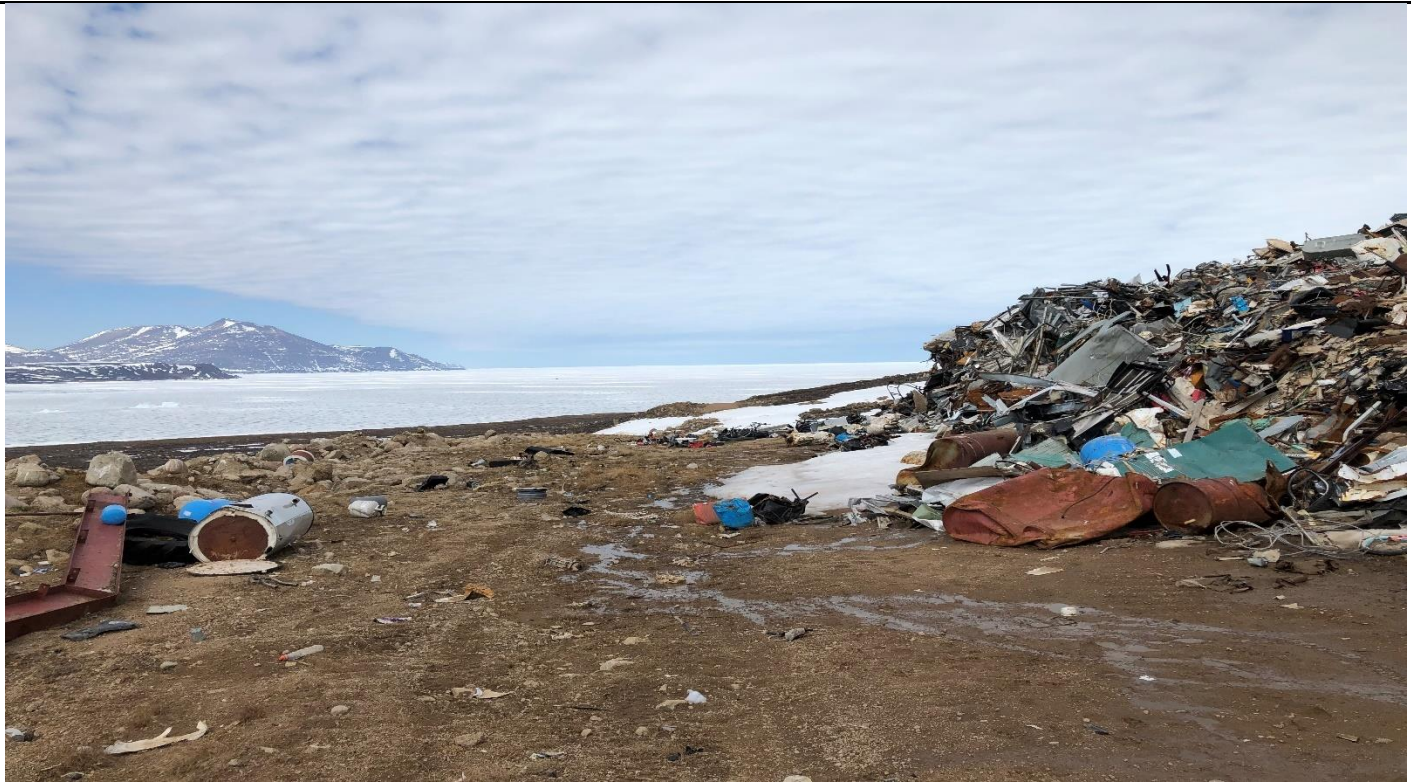
Description: Below the lined, and unlined berms and mixed metals. Water exiting the bulk metals. Observed 2019, this area seems to be the natural drainage route of water.
