July 27, 2000 Water Licence Inspection - Report

MUNICIPAL WATER USE INSPECTION FORM

Date: 2000/07/27 Licensee Rep. (Name/Title): Noah Makayak / Foreman
Dennis Althouse / Utilidor System Manager
Licensee: Municipality of Rankin Inlet Licence No.: N6L3-0779 (expired)

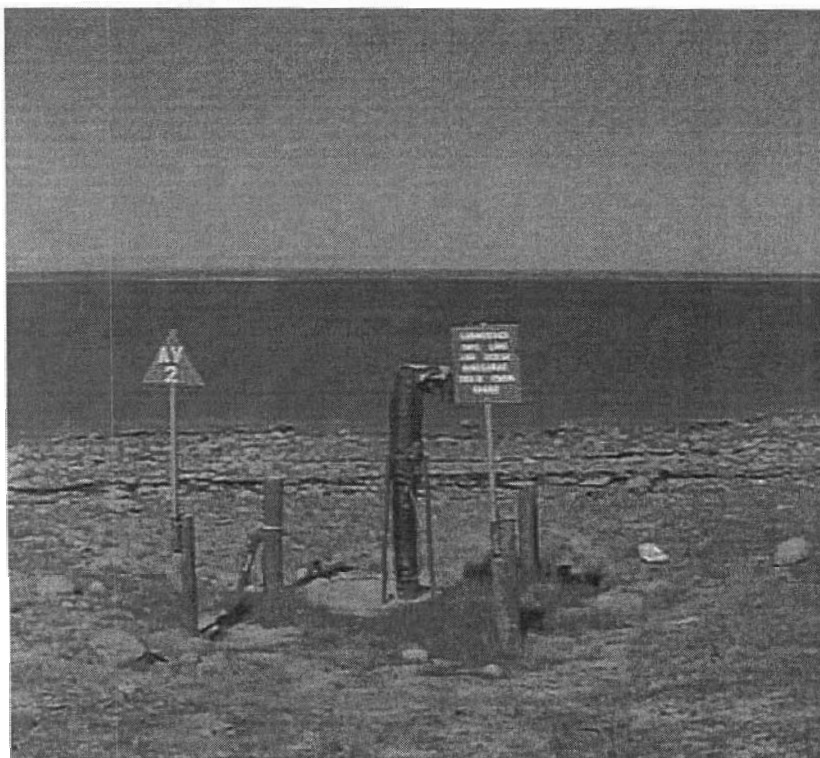
- **Sewage disposal:** Treated sewage is discharged to Prairie Bay via a deep water conveyance line (figure 1). However, the extent of the sewage treatment plant is minimal, being limited to a rotating screen (figure 2) which reportedly often raises the quantity of suspended solids in the effluent. It was also mentioned that upgrades to the water supply network had achieved a reduction in municipal water consumption, yet consequently reduced the dilution of the sewage discharge. Hence, the attached analytical results reveal that the treated sewage discharge at Surveillance Network Station (SNP) station 0779-3 does not meet the required effluent quality standards.

figure 1. Final station along deep-water sewage discharge line; 2000/07/27.

As such, the Municipality needs to ensure that the effluent from the sewage waste disposal facility meets the thresholds imposed within its Water licence, even if the Municipality neither directly owns nor operates the undertaking. Accordingly, by copy of this letter to the Department of Public Works and Housing (DPW&H), the Inspector recommends that the Municipality establish a closer work relationship with the owner/operator of the municipal water use and waste disposal facilities it is ultimately responsible for as Licensee of Water licence N6L4-0779.

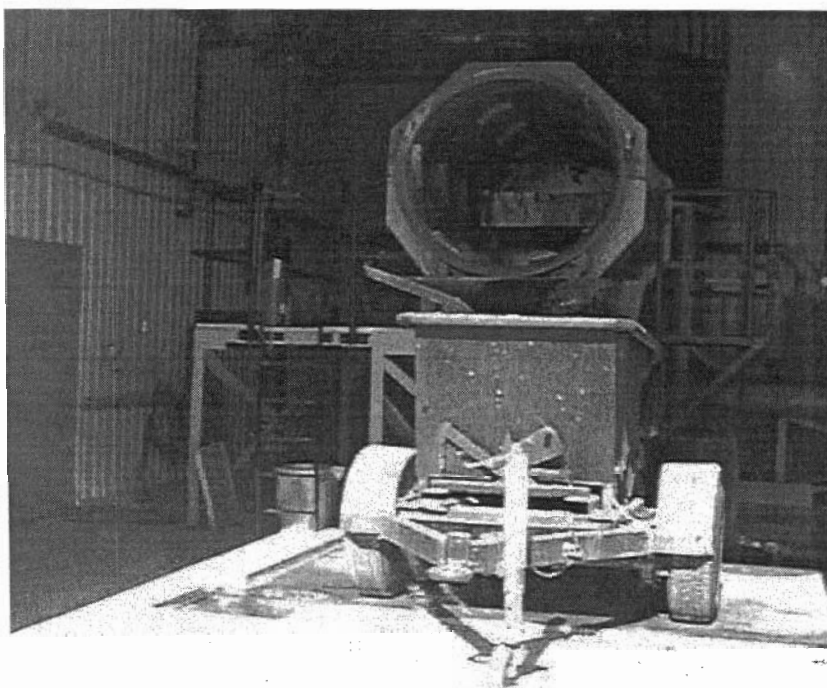
figure 2. Rotating screen acting as sewage treatment plant; 2000/07/27.

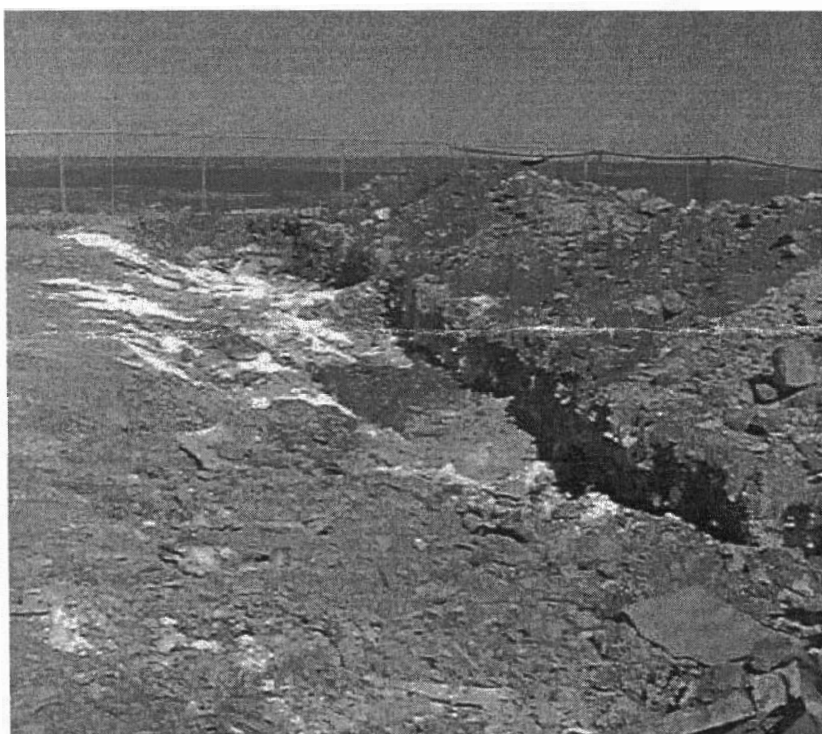
In parallel, Nunavut Water Board (NWB) approval has yet to be granted for the disposal of sewage screenings originating from the sewage treatment facility. Therefore, the Inspector requests that the Licensee either update or validate the attached memorandum relating to the now ongoing disposal of sewage screenings at the solid waste disposal site (figure 3). Formal NWB review could then proceed in a timely manner.

figure 3. Sewage screenings trench, solid waste disposal facility; 2000/07/27.

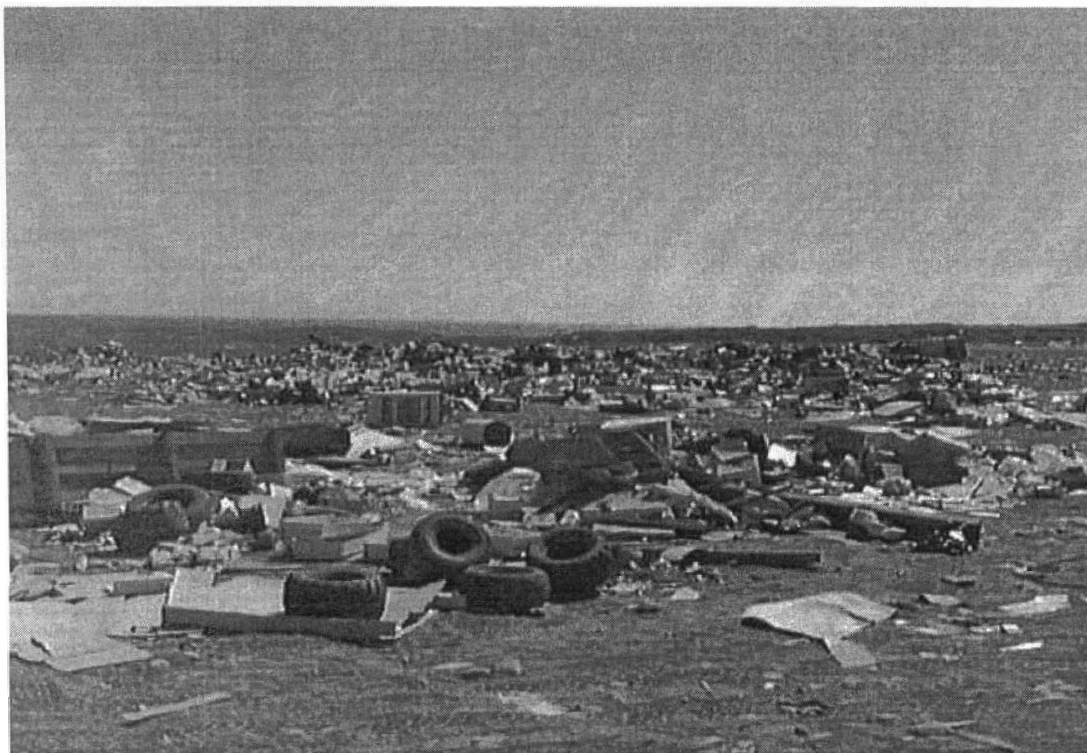
- **Solid waste disposal:** The solid waste disposal facility is now essentially a landfill, as prevailing wind conditions impede periodic burns. No segregation takes place at the general dumping area (figure 4), and waste is neither compacted nor covered. Accordingly, solid waste haphazardly litters an extensive area (figure 5). Furthermore, in addition to posing a wildlife attraction concern, gaps and breaks in the surrounding fence translate into a substantial quantity of windblown waste beyond the perimeter of the facility.

figure 4. Dumping area, solid waste disposal facility; 2000/07/27.

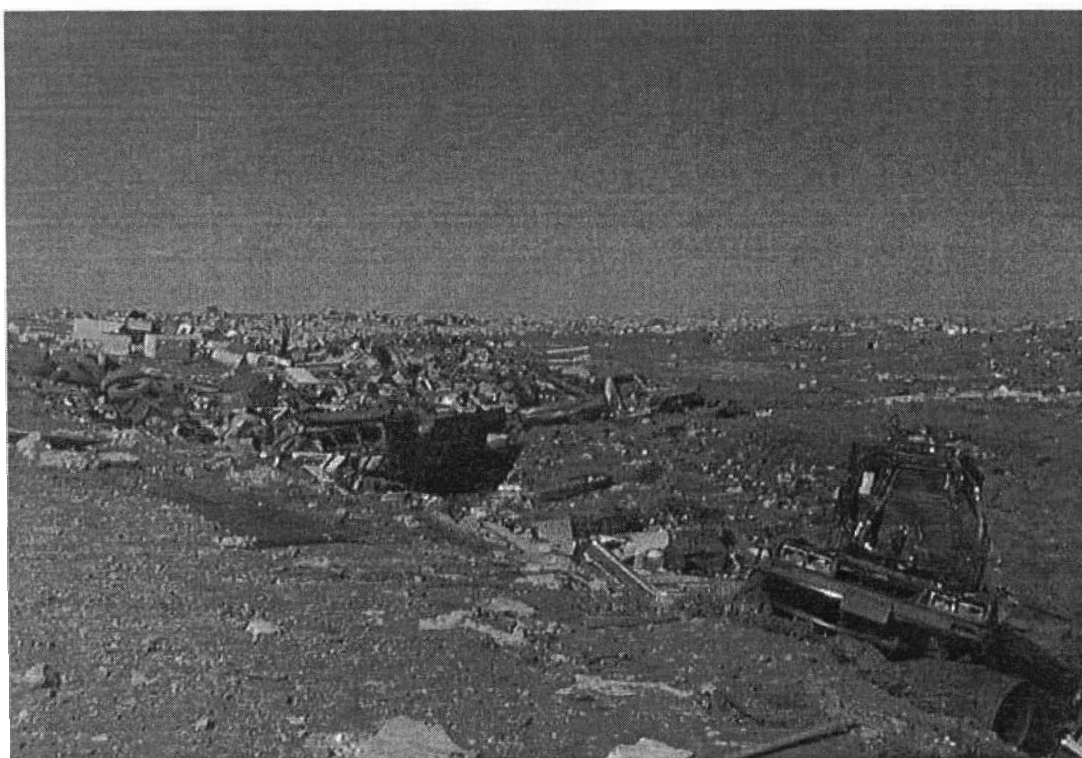
figure 5. Solid waste disposal facility from perimeter; 2000/07/27.

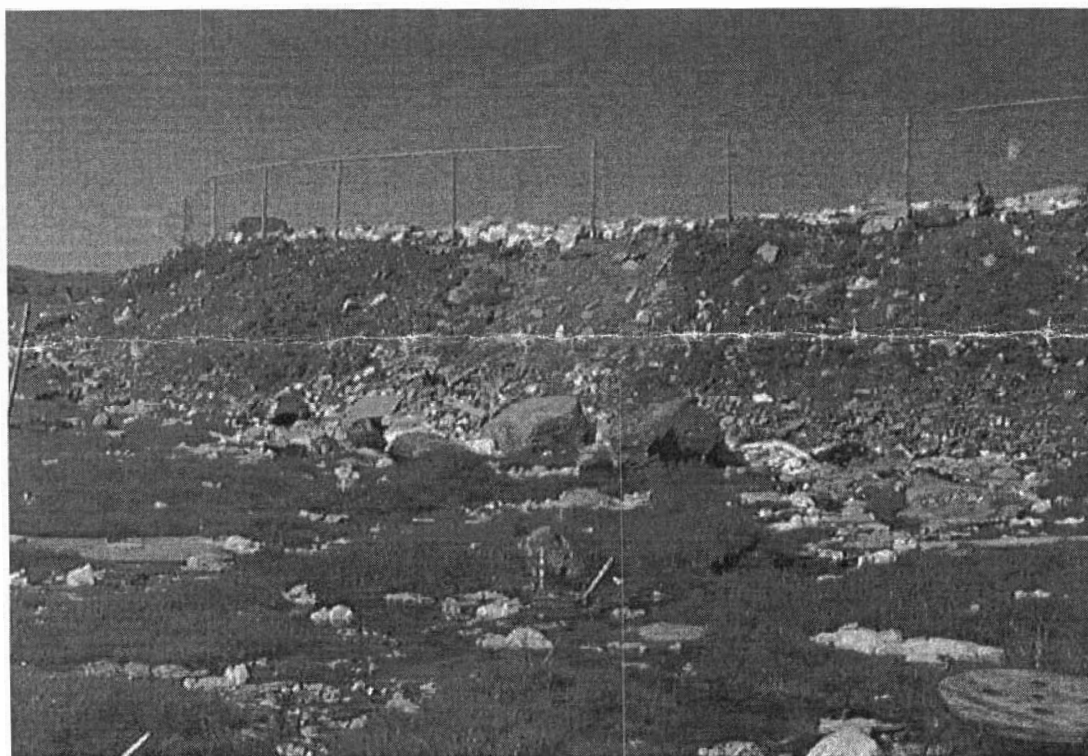
This being said, the attached analytical results relating to the runoff of leachate from the solid waste disposal facility (figure 6) appear largely acceptable in terms of effluent quality standards. In addition, the Microtox sample, which constitutes a reliable indicator of biological toxicity attributed to the associated discharge, came in negative.

figure 6. Leachate from the solid waste disposal facility; 2000/07/27.

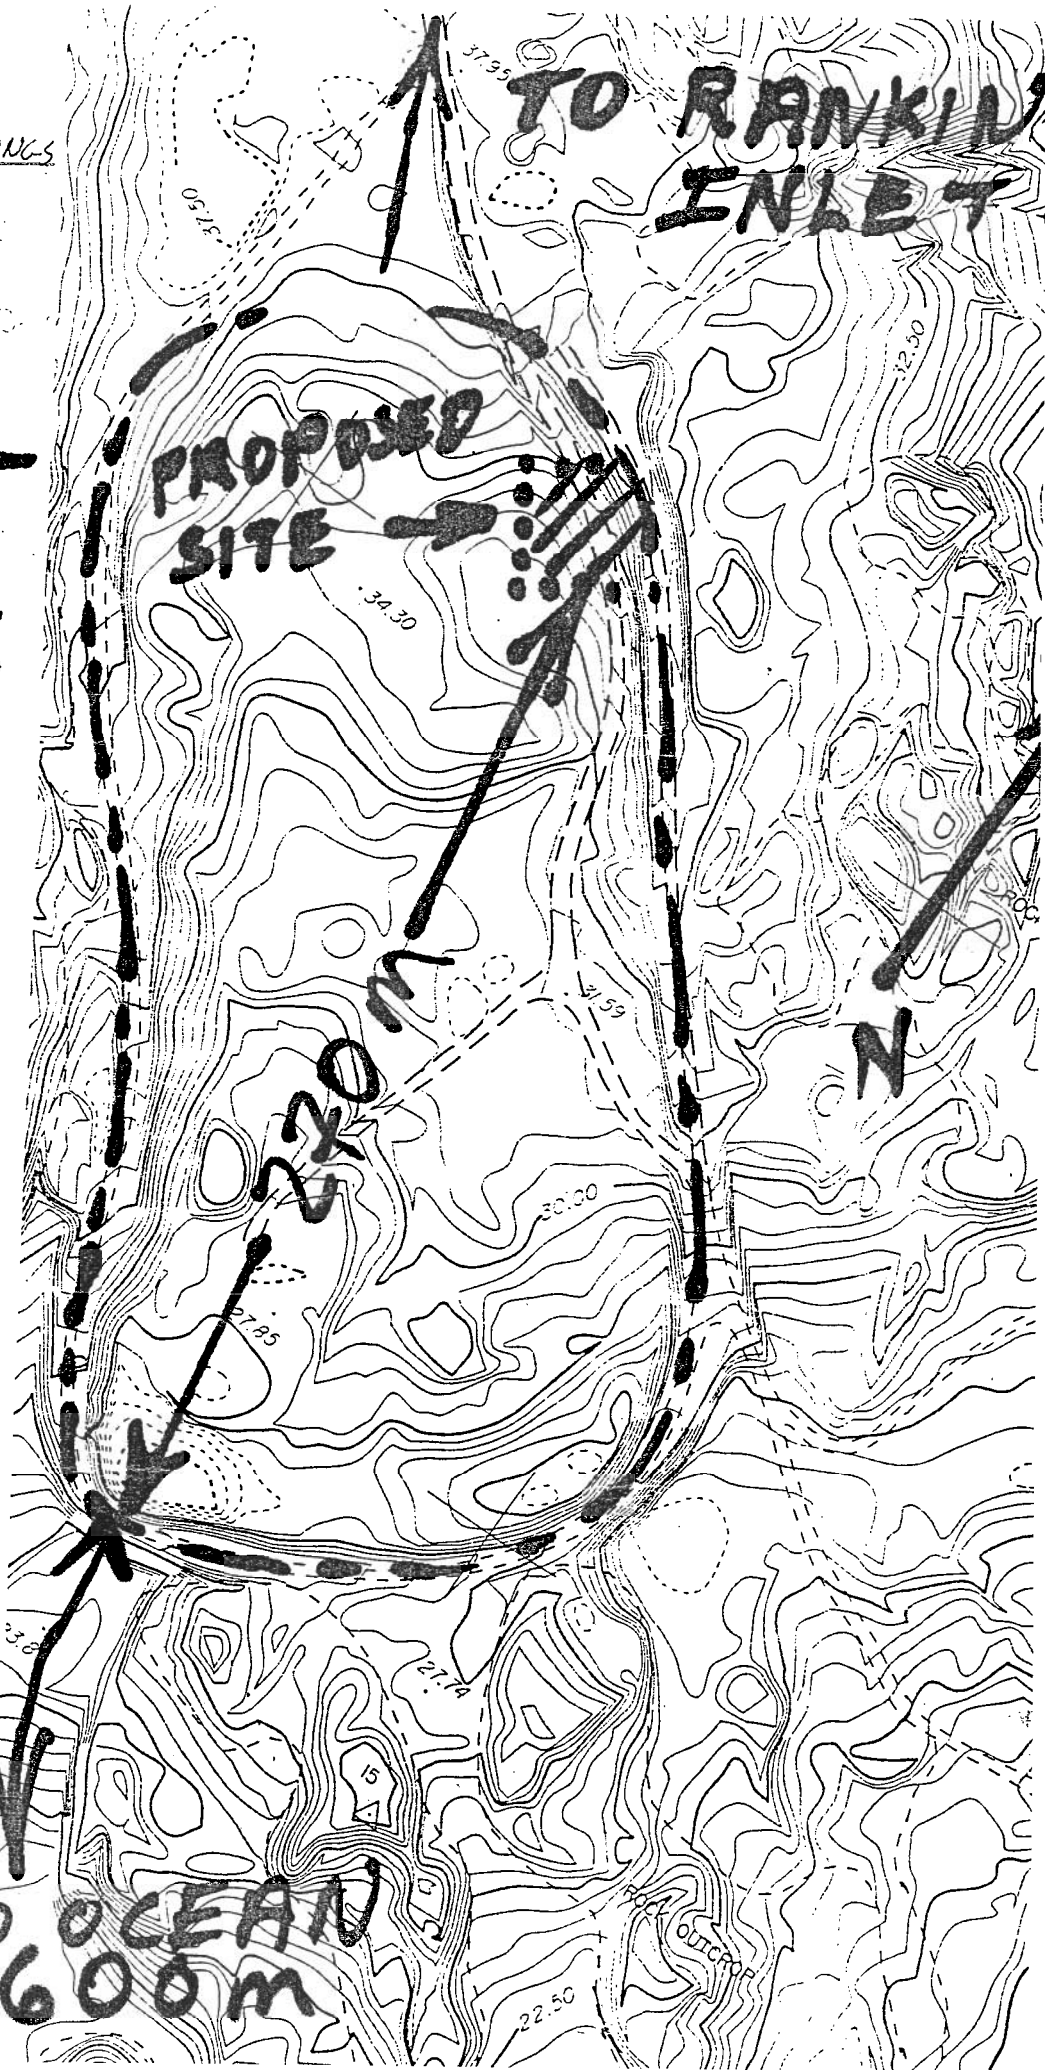
LOCATION PLAN

Leachate from the Site should be minimal as it is located near the high point of the Solid Waste Site. Any leachate from the Site will undergo wetlands treatment along the 270 m flowpath inside the solid waste site and additional wetlands treatment along the 600 m flowpath from the solid waste berm to the Ocean.

SOLID WASTE LANDFILL SITE
FENCE AND BERM

PROPOSED SEWAGE SCREENINGS
LANDFILL SITE
(TO BE FENCED)

RAINAGE TO OCEAN
THROUGH BERM

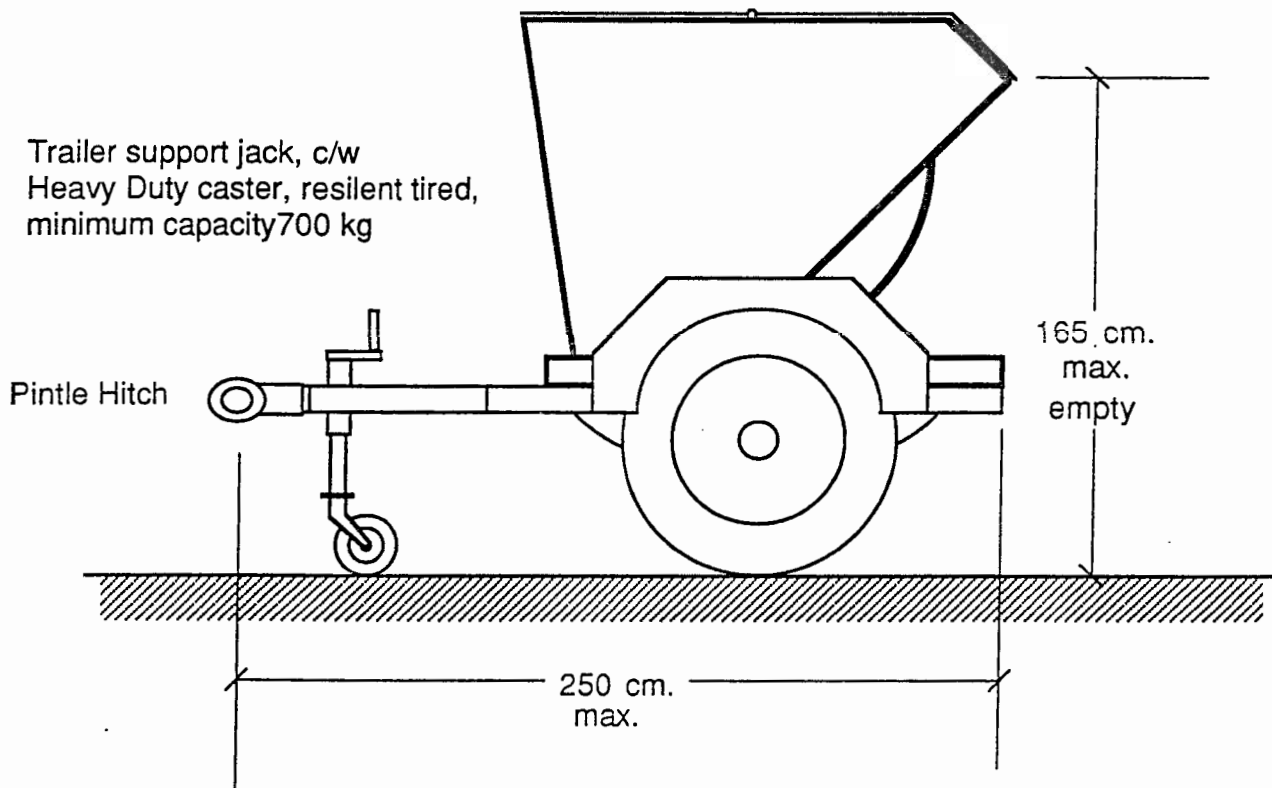
FIGURE 11170-1

1 Cu. Yd Self Dumping
Hopper c/w lid, by
Universal Handling Equipment
Company Ltd., or approved equal

Single Axle trailer, Axle Tires, and Frame to be minimum 2000 kg capacity

Trailer to be sized to fit bin. Bin to be located on trailer frame in such a way as to always maintain a positive trailer tongue weight, with the bin empty or full. Max tongue weight to be 250 kg.

Bin to be permanently welded to trailer frame.

Trailer to be complete with fenders, all required lights for over the road use, and license plate holder.

Trailer Fenders and other horizontal surfaces to be constructed of heavy gauge material and finished on top with non-skid paint, to allow them to be used as steps by the operator.

SCREENING COLLECTOR
BINS
