July 23, 2001 Municipal Water Use Inspection - Report

MUNICIPAL WATER USE INSPECTION FORM

Licensee: Hamlet of Resolute Bay Licence No.: N4L3-1571 (expired)

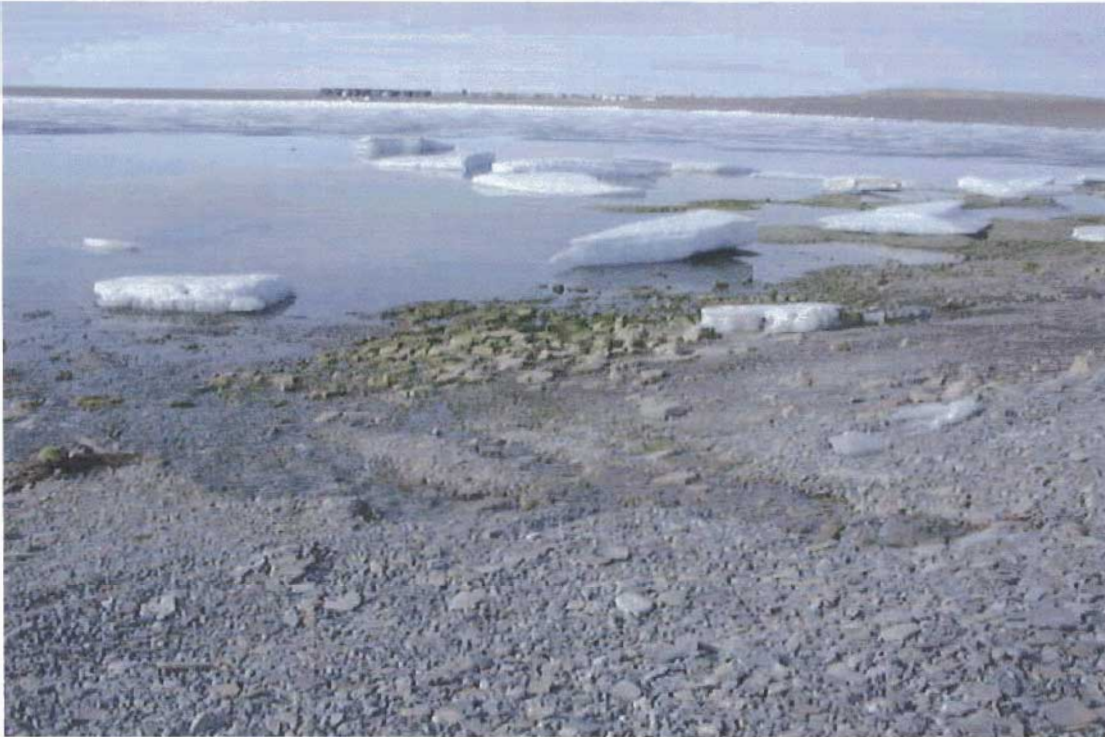
- **Sewage disposal:** Even if somewhat crude, it appears that the filtering provided by the tumbling screens at the sewage treatment plant significantly contributes to the treatment of sewage effluent prior to its discharge to receiving waters. Indeed, the attached analytical results relating to a sample collected from SNP station 1571-3 (figure 1) meet all tested parameters of the *Canadian Water Quality Guidelines for the Protection of Freshwater Aquatic Life*, and of the now expired Water licence N4L3-1571. Moreover, the Microtox sample, which constitutes a reliable toxicity indicator (IC₅₀), did not attribute toxicity to the discharged sewage effluent.

figure 1. Sewage discharge into Resolute Bay, SNP station 1571-3; 2001/07/23.

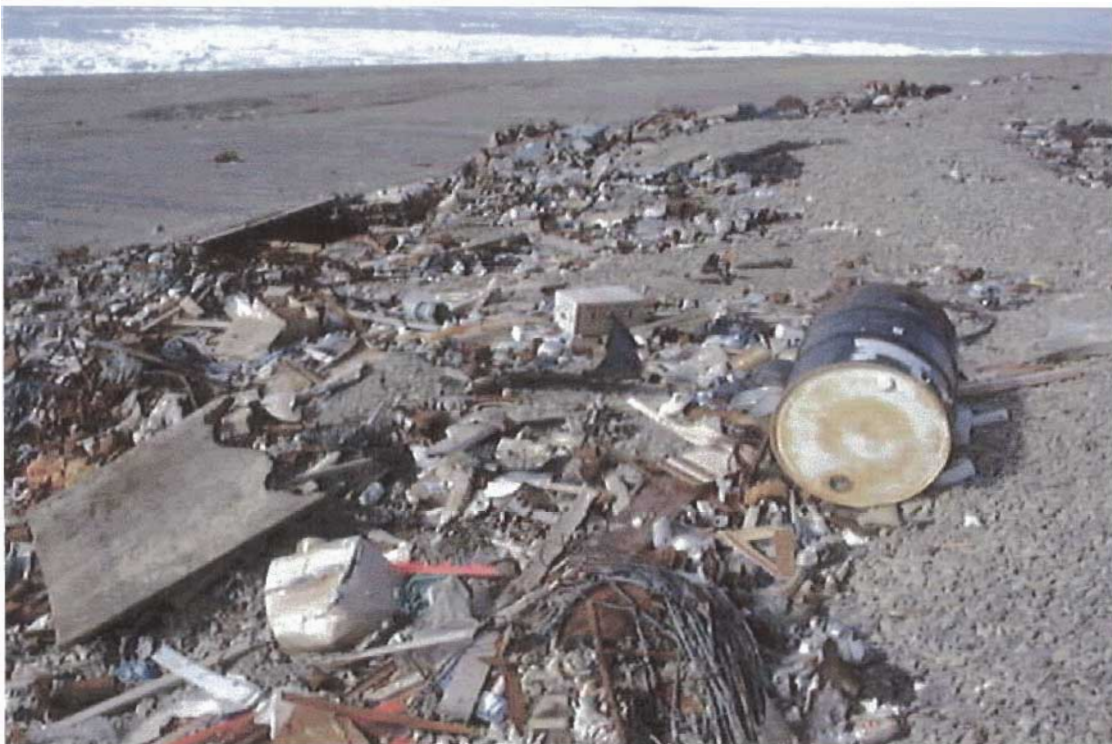
- **Solid waste disposal:** Although household waste appears well burnt/compacted and is annually covered, a significant amount of exposed waste nevertheless lines the toe of the unfenced solid waste disposal facility (figure 2). However, in light of the absence of observable leachate flowing from the site, the impact of the facility on receiving waters appears relatively minimal.

Comments: All but a couple of housing units are connected to the utilidor system. Sewage effluent is filtered prior to discharge. Little apparent segregation of waste occurs at the unfenced solid waste disposal facility. Although the burnt/compacted wastepile is covered annually, a notable amount of waste is nonetheless exposed along the toe of the dump. Third party handles, and disposes of, hazardous materials and waste oils. Trickling flow heard from the toe of the dump, but no surface runoff could be observed. Operation and Maintenance (O&M) plan for municipal waste disposal facilities not submitted. Abandonment and Restoration (A&R) plan for the solid waste disposal facility not provided although work on a replacement site has been undertaken.

figure 2. Toe of the current solid waste disposal facility; 2001/07/23.

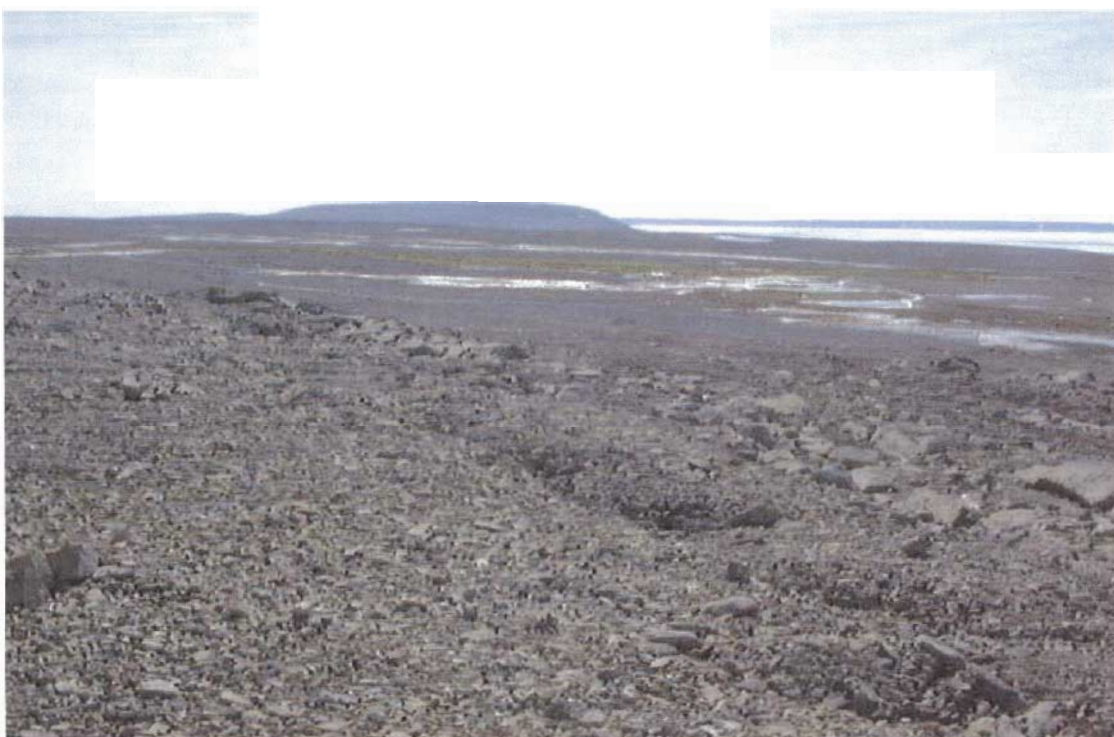
In related matters, concerns were voiced during the inspection in regards to the work undertaken at the location of a proposed replacement solid waste disposal facility (figure 3). Accordingly, the Inspector wishes to remind Community Government and Transportation (CG&T) that relevant information ought to be provided to the Nunavut Water Board (NWB) prior to the commissioning of a facility which may potentially bring about the deposit of waste into waters. Also, as Licensee of Water licence N4L3-1571, the Hamlet is bound to submit to the NWB an Abandonment and Restoration (A&R) plan at least six (6) months before abandoning a waste disposal facility.

figure 3. Fence erected at the proposed location of the new dump; 2001/07/23.
