WATER LICENCE INSPECTION FORM

Licensee	Licensee Representative
Hamlet of Resolute Bay	Bhabesh Roy
Licence No. / Expiry	Representative's Title
3BM-RES2025	Municipal Engineer
Land / Other Authorizations	Land / Other Authorizations
Date of Inspection	Inspector
August 14, 2020	Joseph Monteith & Jeremy Fraser
Activities Inspected	
<input type="checkbox"/> Camp	<input type="checkbox"/> Drilling
<input type="checkbox"/> Roads/Hauling	<input type="checkbox"/> Mining
	<input checked="" type="checkbox"/> Other: Solid Waste Facility, Hazardous Waste Facility
	<input type="checkbox"/> Construction
	<input type="checkbox"/> Reclamation
	<input type="checkbox"/> Fuel Storage
	<input type="checkbox"/> Other:

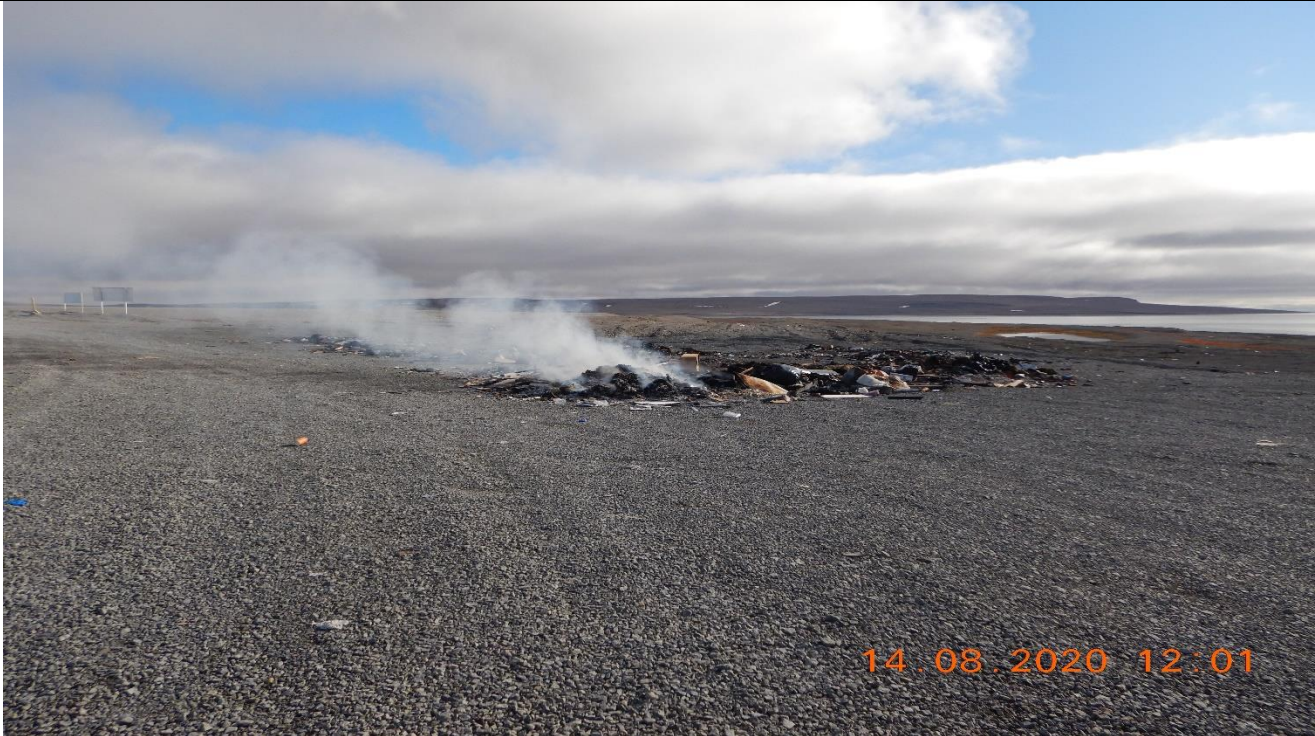
Date	Camera	Inspector	
August 20, 2020	Nikon Cool Pix	Joseph Monteith	
Photo Log	Location		
Photo 1	Resolute Bay

The Hamlet manages their domestic waste by burning and capping along the beach on the south side of the community approximately 206 metres from the high water mark of the ocean. The site doesn't appear to be lined, no signs of water flowing in and out of the facility. This site is active (photo 1, 2, 3).
2.

No signs of water entering the facility, the site is on a sloped rocky beach (photo 1, 2, 3).
5.

No signs of leachate leaving the facility. Slope downgrade of burn and cap steepens. Signs of past deposits capped. A pond down slope lies between the land farm and the ocean (photo 1).

Description: Burn and Cap site Active at the time of inspection.

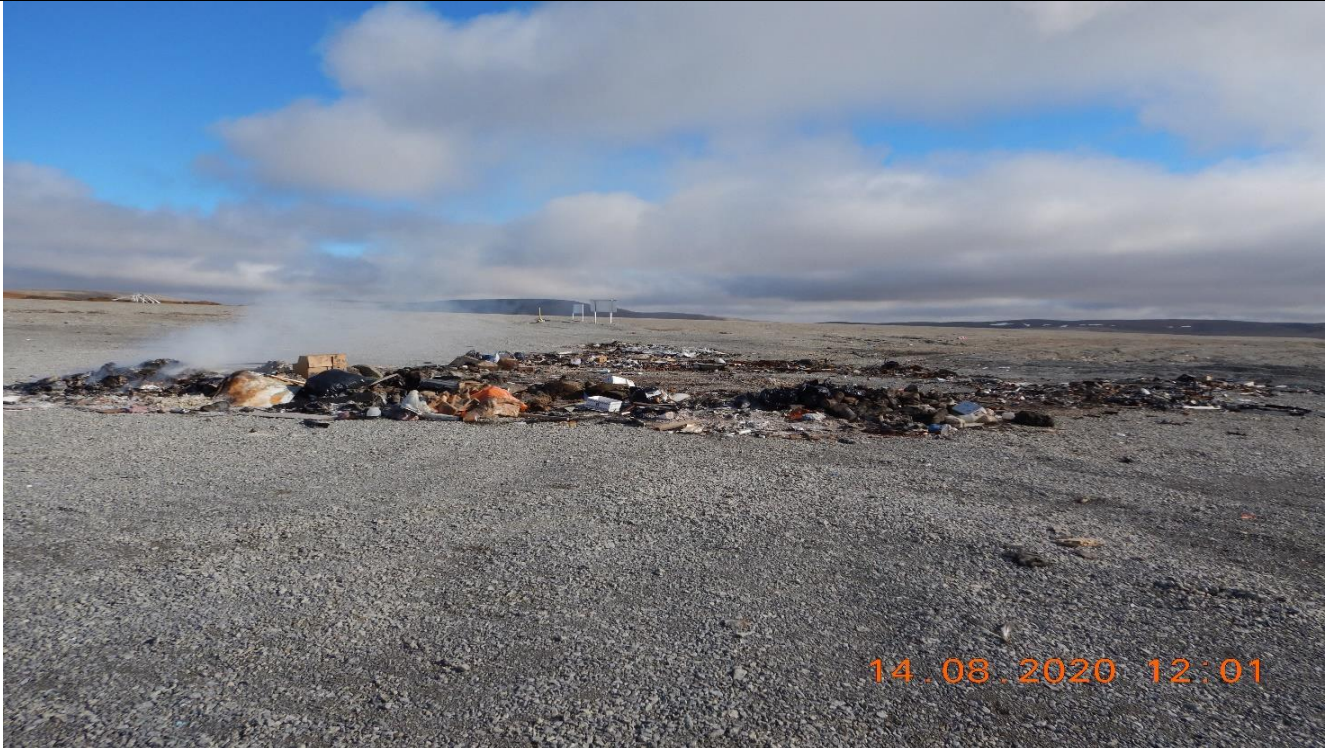
Photo Log	Location
Photo 2	Resolute Bay

Description: Active burn and cap land fill. Scheduled to be decommissioned in place of a new facility.

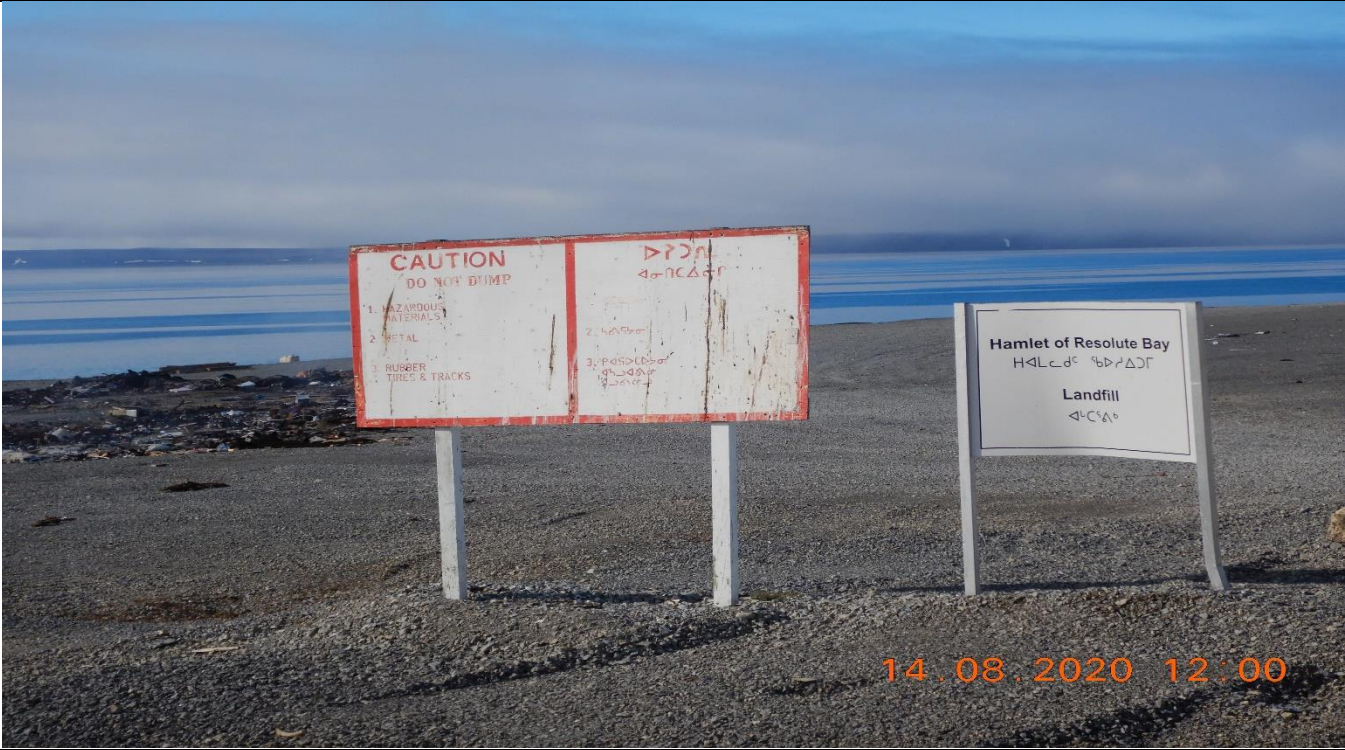
Photo 3

A caution sign was observed cautioning the public from dumping Hazardous Material, Metals, and Rubber Tires, and Tracks. Both signs also in Inuktitut (See Photo 3).
4.

Description: Two signs at the Solid Waste Facility in 2 of the Official Languages of Nunavut. 2018 photo has garbage in background.

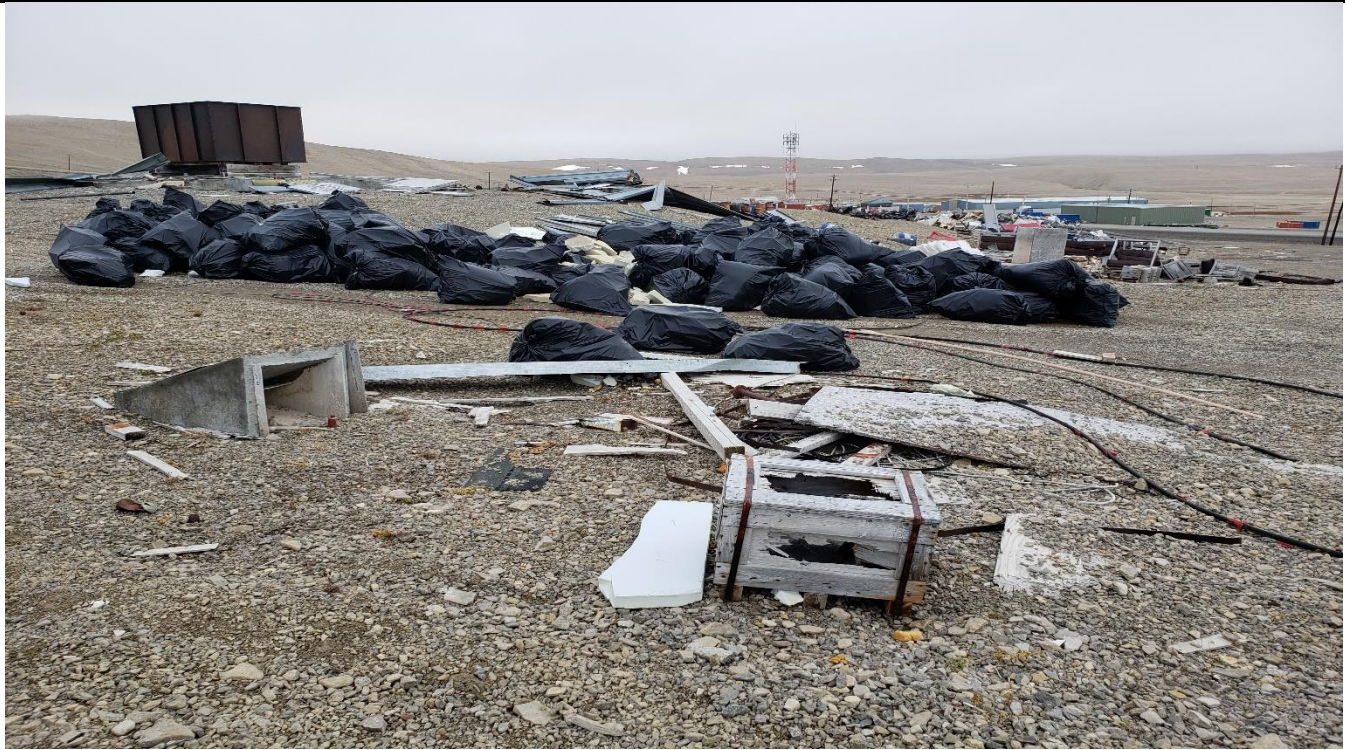
Photo 4

The Metal Dump facility located with the community of Resolute Bay has a mixture of white waste such as water heaters, washers, dryers, fridges, and freezers. Bulk Metal such as abandoned vehicles such as trucks and snowmobiles, pipes, and storage tanks. (See Photo 4).
7.

Description: Bulk Metals Facility. Bags of Insulations. Unauthorized deposit of waste into the bulk metals facility.

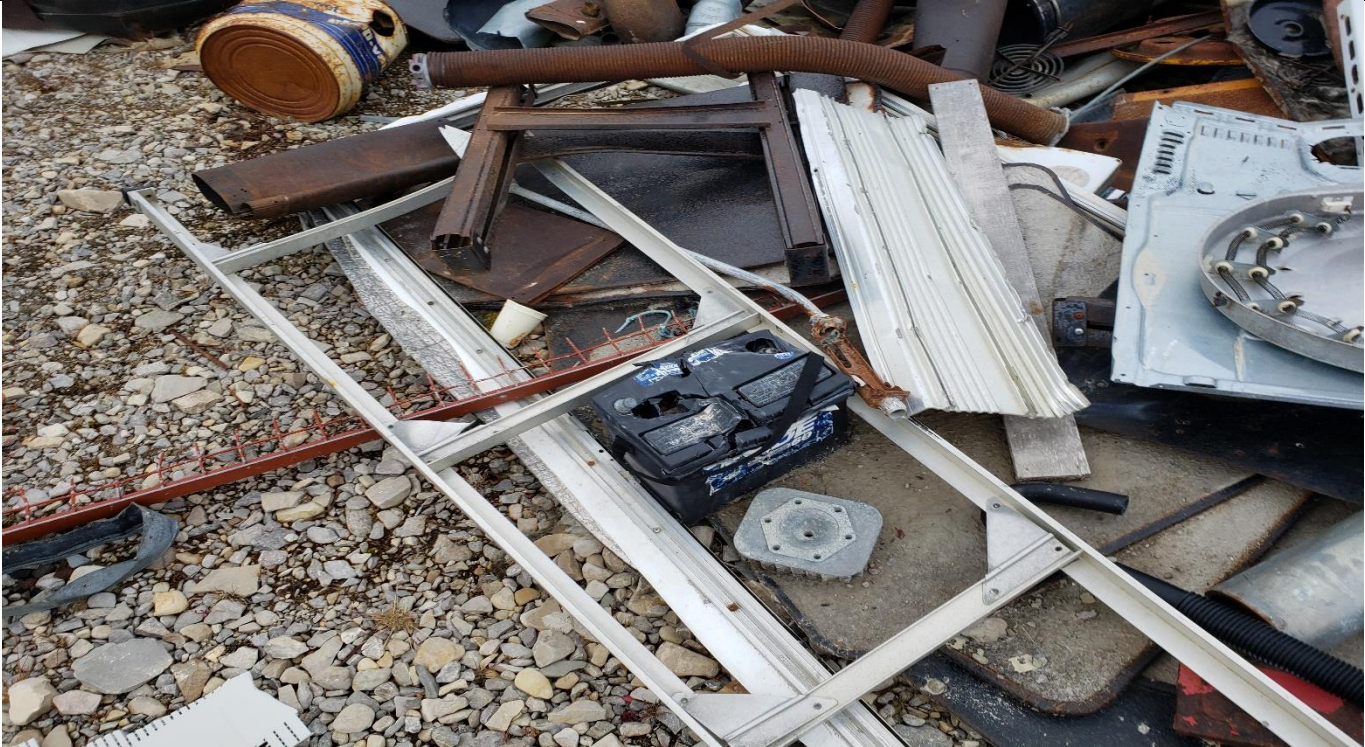
Photo 8

Hazardous Waste such as; old batteries, turbine oil, and waste oil drums and propane cylinders was observed unsegregated around the Metal Dump section (photo 8, 9, 10, &11).

The hazardous waste within the community is exposed to the elements. With some waste oil drums in a berm, while the majority of the hazardous waste outside of a berm (photo 8, 9, 10, 11).
10.

Description: damaged battery and empty drum of oil in the Bulk Metal facility. Observed in 2019 Inspection Report.

- The items listed below are the action's required as summarized from above to ensure compliance:
- Consolidate all hazardous waste such as Paint Cants in the Bulk Metal Storage Facility and Domestic Solid Waste Facility, and store in the hazardous waste section of the Solid Waste Facility
- Consolidate all hazardous waste drums with leaks, and store in an area that prevents the deposit of deleterious substances into any water.
- The Licensee is reminded to remain diligent to prevent wastes from entering water, and the environment.
- Notify the inspector 10 days ahead of a planned open pit burn by emailing Water resource Officer Joseph Monteith at: joseph.monteith@Canada.ca.

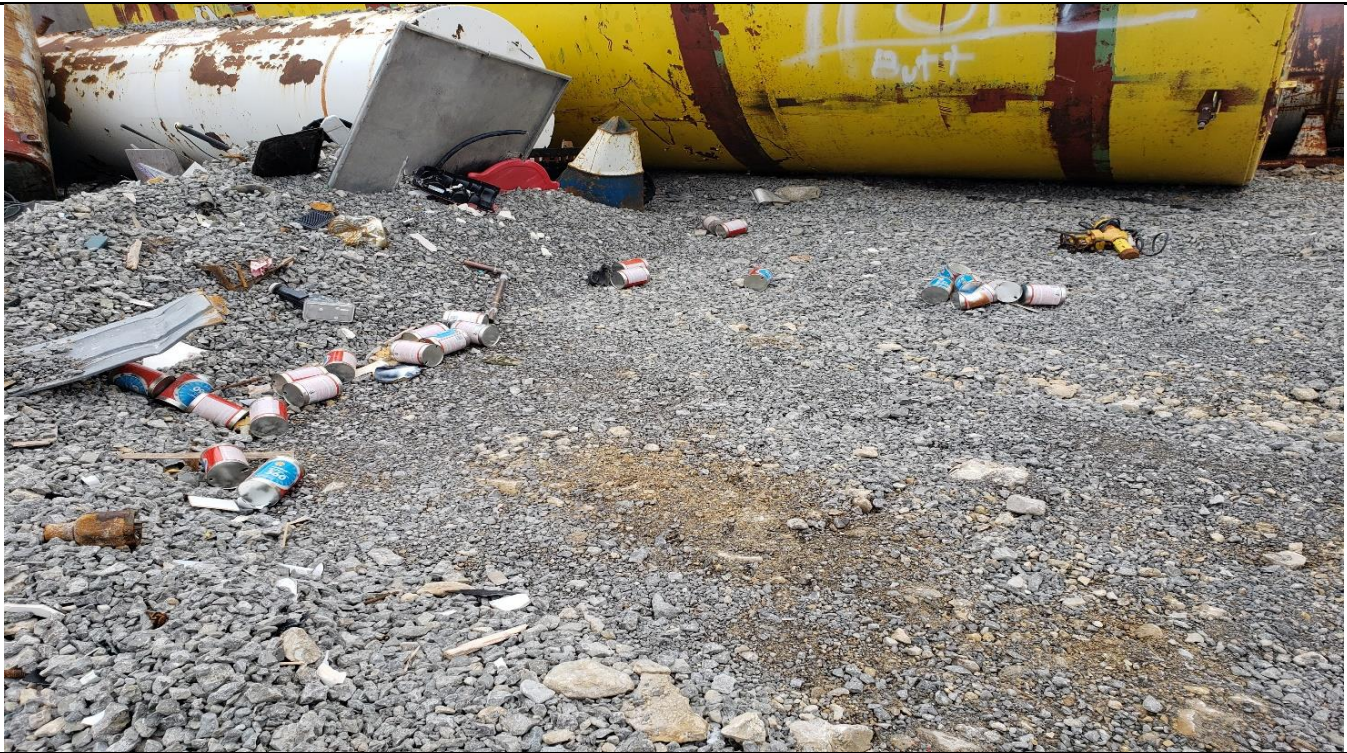
Photo 11

Signs of leaks were observed on site at the time of the inspection (photo 9, 10, & 11).

Description: Empty Oil Can exposed to the outside elements.

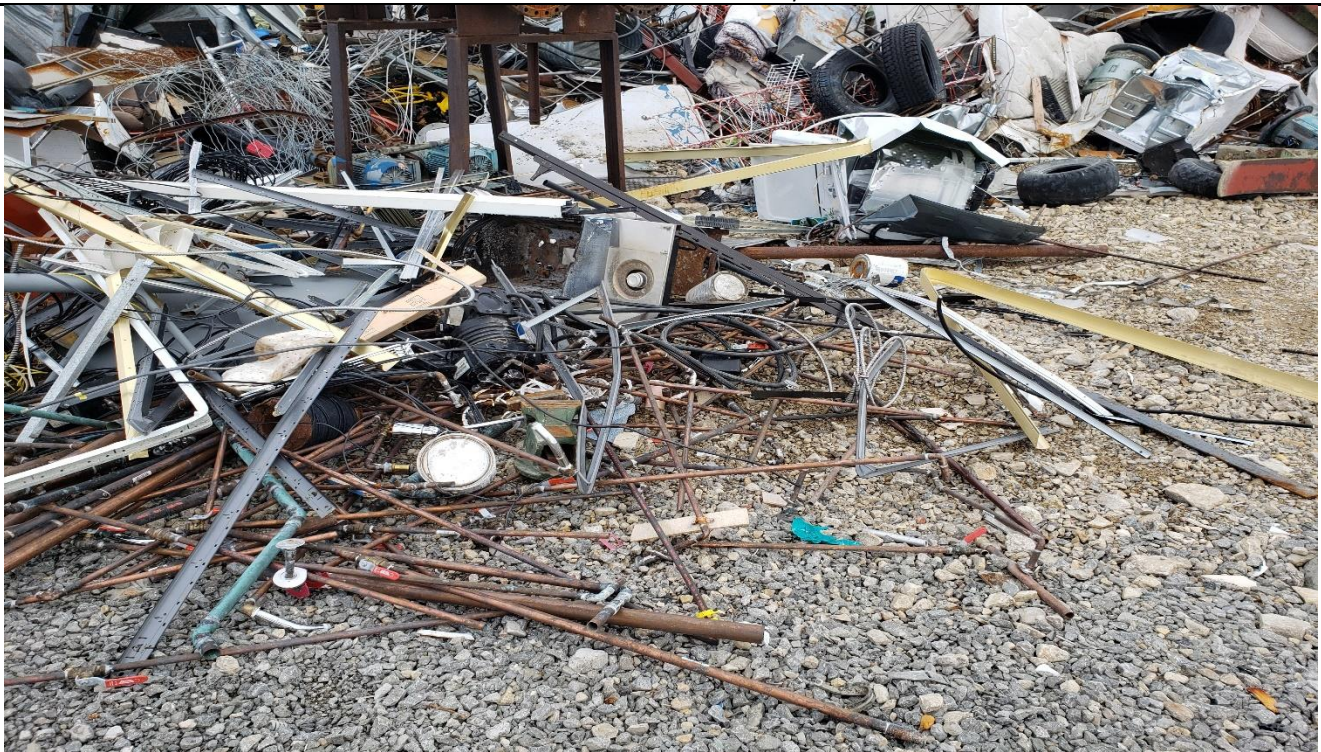
Photo 12

Empty Paint and Oil Cans observed exposed to the outside elements within the fenced area of the domestic waste facility (photo 12, 13 & 14).

Description: Open Can of Paint, exposed to the outside elements, and mixed with the bulk metal waste.

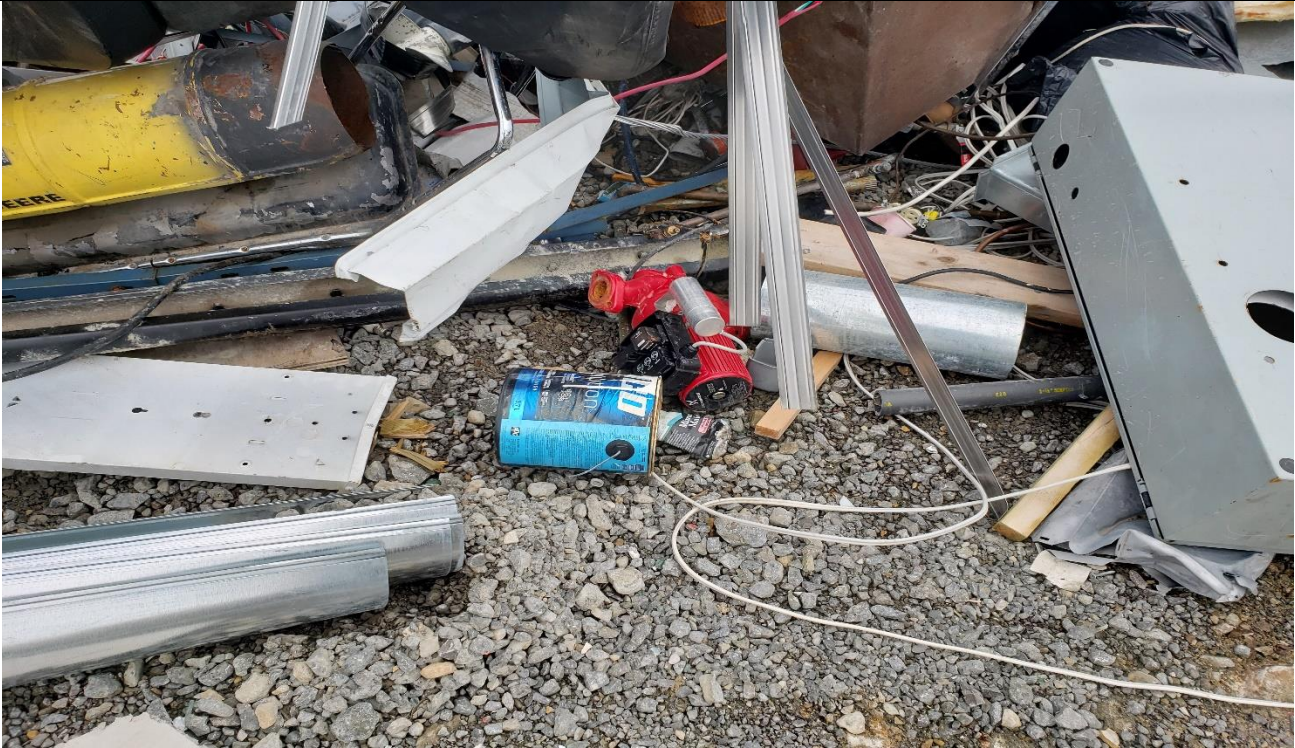
Photo 13

Description: Paint Cans mixed with Bulk Metal Waste

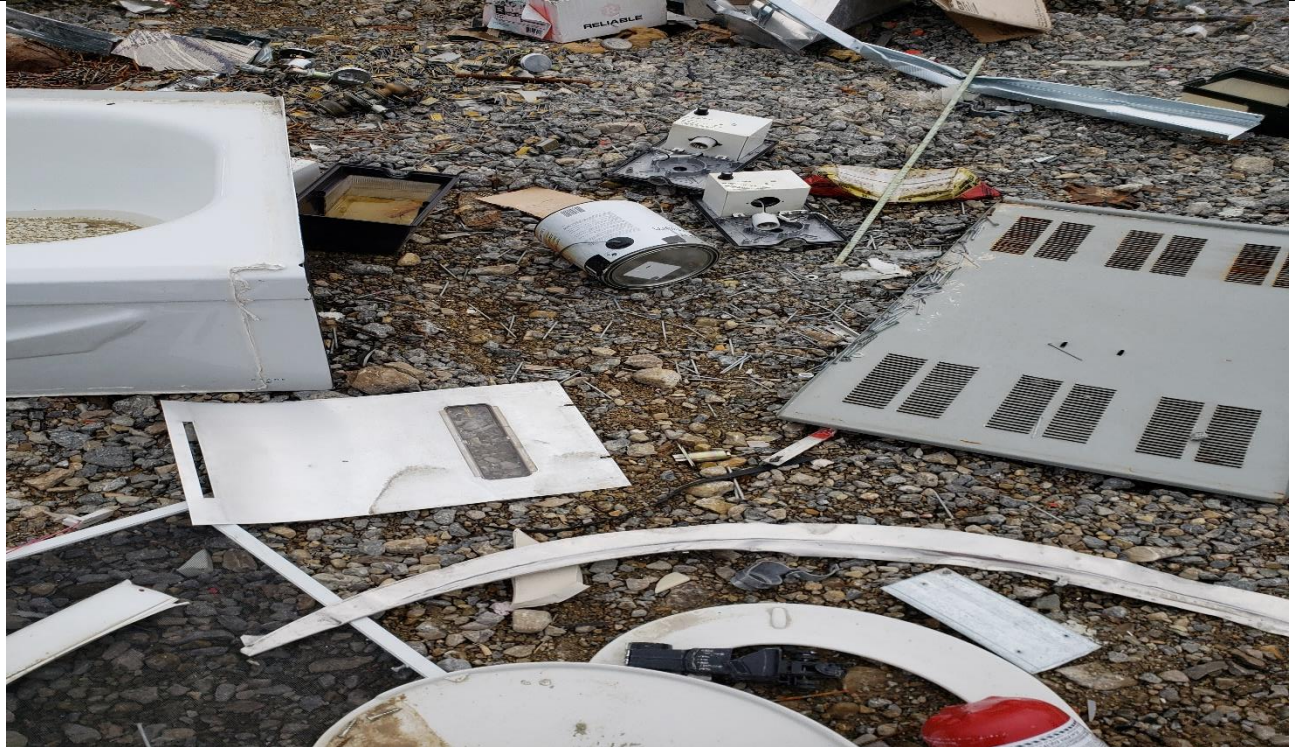
Photo 14

Description: Paint Cans mixed with the Bulk Metal Waste
