WATER LICENCE INSPECTION FORM

| Hamlet of Resolute Bay | Bhabesh Roy |
| 3BM-RES2025 | Municipal Engineer |
| July 19, 2021 | Joseph Monteith |

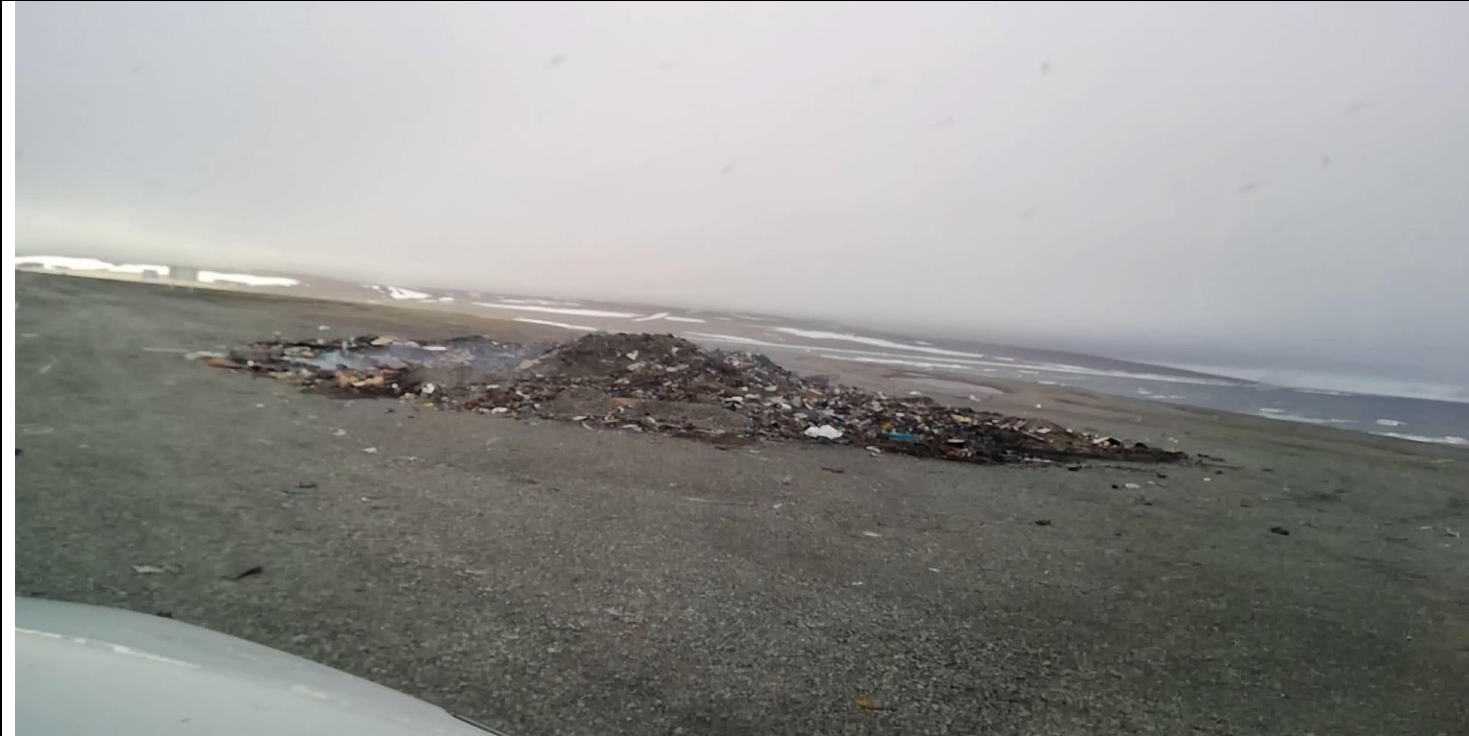
| Date | Camera | Inspector |
|---|---|---|
| Photo 1 | Burn and Cap, Resolute Bay, NU | |

- community approximately 206 metres from the high water mark of the ocean. The site doesn't appear to be lined, no signs of water flowing in and out of the facility. This site was active at the time of inspection (photo 1).
2. No minimum 10 day notice has been given to the inspector since April 2018 for open pit burning.
  3. A caution sign was observed cautioning the public from dumping Hazardous Material, Metals, and Rubber Tires, and Tracks. Both signs also in Inuktitut.
  4. No signs of water entering the facility, the site is on a sloped rocky beach (photo 1).
  5. No signs of leachate leaving the facility. Slope downgrade of burn and cap steepens. Signs of past deposits capped.

Description: Burn and Cap site Active at the time of inspection.

- The Licensee is reminded to remain diligent to prevent wastes from entering water, and the environment.
- Notify the inspector 10 days ahead of a planned open pit burn by emailing Water resource Officer Joseph Monteith at: [joseph.monteith@rcaanc-cirnac.gc.ca](mailto:joseph.monteith@rcaanc-cirnac.gc.ca).
- Consult with neighbouring land owners on an agreement to mitigate the interaction of water on access to the new bulk metal solid waste facility.

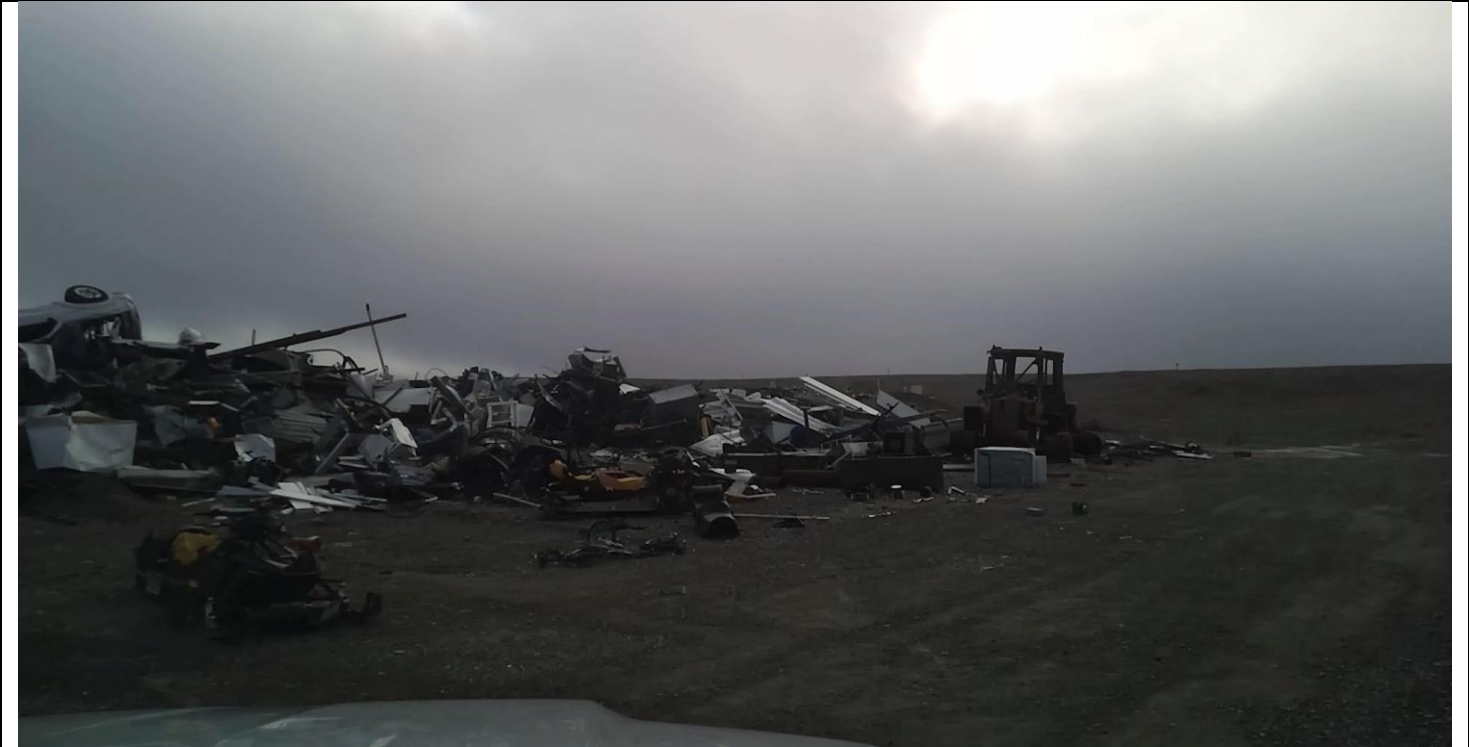
| Photo Log | Location |
|---|---|
| Photo 2 | Community Bulk Metal Solid Waste Facility, Resolute Bay, NU |

6. The Metal Dump facility located with the community of Resolute Bay has a mixture of white waste such as water heaters, washers, dryers, fridges, and freezers. Bulk Metal such as abandoned vehicles such as trucks and snowmobiles, pipes, and storage tanks. (See Photo 2).
7. Water enters the site coming out from underground and migrating through the facility (photo 2).

Description: Bulk Metals Facility within the community,

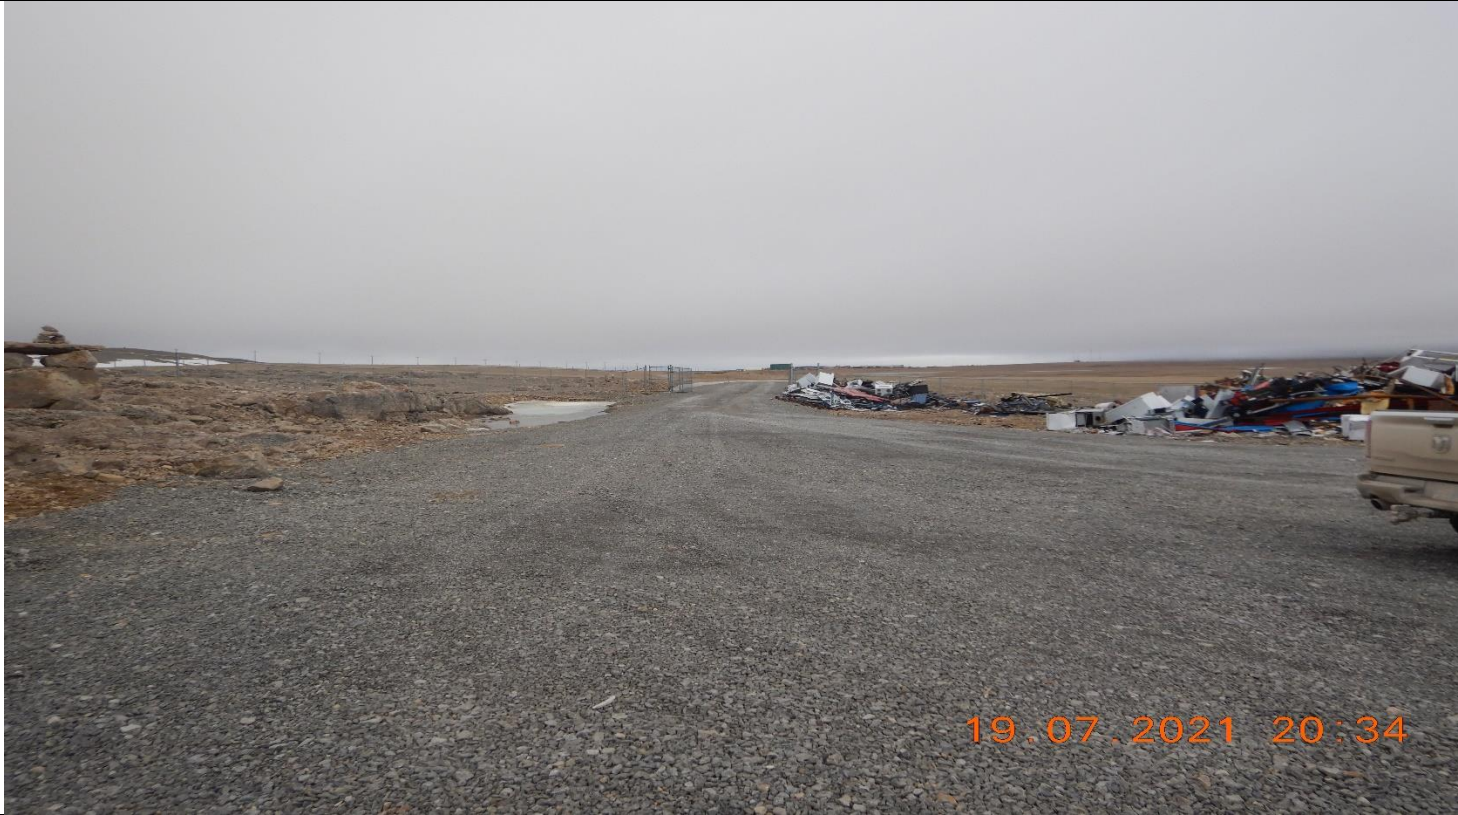
Photo 3

10. Inside the new bulk metal Solid Waste Facility west of Resolute Bay (photo 3 & 4).
11. Empty Paint and Oil Cans observed exposed to the outside elements within the fenced area of the domestic waste facility.

Description: Water accumulation within the fenced area of the second Bulk Metal solid Waste Facility.

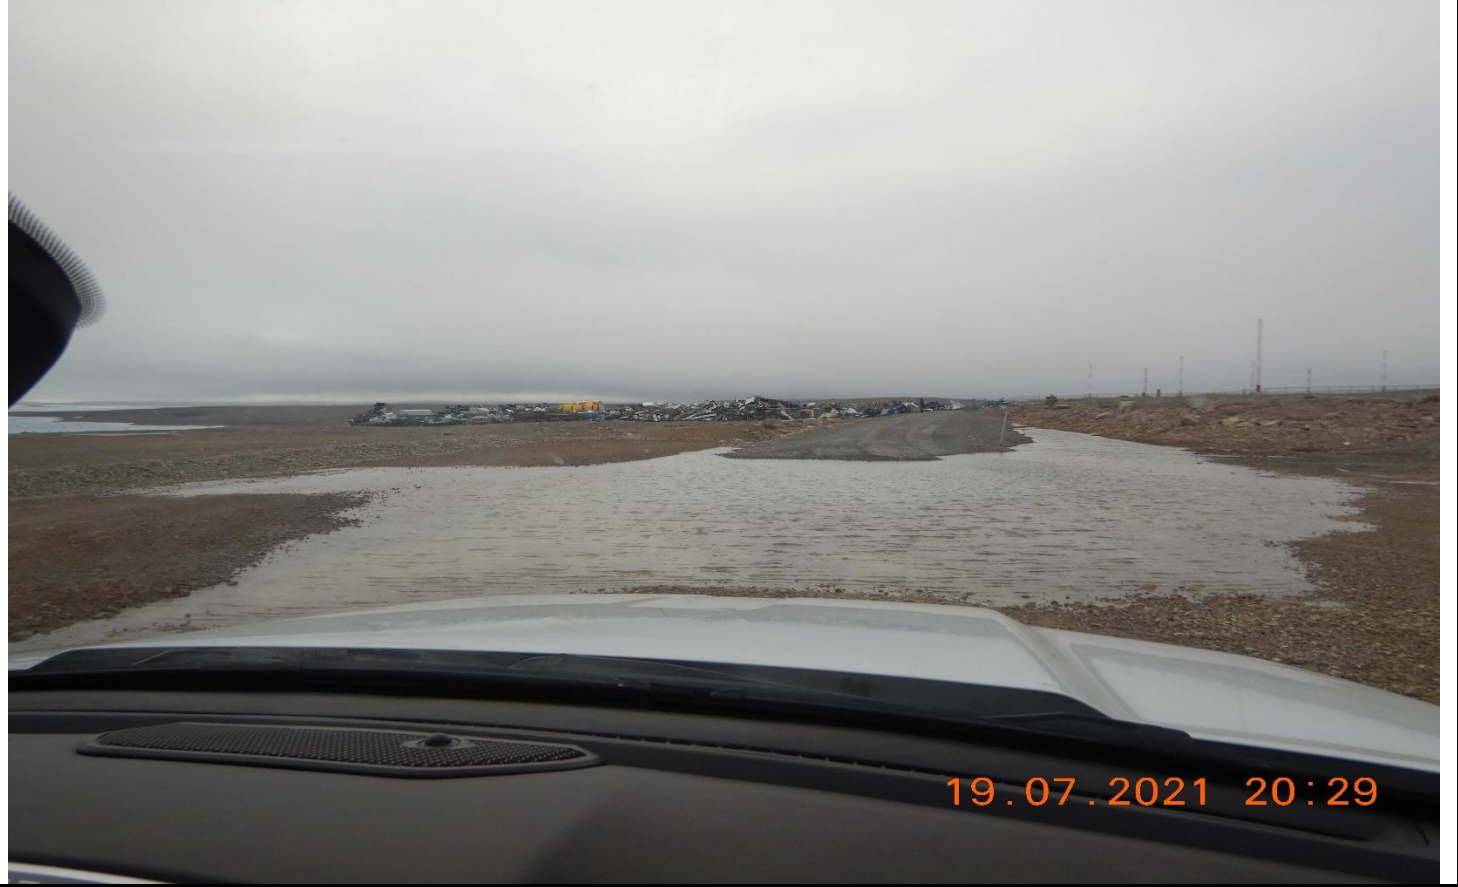
Photo 4

Description: A pool of water at the entrance to the new bulk metal facility.
