# WATER LICENCE INSPECTION FORM

<b>Licensee</b>	<b>Licensee Representative</b>
Hamlet of Resolute Bay	Ian Dudla
<b>Licence No. / Expiry</b>	<b>Representative's Title</b>
3BM-RES2025	Regional Engineer
<b>Land / Other Authorizations</b>	<b>Land / Other Authorizations</b>
<b>Date of Inspection</b>	<b>Inspector</b>
July 10, 2024	Joseph Monteith
<b>Activities Inspected</b>	
<input type="checkbox"/> Camp <input type="checkbox"/> Drilling <input type="checkbox"/> Mining <input type="checkbox"/> Construction <input type="checkbox"/> Reclamation <input type="checkbox"/> Fuel Storage <input checked="" type="checkbox"/> Roads/Hauling <input checked="" type="checkbox"/> Other: Solid Waste Facility, Hazardous Waste Facility <input type="checkbox"/> Other:

**PHOTO LOG**

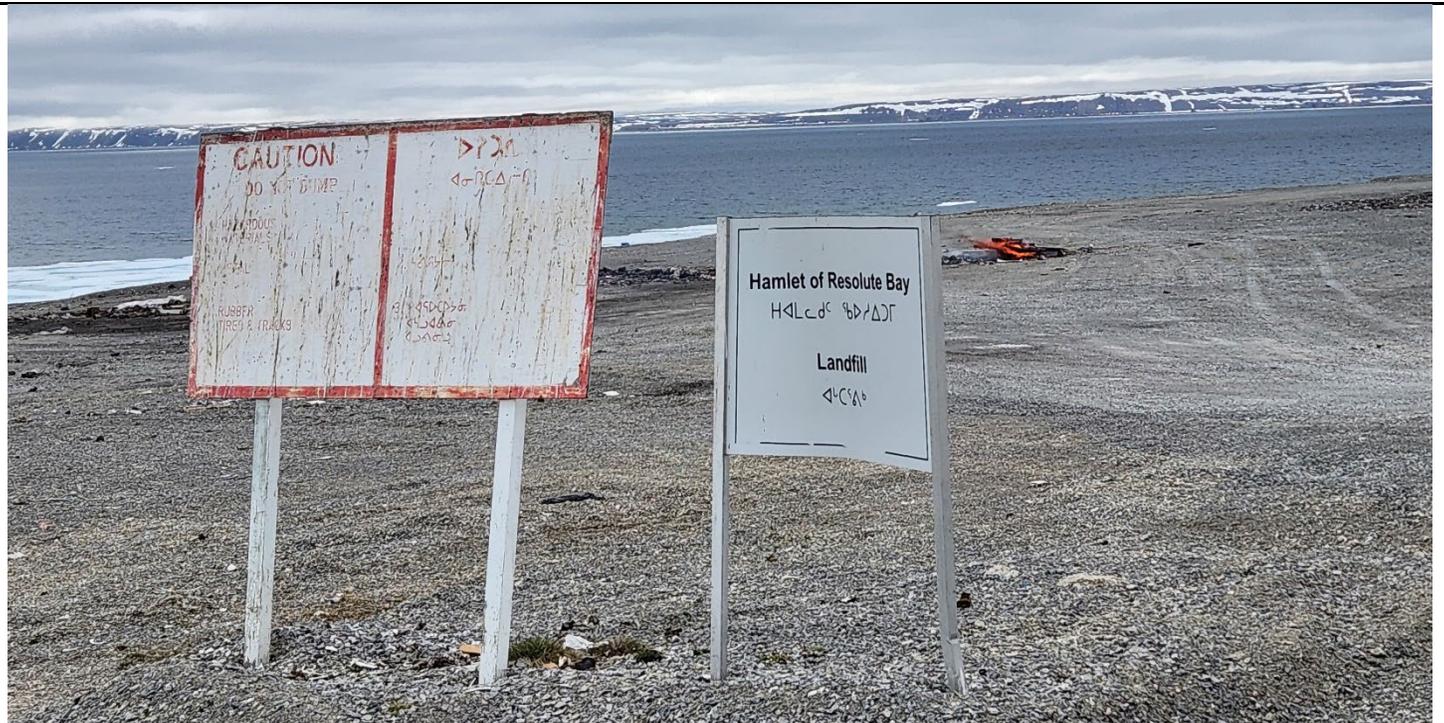
Date	Camera	Inspector
July 6, 2025	Nikon Cool Pix	Joseph Monteith
Photo Log	Location	
Photo 1	Burn and Cap, Resolute Bay, NU

1. The Hamlet manages their domestic waste by burning and capping along the beach on the south side of the community approximately 206 metres from the high water mark of the ocean. The site doesn't appear to be lined, no signs of water flowing in and out of the facility. This site was active at the time of inspection (photo 2).

Description: Burn and Cap site active at the time of inspection.

- Consolidate all hazardous waste such as paint cans and oil cans in the Bulk Metal Solid Waste Facility and Domestic Solid Waste Facility, and store in the hazardous waste section of the Solid Waste Facility to be compliant with Part D: Item 4
- Notify the inspector 10 days ahead of a planned open pit burn by emailing Water Resource Officer Joseph Monteith at: [joseph.monteith@rcaanc-cirnac.gc.ca](mailto:joseph.monteith@rcaanc-cirnac.gc.ca). To be compliant with Part D:Item 3.
- Consult with neighbouring land owners on an agreement to mitigate the interaction of water on access to the new bulk metal solid waste facility, to be compliant with Part C: Item 2
- Apply for a water licence for deposit of waste as per 12(1) of the Nunavut Waters and Nunavut Surface Rights Tribunal Act.
- The Licensee is reminded to remain diligent to prevent wastes from entering water, and the environment.

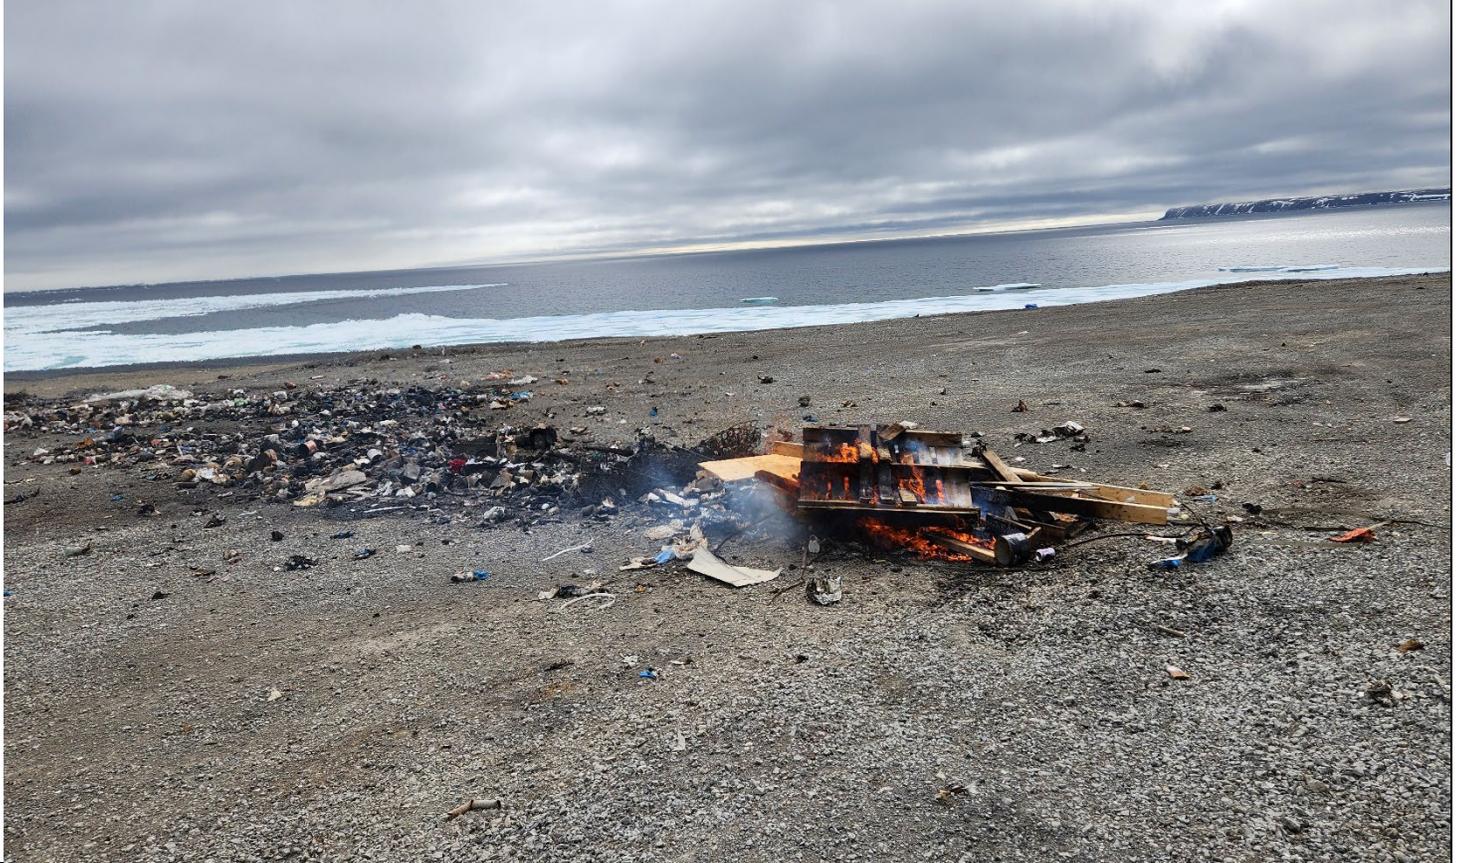
Photo 2

4. No signs of water entering the facility, the site is on a sloped rocky beach (photo 2).
5. No signs of leachate leaving the facility. Slope downgrade of burn and cap steepens. Signs of past deposits capped.

Description: Burn and Cap smoldering with domestic waste, and bulk wood. Gravel used for capping is stored next to the open pit for use.

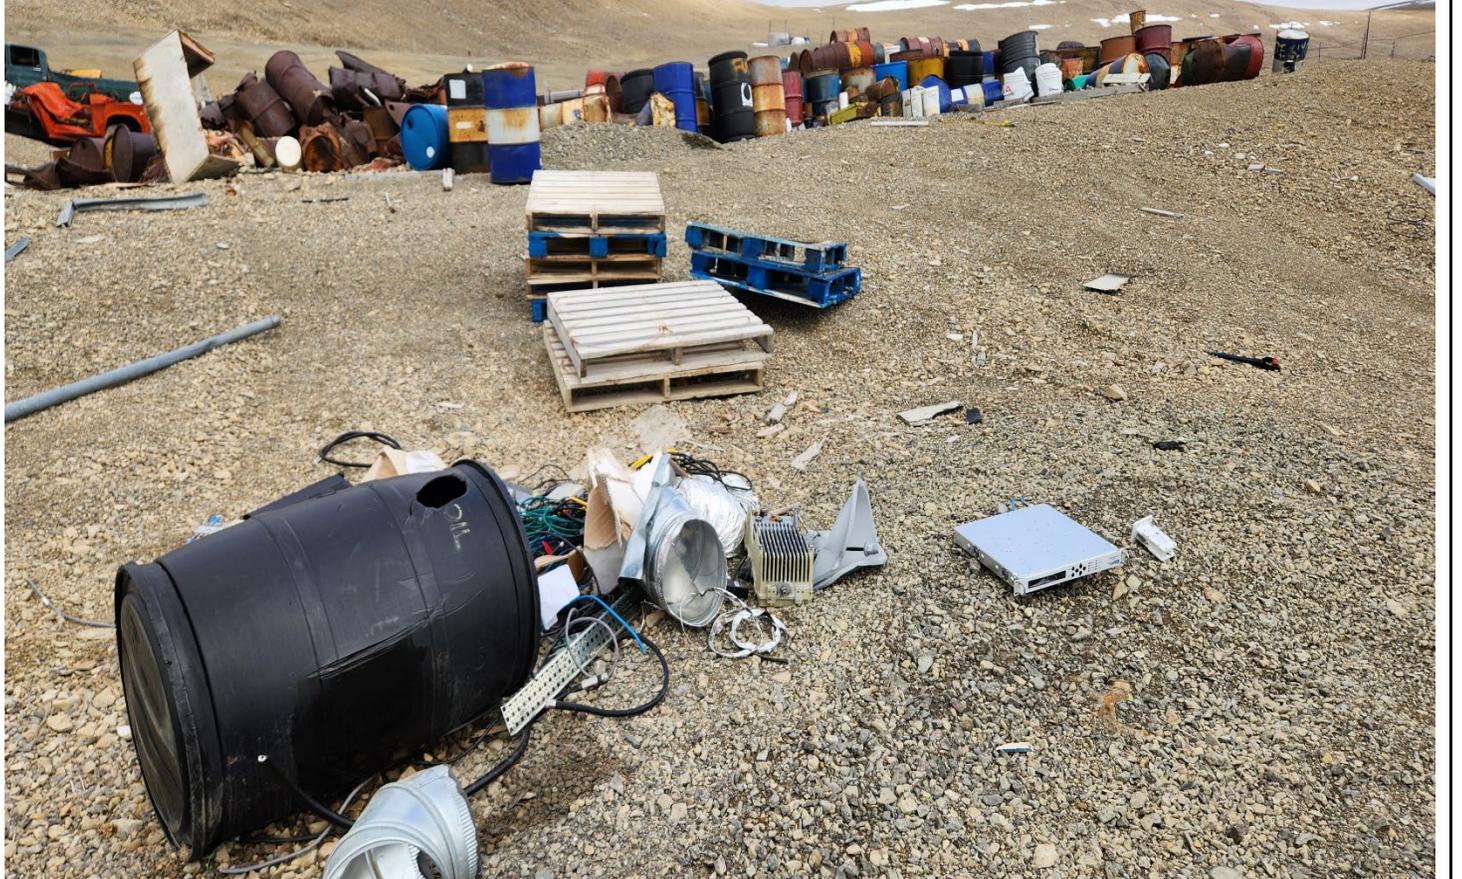
Photo 3

8. The hazardous waste within the community is exposed to the elements. With most waste oil drums in a berm, with some hazardous waste outside of a berm.
9. Signs of leaks were observed on site at the time of the inspection (photo 3).

Description: Open drum of waste oil outside of secondary containment, signs of spill from drum. Drum isn't supported to ensure I doesn't roll away and spill its contents.

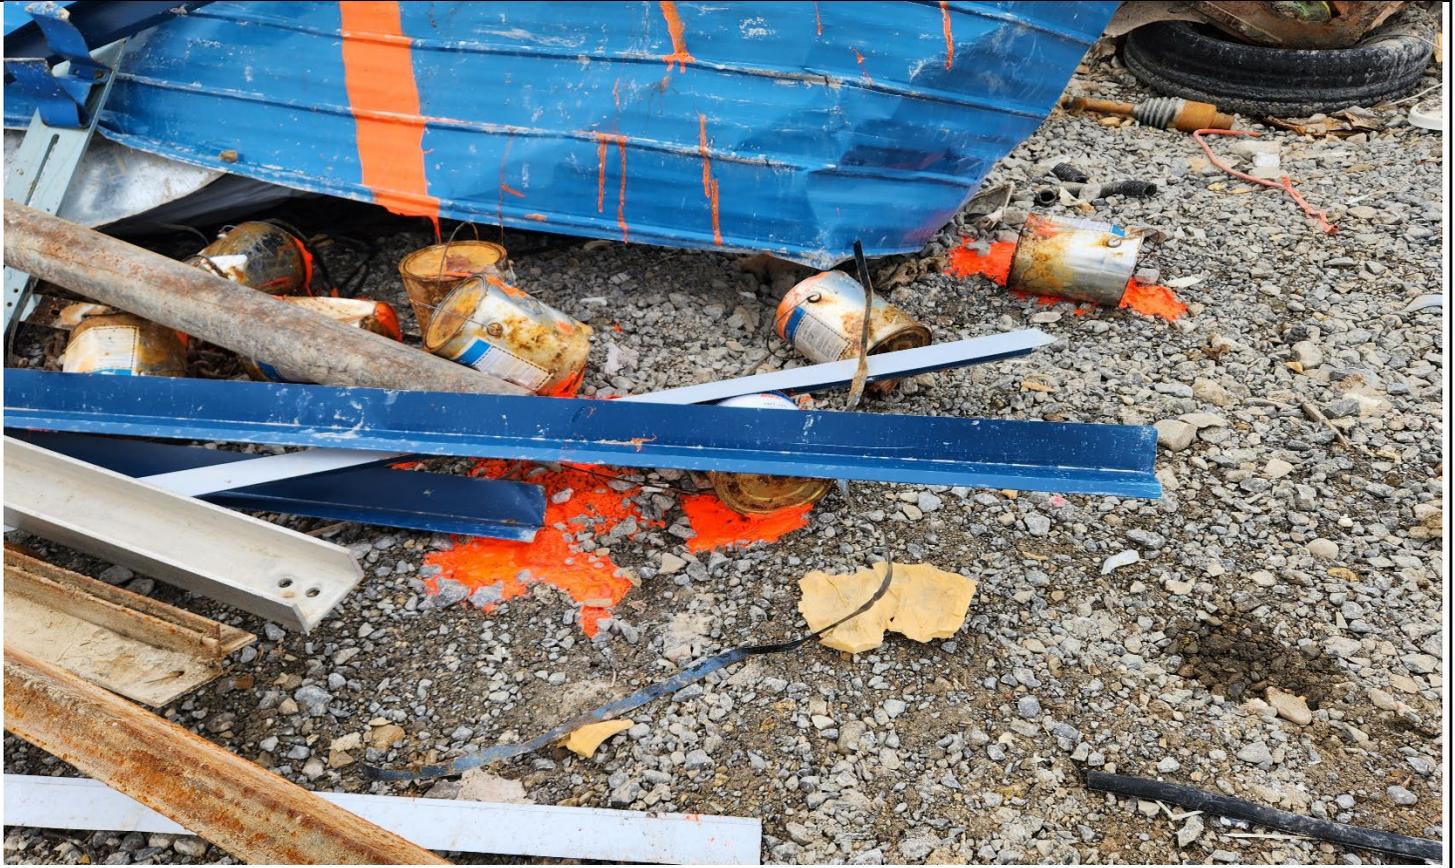
Photo 6

10. Inside the new bulk metal Solid Waste Facility west of Resolute Bay (photo 3 & 4).
11. Battery, waste oil can observed exposed to the outside elements within the fenced area of the domestic waste facility (photos 5- 8).

Description: Bulk Metals Facility outside the community. Orange paint cans deposited and spilt into the facility.

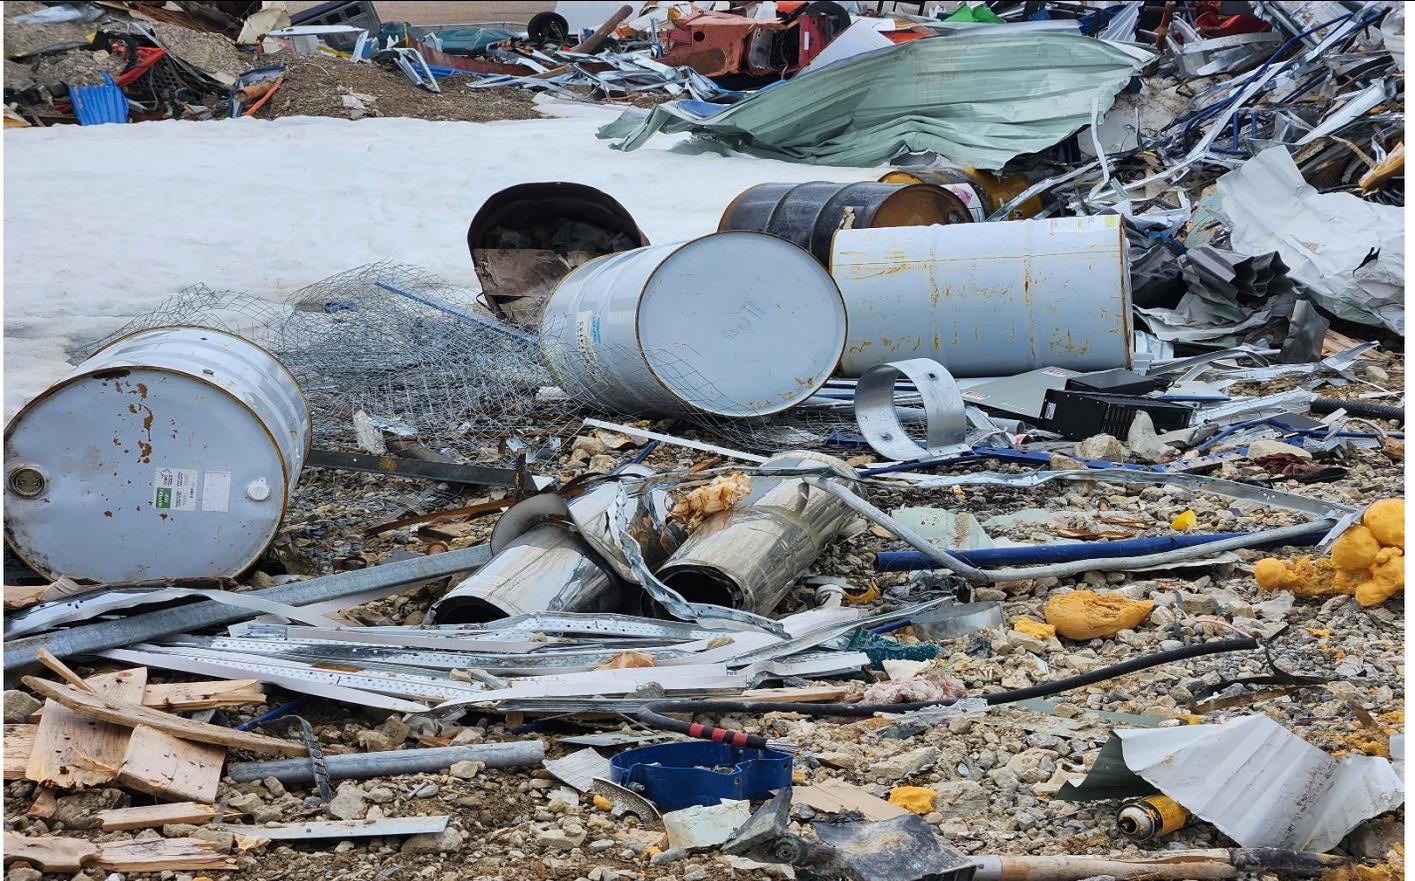
Photo 7

Description: Bulk Metal Facility outside the community. 6 drums deposited

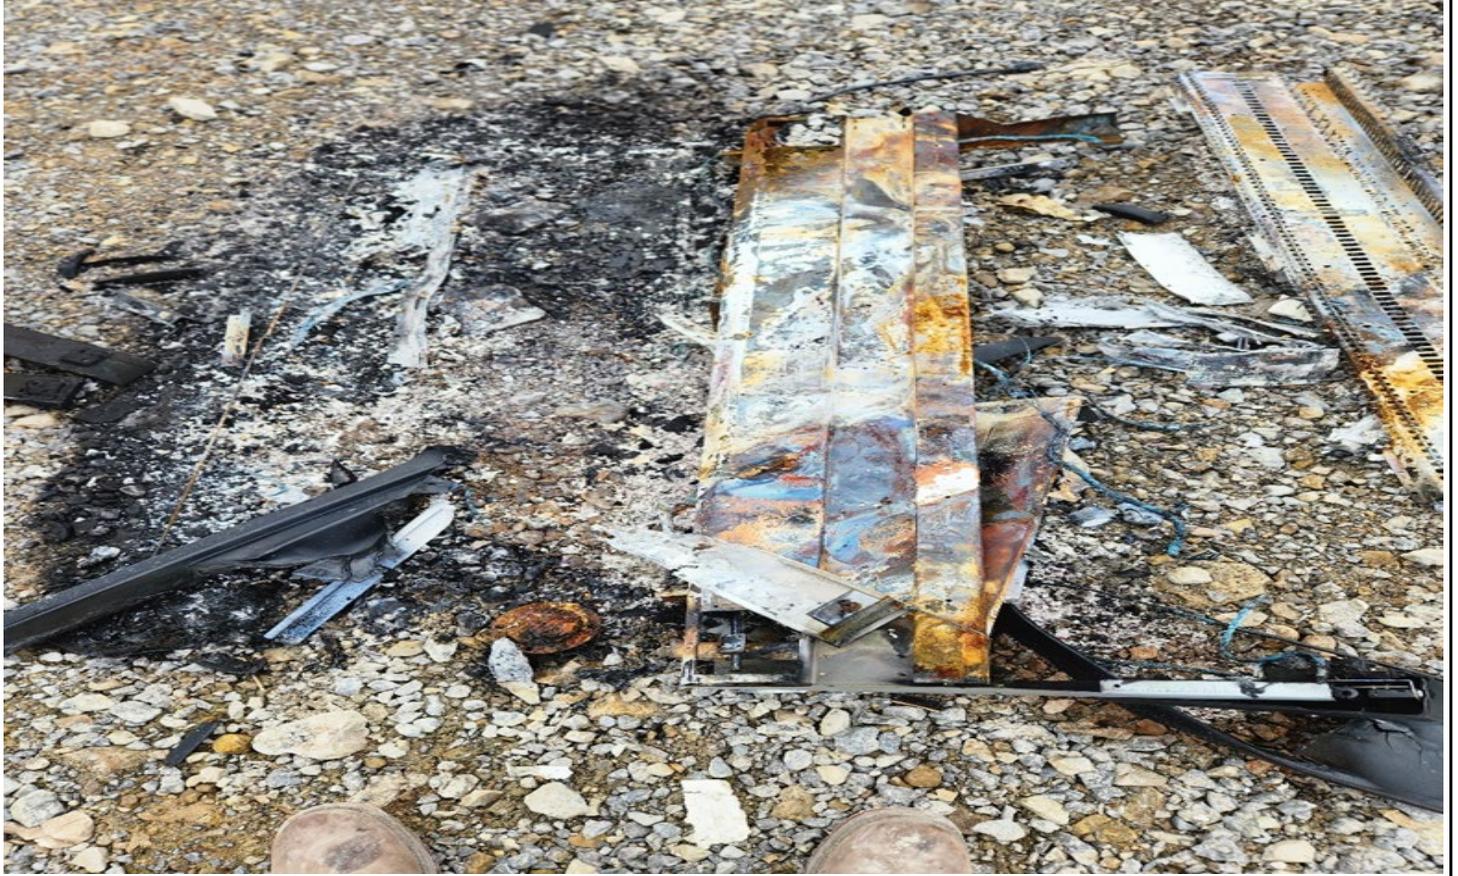
Photo 8

Description: possible hazardous electronic components ignited when exposed to the elements.

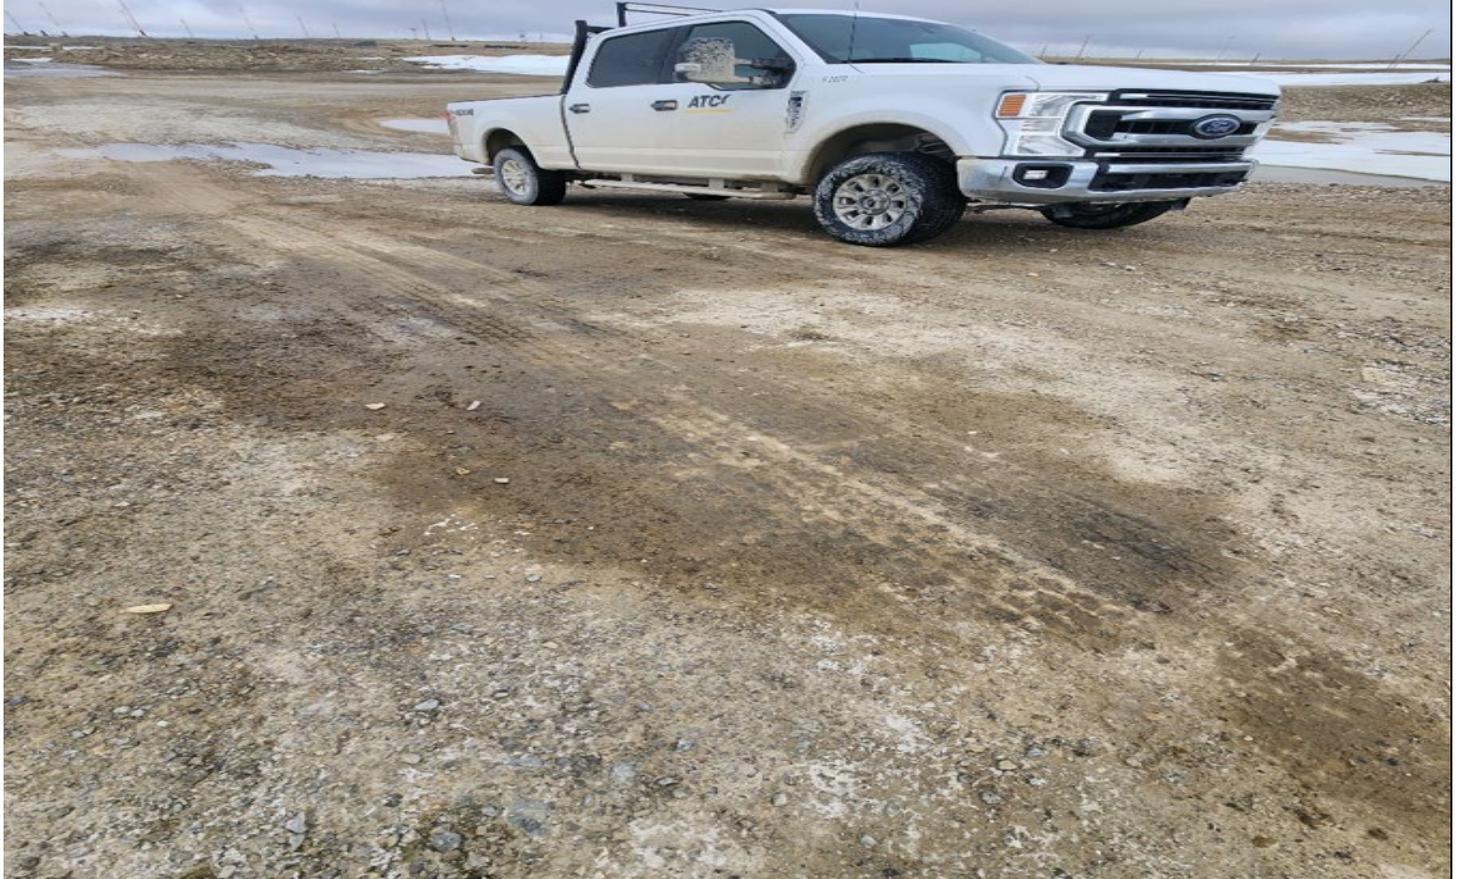
Photo 9

Description: Surface pools of water continues to settle at the entrance of the bulk metal facility.
