WATER LICENCE INSPECTION FORM

Licensee	Licensee Representative
Hamlet of Resolute Bay	Gord Marinic
Licence No. / Expiry	Representative's Title
3BM-RES2025	Regional Engineer
Land / Other Authorizations	Land / Other Authorizations
Date of Inspection	Inspector
July 7, 2022	Joseph Monteith
Activities Inspected	
<input type="checkbox"/> Camp	<input type="checkbox"/> Drilling
<input type="checkbox"/> Roads/Hauling	<input type="checkbox"/> Mining
	<input type="checkbox"/> Construction
	<input checked="" type="checkbox"/> Other: Solid Waste Facility, Hazardous Waste Facility
	<input type="checkbox"/> Reclamation
	<input type="checkbox"/> Fuel Storage

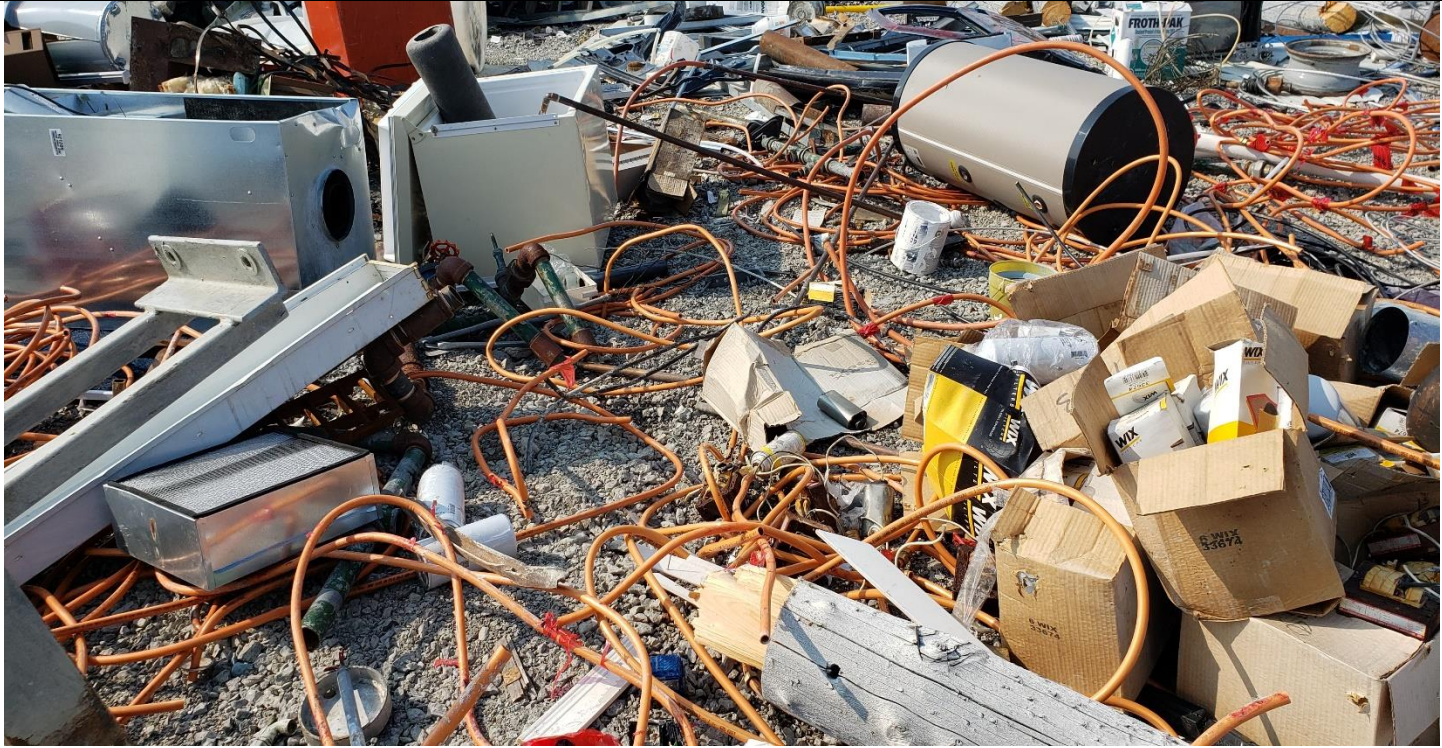
Photo 3

Description: Bulk Metals Facility within the community. Paint can, 2x waste oil filter observed.

- Consolidate all hazardous waste such as paint cans and oil cans in the Bulk Metal Solid Waste Facility and Domestic Solid Waste Facility, and store in the hazardous waste section of the Solid Waste Facility
- The Licensee is reminded to remain diligent to prevent wastes from entering water, and the environment.
- Notify the inspector 10 days ahead of a planned open pit burn by emailing Water Resource Officer Joseph Monteith at: joseph.monteith@rcaanc-cirnac.gc.ca.
- Consult with neighbouring land owners on an agreement to mitigate the interaction of water on access to the new bulk metal solid waste facility.

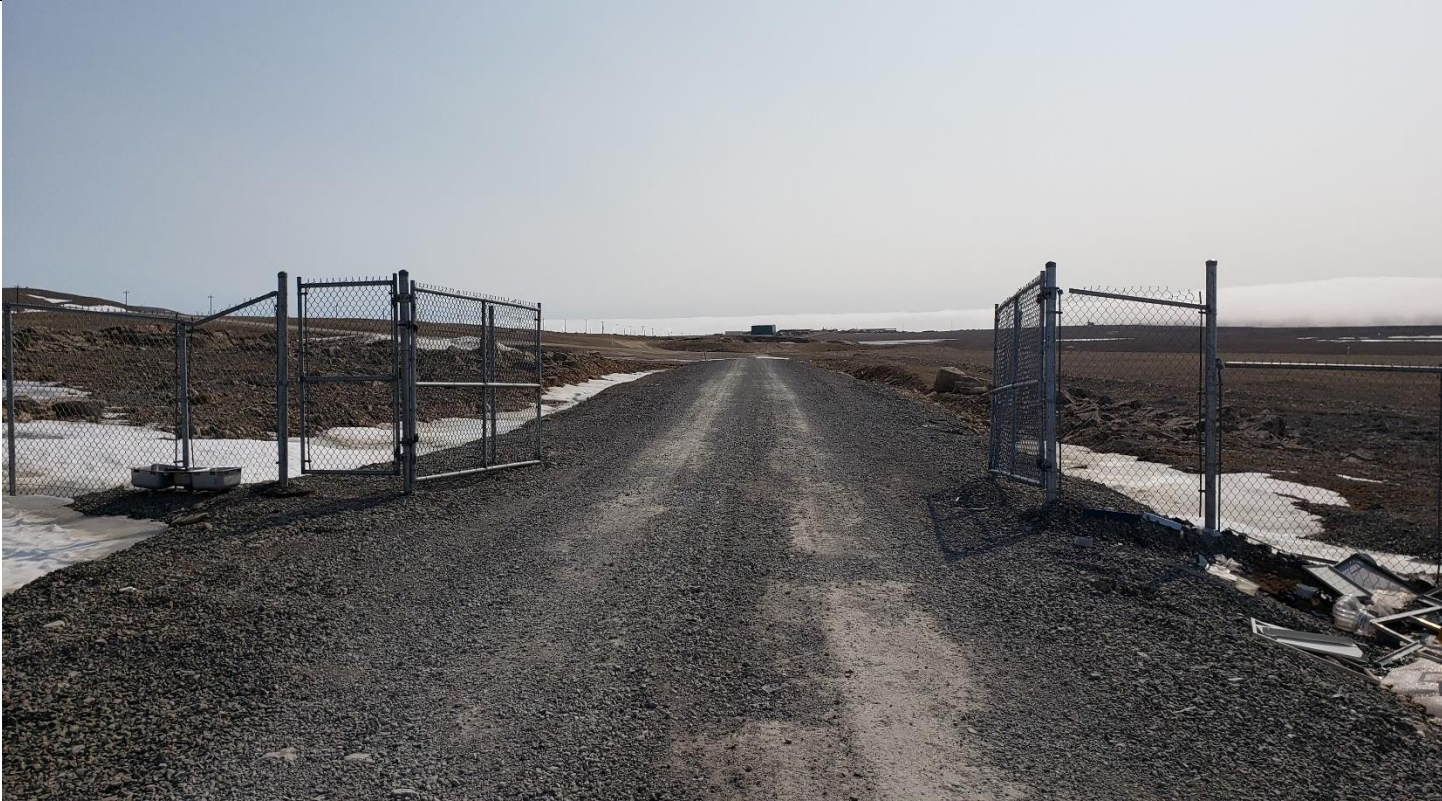
Photo 4

Description: Water or snow, accumulates between the fenced area of the entrance to the Bulk Metal Facility, and the outside fenced area.

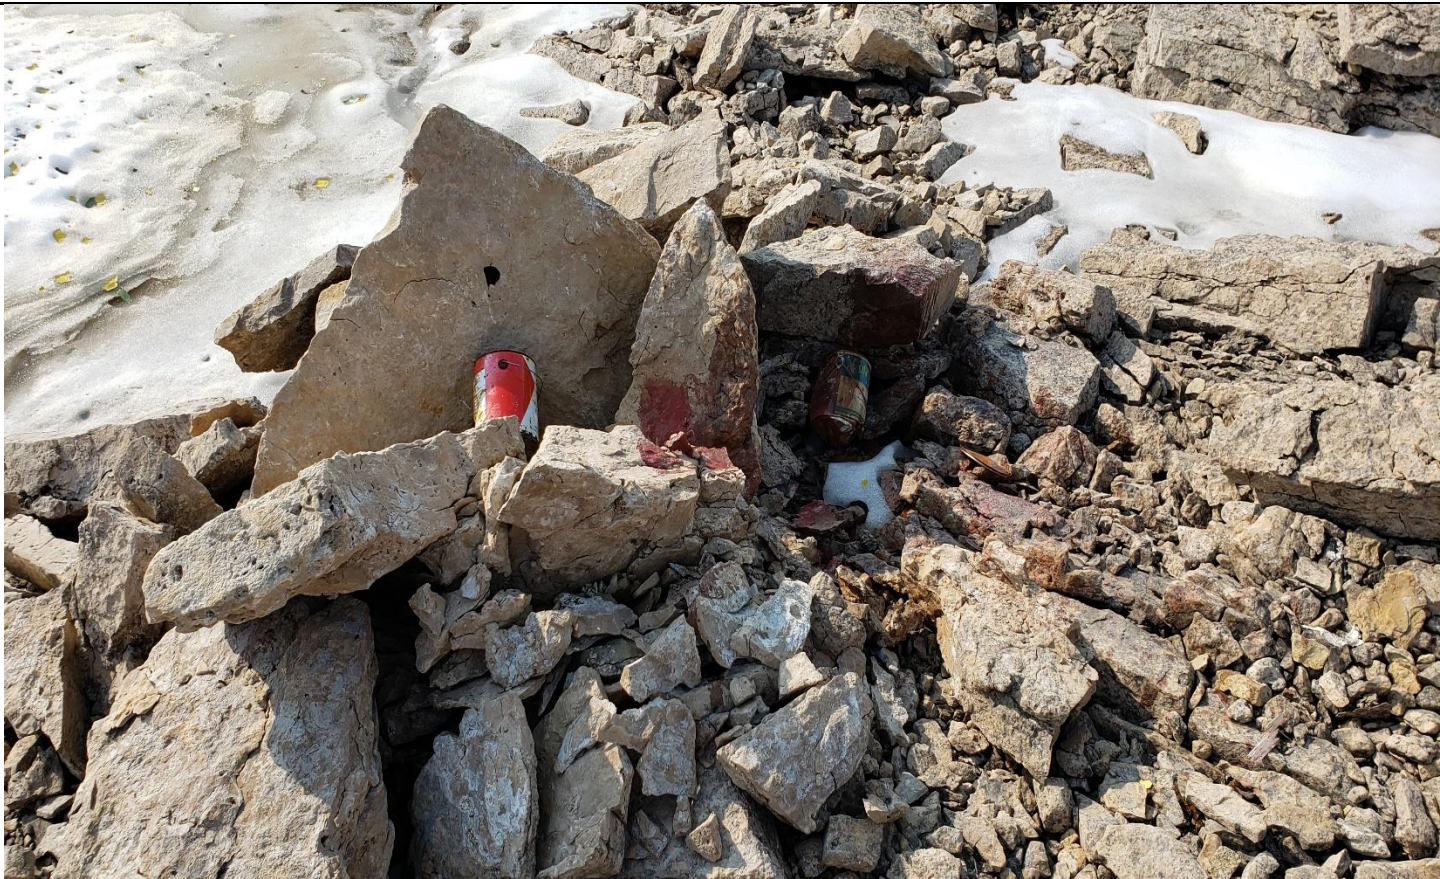
Photo 5

10. Inside the new bulk metal Solid Waste Facility west of Resolute Bay (photo 3 & 4).
11. Empty Paint and Oil Cans observed exposed to the outside elements within the fenced area of the domestic waste facility.

Description: Empty Hazardous Waste Oil Cans first observed, and advised to move to hazardous waste facility found buried into Earth works.

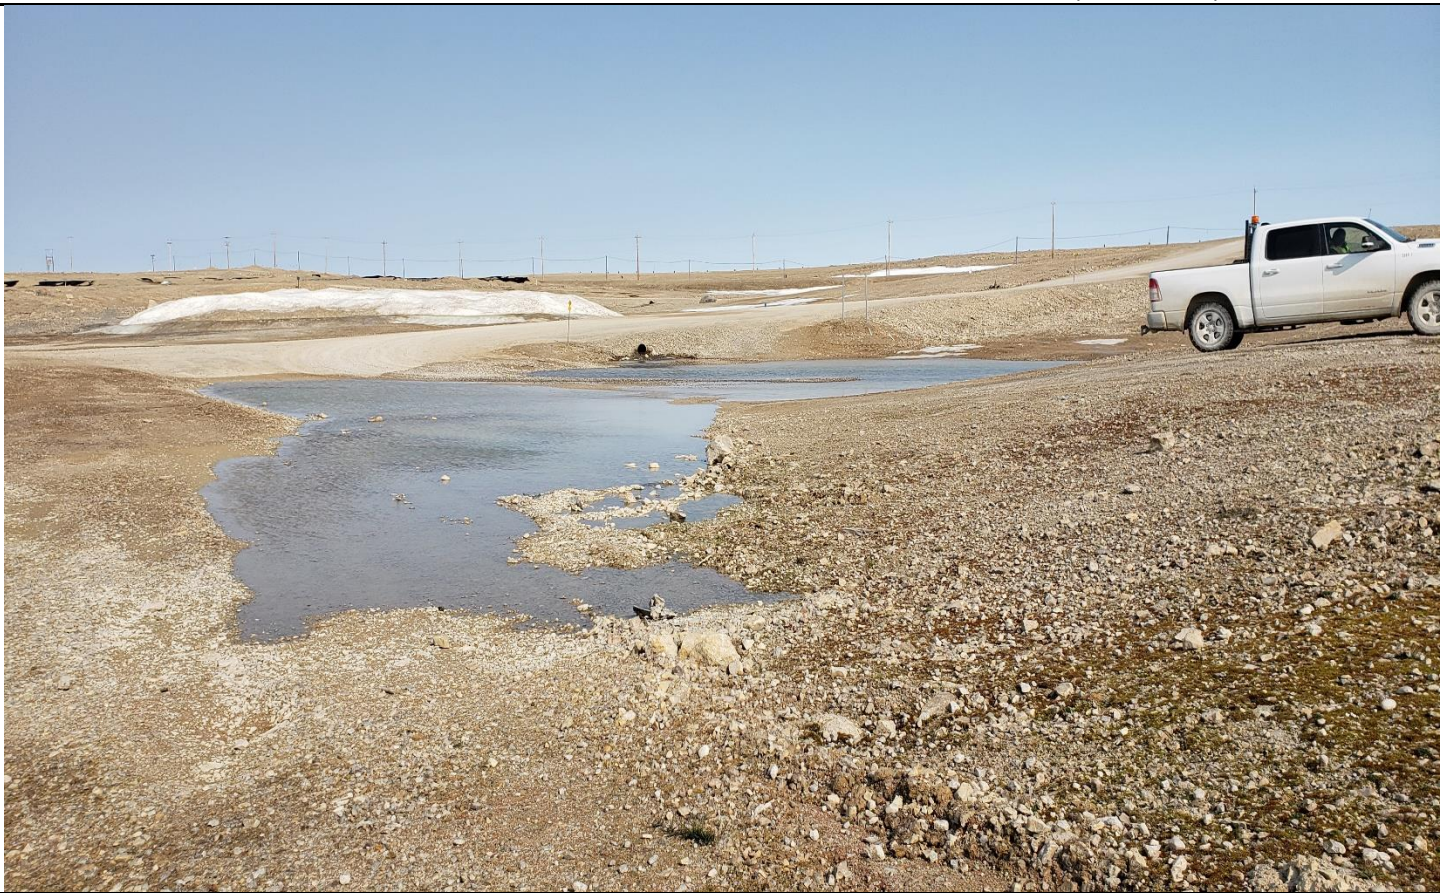
Photo 6

Description: A pool of surface water at the entrance to the new bulk metal facility and Sewage Lagoon.
