June 7, 2001 Municipal Water Use Inspection - Report

MUNICIPAL WATER USE INSPECTION FORM

Licensee: Municipality of Sanikiluaq Licence No.: unlicensed

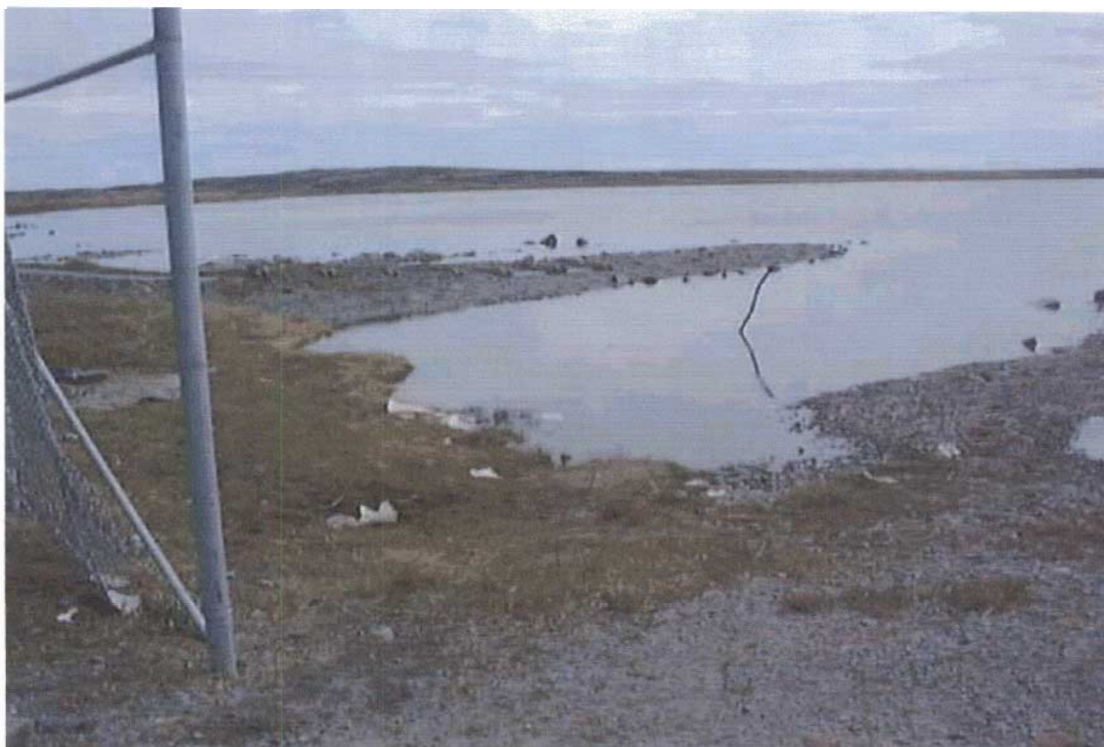
Comments: Water intake station kept clean and tidy. Only one pump operating due to heat trace problems leading to freeze up last winter. Pump repair and intake screen replacement scheduled for later in the summer. Intake is not metered; water use is recorded through truck delivery. Chlorination in use.

figure 1. Intake at Sanikiluaq Lake; 2001/06/07.

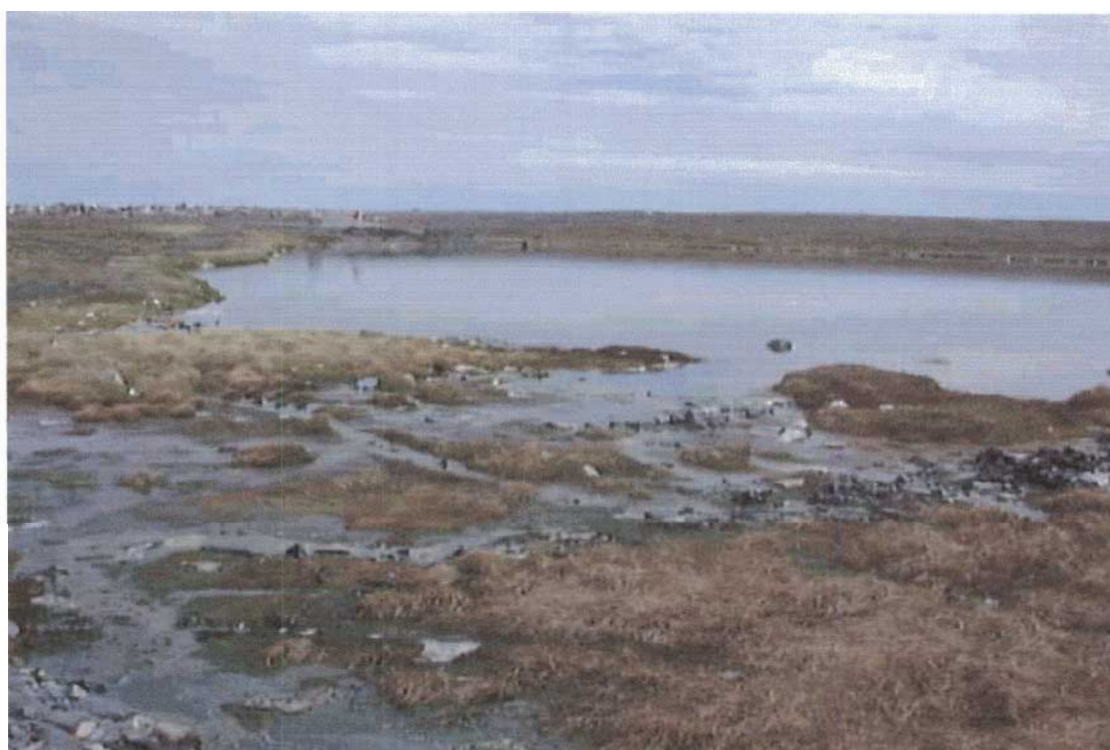
- **Sewage disposal:** Although some signs of erosion were observed in the truck discharge area, very little concerns were noted at the sewage disposal facility (figure 2). In fact, the combination of lagoon with retention berm (figure 3) and ample vegetation along the path of discharge (figure 4) seems to provide substantial treatment. As such, the attached analytical results indicate that the effluent is relatively benign. However, the concentration of ammonia within the sewage effluent notably exceeds *Canadian Water Quality Guidelines for the Protection of Freshwater Aquatic Life* (18 mg/L vs 2.2 mg/L).

figure 2. Sewage lagoon, with truck dumping area in background; 2001/06/07.

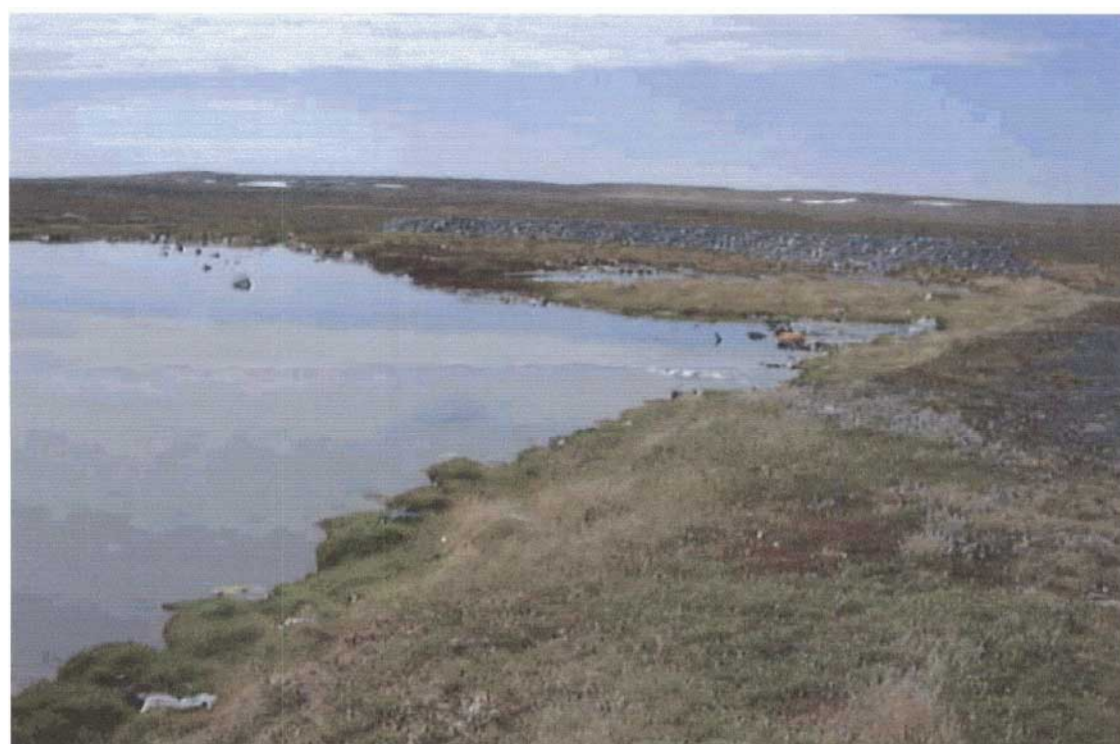
Comments: Berm erected in lagoon's decant area appears to increase retention time and treatment of effluent prior to discharge. Extensive vegetation noted along discharge path. Signs of erosion at the truck discharge station; beams have been installed to limit impact. The unfenced solid waste disposal facility sprawls a vast area. Limited segregation of bulky metal wastes was noted. The wastepile is burnt infrequently. No proper containment for hazardous materials was apparent. Waste oil is now burnt at the municipal garage's furnace. No runoff or leachate could be observed flowing from the solid waste disposal facility.

figure 3. Bermed discharge area of the sewage lagoon; 2001/06/07.

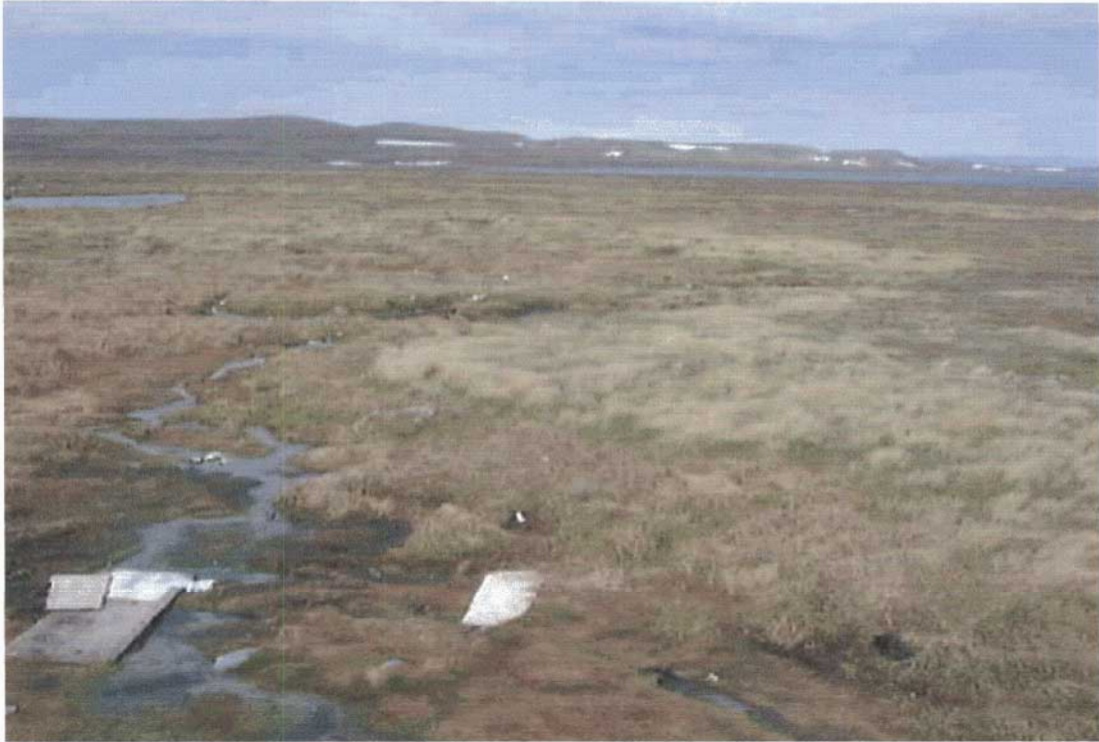
figure 4. Path of discharge from the sewage lagoon; 2001/06/07.

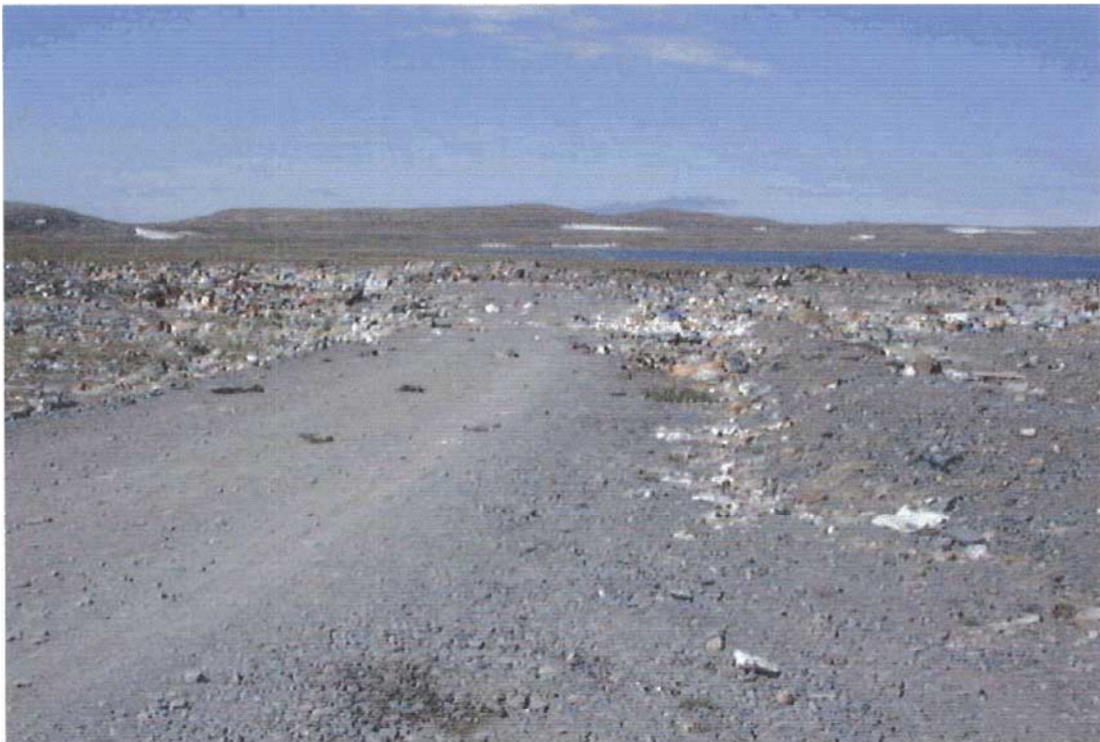
figure 5. Solid waste disposal site; 2001/06/07.

- **Solid waste disposal:** The solid waste disposal facility covers a vast area (figure 5), and its perimeter is notably extended by windblown garbage (figure 6). Accordingly, it was suggested during the inspection that the municipality compact the wastepile and then confine the area with a fence so as to prevent windblown waste from entering waters; it may be possible to undertake this work in light of the capital funds reportedly identified for the municipal solid waste disposal facility. Although bulky wastes are set aside to the metal dump, additional segregation of waste could be undertaken. In this regards, it was suggested that a sealift container be used to store hazardous materials and thus minimise the chances of release of contaminants to the environment. Nevertheless, no runoff or leachate could be observed flowing from the solid waste disposal facility.

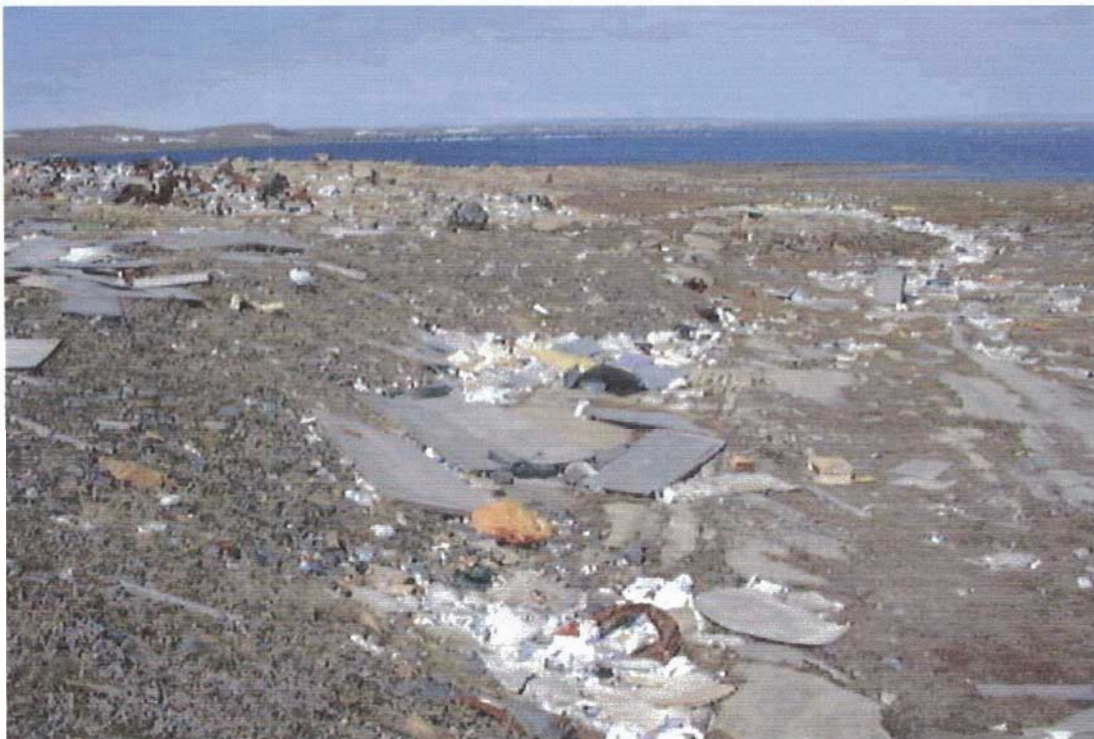
figure 6. Perimeter of the solid waste disposal site; 2001/06/07.
