Explanation and respond to NWB letter dated June 02, 2014

Taloyoak Water Licence 3BM-TAL 0813

Sewage effluent and waste runoff samples results

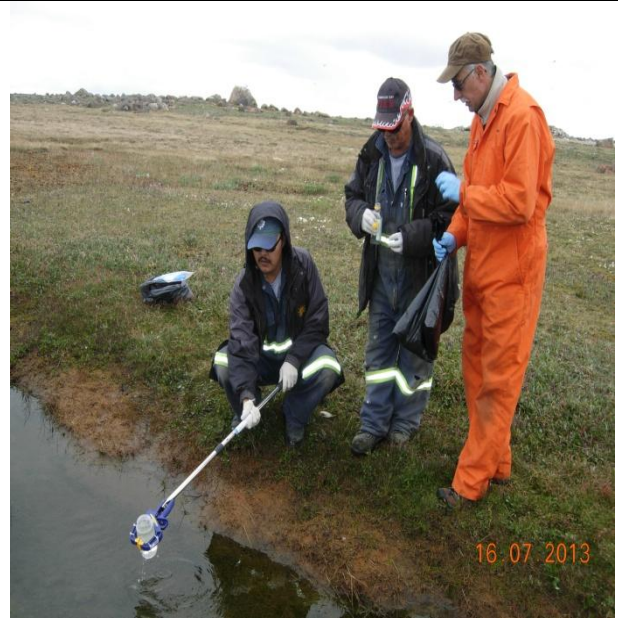
Picture 2: Monitoring Station TAL-4 for sampling

Effluent sampling: Grab samples are taking from monitoring stations TAL-2, TAL-3 and TAL-4 during the period July - September from available flow of effluents. TAL-2 sample represent the effluent from secondary cell of sewage lagoon, TAL-3 sample of Solid waste runoff and TAL-4 sample represent the final runoff of combined effluents before meeting into Stanners Harbour (see Monitoring Stations location). Sample results are attached for information.

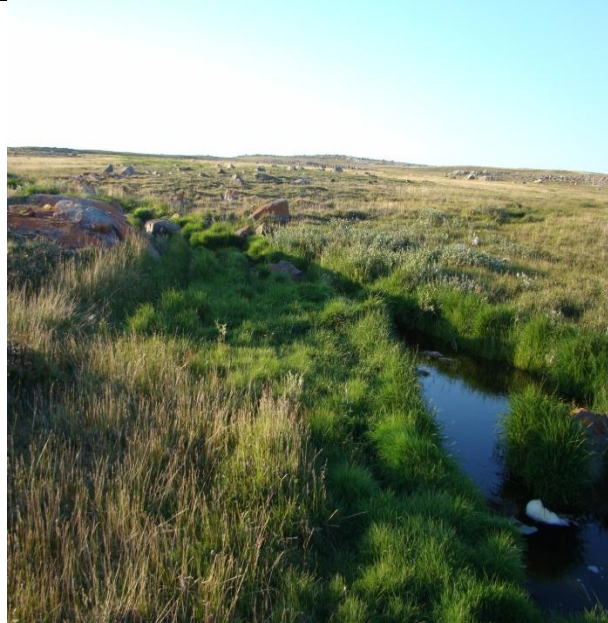
Picture 3: Green vegetation at Taloyoak Wetland

Summer vegetation enriched wide area wetland is part of additional treatment for Taloyoak sewage effluent, serving the job for long time. Each year, samples collected from flowing effluents over in wetland at designated monitoring stations, test for parameters to Taiga Lab in Yellowknife and compile results to the Board. See the pictures for wetland and test results of effluent samples.

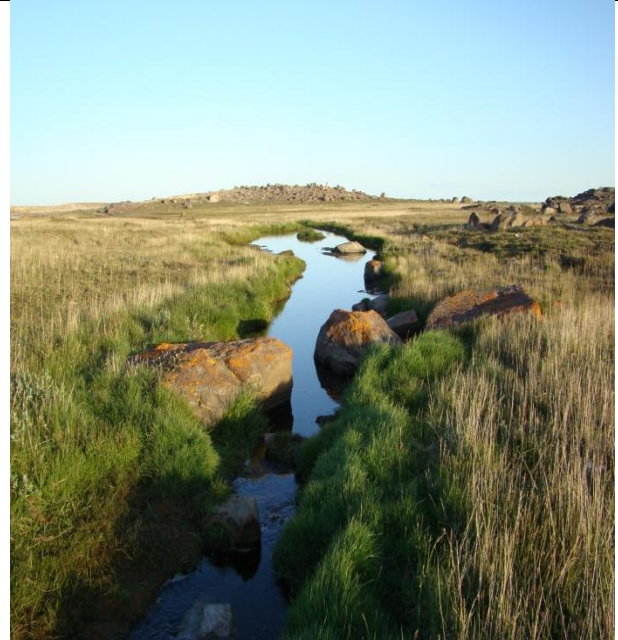
Picture 4: natural drainage for effluent flow

Lagoon decanting and erosion of berm: Taloyoak Sewage lagoon composed of a series of two main cells divided by a natural semi-submerged berm and with no man made berm around. Lagoon sides are naturally built with sedimentary rocks (carbonates, shale's and sandstones); therefore, not a concern for erosion of berms. No decanting requires as the only natural discharge from the secondary cell into wetland when detained sewage thaws in summer.

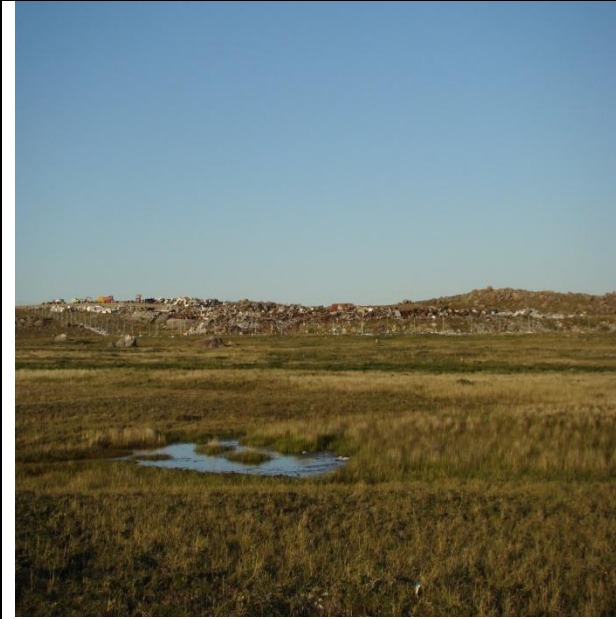
Picture 5: solid waste run-off storage sump

Leachate runoff from solid waste site collects in the ponding area outside of the facility (as seen in picture). With a stopover in the ponding area, overflow leachate runs onto the shallow stream on wetland where meets with sewage effluent and finally run to Stanners Harbour.

The solid waste facility is on an area of sloping topography – metal dump at one end and municipal solid waste at the other lower sloped end, secured with perimeter fence. Down the sloping area outside of the facility, a shallow sump pond for leachate runoff storage before overflow onto wide area wetland and finally merge with sewage effluent in the shallow drains (as seen in the picture). Grab sample are collecting from the available runoff storage sump (outside the solid waste fence) and test for parameters. Such runoff mostly available during the summer when snow melts and water helps the runoff flow, generally not available after the summer months.

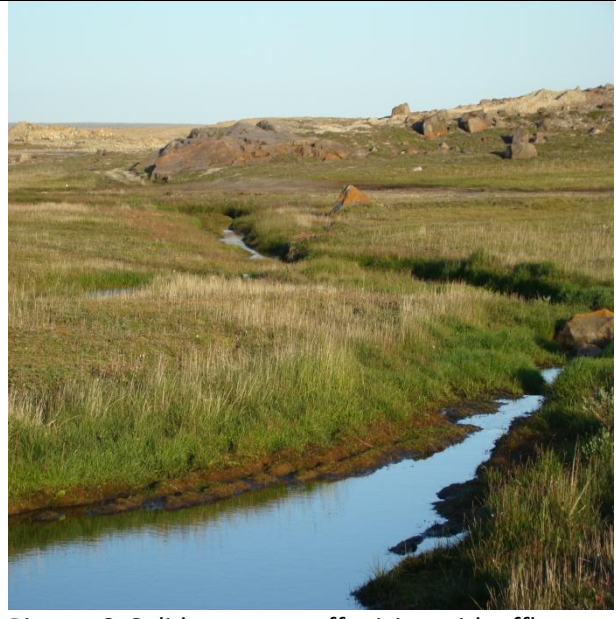
Picture 6: Solid waste runoff mixing with effluent

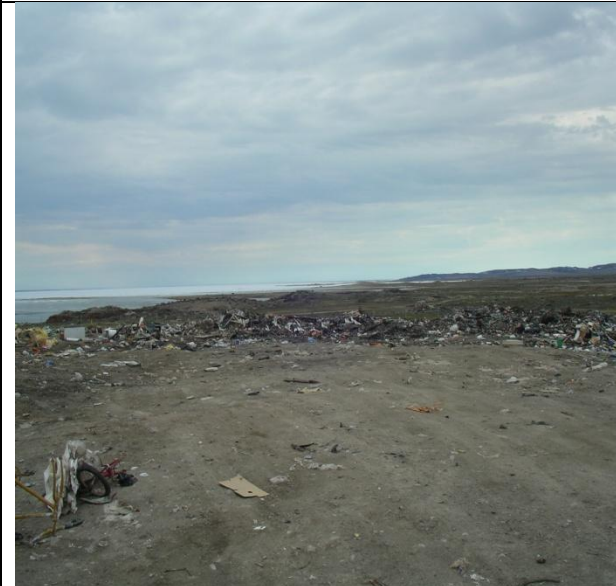
Picture 7: Taloyoak Solid waste site

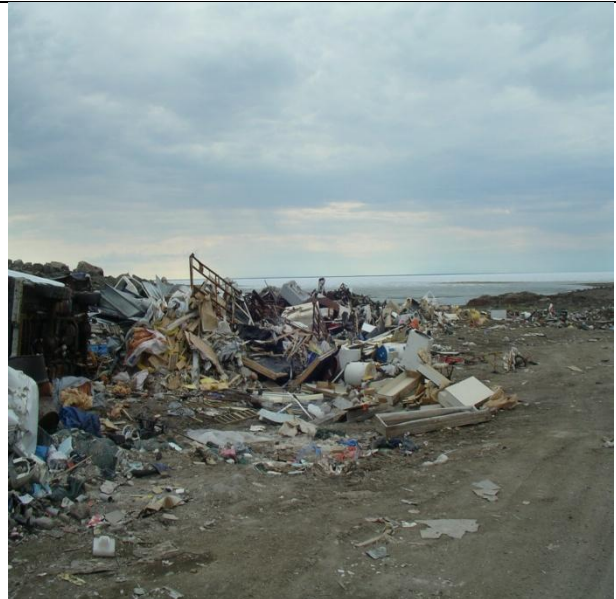
Picture 8: Taloyoak Solid waste on down gradient
