Annual Report-2019

Water Licence: 3BM-TAL 1926

Annual Report 2019

WATER LICENCE INSPECTION FORM

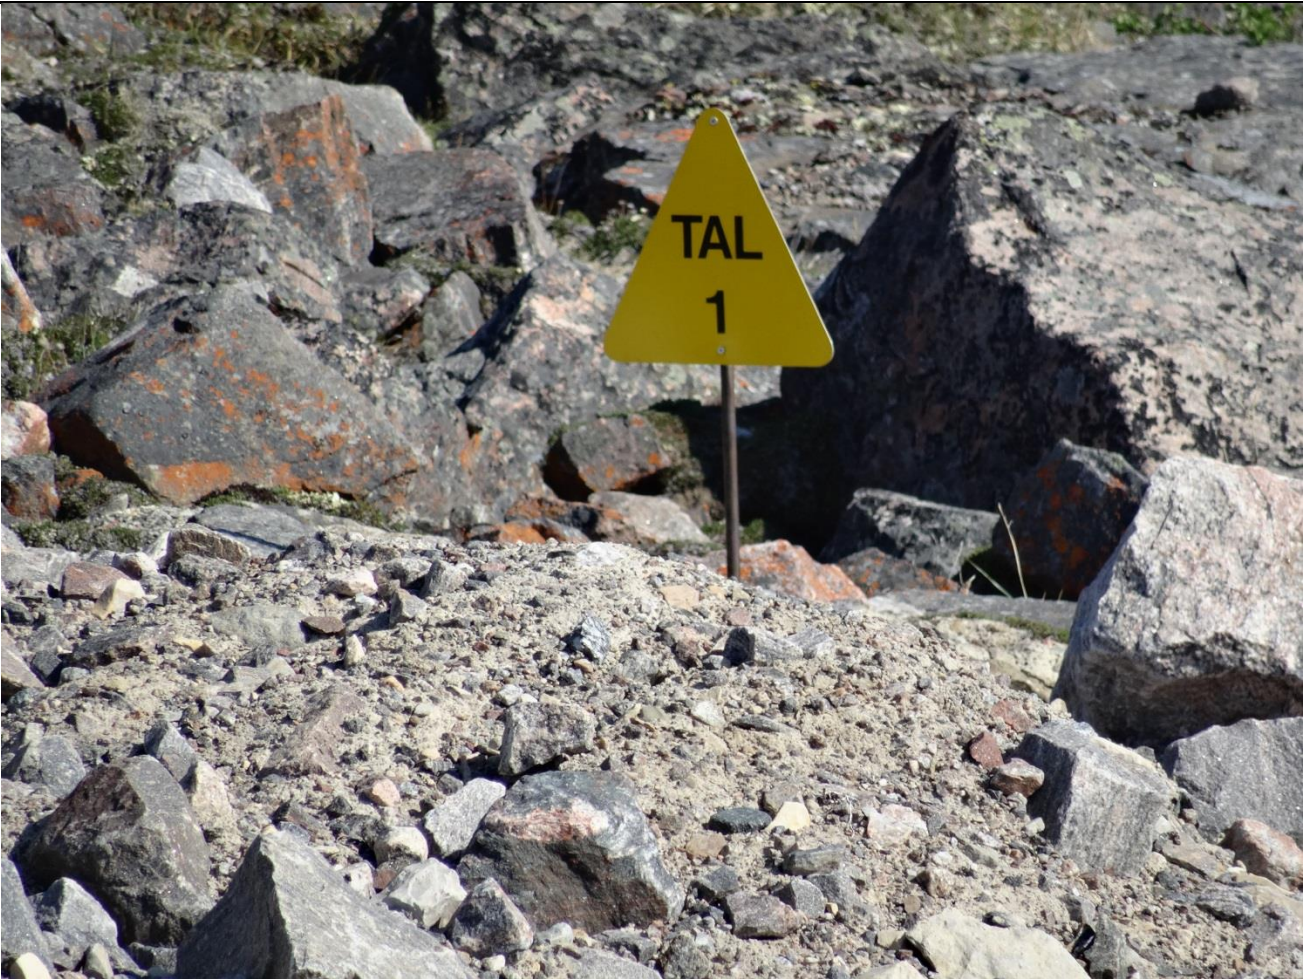
Photo 1

Description: Sample Station TAL-1 Signage installed as per my request last year – Thank you

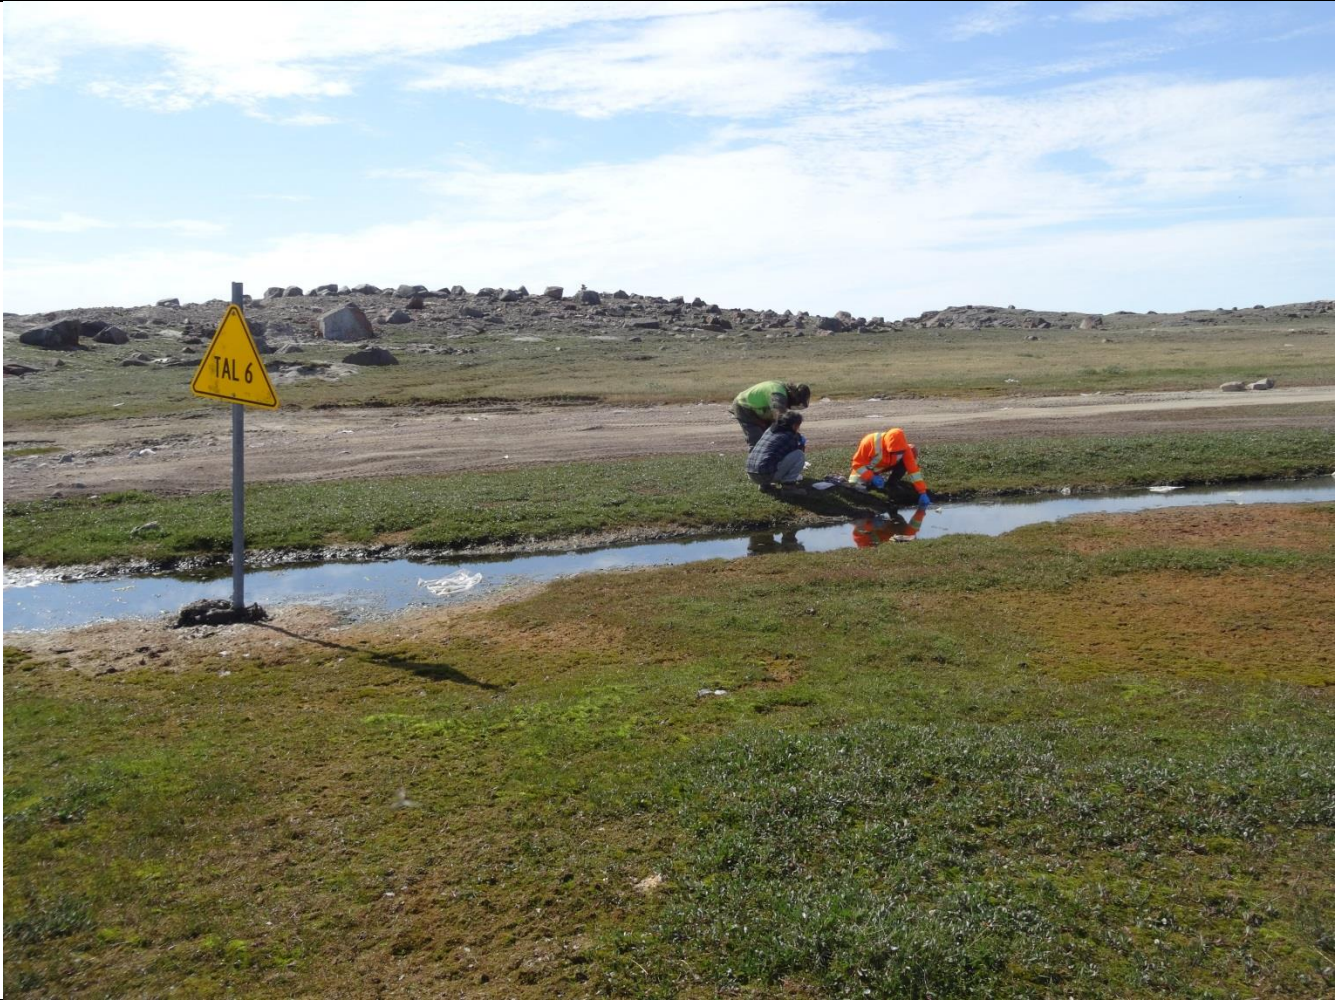
Photo 3

Description: Hamlet and GN-CGS Staff taking Samples at the TAL-6 Final Discharge Sample Station

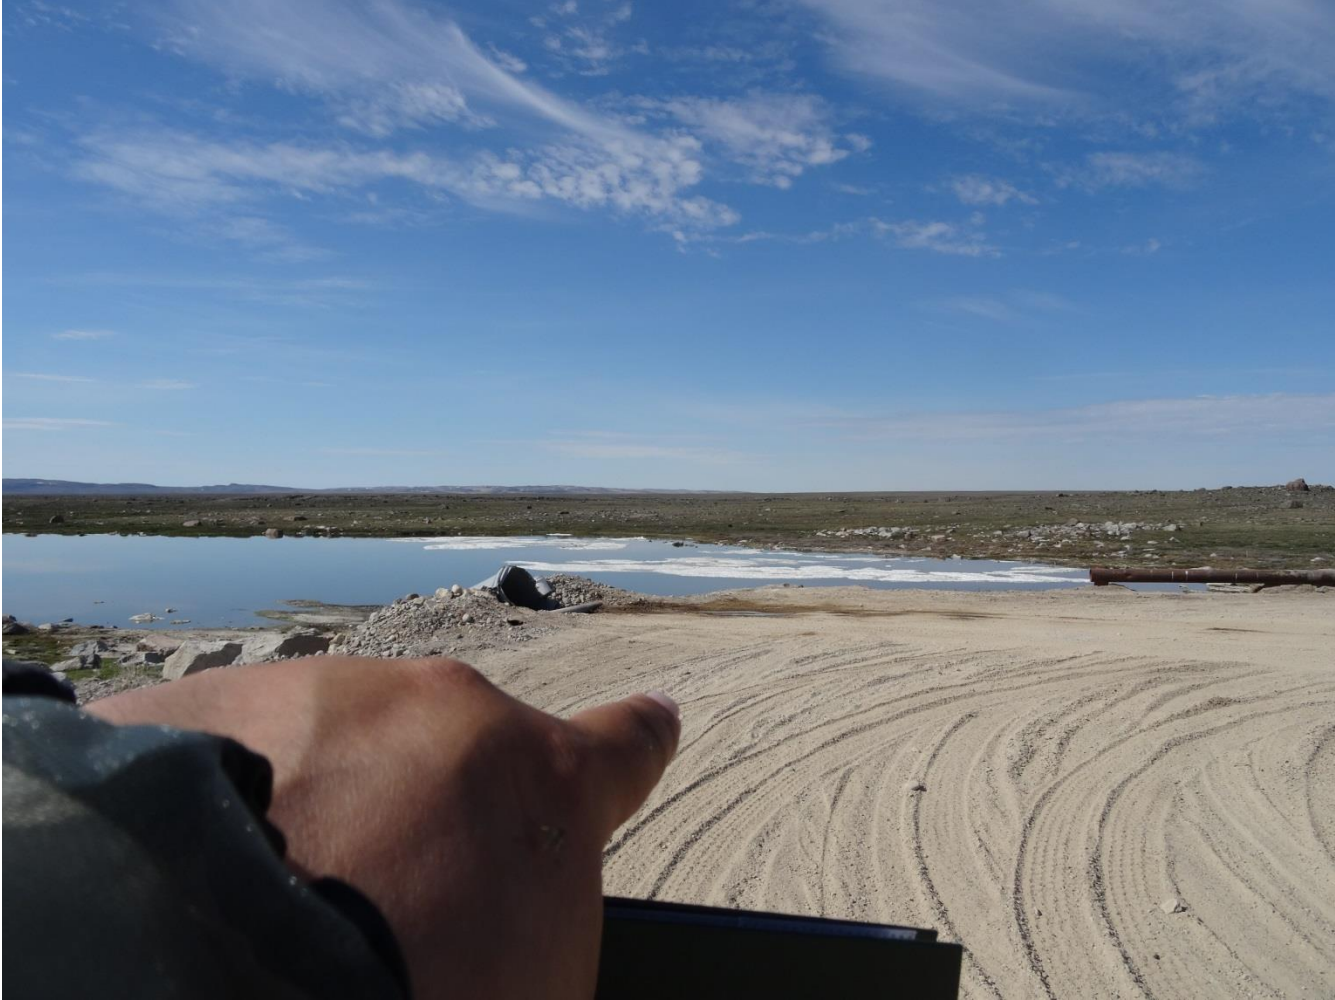
Photo 4

Description: The area behind and adjacent to the Sewage Lagoon where the Hamlet an GN plan to build a Lined Cell to add to the Lagoon

- No new construction or modification done to water, sewage and solid waste facilities.
- A new lagoon cell construction is in plan and waiting for shortage fund allocation to confirm engaging a contractor and consultant for design and development.

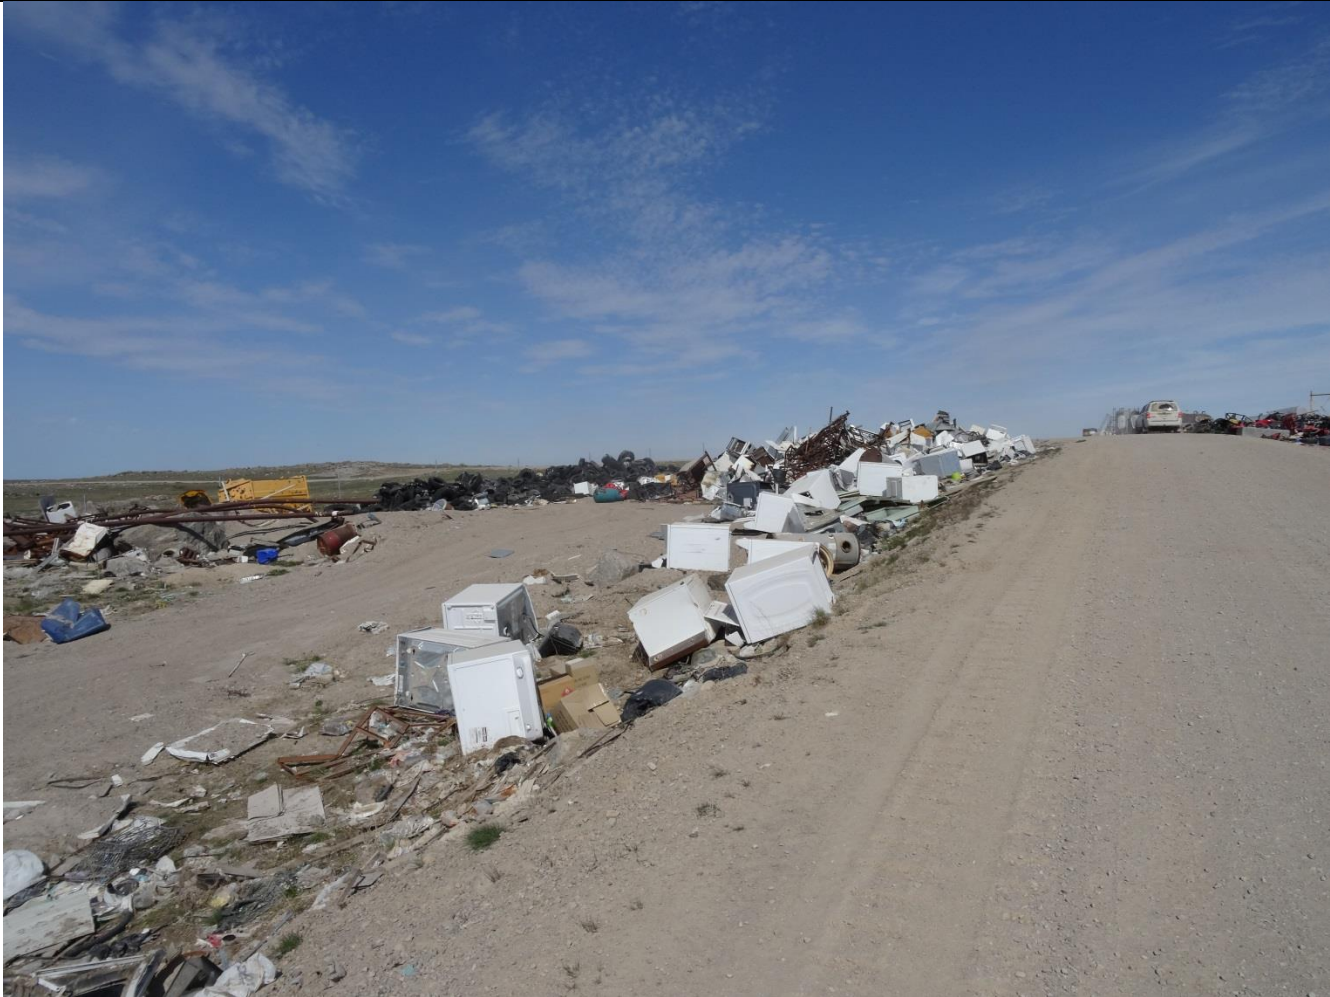
Photo 5

Description: The Garbage Dump showing good organization and segregation of various products

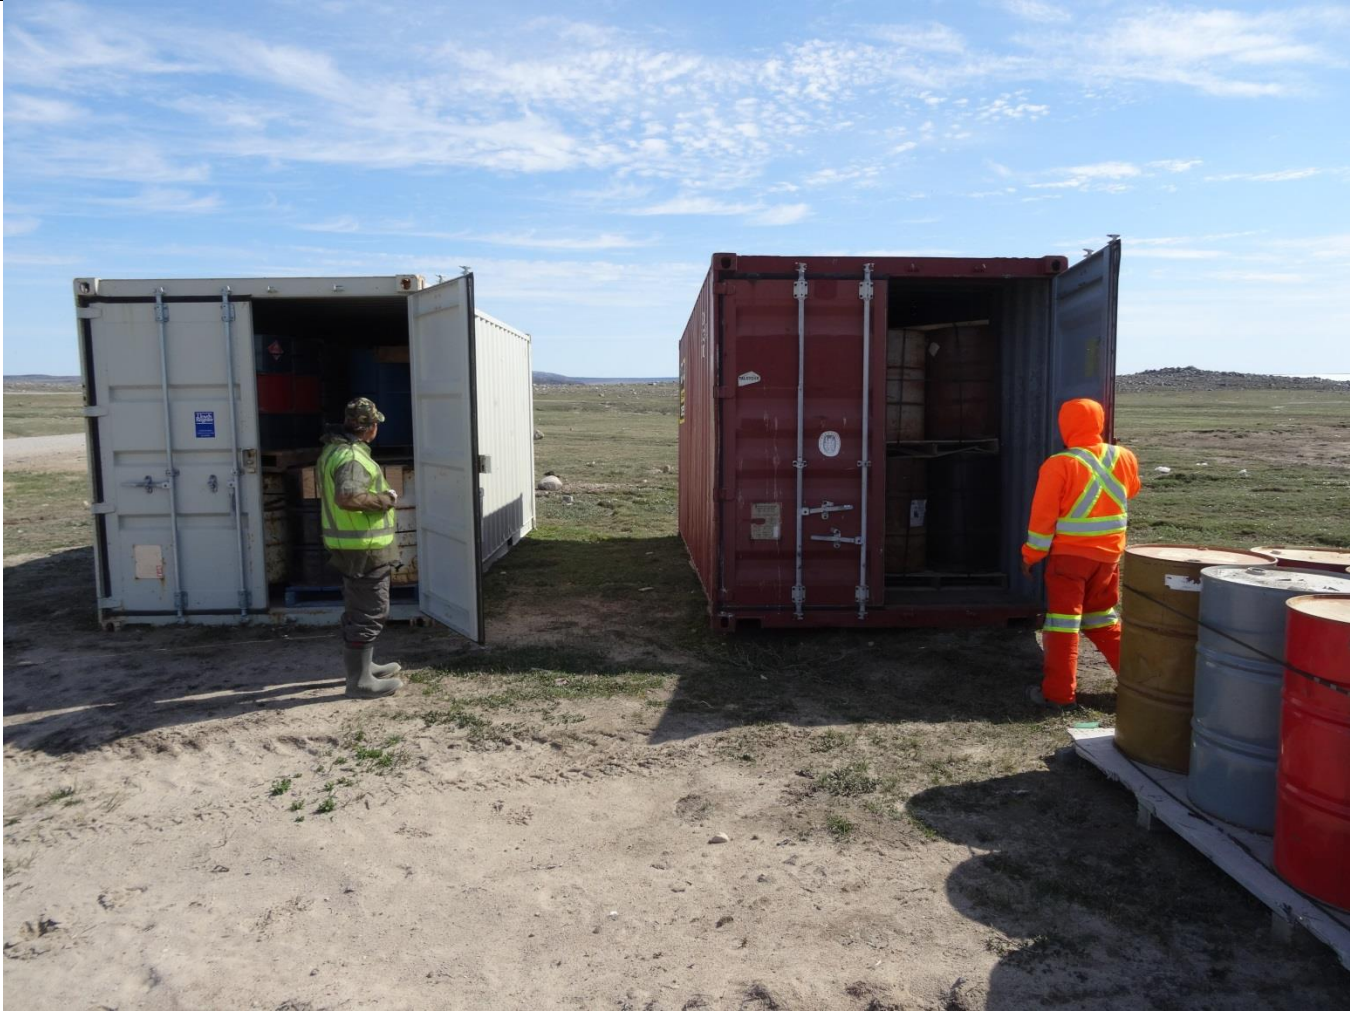
Photo 6

Description: Waste Oils being stored in Drums stacked neatly in Sea Can Containers

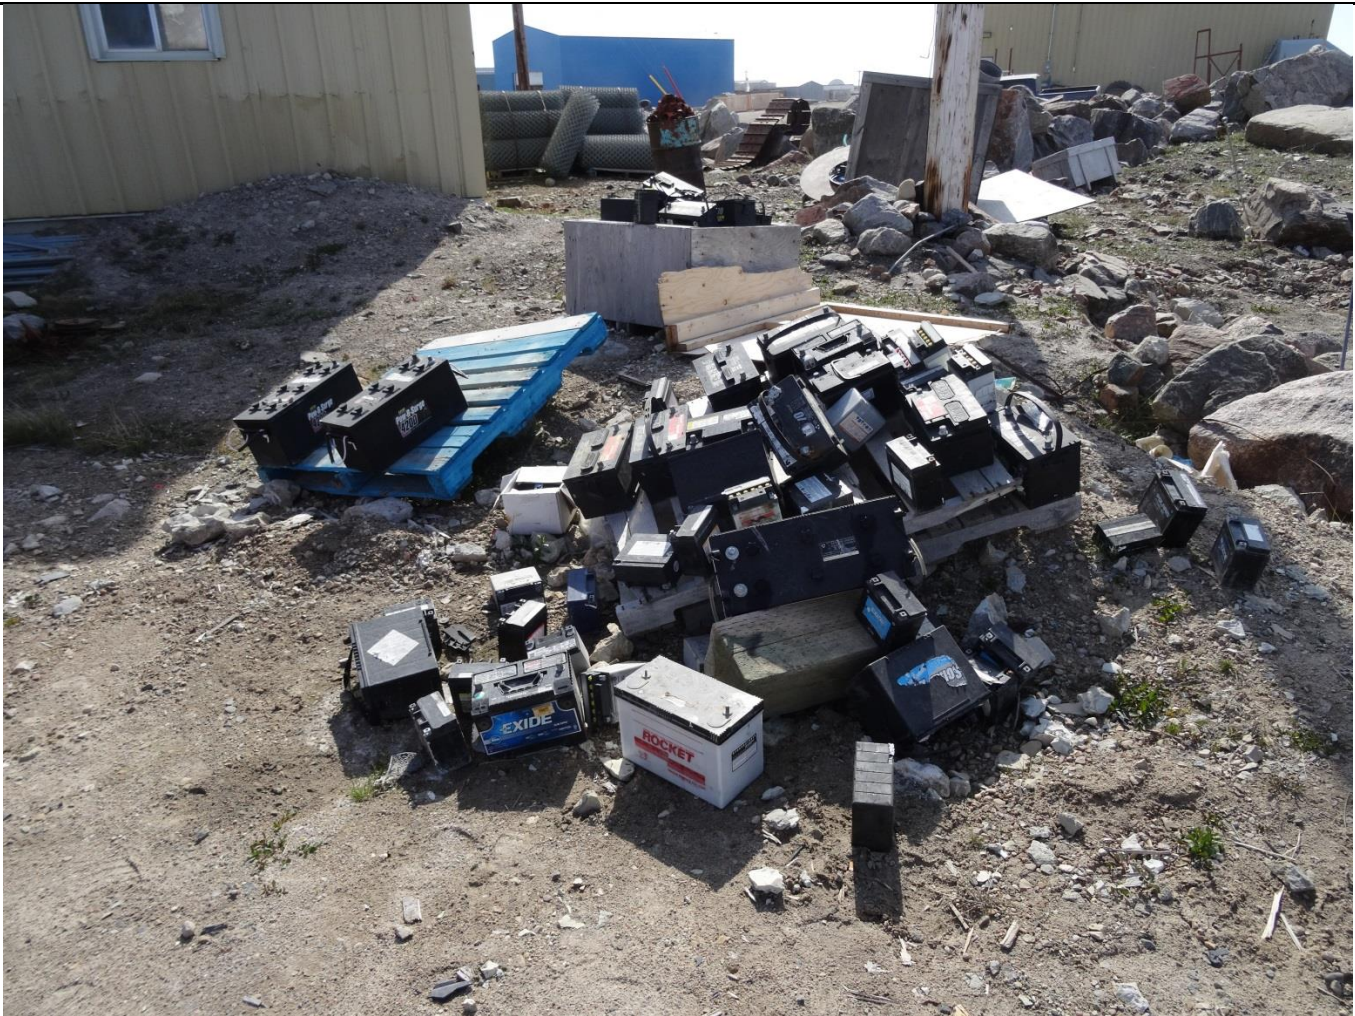
Photo 7

Description: Used Batteries requiring clean-up and secure storage while awaiting proper disposal

1. That Hamlet must ensure to submit a Renewal Request to the Nunavut Water Board prior to the current License Expiring. 2. Thank you for installing appropriate Signage as requested last year. 3. All Water Consumption used for any and all types of usage must be accounted for. 4. Thank you for installing appropriate Signage as requested last year. 5. This is an information item only at this time. 6. The Dump was fairly well organized and in an acceptable state. 7. Thank you for this secure storage of Used Oils, please continue this practice going forward. 8. The current state of Used Battery storage is unacceptable. All Used Batteries must be stored in Wooden Crates lined with Plastic Poly. This must be taken care of by next year's Inspection. 9. All Raw Water Usage MUST be accounted for in Total Consumption Records. These Load Counts must be included in Total Consumption Records. 10. The old Raw Water Pump House and above ground Water Line were stopped being used in 2011, they need to be Decommissioned and Removed in the summer of 2020.

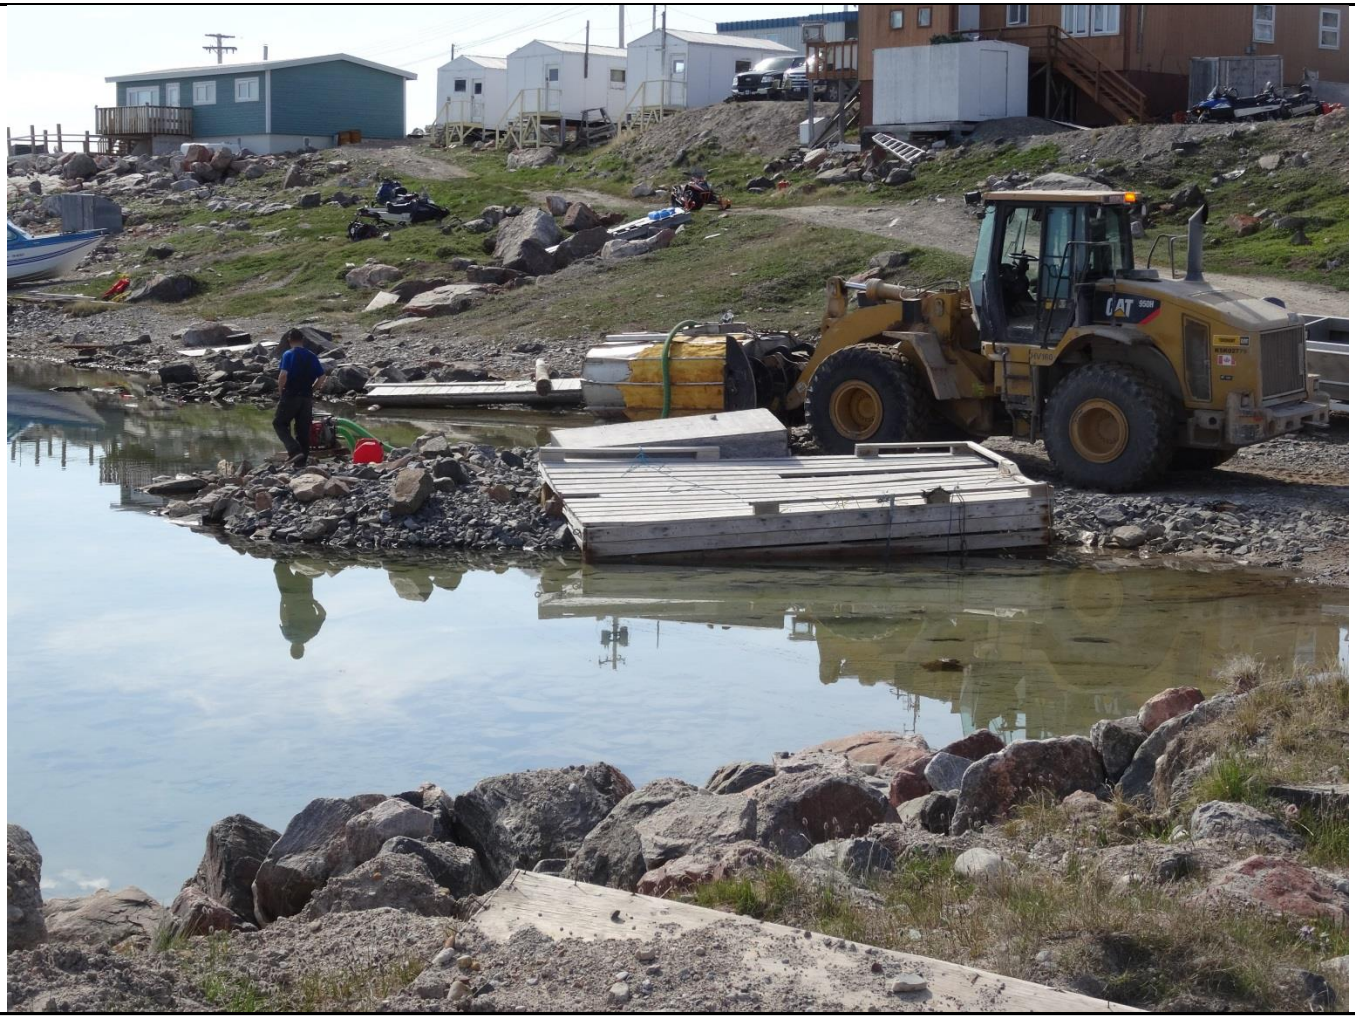
Photo 8

Description: Salt Water being drawn that requires proper Load Counts to be included in Total Consumption Data

No specific request or details about water intake, water supply, sewage or waste disposal. The inspector has requested to keep records water supply to all purposes including any wastage and sewage waste disposal quantity (normally rough order estimate by counting truck loads).

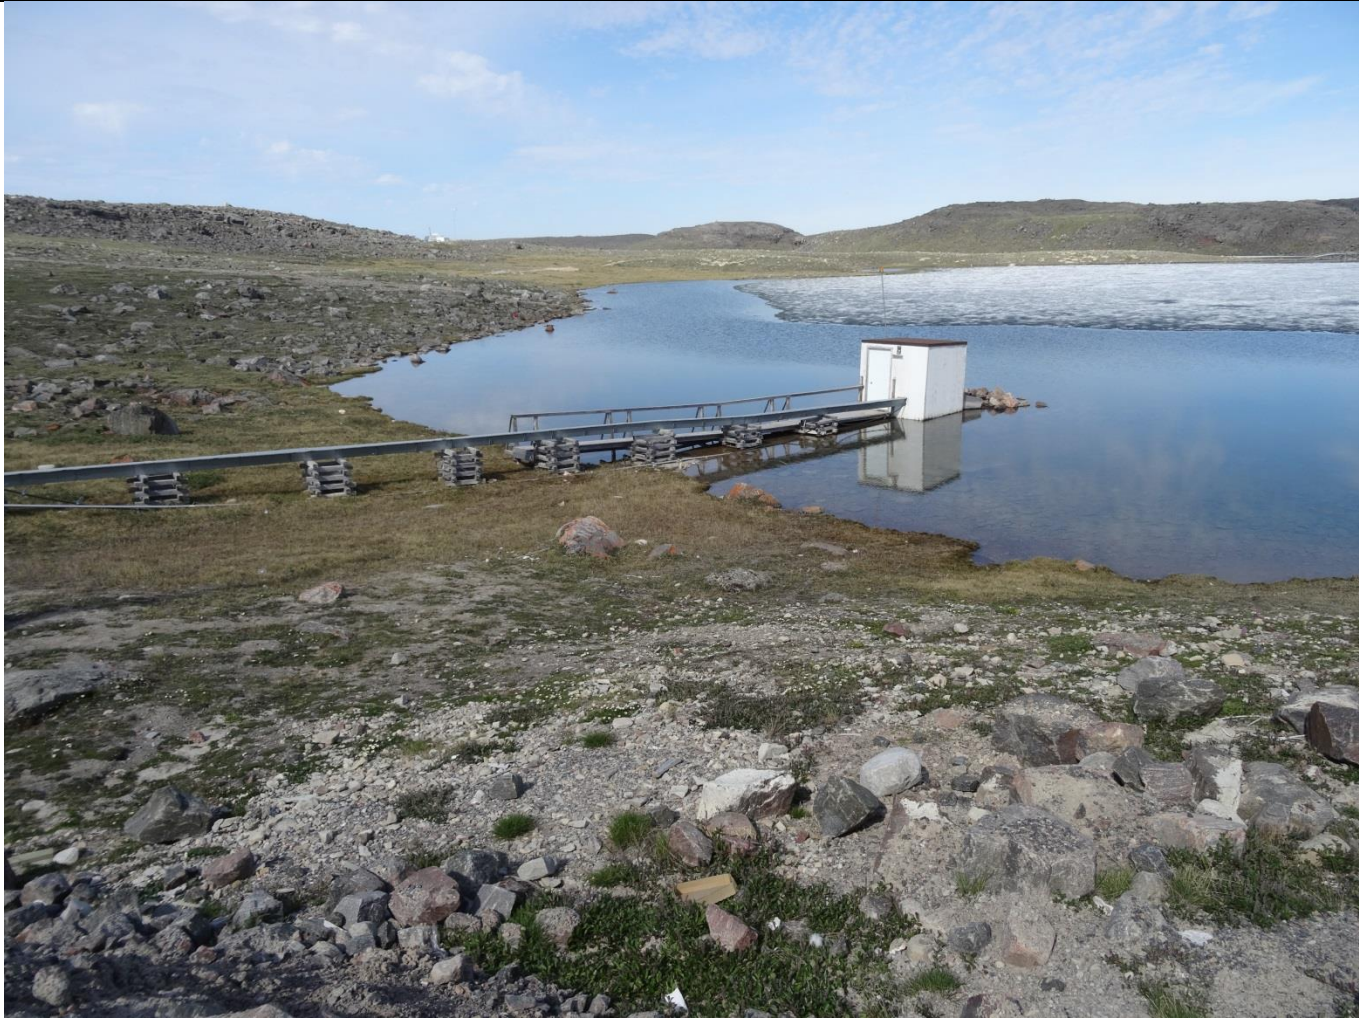
Photo 9

SECTION 1	<input checked="" type="checkbox"/> Comments (s. __)	<input type="checkbox"/> Non-Compliance with Act or Licence (s. __)	<input type="checkbox"/> Action Required (s. __)
On July 4, 2019 I Inspected the Hamlet of Taloyoak's Water License 3BM-TAL1419. I was accompanied by Shah Alam from the GN-CGS as well as James Ashevak and Ashoona Irquit from the Hamlet of Taloyoak.			
SECTION 2	<input checked="" type="checkbox"/> Comments	<input type="checkbox"/> Non-Compliance with Act or Licence	<input type="checkbox"/> Action Required
We discussed 1. The Water License is due to expire this year. At the Raw Water Intake Pump House we saw, 2. The TAL-1 Raw Water Sample Station Signage (photo 1) and, 3. The Flow Meter which records all Consumption (photo 2). We also saw 4. The TAL-6 Final Discharge Sample Station (photo 3), 5. The area across and adjacent to the Sewage Lagoon where the Hamlet and the GN are planning to build a new Lined Cell (photo 4), 6. The Garbage Dump (photo 5), 7. The Waste Oil Storage (photo 6), 8. The Used Battery Storage (photo 7), 9. The Salt Water pump for use as Dust Suppressant on Municipal Roads (photo 8), and 10. The old abandoned Raw Water Pump House and above ground Water Line (photos 9 & 10).

Description: The old abandoned Raw Water Intake Pump House requiring decommissioning/dismantling/removal

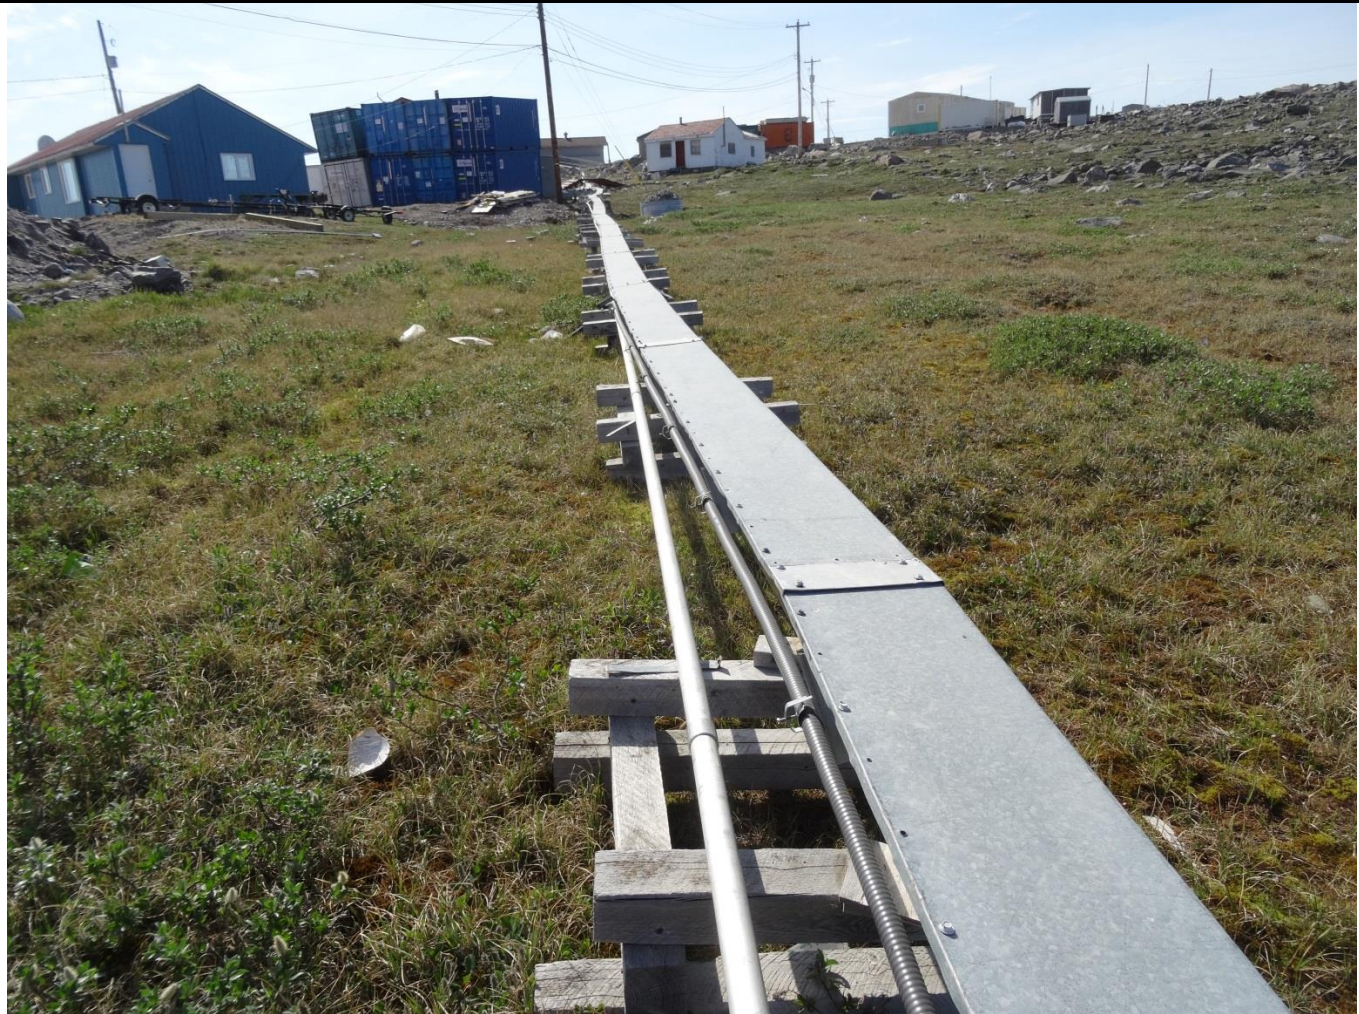
Photo 10

Description: The old abandoned Raw Water above ground Water Line requiring decommissioning/dismantling/removal
