### August 30, 2001 Municipal Water Use Inspection - Report

## MUNICIPAL WATER USE INSPECTION FORM

Date: 2001/08/30 Licensee Rep. (Name/Title): Guy Enuapik/ Foreman  
Licensee: Hamlet of Whale Cove Licence No.: unlicensed

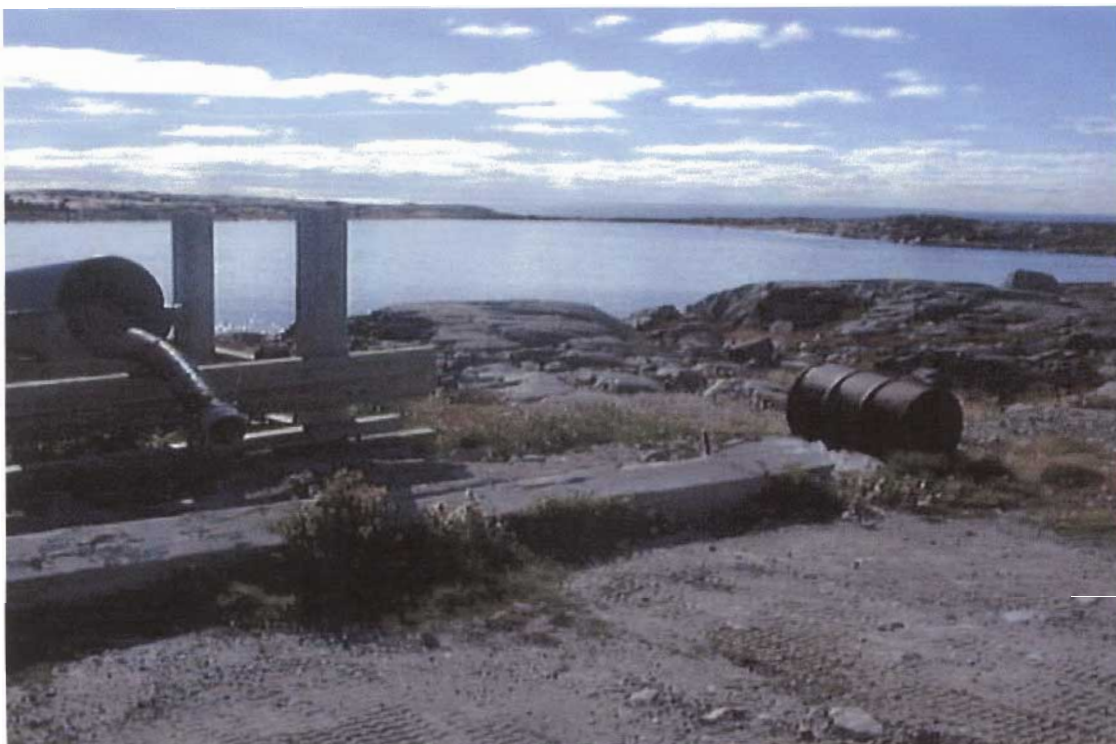
- **Sewage disposal:** Although areas of minor slumping were observed along its permeable retention berm, no significant concerns were noted at the sewage disposal facility (figure 1). In fact, the combination of the initial retention time provided by the lagoon and the additional treatment granted by the vegetation lining the path of discharge appears to produce a very efficient sewage effluent treatment system. Accordingly, the attached analytical results relating to a sample taken five metres below the retention berm along the main vein of seepage (figure 2) reveal that except ammonia (13 mg/L vs 2.2 mg/L), all tested parameters meet the *Canadian Water Quality Guidelines for the Protection of Freshwater Aquatic Life*. Further, the Microtox sample, which constitutes a reliable toxicity indicator (IC<sub>50</sub>), did not attribute toxicity to the sewage effluent discharge.

**figure 1.** Sewage disposal facility from the truck dumping point; 2001/08/30.

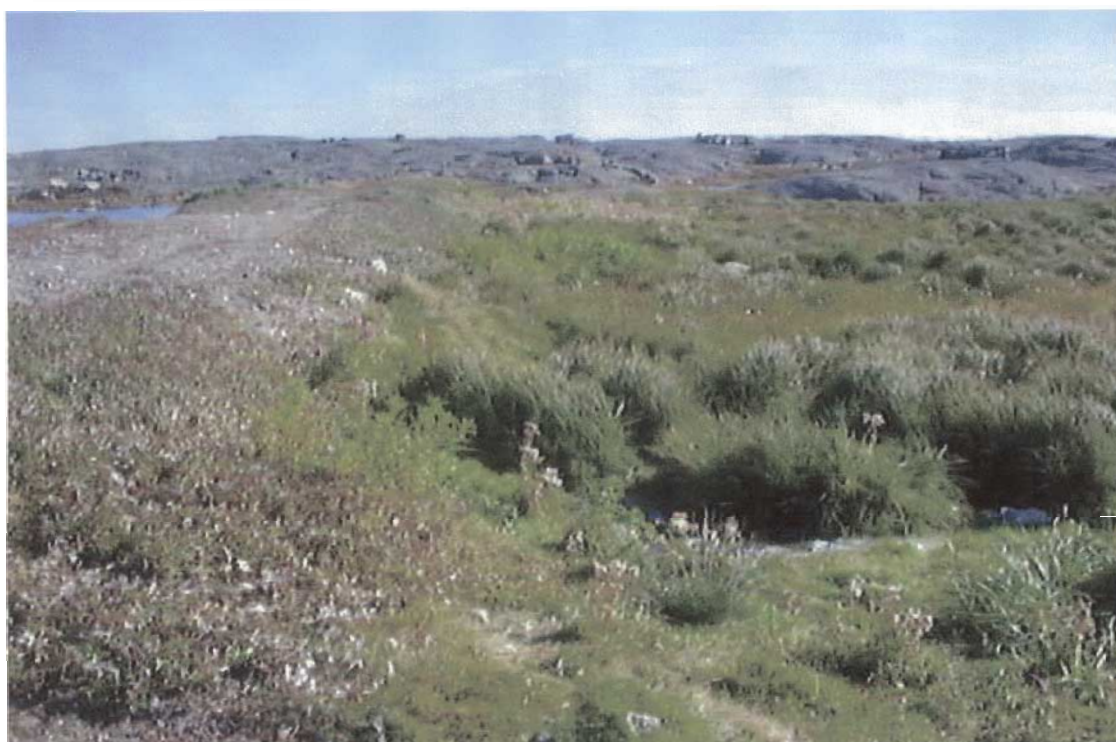
Comments: Minor slumping of the permeable berm of the sewage disposal facility noted; maintenance work scheduled prior to fall freeze up. Abundant vegetation growth along the outer face of the decanting berm and the path of sewage effluent discharge. Notable amount of work done/planned at the solid waste disposal facility. Accumulated waste compacted away from the shoreline, but highest tide reportedly still laps the toe of the wastepile. In the process of crushing the bulky metal wastes in order to fill ground depressions prior to the planned covering with fill material. Sheen and signs of hydrocarbon contamination noted in the vicinity of the waste oil storage site; soil to be removed before backfilling work is undertaken. Batteries and other hazardous materials are now set aside, but no form of containment is provided.

**figure 2.** Seepage along the sewage disposal facility's permeable berm; 2001/08/30.

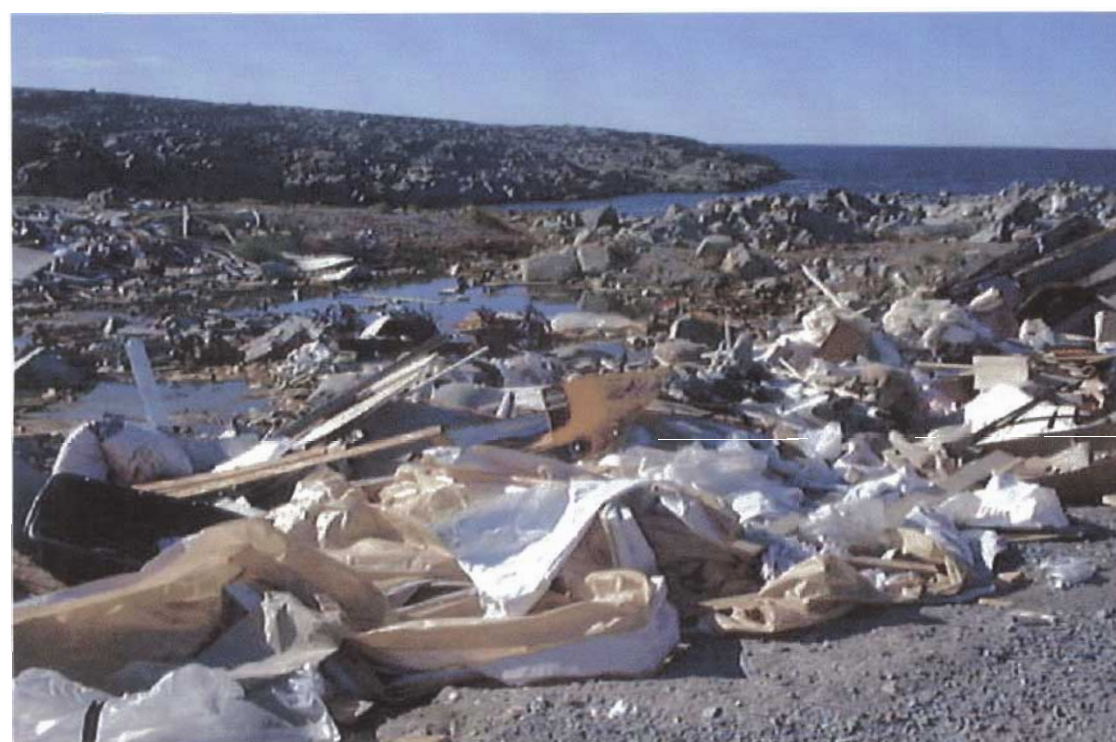
- **Solid waste disposal:** A considerable amount of work has been undertaken at the solid waste disposal facility since the last inspection. As such, efforts have been made to move the combustible household wastepile away from the shoreline and the water pooled in the area (figure 3). In addition, bulky metal waste are being compacted prior to infilling and capping work (figure 4). However, these operations appear to have brought about the migration and/or exposure of the hydrocarbon contamination previously noted in the vicinity of the waste oil storage area (figure 5). It was consequently mentioned during the inspection that the contaminated soil ought to be removed before the planned covering of the area is initiated, and that only non-hazardous solid wastes are to be buried on-site. In parallel, it was once more suggested that in order to minimize the likelihood of the deposit of waste into waters, a sealift container should be dedicated to the storage of batteries and other hazardous materials prior to their proper disposal, and that fencing work should enclose the solid waste disposal facility once the ongoing work is completed. This being said, the attached analytical results relating to a sample collected of the final discharge from the site (figure 6) indicate that concentrations of copper ( $5 \mu\text{g/L}$  vs  $4 \mu\text{g/L}$ ) and iron ( $349 \mu\text{g/L}$  vs  $300 \mu\text{g/L}$ ) slightly exceed the *Canadian Water Quality Guidelines for the Protection of Freshwater Aquatic Life*. Nevertheless, the associated Microtox sample did not denote toxicity.

**figure 3.** Pooled water along the toe of the solid waste disposal facility; 2001/08/30.

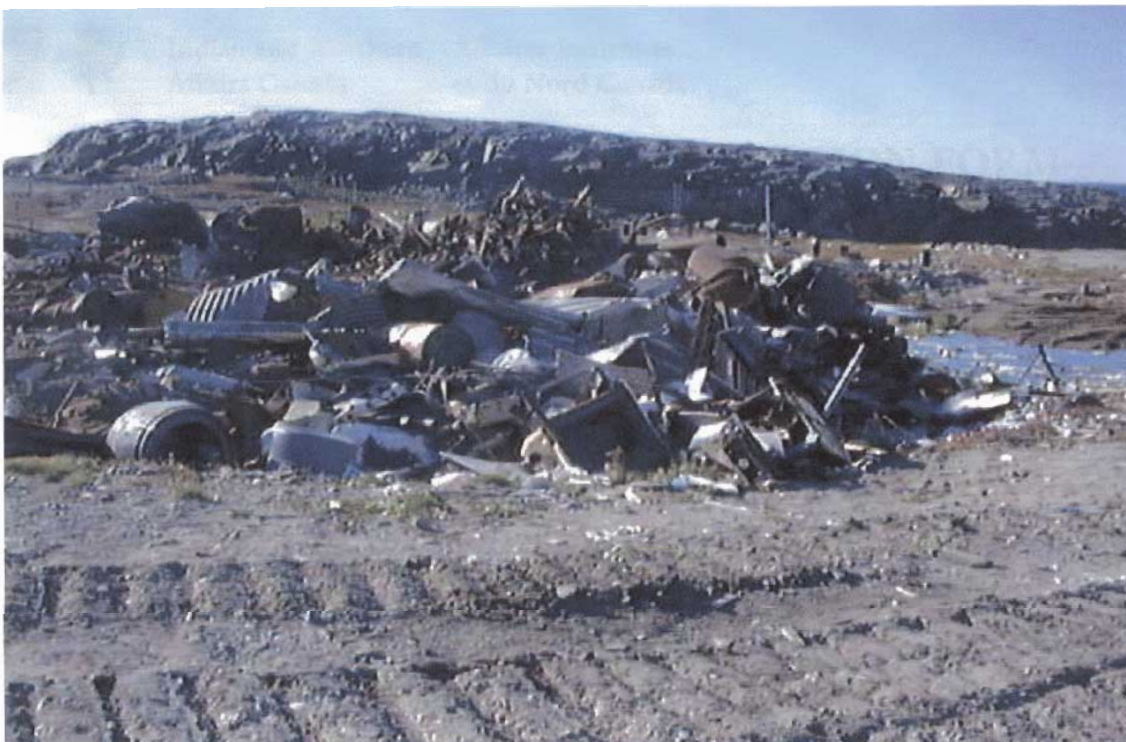
**figure 4.** Bulky metal wastes disposal site; 2001/08/30.

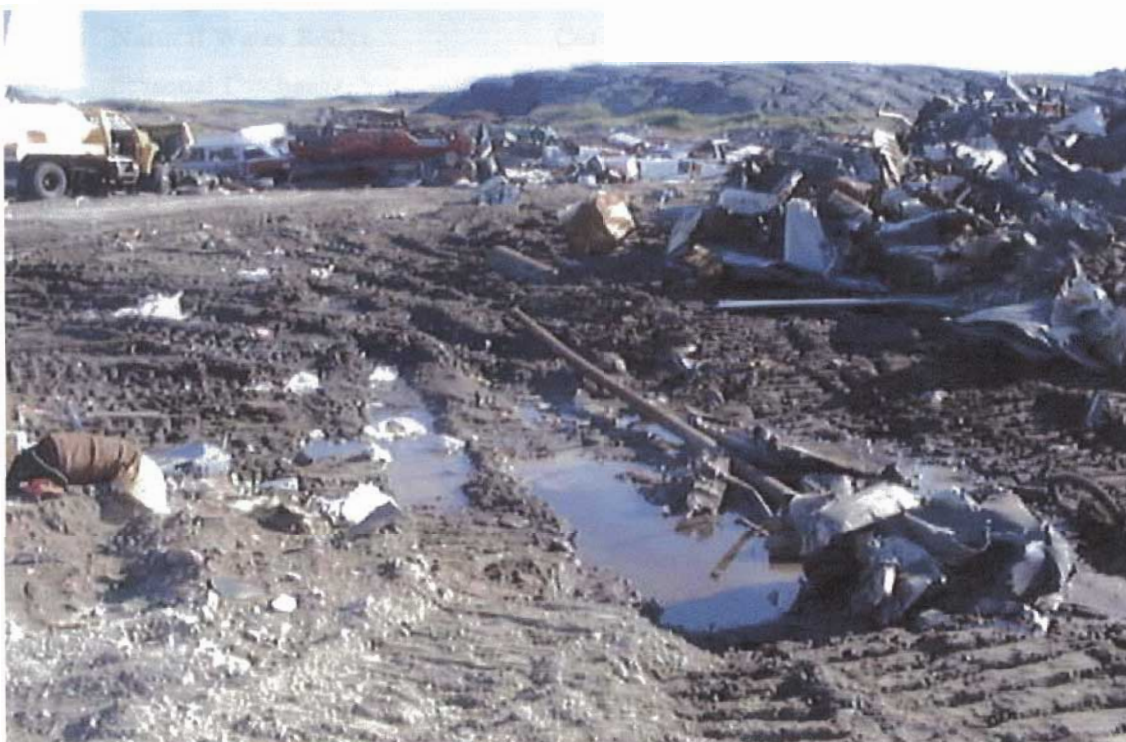
**figure 5.** Hydrocarbon contamination downslope of the waste oil storage site; 2001/08/30.

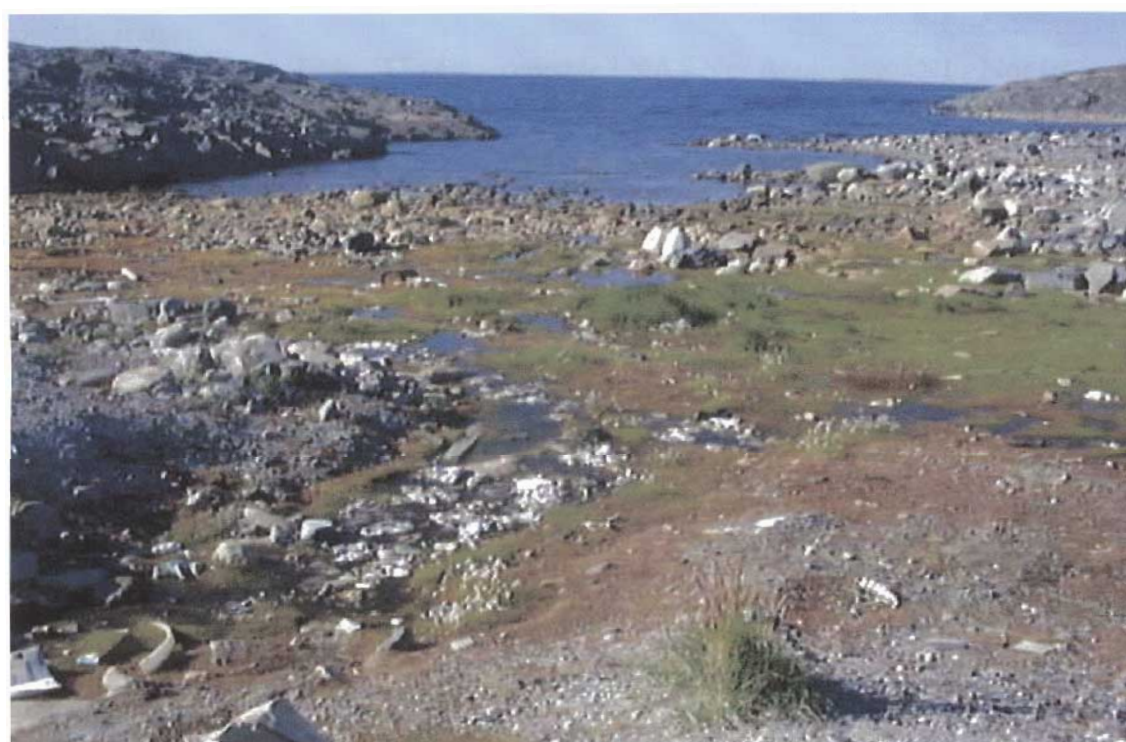
**figure 6.** Final discharge from the solid waste disposal facility; 2001/08/30.
