**RE: July 12, 2002 Municipal Water Use Inspection - Report**

## MUNICIPAL WATER USE INSPECTION REPORT

Licensee: Hamlet of Whale Cove

Licence No.: NWB3-WHA0207 (NEW)

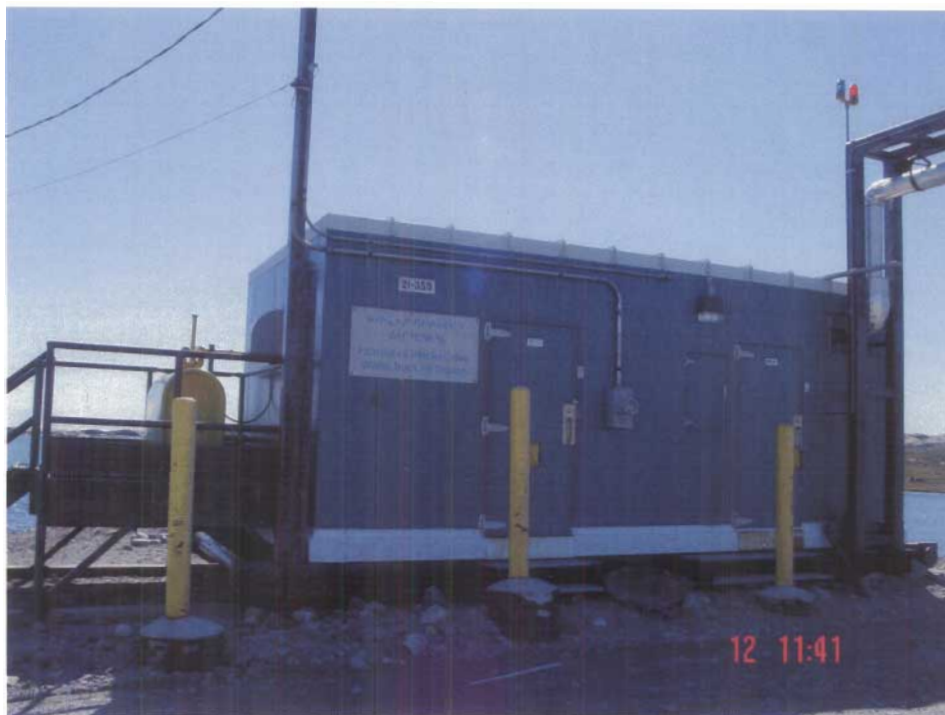
Photo # 1 Water Intake Facility on Water Lake, truck fill station.

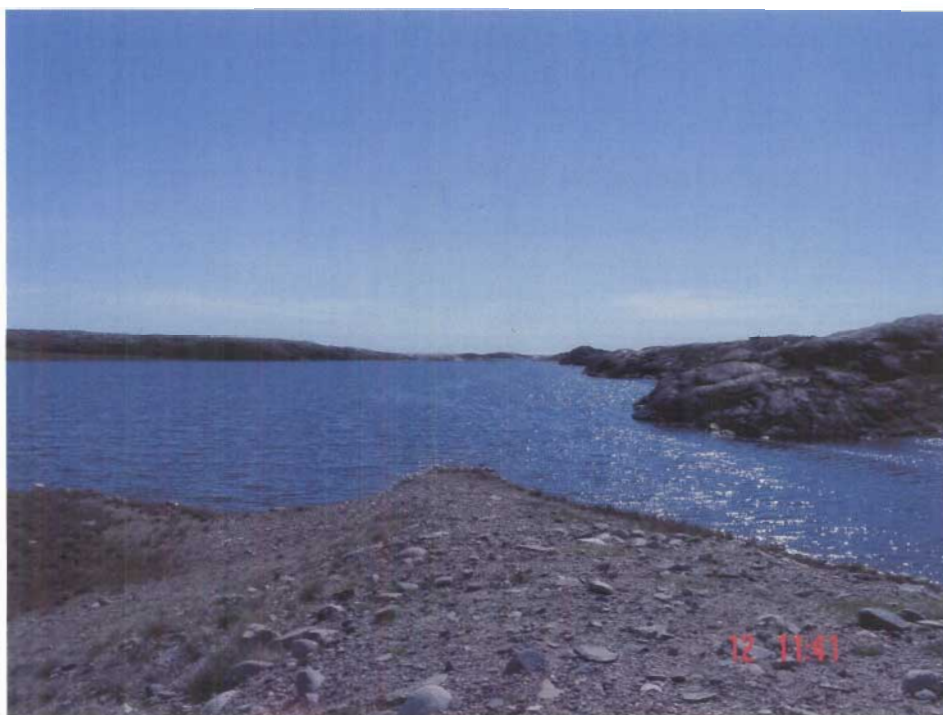
Photo # 2 Location of potable water sample on water supply facility intake line on Water Lake.

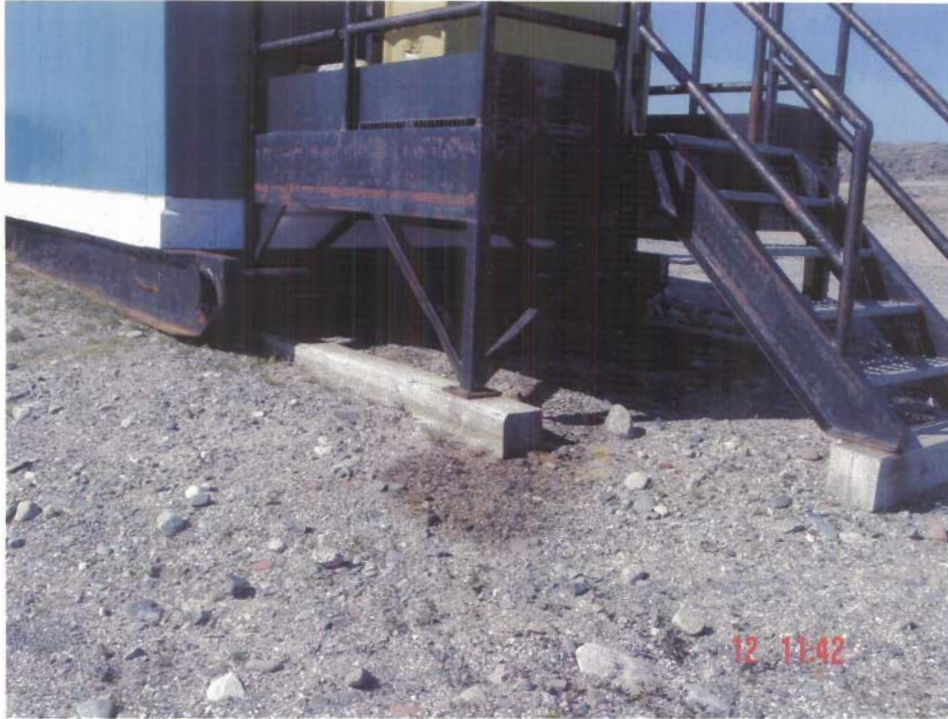
- ☐ **Water Supply:** The Water Intake Facility located on Fish Lake has a well kept interior. Noted at the time of inspection, was the spilled fuel by the fuel tank at the Water Intake Facility (Photo 3). There was also no spill equipment at the facility, in the event of a fuel or oil spill. There was a formula for mixing up the concentrated chlorine for water disinfection (Photo 4). The attached analysis of samples taken from (WHA-1) Fish Lake Water Intake Facility, indicate that Colour ( 20 TCU vs 15 TCU), Turbidity (4.2 NTU vs 1.0 NTU) are in excess of the *Guidelines for Canadian Drinking Water Quality*.

**Comments:** Water Intake Facility located on Fish Lake is a clean operational facility. It was noted at the time of inspection that there had been a spill of fuel oil at the Water Intake Facility fuel oil tank. The chlorination system for potable water is presently in use.

Photo # 3 Spilled fuel oil was noted at the time of inspection. No spill protection or recovery equipment was available at the intake facility.

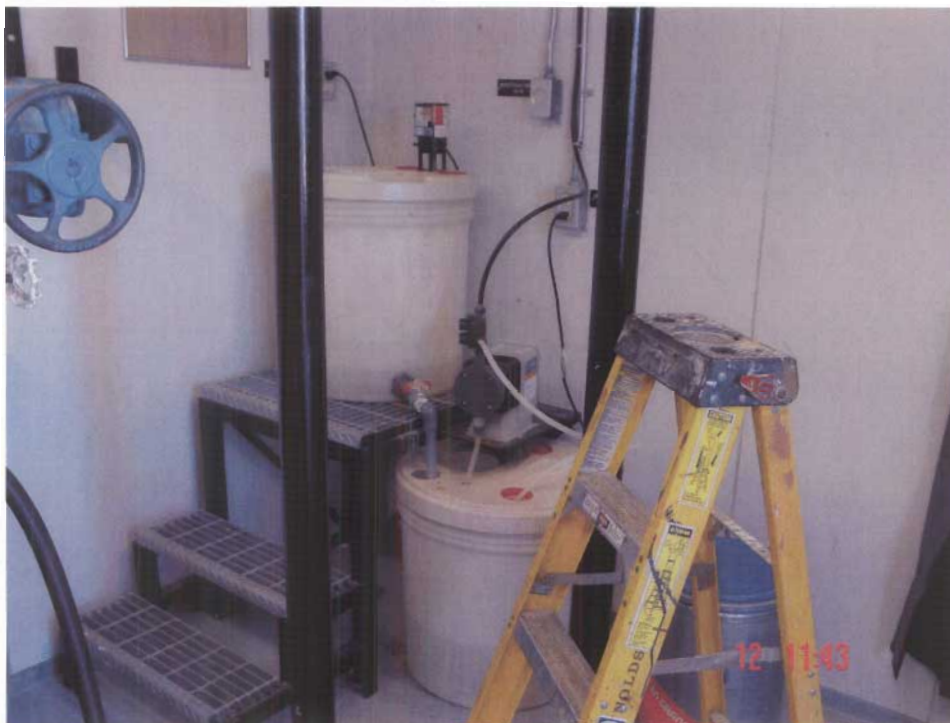
Photo # 4 Chlorination system inside Water Intake Facility.

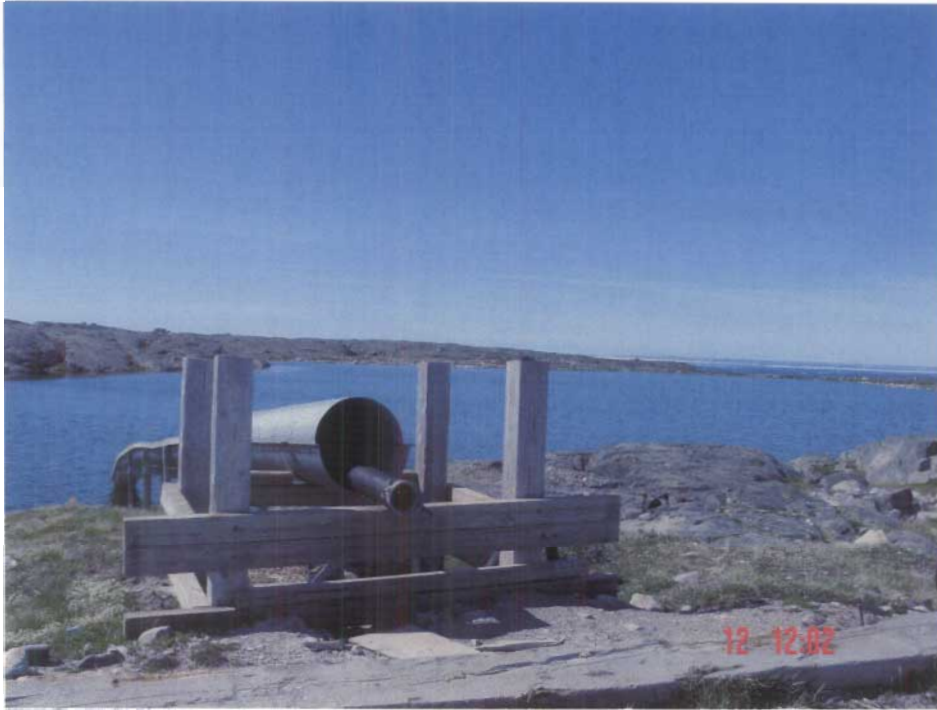
- ☐ **Sewage Disposal:** The sewage lagoon appeared to be operating within designed parameters. The sewage truck discharge structure was in good condition ( Photo 5 & 6). All berms appeared in good shape. Enclosed analysis of (WHA-3) Sewage Lagoon effluent indicate that Biological Oxygen Demand (9 mg/L vs 100), Total Suspended Solids ( 20 mg/L vs 120) and pH (8.05 vs 6.5-9), are within *Municipal Wastewater Effluent Quality Guidelines*.

Photo # 5 Sewage truck discharge structure at Sewage Treatment Facility.

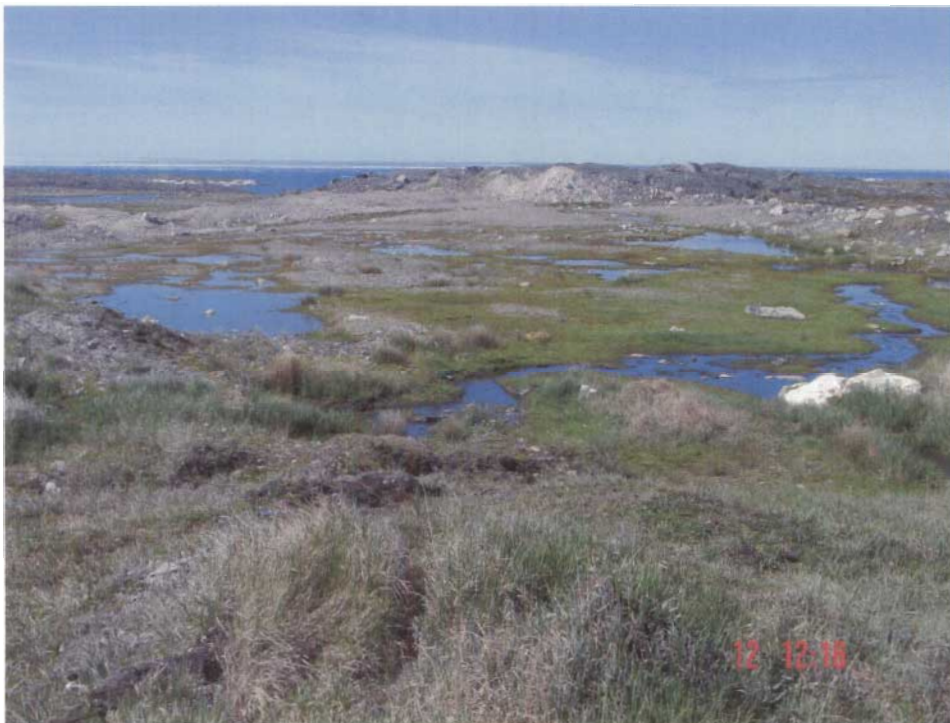
Photo # 6 Effluent path from sewage disposal facility overland to the ocean. Centre of photo location of sewage effluent sample .

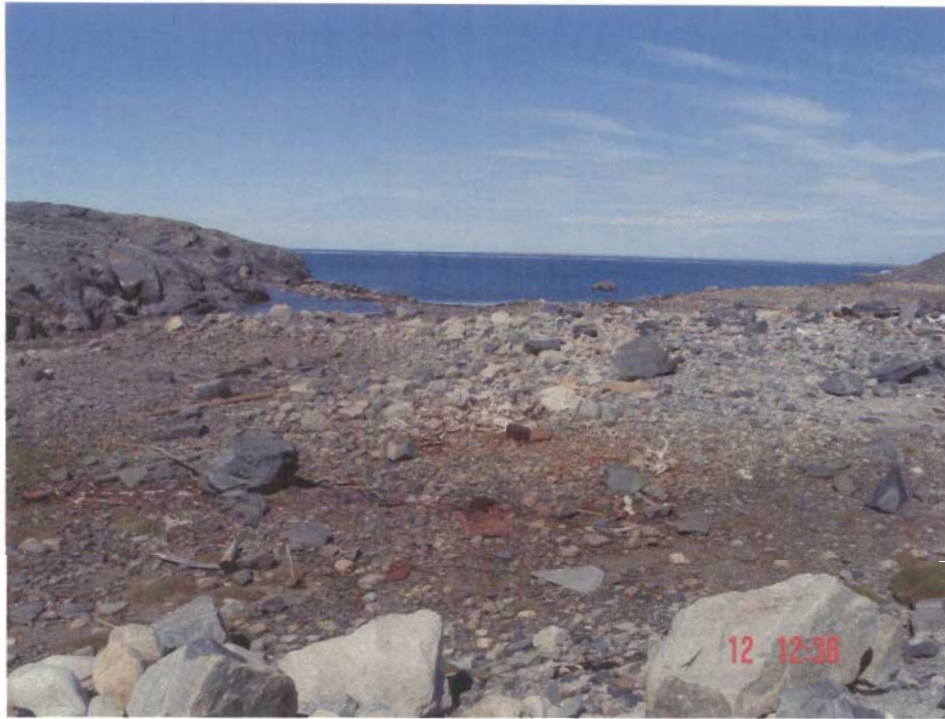
Photo # 7 Solid waste disposal facility showing inlet proximity to dump tipping face.

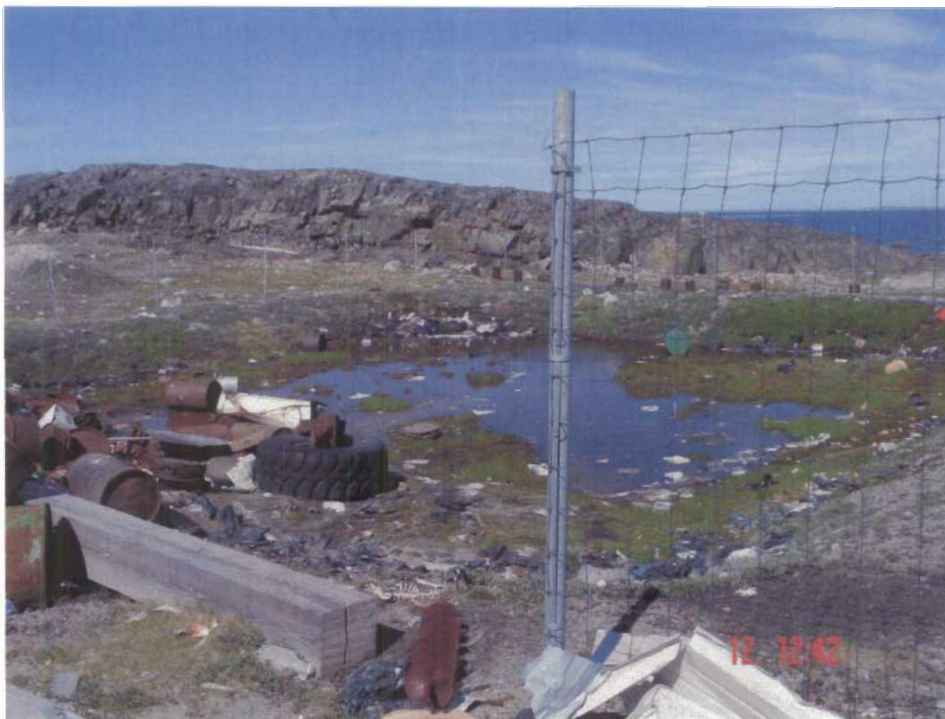
Bag area at the dump, appears to be seeping to the ocean (Photo 8). The solid waste disposal facility has some fencing, while other sections of the facility are contained by rock cliffs. Samples taken of effluent from (WHA-2) the Solid Waste Disposal Facility have yet to be analyzed by the laboratory, these analysis will be made available once received by the WRO.

**Comments:** The Sewage Lagoon has sufficient freeboard. Sewage Lagoon truck discharge structure and berm are in good condition. Seepage of effluent from the dump to the ocean was observed.

Photo # 8 Old sewage lagoon shown in solid waste disposal grounds. Liquid noted in picture was seen leaching out into ocean.

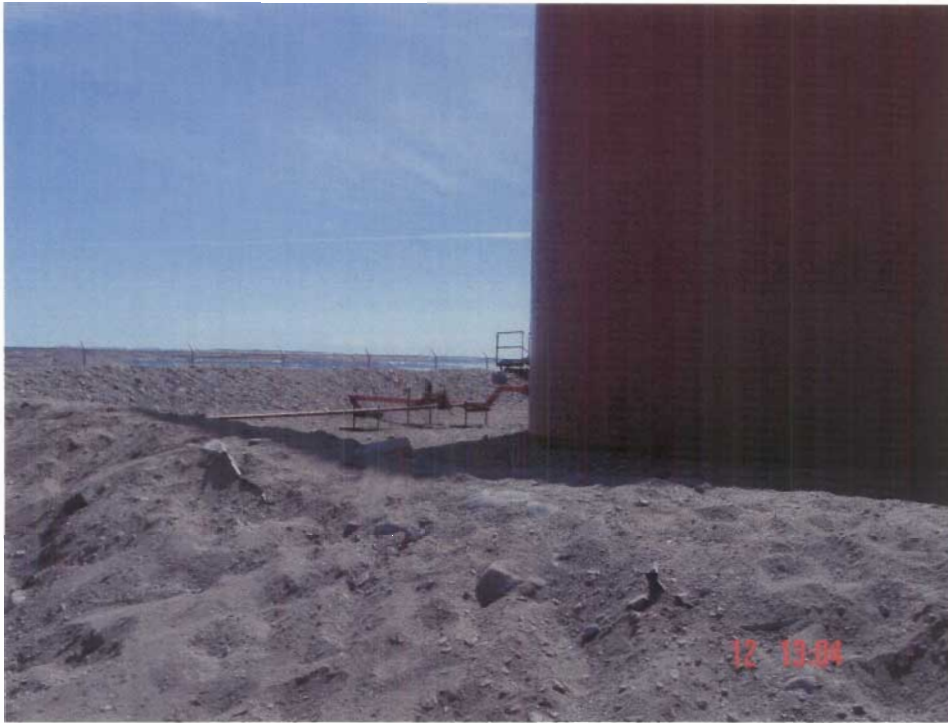
- **Fuel Storage:** The Tank Farm berms, appear to need re-contouring. There are several sections along the berm that have the geomembrane showing (Photo 9). Two new fuel tanks have been installed and at the time of inspection they have yet to be commissioned, these tanks also have no form of secondary containment (Photo 10).
- **Non-Compliance of Act or Licence:** A spill report should be made, for the spill that occurred at Fish Lake Water Intake Facility. New fuel tanks at the Tank Farm, should have spill containment in place prior to use. In accordance with General Conditions, Part B of the *Water Licence*; Within 90 days of the first visit of the Inspector, all necessary signs including Surveillance Network Program (SNP) stations will be posted in all official languages of Nunavut to the satisfaction of the Inspector.

Photo # 9 Tank farm showing exposed liner in berm.

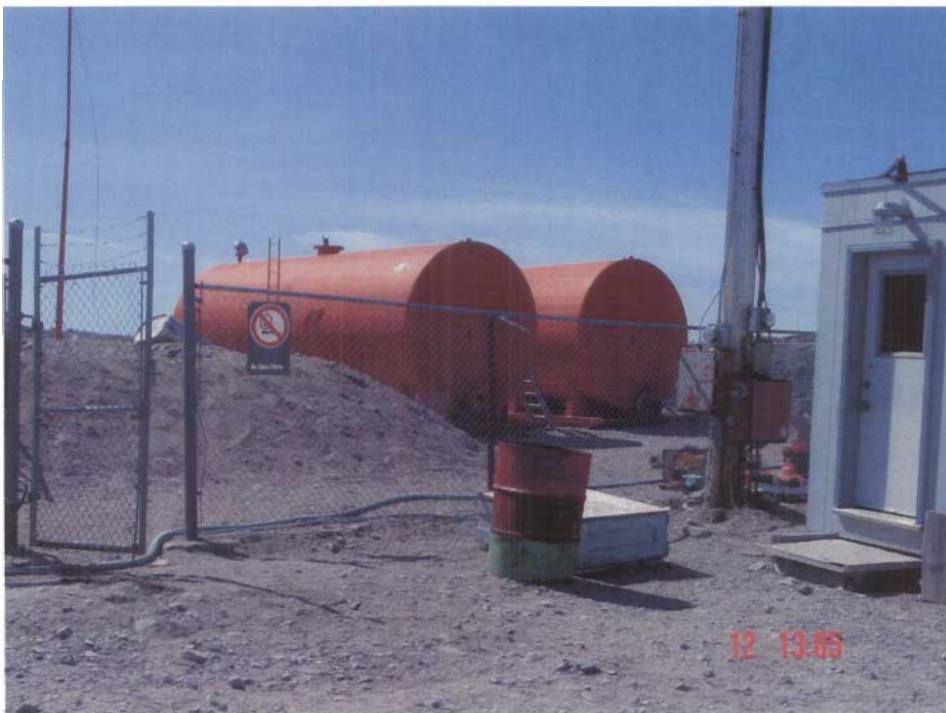
Photo # 10 Note new fuel tanks at tank farm do not have any secondary spill containment.
