WATER LICENCE INSPECTION FORM

Licensee	Licensee Representative
Hamlet of Whale Cove	Paul Kaludjak, Megan Lusty (CGS)
Licence No. / Expiry (DD/MM/YYYY)	Representative's Title
3BM-WHA0914 (31/05/2014)	Senior Administrative Officer
Date of Inspection (DD/MM/YYYY)	Inspector
07/07/2014	WRO C. Wilson, A/WRO J. Hack

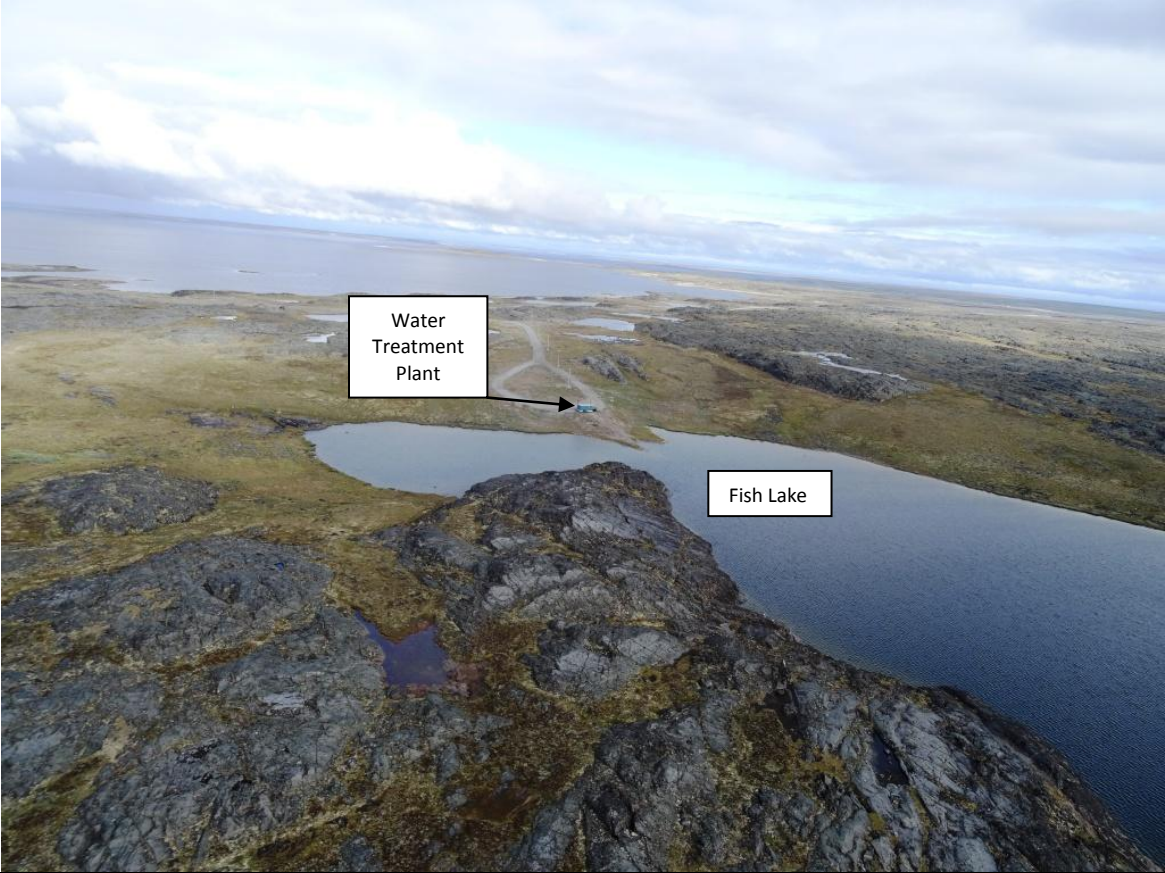
Location name:	Lat/Long (DD.MM.SS.SS, NAD83)
Photo 1	N62° 11 '47.8", W 92° 33' 48.16"

Desciption:
Water Treatement Plant, Fish Lake, Whale Cove

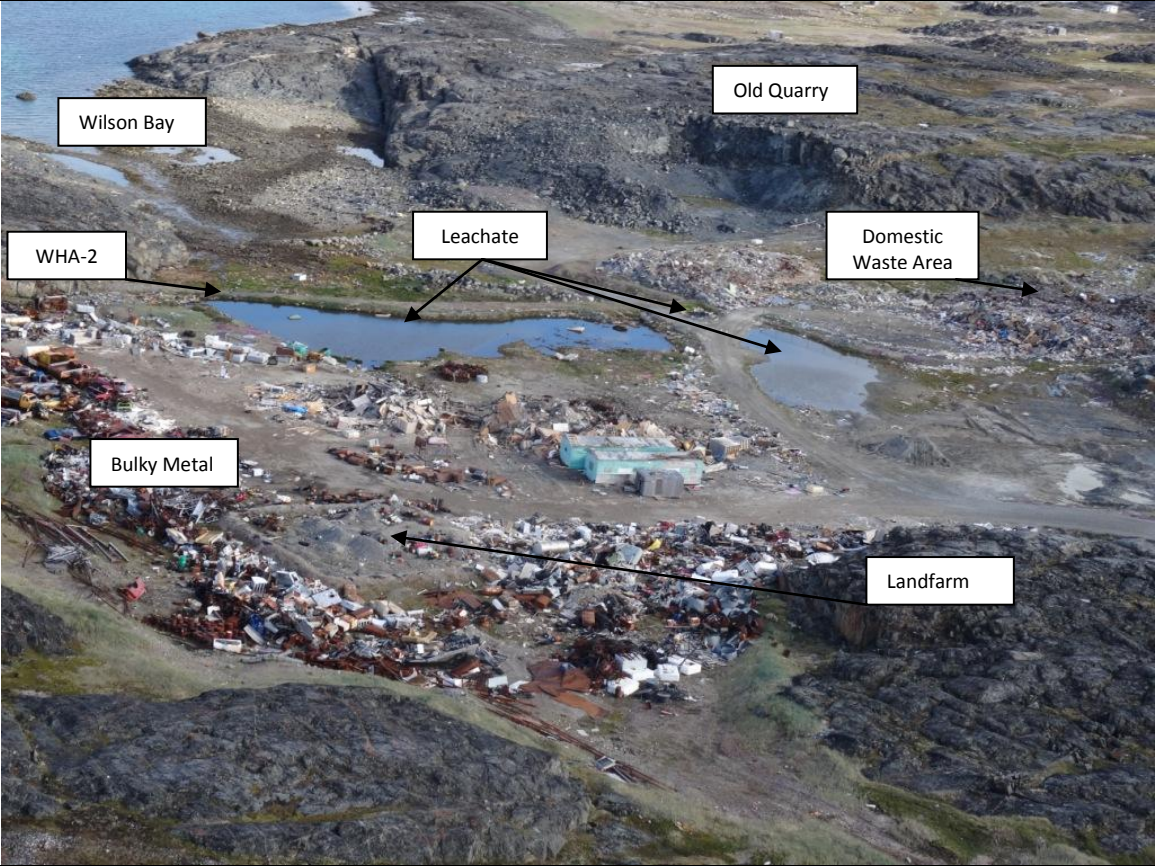
Location name:	Lat/Long (DD.MM.SS.SS, NAD83)
Photo 2	NA

- 5) The Solid Waste Management Area appears to be divided into two major sections; an area for domestic waste and an area for bulky waste (photo 2). The Solid Waste Management Area requires; waste segregation, fencing, water/ waste containment structures, signage and regular monitoring. The facility is not being operated as per the O & M Plan as required under Part B item 11 and 12 (see comment 19).

Desciption:
Soild Waste Managment Area

- The Hamlet will install and maintain fencing at the Solid Waste Management Facility as discussed during the inspection. The upgrades will be recorded and included in the 2014 annual report as per PART B item (1)(d).

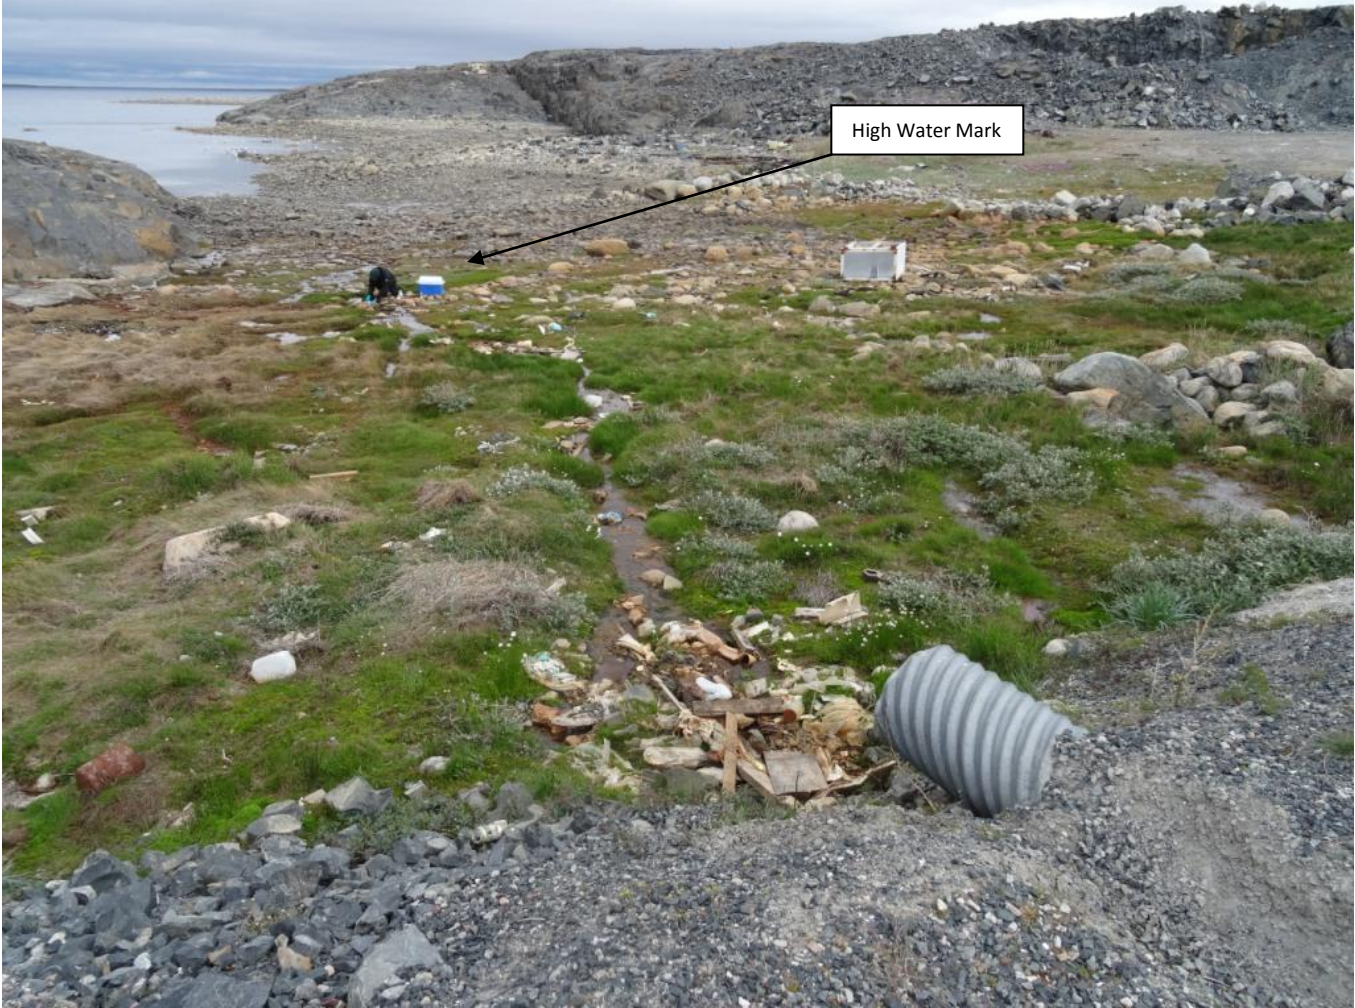
Location name:
PHOTO 3

- 6) Located immediately adjacent to the tidal flats of Wilson Bay is a large pond of leachate water from the Solid Waste Management Area. Leachate was observed running from under the containment berm down towards the Bay. The containment berm is fitted with a culvert which allows leachate to pass from the containment pond to the Bay. The Hamlet is required under PART D item 15, to take the necessary steps to ensure leachate from the Solid Waste Management Area does not enter water (photo 3). The pond did not meet the requirements under PART D item 4 of a minimum of one (1) meter freeboard.

Description:
Soild Waste Managment Area leachate flowing from containment pond to Wilson Bay.

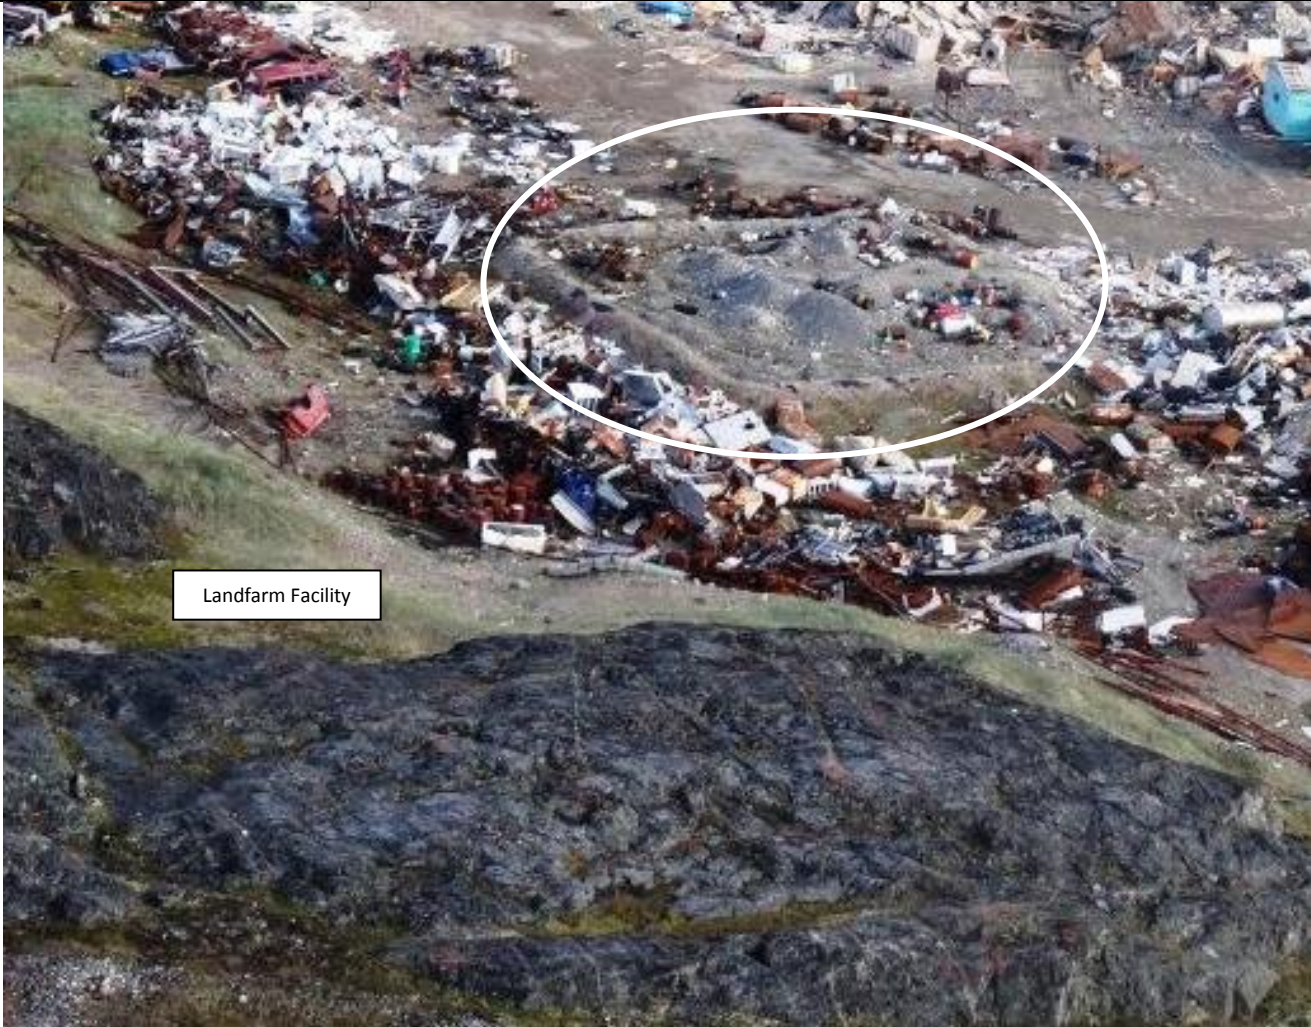
Location name:
PHOTO 4

- 8) The Landfarm Facility ('facility') is located within the Solid Waste Management Area (photo 4). At the time of the inspection hazardous waste (e.g.: batteries, paint cans, and drums of unknown content) were being stored in the facility (photo 5). The Landfarm Management Plan is not being implemented as required under PART B item 11 and PART D item 6.

Description:
Landfarm within the Soild Waste Managment Area, Note the garabage inside and surrounding the facility.
