SECTION 1	<input checked="" type="checkbox"/> Comments (s. __)	<input type="checkbox"/> Non-Compliance with Act or Licence (s. __)	<input type="checkbox"/> Action Required (s. __)
BACKGROUND <p>Application is by the Government of Nunavut – Community and Government Services, on behalf of the Government of Nunavut – Department of Economic Development and Transportation (the Licensee), for the renewal, for a term of five (5) years, as well as the amendment of an expired, Type “B” Water Licence (Licence No. 3BM-YRB0308/NWB3YRB0308), to allow for the continued operation of a Sewage Disposal Facility (the Facility). The Facility in question is located within the Hamlet of Resolute Bay, in the Qikiqtani Region, Nunavut. The Licence under which the Facility operated was issued on November 30, 2003 and expired on November 30, 2008. The Expired Licence allowed for the use of Water and the deposit of Waste in support of a Municipal undertaking that included the operation of a potable water treatment facility, solid waste disposal facility, and sewage treatment facility. The scope of the Renewal-Amendment Application, however, excluded the portable water supply facility and several other facil

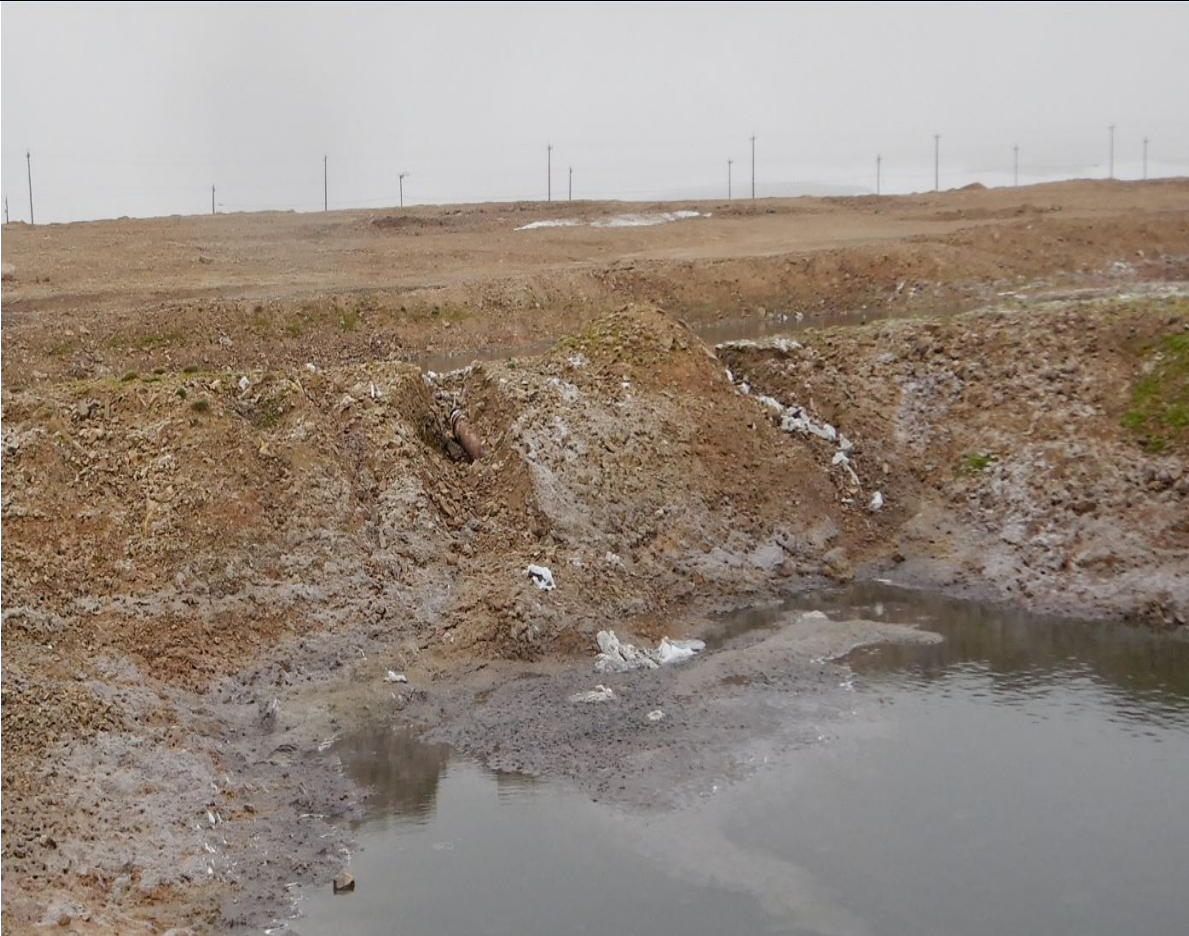
Photo Log #

- 5.Signs of Slumping and Erosion were observed (See Photo #5). This observation appears to not have been addressed as requested in past inspection reports. The state of the walls appears to have gone into further decline.

Description: The erosion on the right was observed in the 2017 inspection report, the Erosion on the left is new and wasn't observed in the 2017 inspection report

- articulate how you calculate the amount of waste deposited into the Sewage Disposal Facility.
- label the two monitoring posts as listed in the water licence
- provide all requirements for submission of Annual Reports
- maintain the 1 metre free board at the Sewage Disposal Facility
- repair the walls of the Sewage Disposal Facility
- notify WRO Monteith at Joseph.Monteith@Canada .ca when decanting the Sewage Disposal Facility.
- report to the Spill Line when overflow is observed at the Sewage Disposal Facility
- the Licensee is reminded to remain diligent to prevent wastes from entering water, the environment, and to adhere to the discharge criteria listed in the licence.

Part D: Item 6 - The Sewage Disposal Facilities shall be maintained to the satisfaction of an Inspector, and operated in such a manner as to prevent erosion and structural failure.
