July 23, 2001 Municipal Water Use Inspection - Report

MUNICIPAL WATER USE INSPECTION FORM

Date: 2001/07/23 Licensee Rep. (Name/Title): Rick Gaulton / Site Supervisor
Licensee: Government of Nunavut, Arctic Airports Licence No.: N4L3-1561 (expired)

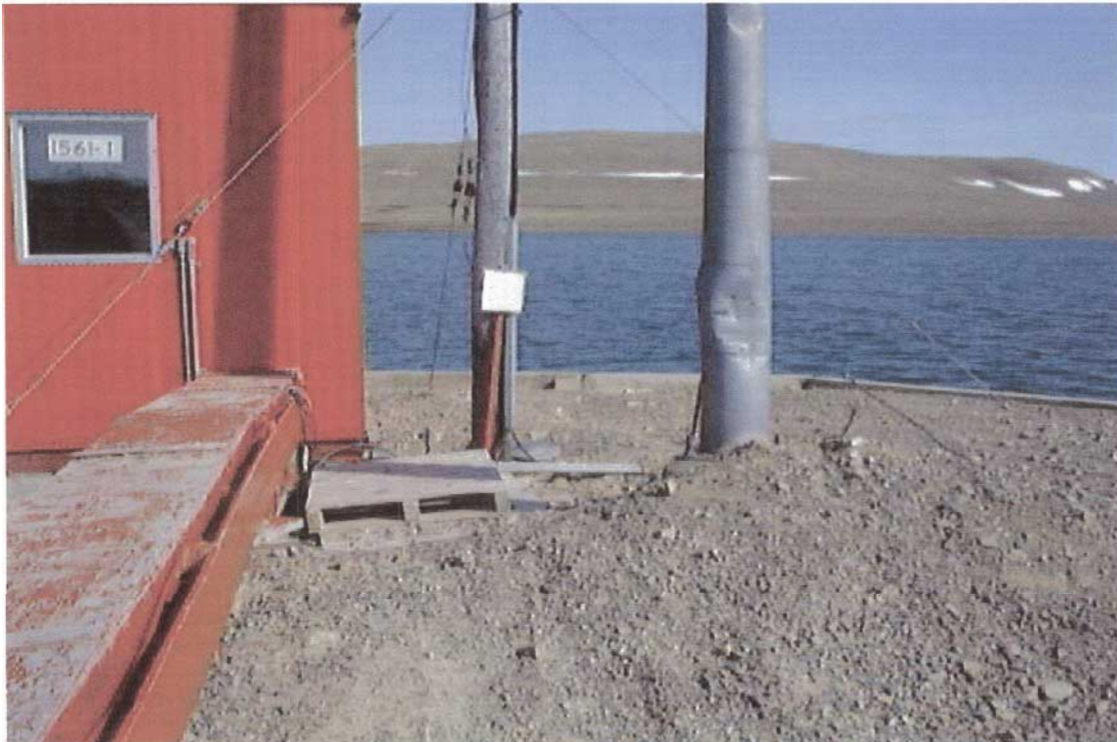
- **Water supply:** No concerns were noted at the Strip Lake water intake facility, which serves as direct truckfill station since the conveyance line failure in 1996. Further, the attached analytical results relating to a sample collected from Surveillance Network Station (SNP) station 1561-1 (figure 1) indicate that the raw water readily meets the *Guidelines for Canadian Drinking Water Quality* for all tested parameters.

figure 1. Water intake facility at Strip Lake, SNP station 1561-1; 2001/07/23.

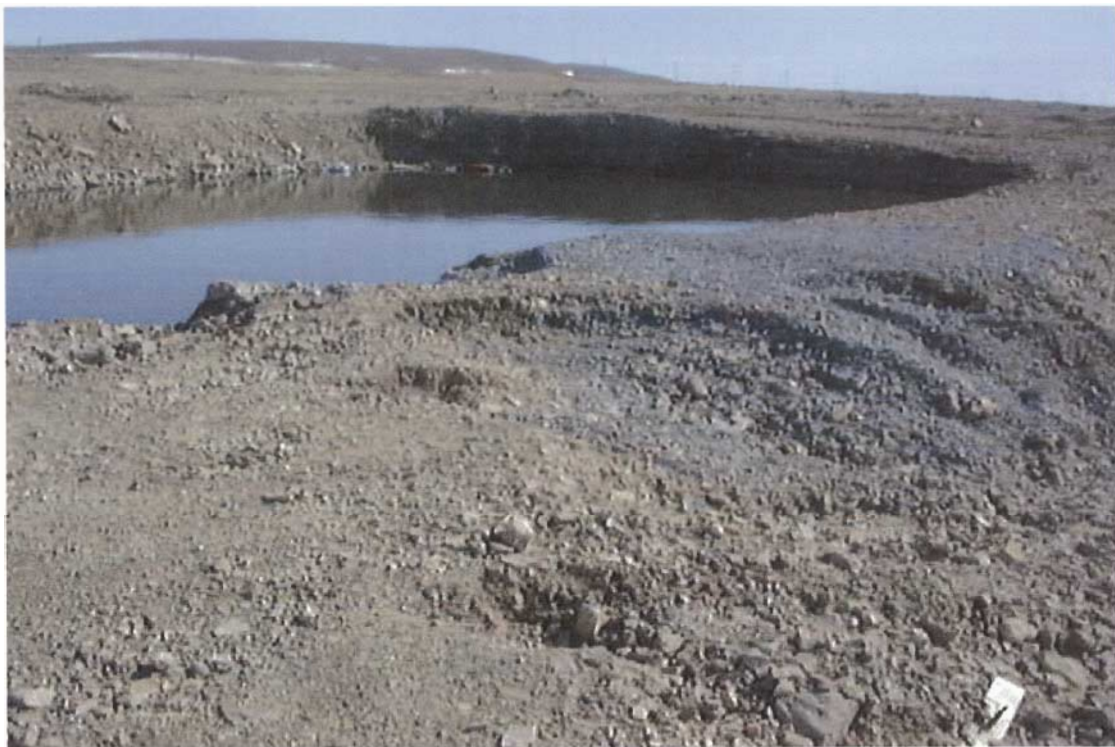
- **Sewage disposal:** At the time of the inspection, significant erosion of the outer retention berms of both the upper (figure 2), and the lower (figure 3), lagoon cells was observed. In addition, it was related that since the content of the upper lagoon cell freezes and spills over, the discharge of raw sewage into the lower lagoon cell occurs annually during wintertime. Further, the presence of both dried sewage solids along the outer berm of the lower lagoon cell and of frozen sewage effluent immediately downslope of the cell (figure 4) implies that the lower lagoon cell also overflows. As such, the attached analytical results relating to a sample taken downslope of the lower lagoon cell (figure 5) reveal that the level of total suspended solids (135 mg/L vs 35 mg/L) breaches the effluent quality standards set for SNP station 1561-4 of the now expired Water licence N4L3-1561, and that concentrations of ammonia (30.4 mg/L vs 2.2 mg/L) and phenols (35 µg/L vs 4.0 µg/L) exceed the *Canadian Water Quality Guidelines for the Protection of Freshwater Aquatic Life*.

Comments: Sewage disposal facility is undersized; evident signs of overflow from the upper and lower lagoon cells. Significant erosion of the outer berms of both lagoon cells; fill was added in 2000 in an attempt to reinforce the upper berm. Dried sewage solids noticeable along the top of the lower lagoon's outer berm, and in the area immediately downslope of the facility. No flow observed from the lower lagoon cell's decant pipe, but thawed sewage effluent was discharging alongside the toe of the abandoned airport landfill. Solid wastes are directed to the municipal solid waste disposal facility.

figure 2. Upper lagoon cell of the sewage disposal facility; 2001/07/23.

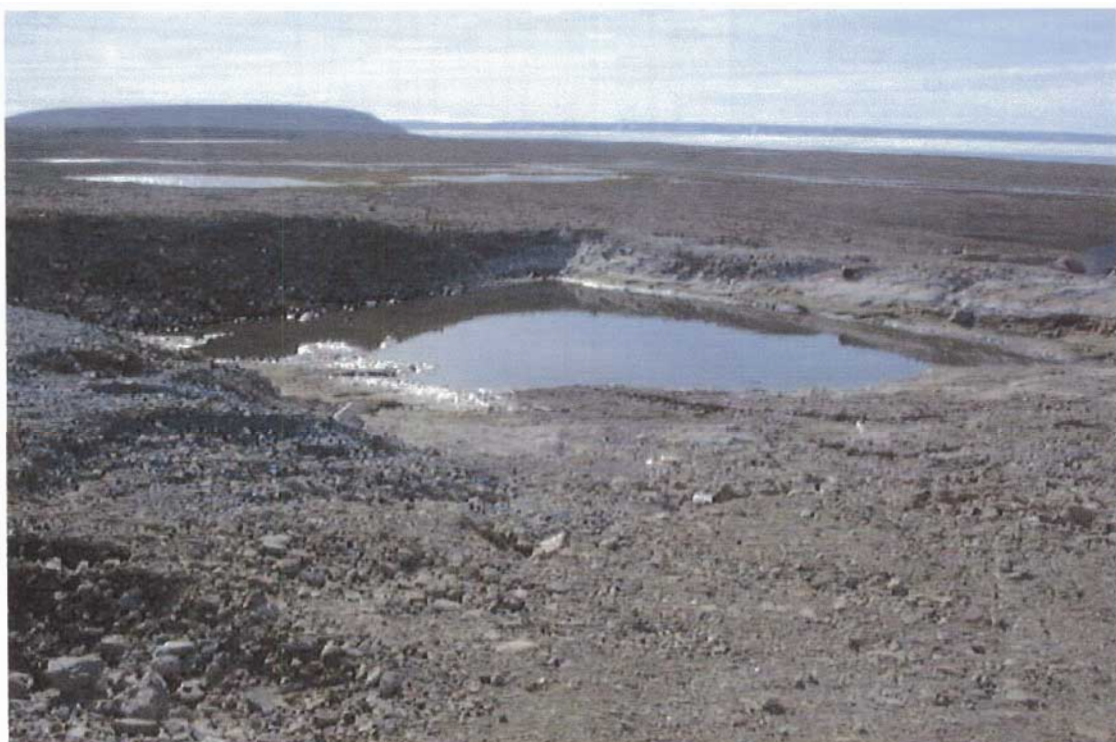
figure 3. Lower lagoon cell of the sewage disposal facility; 2001/07/23.

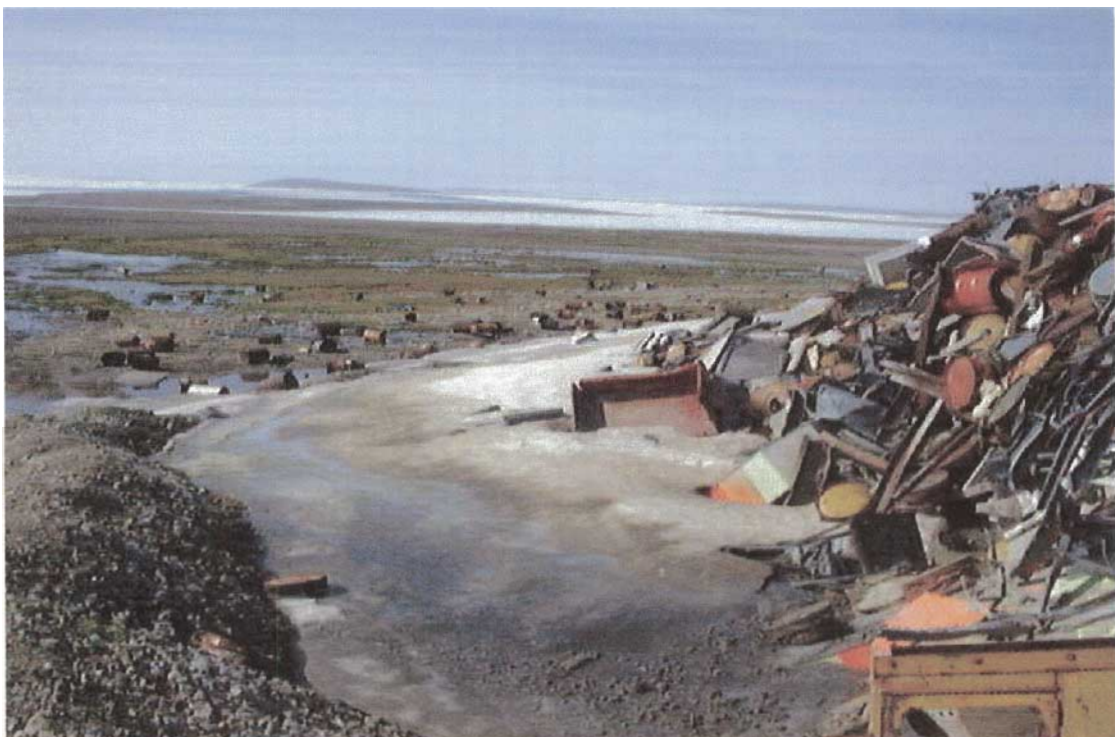
figure 6. Sewage effluent discharge along the toe of the old airport landfill; 2001/07/23.
