WATER LICENCE INSPECTION FORM

Sewage Disposal Facility

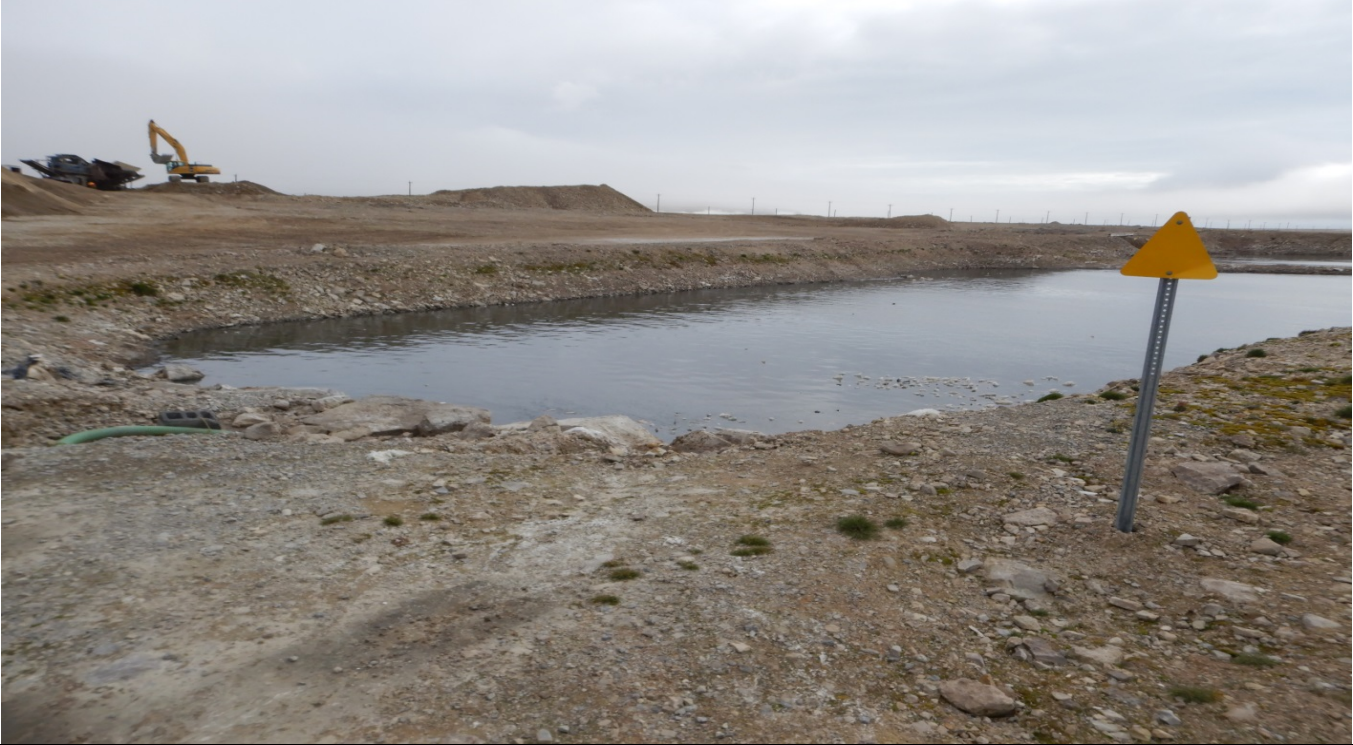
Photo Log #	Location
Photo 2	Resolute Bay, NU

- 1.The Sewage Disposal Facility is a non-engineered 3 cell lagoon.
- 2.Two yellow triangle signs were observed contrary to Part B: Item 5. (See Photo #1 & 2).

Description: no titling convention on sign, and in the official languages of Nunavut.

- articulate how you calculate the amount of waste deposited into the Sewage Disposal Facility.
- label the two monitoring posts as listed in the water licence
- provide all requirements for submission of Annual Reports
- maintain the 1 metre free board at the Sewage Disposal Facility
- repair the walls of the Sewage Disposal Facility
- notify WRO Monteith at Joseph.Monteith@Canada .ca when decanting the Sewage Disposal Facility.
- report to the Spill Line when overflow is observed at the Sewage Disposal Facility
- the Licensee is reminded to remain diligent to prevent wastes from entering water, the environment, and to adhere to the discharge criteria listed in the licence.
