WATER LICENCE INSPECTION FORM

Sewage Disposal Facility

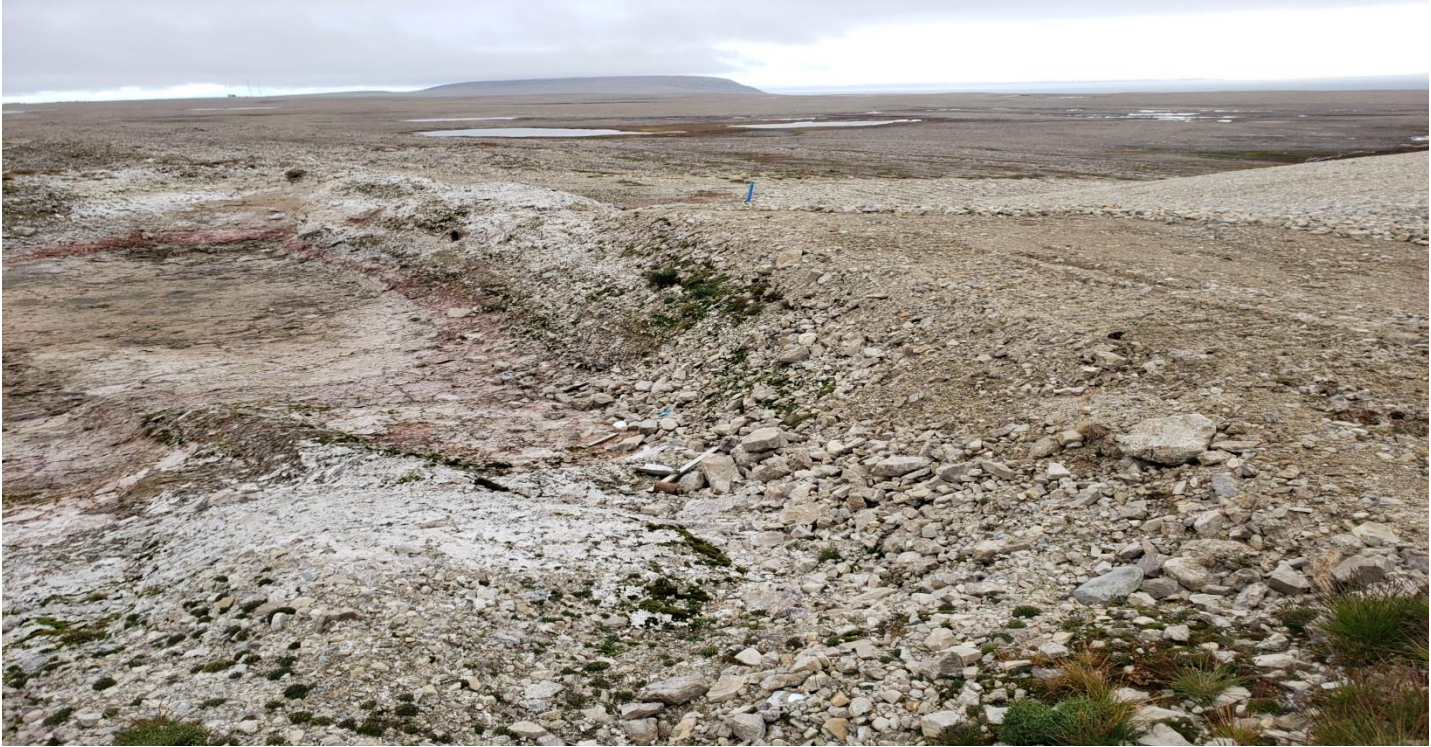
Photo Log #	Location
Photo 4	Resolute Bay, NU

- 3.The Freeboard was above 1 metre (See Photo #3).
- 4.Signs of over flow were observed (See Photo #4). Spill report 2017-127 was reported on April 25, 2017 for 50,000 Litres of waste water from an overflow event at the Sewage Lagoon.

Description: Sewage Lagoon was dry due to natural filtration. Due to COVID-19 seasonal deposits decreased.

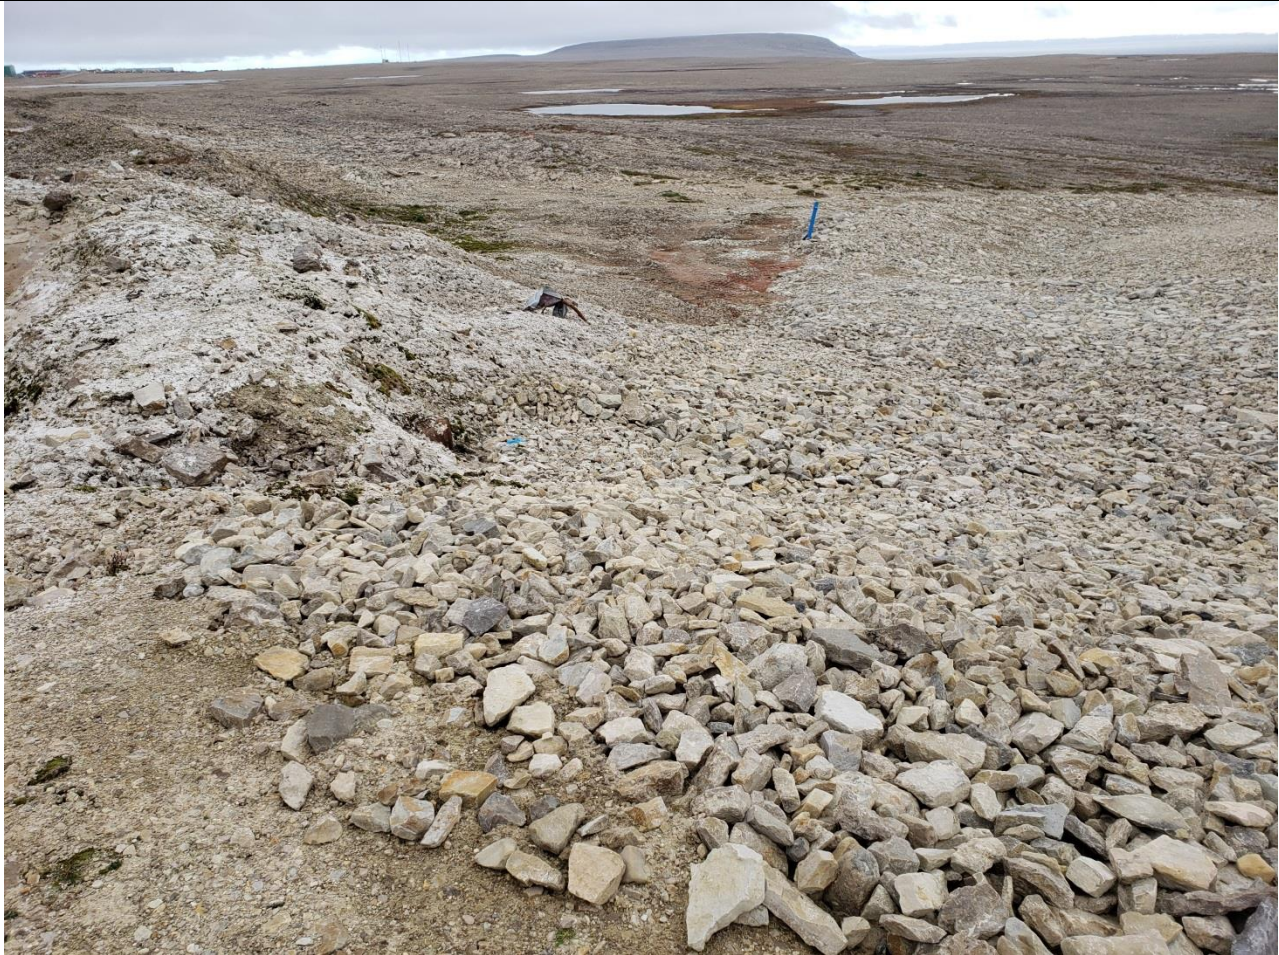
Photo 5

- 5.Signs of Slumping and Erosion were observed (See Photo #5). This observation appears to not have been addressed as requested in past inspection reports. The state of the walls appears to have gone into further decline.

Description: New material was placed downgrade of the sewage discharge location.

<input type="checkbox"/> Comments	<input type="checkbox"/> Non-Compliance with Act or Licence	<input checked="" type="checkbox"/> Action Required
The following information is a summary of the Actions Required by the licensee to promote and ensure compliance: -articulate how you calculate the amount of waste deposited into the Sewage Disposal Facility. -label the two monitoring posts as listed in the water licence -provide all requirements for submission of Annual Reports -maintain the 1 metre free board at the Sewage Disposal Facility -repair the walls of the Sewage Disposal Facility -notify WRO Monteith at Joseph.Monteith@Canada .ca when decanting the Sewage Disposal Facility. -report to the Spill Line when overflow is observed at the Sewage Disposal Facility -the Licensee is reminded to remain diligent to prevent wastes from entering water, the environment, and to adhere to the discharge criteria listed in the licence.
