WATER LICENCE INSPECTION FORM

Licensee	Licensee Representative				
Canadian Arctic Holidays	Richard Weber				
Licence No. / Expiry	Representative's Title				
7BL-AWL1722	Owner/ Operator				
Land / Other Authorizations	Land / Other Authorizations				
N2013J0013 expired.	Lease 58F/2-1-2				
Date of Inspection	Inspector				
July 9, 2019	Joseph Monteith				
Activities Inspected					
<input type="checkbox"/> Camp	<input type="checkbox"/> Drilling	<input type="checkbox"/> Mining	<input type="checkbox"/> Construction	<input type="checkbox"/> Reclamation	<input type="checkbox"/> Fuel Storage
<input type="checkbox"/> Roads/Hauling	<input checked="" type="checkbox"/> Other:	<input type="checkbox"/> Other:

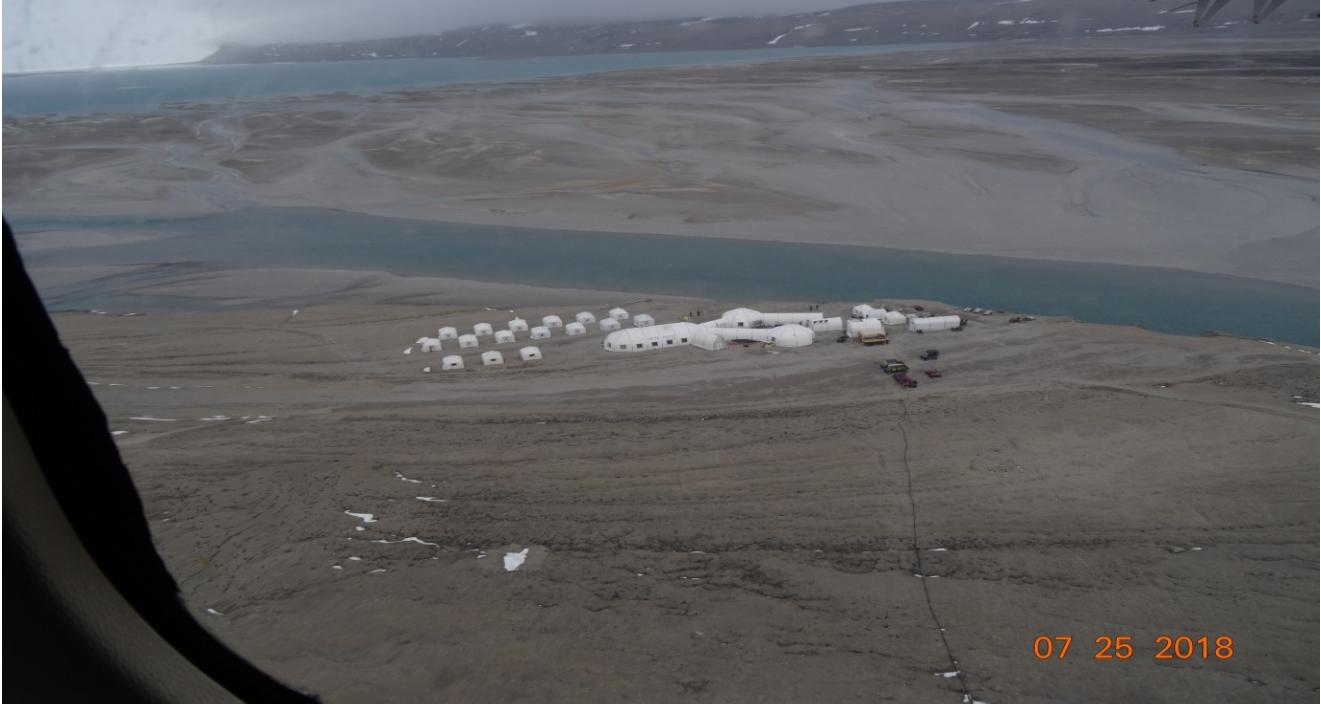
Date	Camera	Inspector
July 9, 2019	Nikon Cool Pix	Joseph Monteith
Photo Log #		Location
Photo 1		Arctic Watch Cunningham inlet

1. Water withdrawn from the Cunningham River which flows 5 metres below the camp as the camp is situated on an ancient river bed (photo1).

Description: 2018 photo of site - 22 buildings plus, 1 building with 3 sections. Cunningham River, and Cunningham inlet in the background

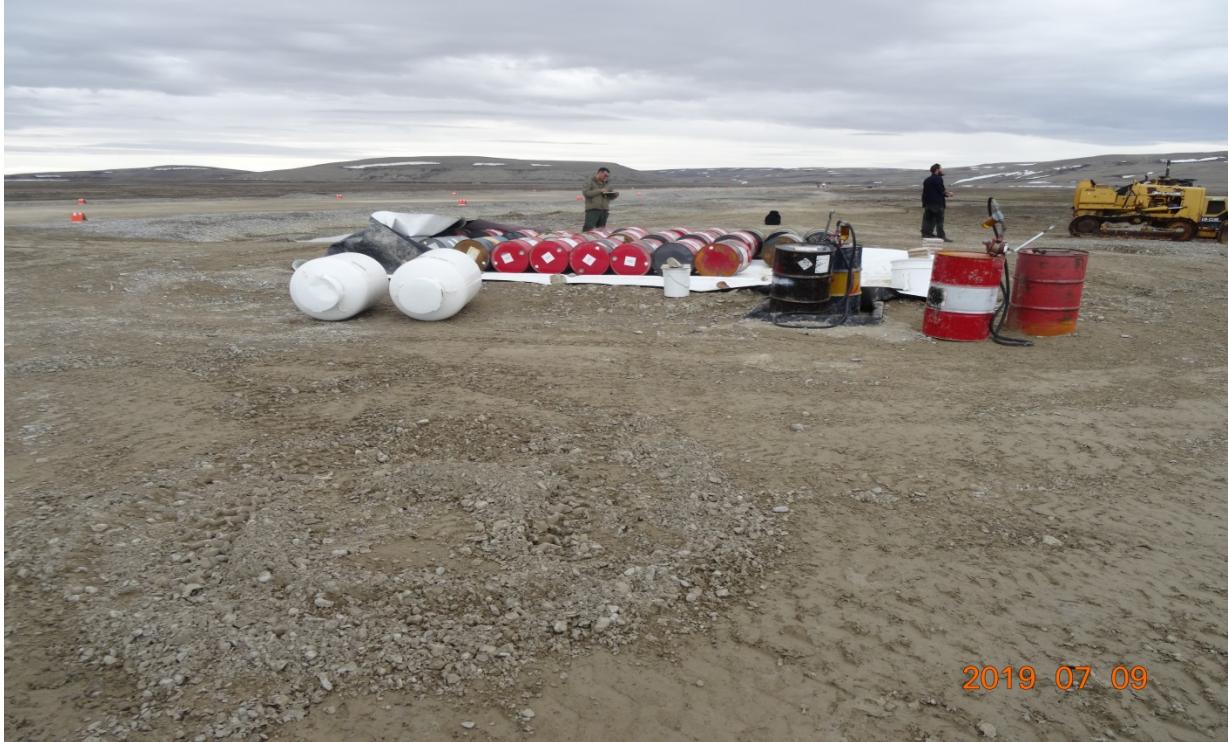
Photo 2

The fuel caches secondary containment appears to have walls flush with the surrounding environment. They might have an inch or two of containment ability. But, may not be 10% greater than the capacity of the largest fuel container.

16. Fuel Cache #1 by the airstrip on IOL (photo 2, 3, 4 & 5).
17. Fuel Cache #2 within 31 metre of fresh water. Secondary containment flush with the surrounding environment. (Photo 2, 4, & 5).
18. Fuel Transfer Area, in secondary containment (Photo 16 & 17).

Description: Fuel Cache secondary containment walls are flush with the surrounding landscape. 19 barrels on top of liner. Also a fuel transfer station.

SECTION 2	<input type="checkbox"/> Comments	<input type="checkbox"/> Non-Compliance with Act or Licence	<input checked="" type="checkbox"/> Action Required
-Report all spills as per the water licence requirements -Do not store mobile sewage storage tank within 31 metres of any water body -Remove the bulk metal and incinerator as those sites are no longer covered under a land use permit, and should have been removed before the expiry of the Land Use Permit. Provide a time line when this non-compliance with the permit will be corrected. -Calculate and articulate how the secondary containment observed under photos is able to contain a minimum of 110% of the original vessel, and 10% of the aggregate volume of all other vessels located in the containment. If it doesn't match the definition of secondary containment, install a proper secondary containment.

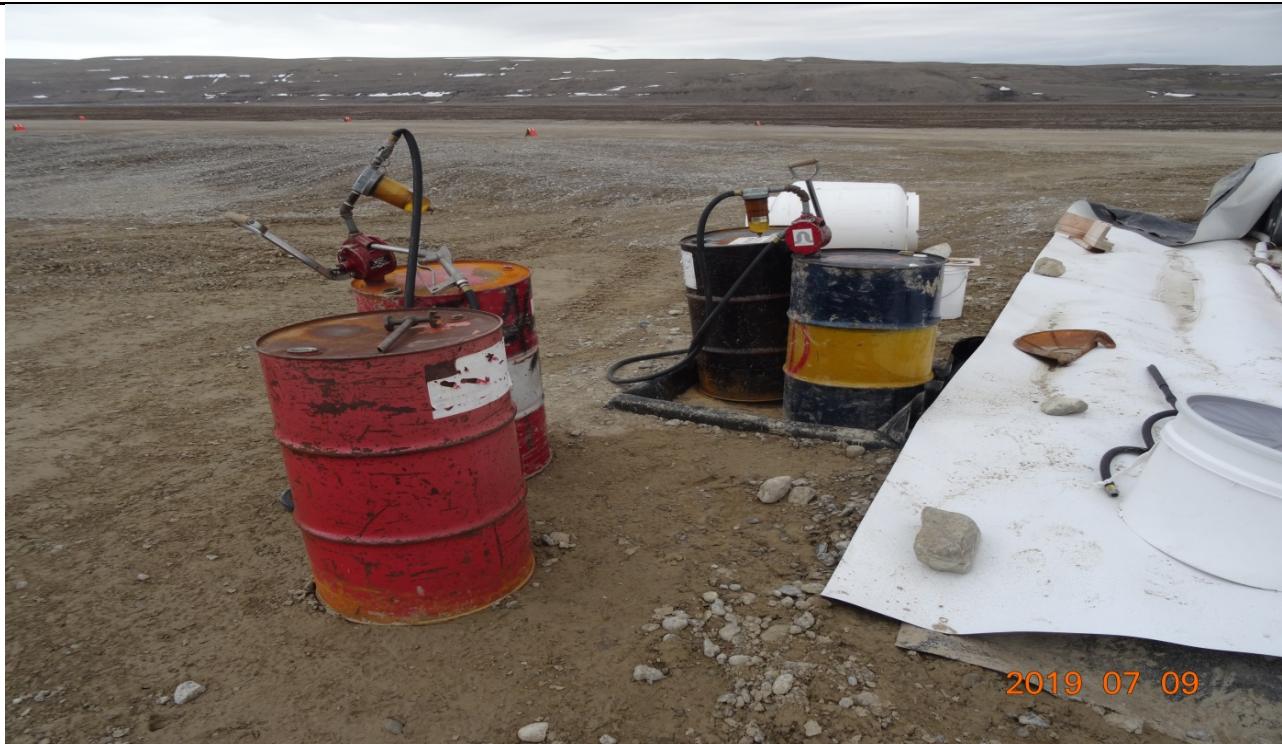
Photo 3

Description: Fuel Cache within 31 metres of the high water mark of any water body.

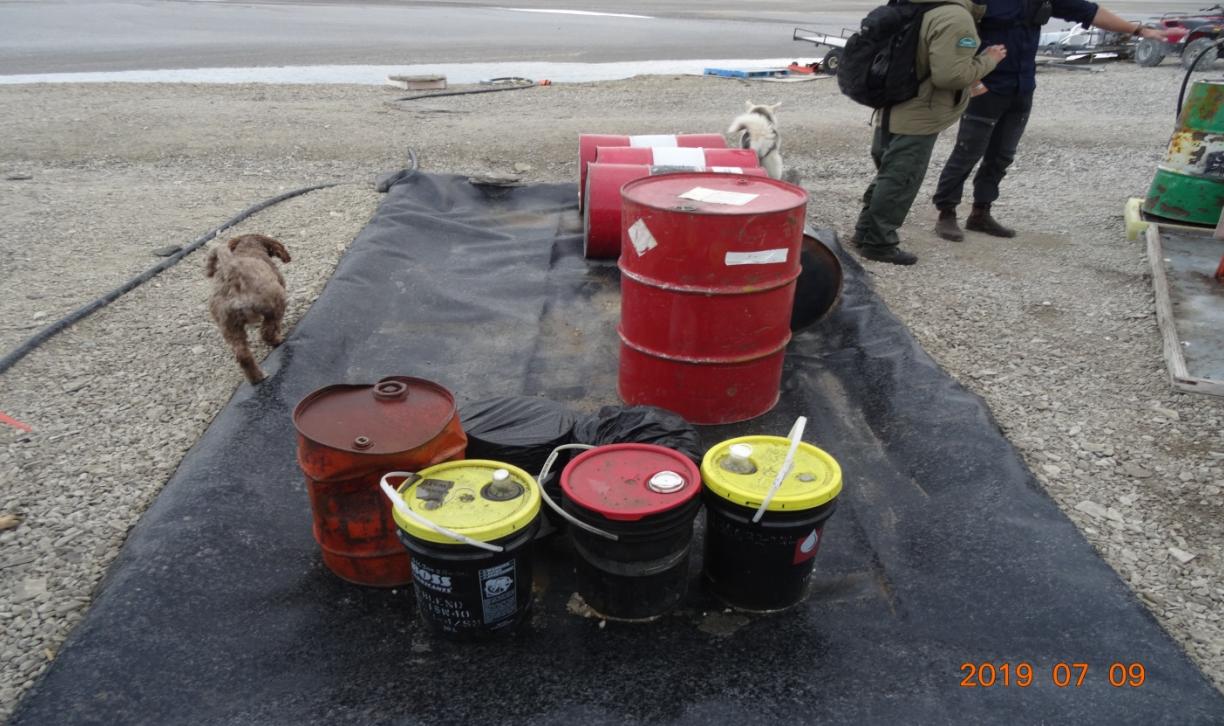
Photo Log #	Location
Photo 4	Arctic Watch Cunningham inlet

Description: hazardous waste ontop of liner, but on the outer edges. Secondary containment would not keep hazardous waste in.

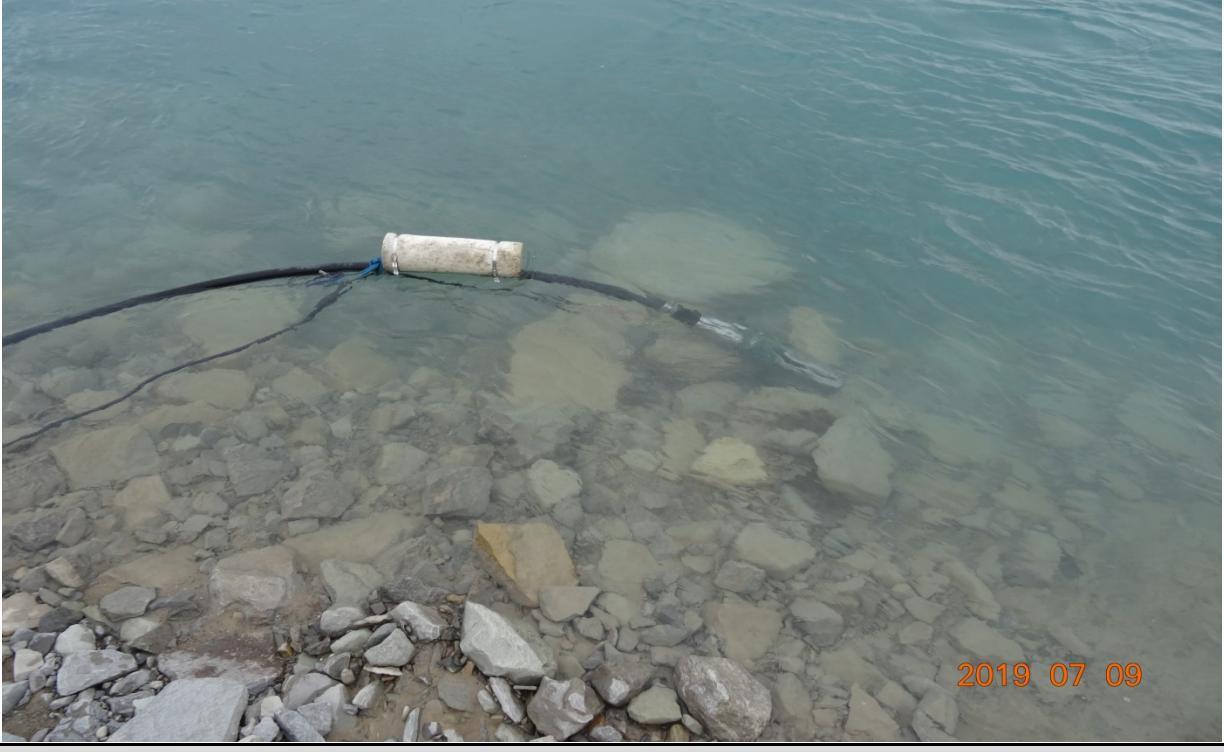
Photo Log #	Location
Photo 6	Arctic Watch Cunningham inlet

2. Water intake hose has a fish mesh screen (photo 6).
3. Three 100 Gallon Water Storage Tanks, and one 500 Gallon Water Storage (photo 7).
4. No flow metre, recorded in log book on each fill up of tank.
5. Log book indicates below 5m³ withdrawal of water from the Cunningham River. (photo)
6. 3 water storage tanks. 1-500 Gallon, and 3-100 Gallon water storage tanks (photo)
7. 2 x washing tubs (photo 11).
8. Water meter photographed on July 9, 2019 showing 13613 US Gallons withdrawn (Photo 13).
9. Water meter photographed, and sent in on August 31, 2019 showing 63111 US Gallons withdrawn (Photo 14).

Description: Water withdrawal site. Fish Mesh Screen visible

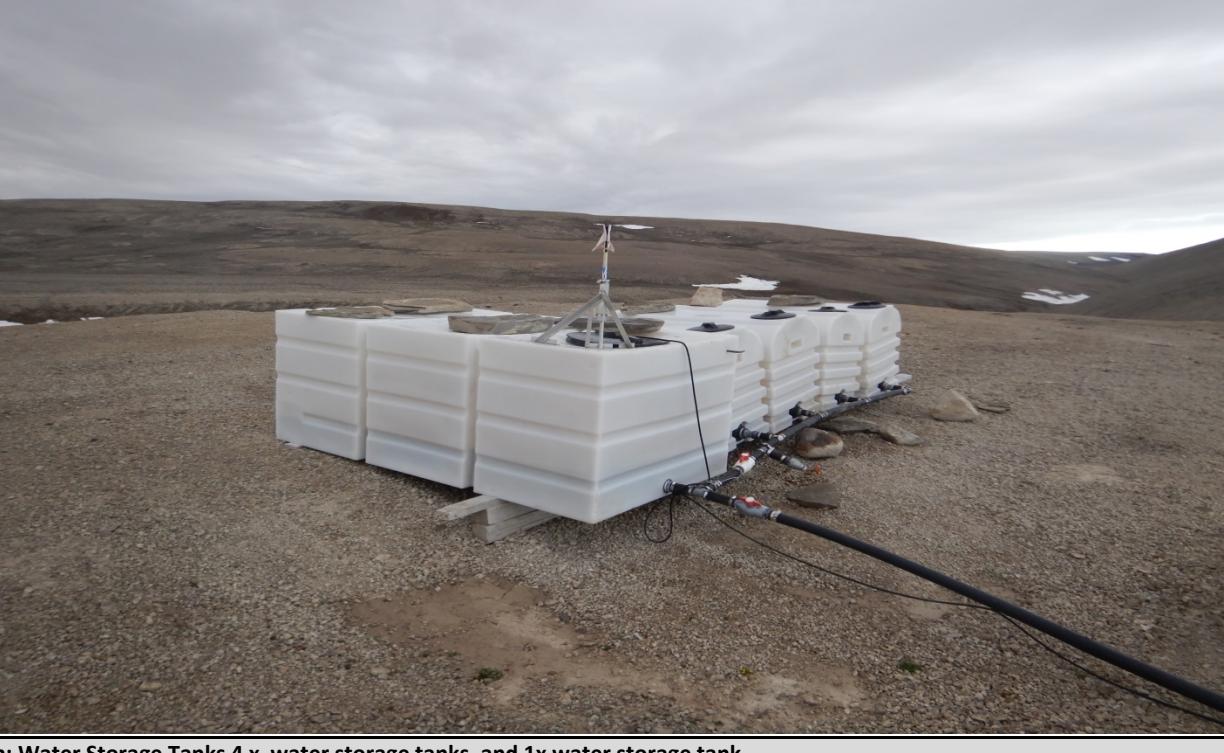
Photo Log #	Location
Photo 7	Arctic Watch Cunningham inlet

Description: Water Storage Tanks 4 x water storage tanks, and 1x water storage tank

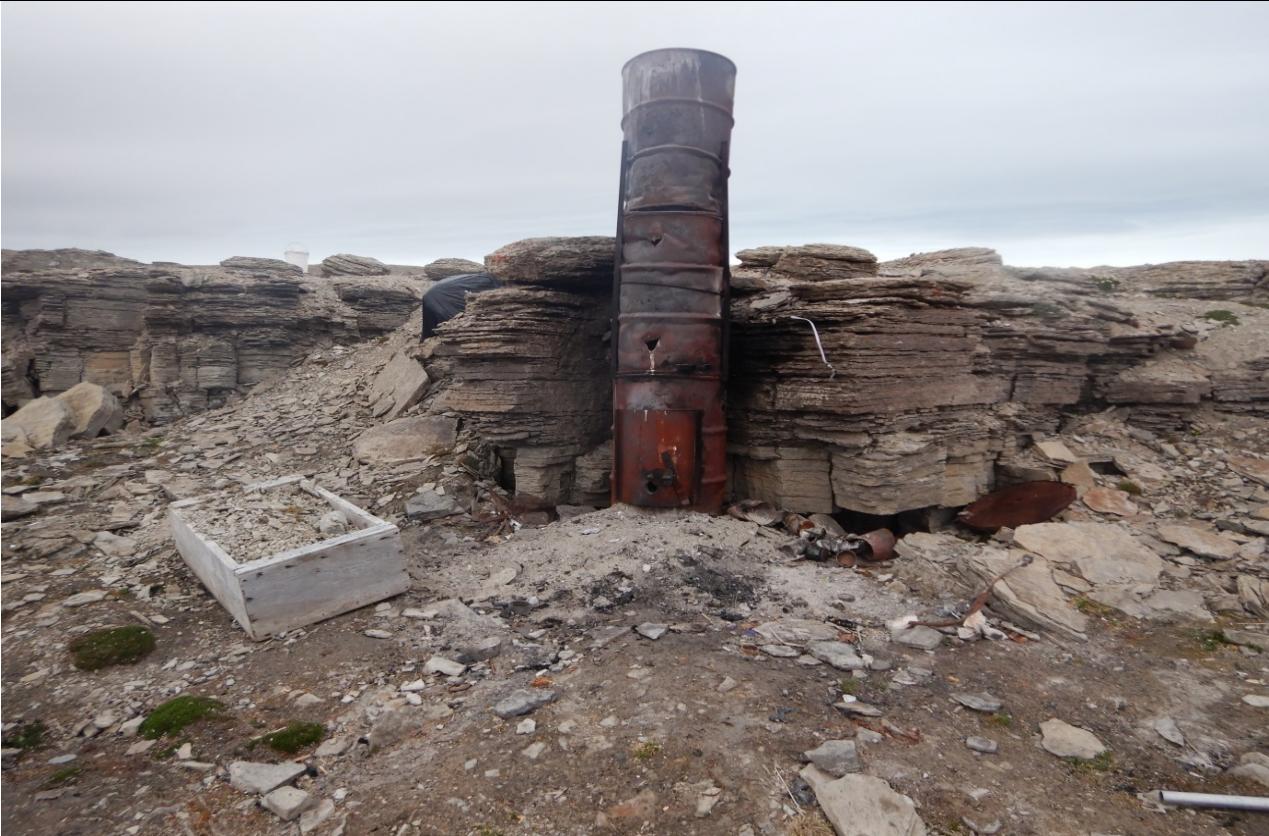
Photo 8

10. Sump Pit (Photo12)
11. Forced Air Incinerator (Photo16)
12. Bulk Metals and Solid Wastes are left on site, and flown to Yellowknife for proper disposal at the City Land Fill. (Photo 9 & 10). Old incinerator (photo 8).
13. A Mobile Sewage Tank Stored within 31 metres of a water body. This runs contrary to Part D: Item 1 Conditions Applying to Waste Disposal (photo 18).
14. Waste in drums at incinerator (photo 17).

Description: old incinerator

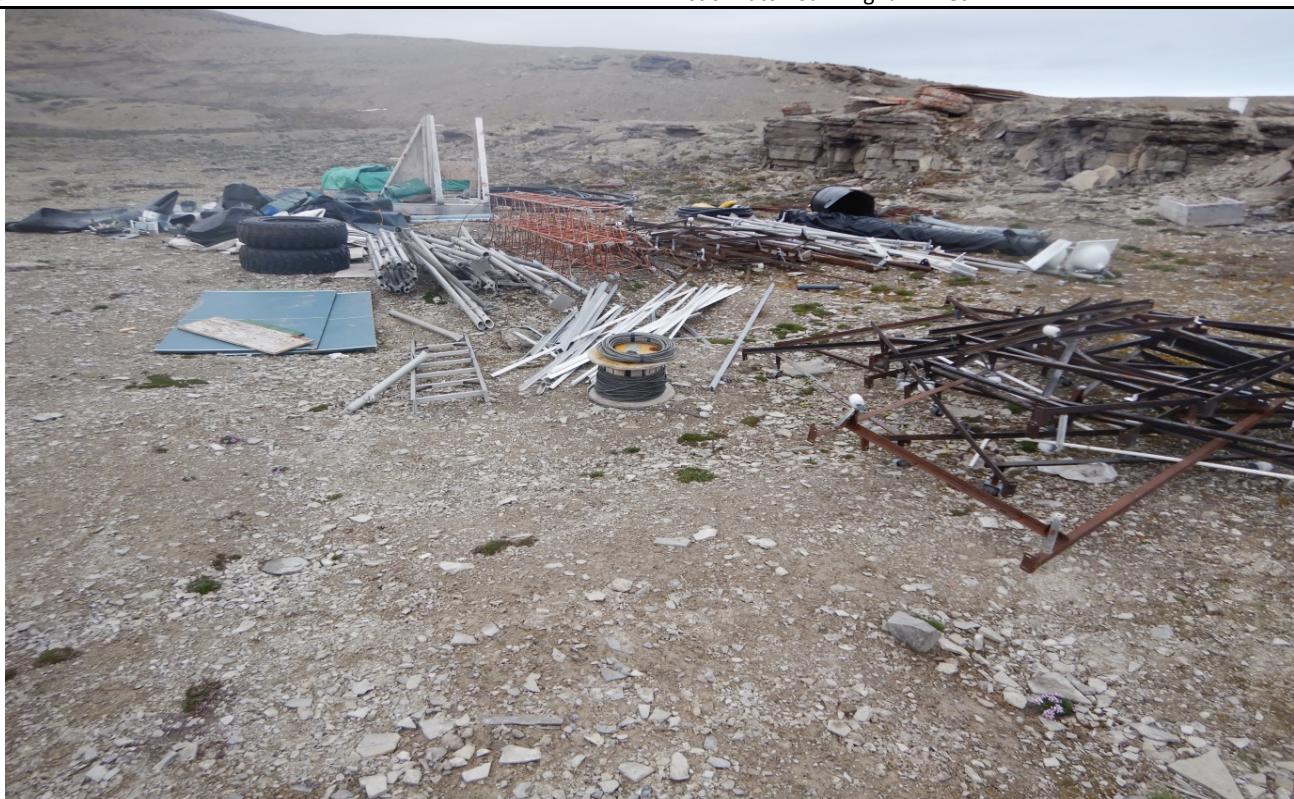
Photo 9

Description: Solid Waste, bulk metal

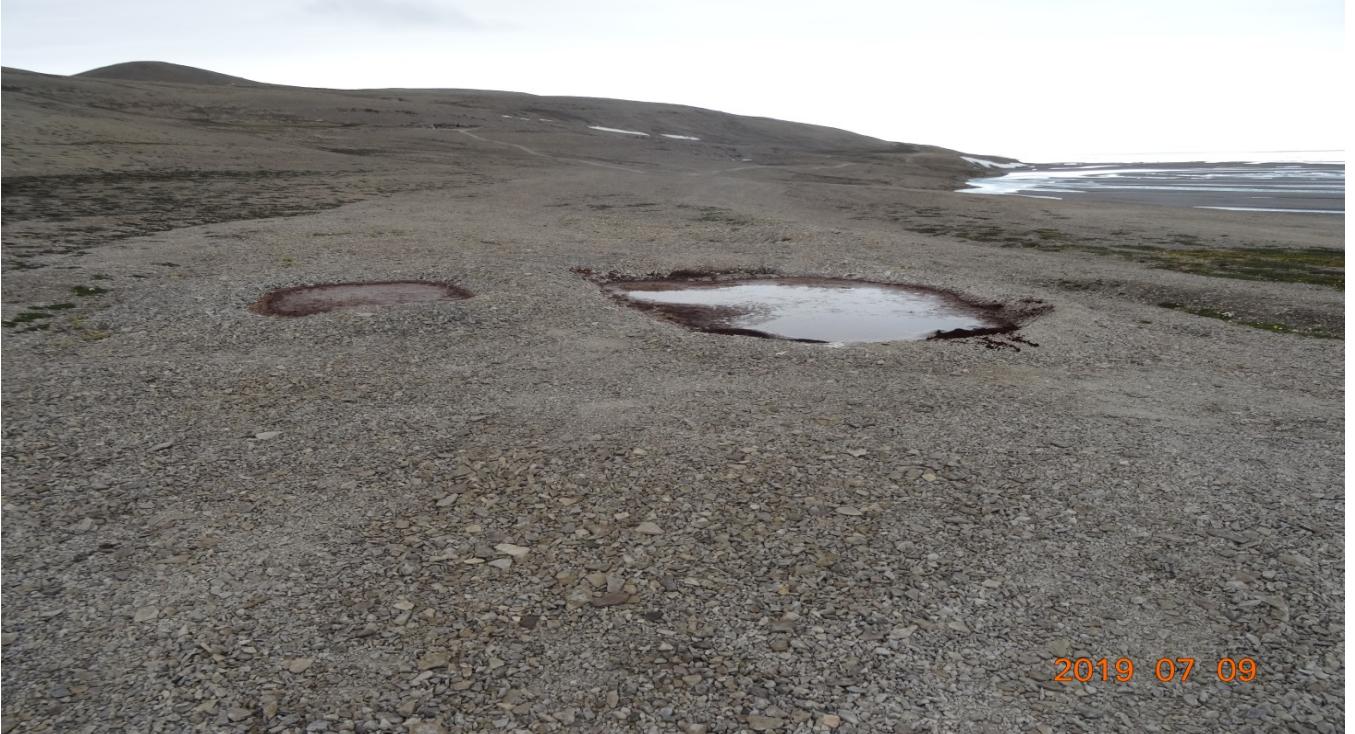
Photo Log #	Location
Photo 12	Arctic Watch - Cunningham inlet

Description: 2 sump pits.

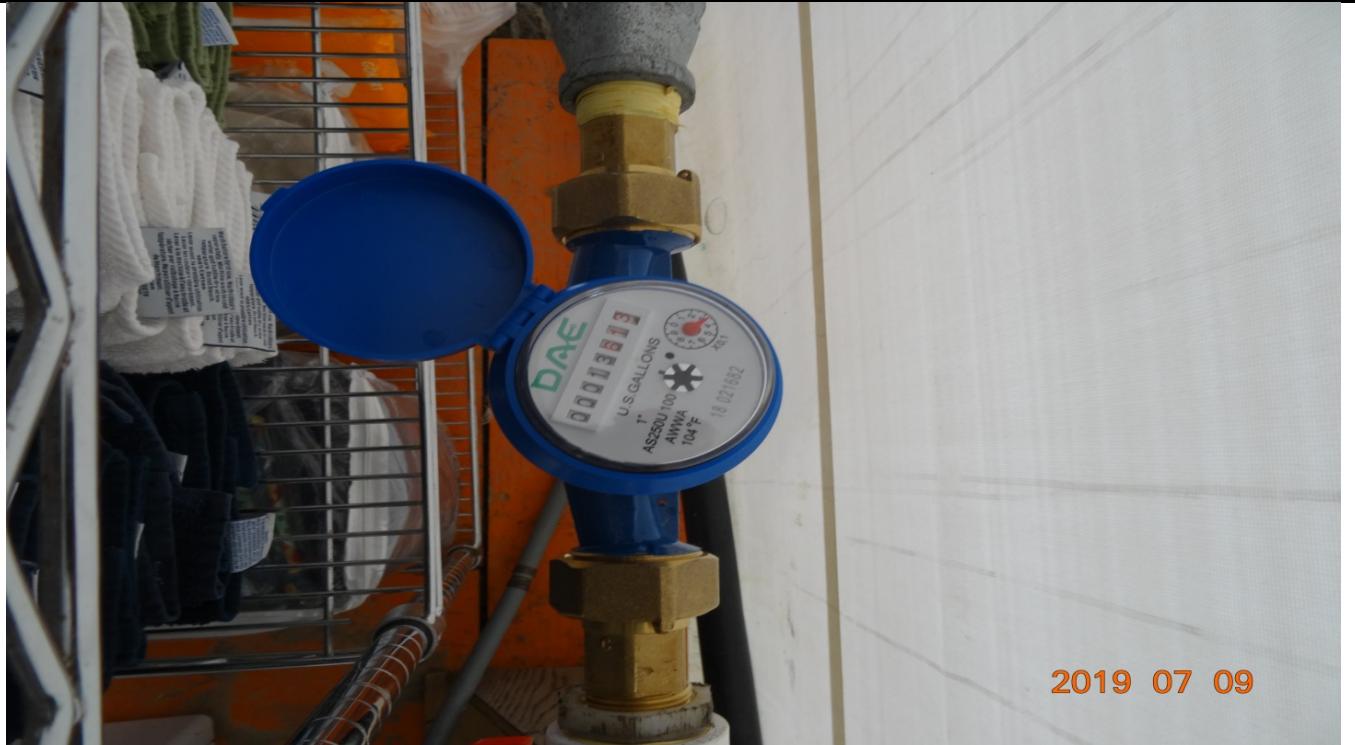
Photo Log #	Location
Photo 13	Arctic watch – Cunningham Inlet

Description: DAE Water Meter reads 13613 US Gallons

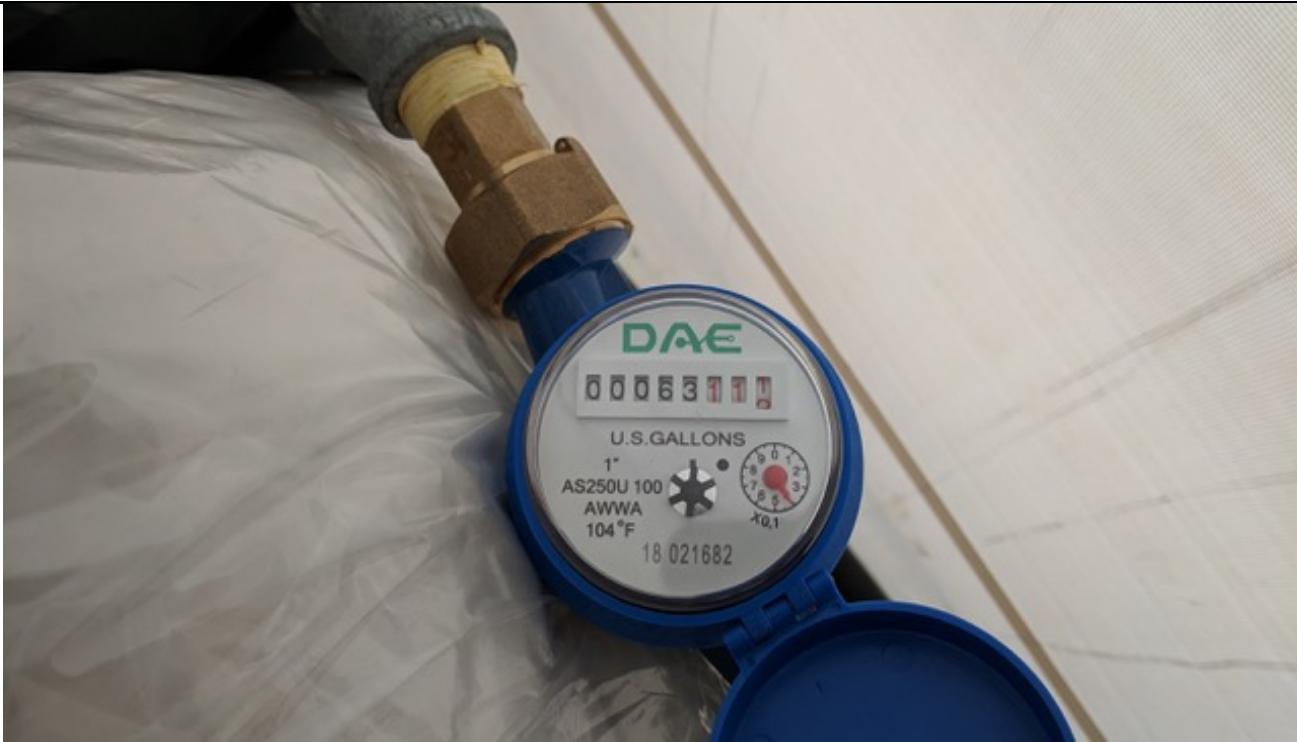
Photo 14

15. On August 31, 2019 WRO Monteith received an email from Richard Weber, Operator of Arctic Watch, Cunningham Inlet, NU, with a photograph of a water metre reading measured in US Gallons at 63111Gallons (Photo 14) also a word document titled "Arctic Watch Garbage & Water Log 2019"(photo 20). The document contained the dates of the garbage log. The document also had a sentence regarding the amount of water used at 63111 Gallons used between June 15 and August 20, 2019. With a calculation of use per day at 3.6 m³ the licensee is authorized for 5 m³ per day.

Description: Photo of Water Meter sent to WRO Monteith on Aug. 31, 2019, showing 63111 US Gallons withdrawn.

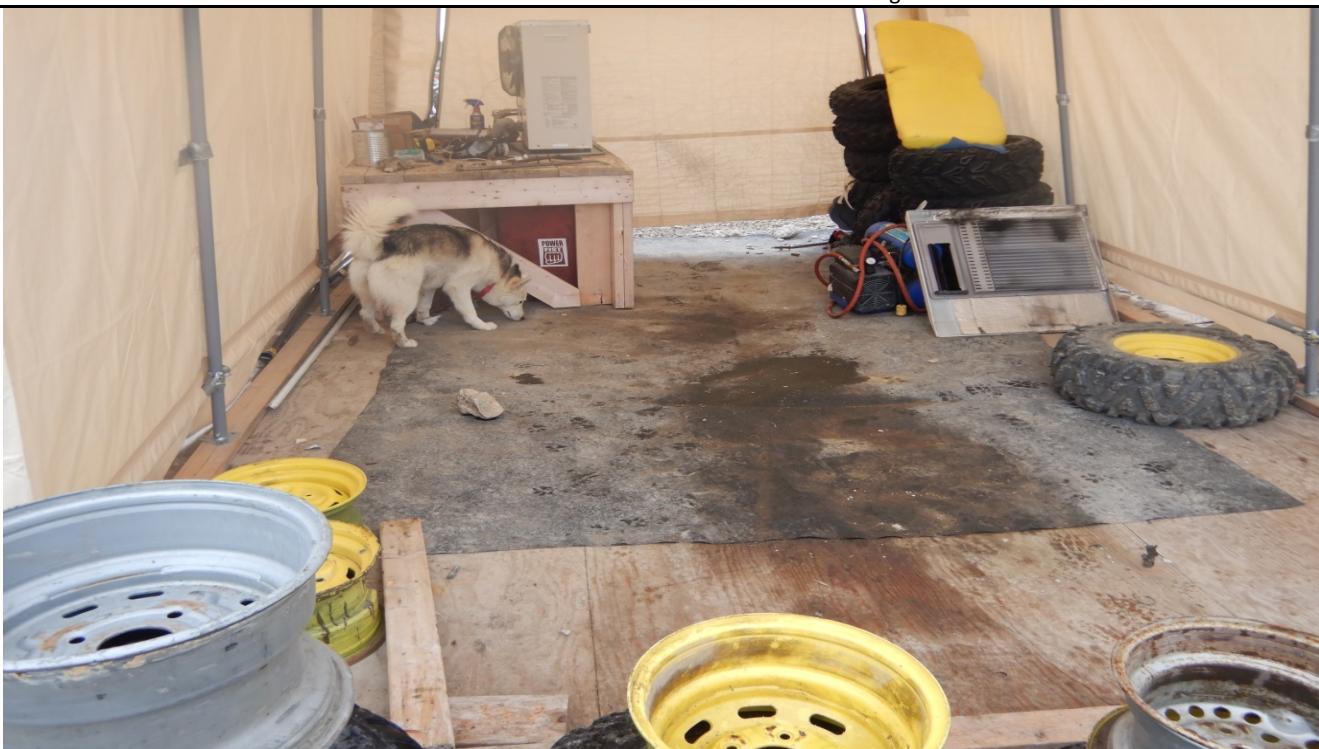
Photo 15

No spill reports have come out of this site. Signs of spills were observed in the ATV tent (photo 15). This runs contrary to Part H: Item 6 of the water licence.

Description: Vehicle Maintenance Tent. Flooring is ply wood, and rubber mat. Sign of spills.

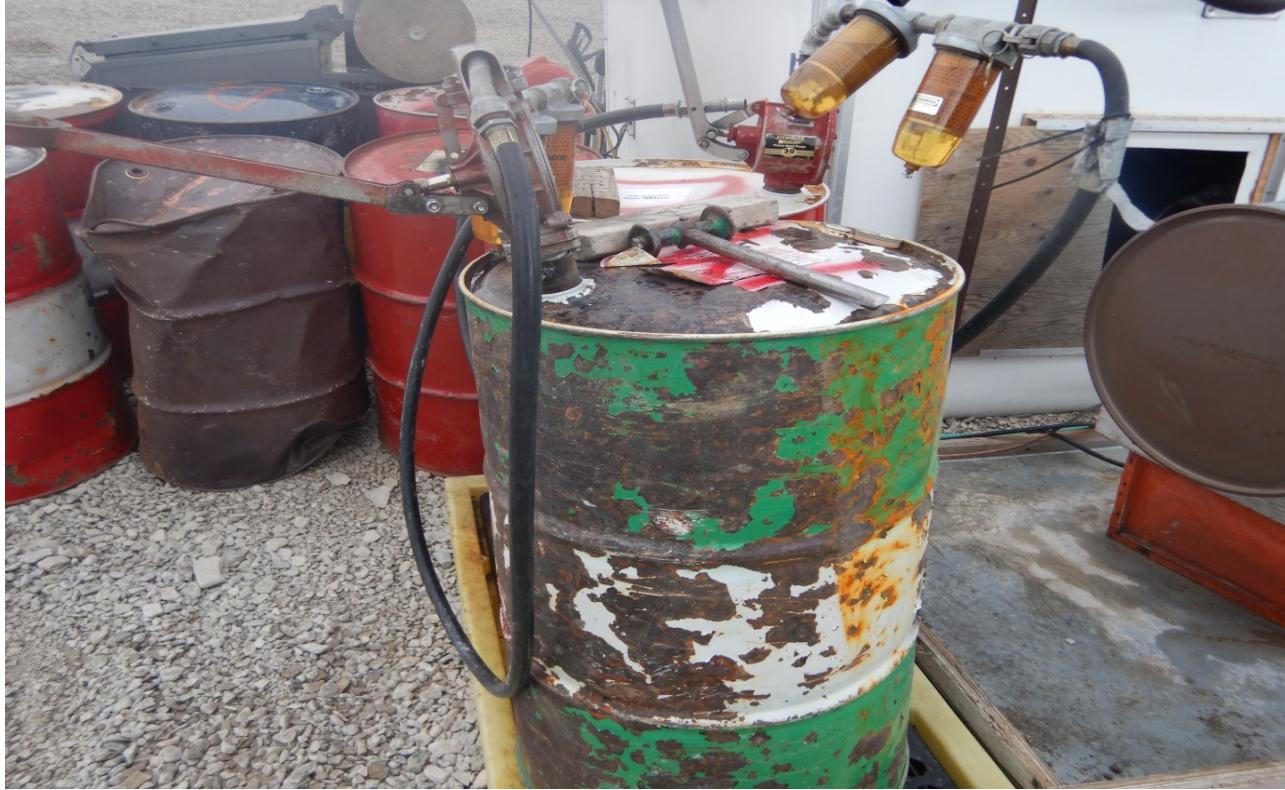
Photo Log #	Location
Photo 16	Arctic watch – Cunningham Inlet

Description: Fuel Transfer Station in secondary containment. 2 x fuel filters, and fuel pump.

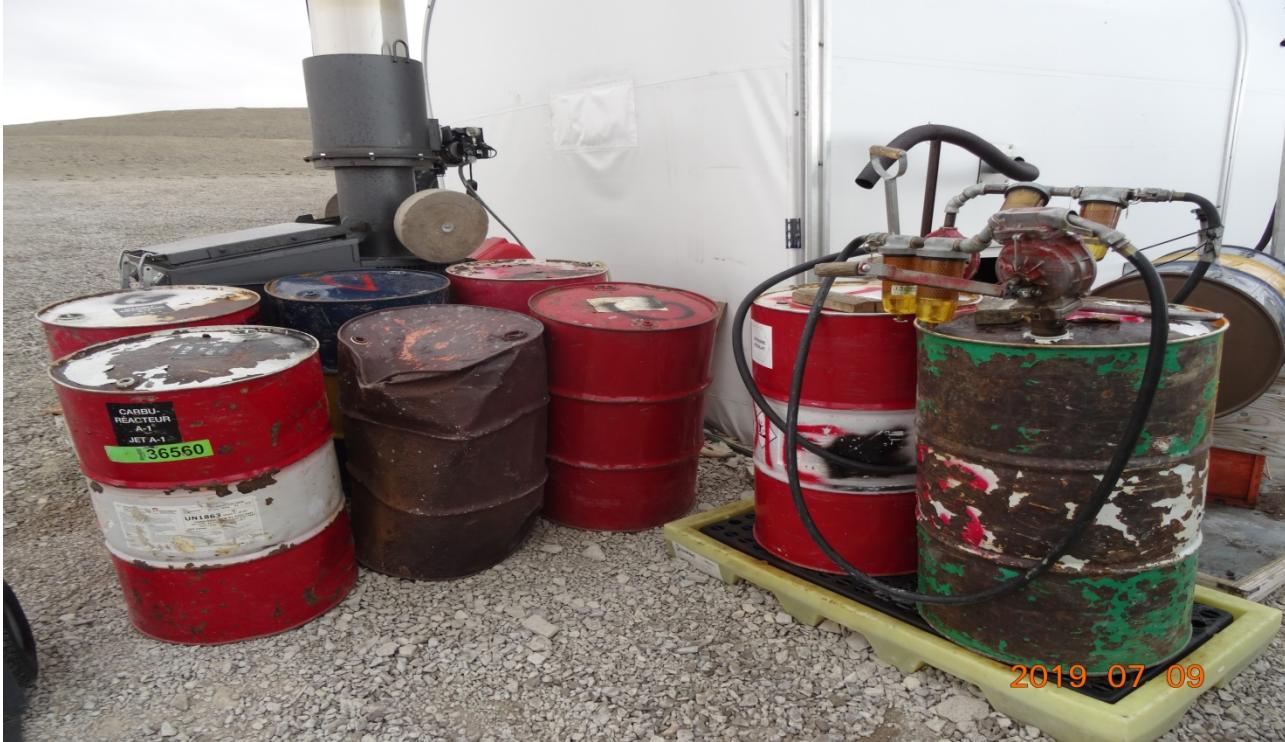
Photo Log #	Location
Photo 17	Arctic watch – Cunningham Inlet

Description: Incinerator and waste drums

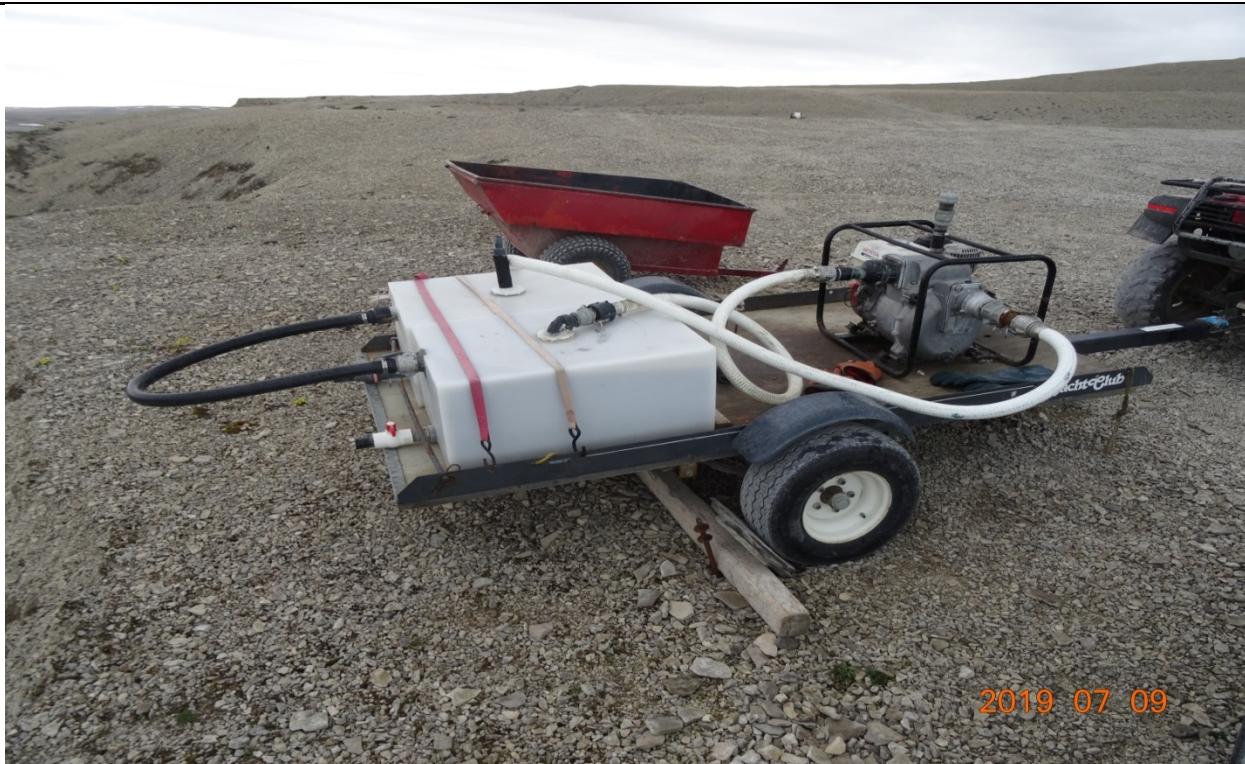
Photo 18

Description: mobile sewage tank. Within 31 metres of the high water mark.

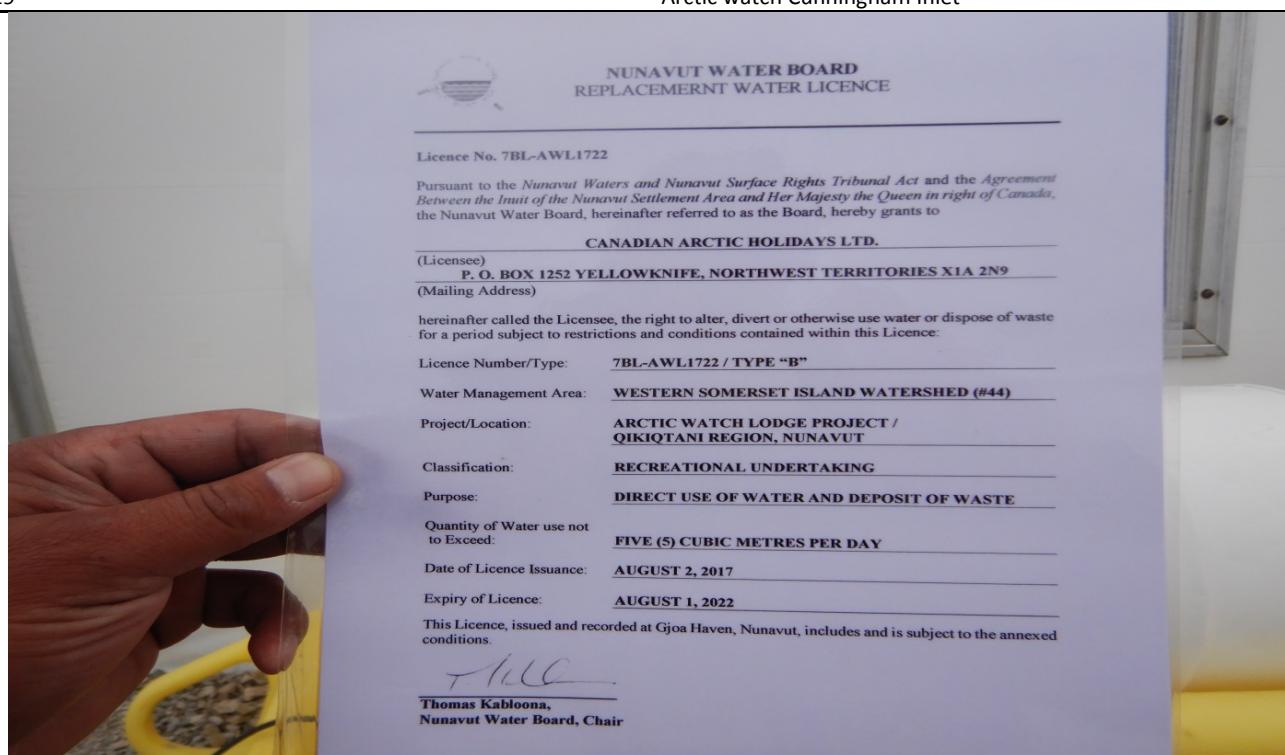
Photo 19

Description: Copy of Water Licence.
