WATER LICENCE INSPECTION FORM

Licensee	Licensee Representative
Weber Arctic Expeditions Ltd.	Richard Weber
License No. / Expiry	Representative's Title
7BL-AWL2333	Owner/ Operator
Land / Other Authorizations	Land / Other Authorizations
Lease 58F/2-1-2	
Date of Inspection	Inspector
July 11, 2023	Joseph Monteith & James Bolt
Activities Inspected <input checked="" type="checkbox"/> Camp <input type="checkbox"/> Drilling <input type="checkbox"/> Mining <input type="checkbox"/> Construction <input type="checkbox"/> Reclamation <input checked="" type="checkbox"/> Fuel Storage <input type="checkbox"/> Roads/Hauling <input checked="" type="checkbox"/> Other:

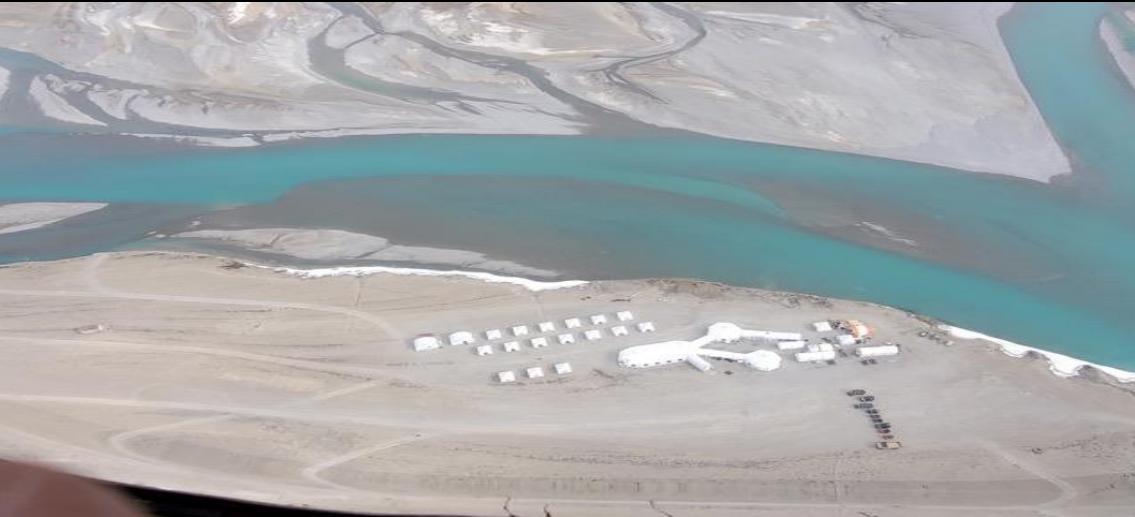
Date	Camera	Inspector		
July 11, 2023	Galaxy S9	Joseph Monteith		
Photo Log #	Location			
Photo 1	Arctic Watch, Cunningham inlet

Description: camp and structures used in relation to the project

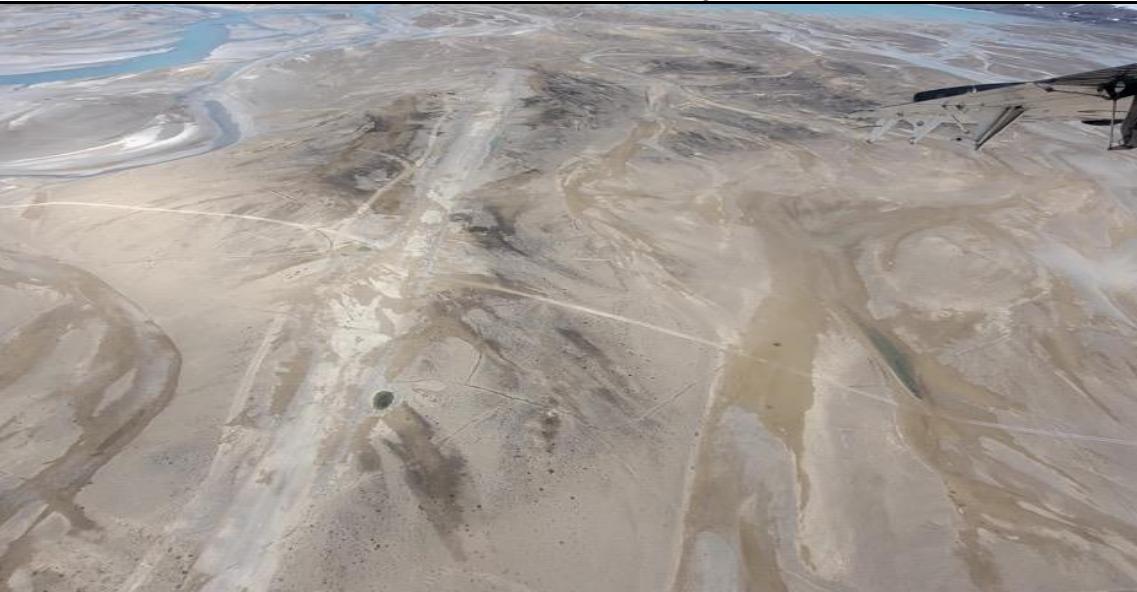
Photo Log #	Location
Photo 2	Arctic Watch Cunningham inlet

Description: Arctic Watch Airstrip at Cunningham River, Somerset Island, Nunavut.

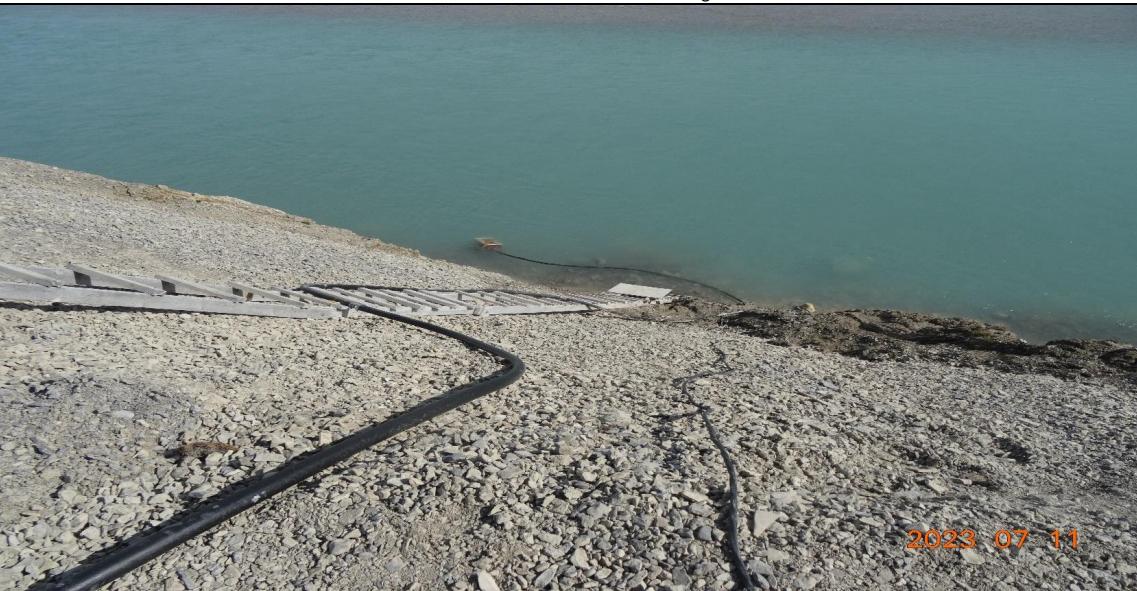
Photo Log #	Location
Photo 3	Arctic Watch Cunningham inlet

Description: Water withdrawal site. Fish Mesh Screen visible

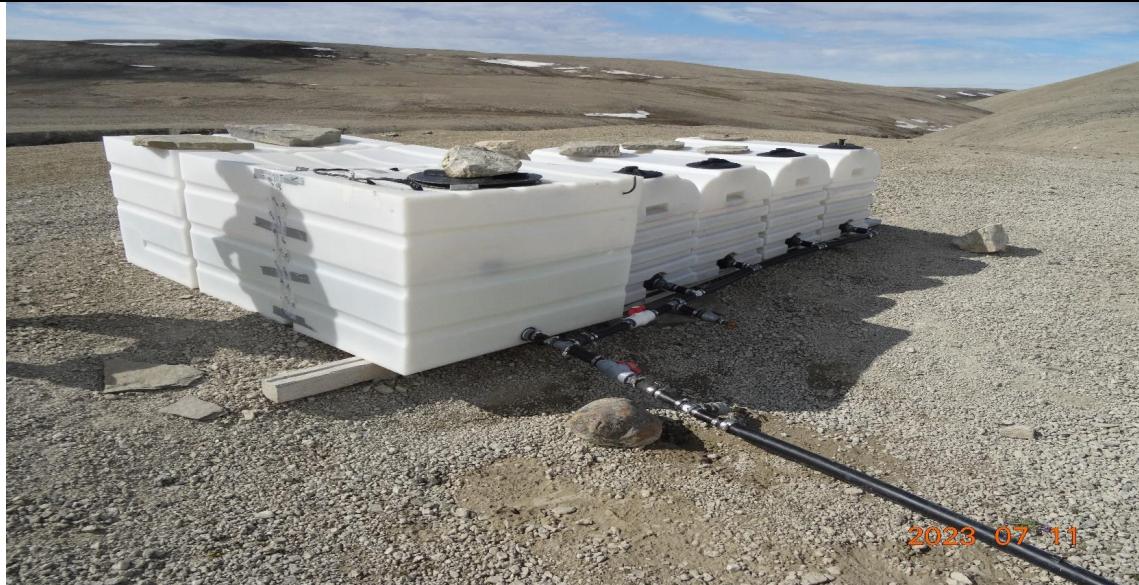
Photo 4

3. 5 water storage tanks. 1-500 Gallon, and 4-100 Gallon water storage tanks (photo 4).
4. Water meter photographed on July 11, 2023 showing 125325.6 US Gallons (474.40 m³) withdrawn (photo 5).
5. Water Usage Logs from June 14, 2023 to July 2, 2023 shows 123386 US Gallons (467.06 m³) were withdrawn. Water meter and Water usage log recordings do not have same information on the day of inspection. Total water withdrawn during that time did not exceed the daily withdrawal amount of 5m³ (photo 6).
6. Water Usage Logs from July 16, 2023 to August 23 shows 123386 US Gallons and cubic metres. Log book indicates below 5m³ daily withdrawal of water from the Cunningham River (photo 7).

Description: 1-500 Gallon, and 4-100 Gallon water storage tanks

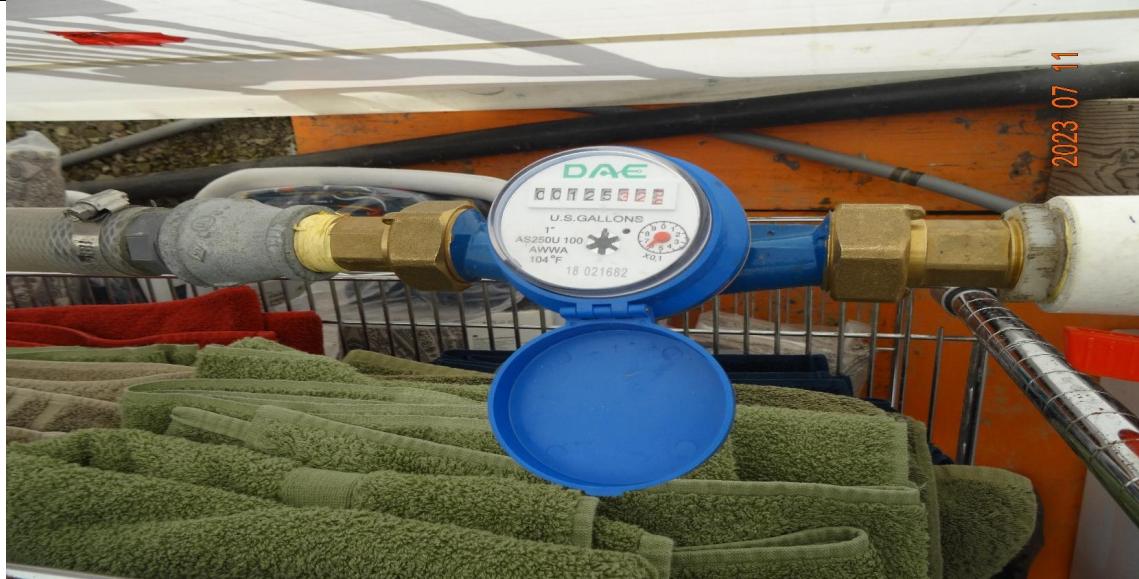
Photo 5

Description: DAE Water Meter reads 125325.6 US Gallons

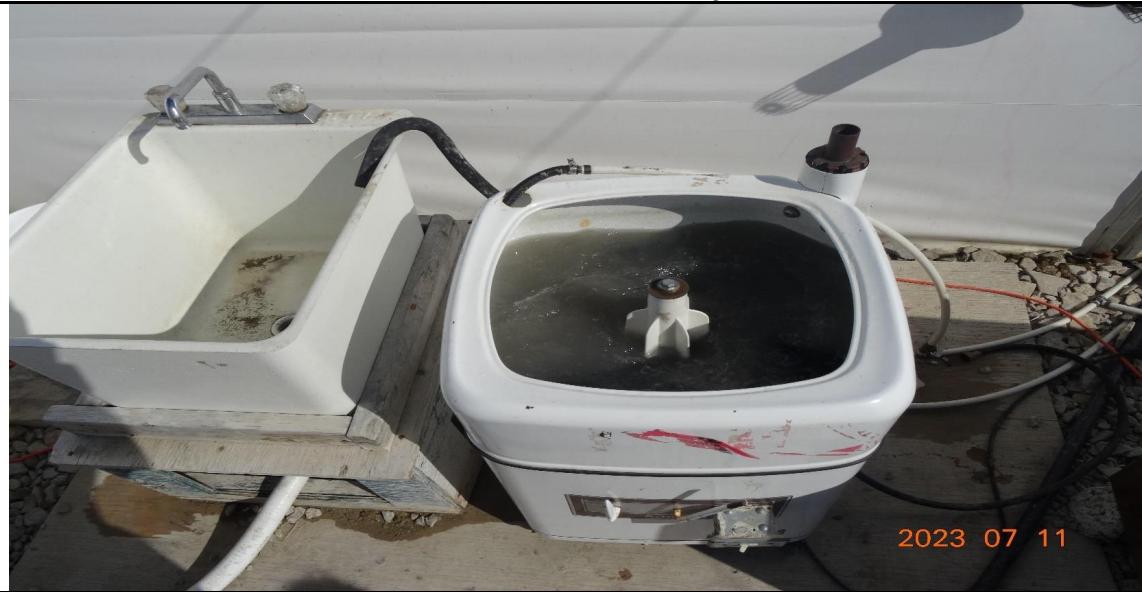
Photo 8

Description: 2 washing stations with grey water.

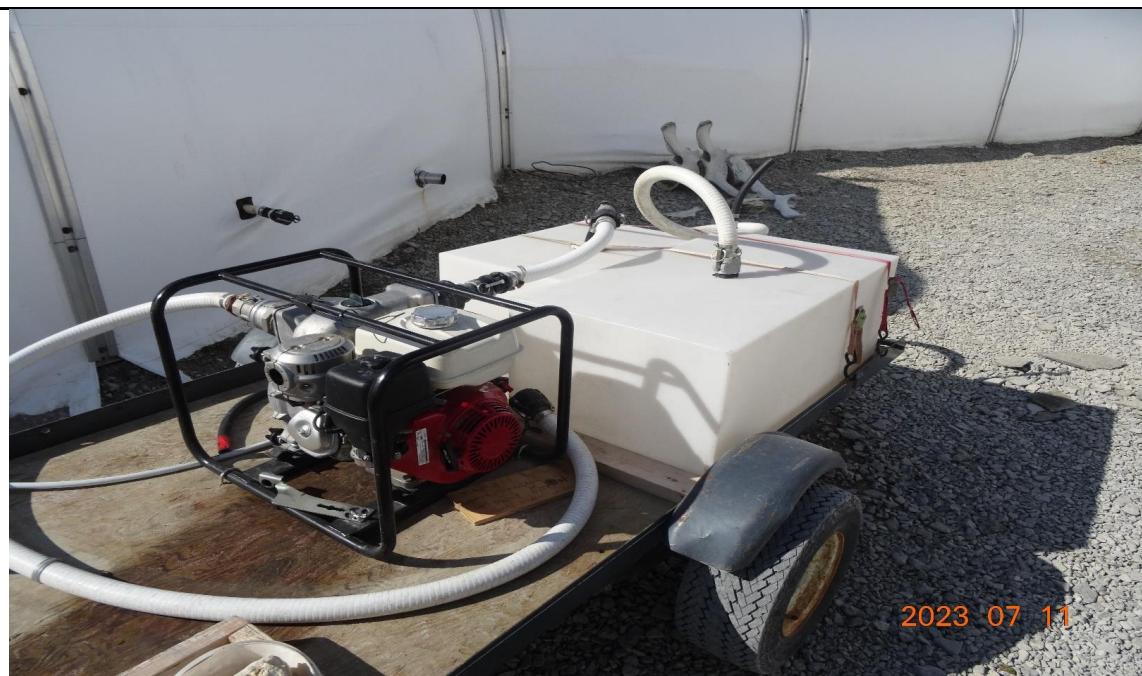
Photo 9

Description: mobile sewage tank.

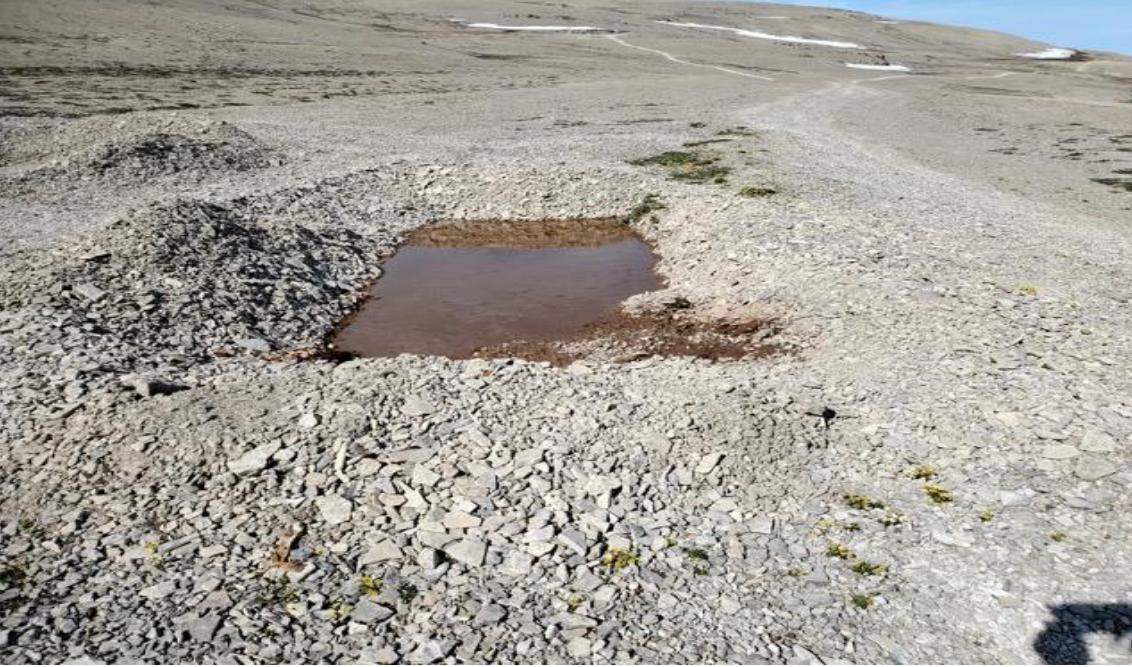
Photo Log #	Location
Photo 11	Arctic Watch - Cunningham inlet

Description:2 of 2 sump pits.

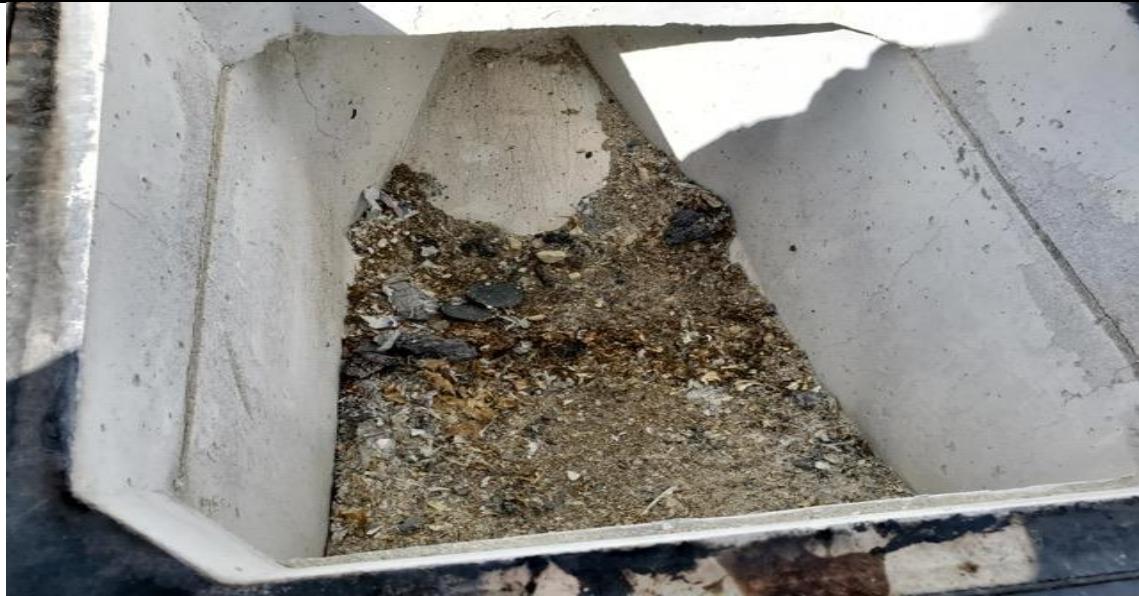
Photo 14

Description: Inside the Incinerator. Incinerated debris, typically drummed up in empty fuel drums, and flown to an approved waste disposal facility in Yellowknife, NT.

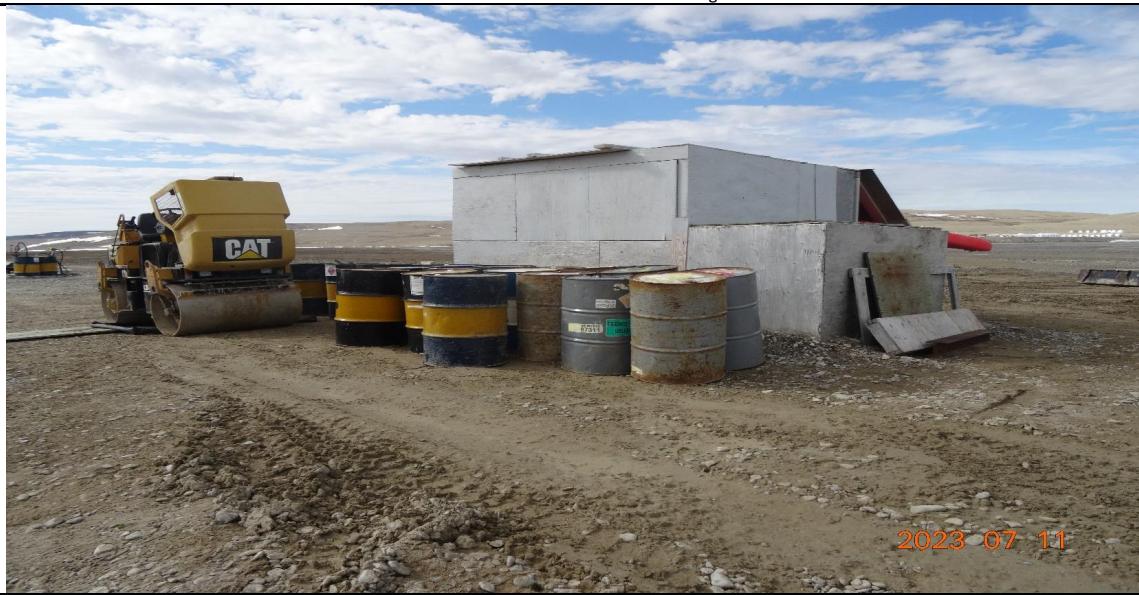
Photo 15

Description: Behind vehicle and waste drums storage at the airstrip

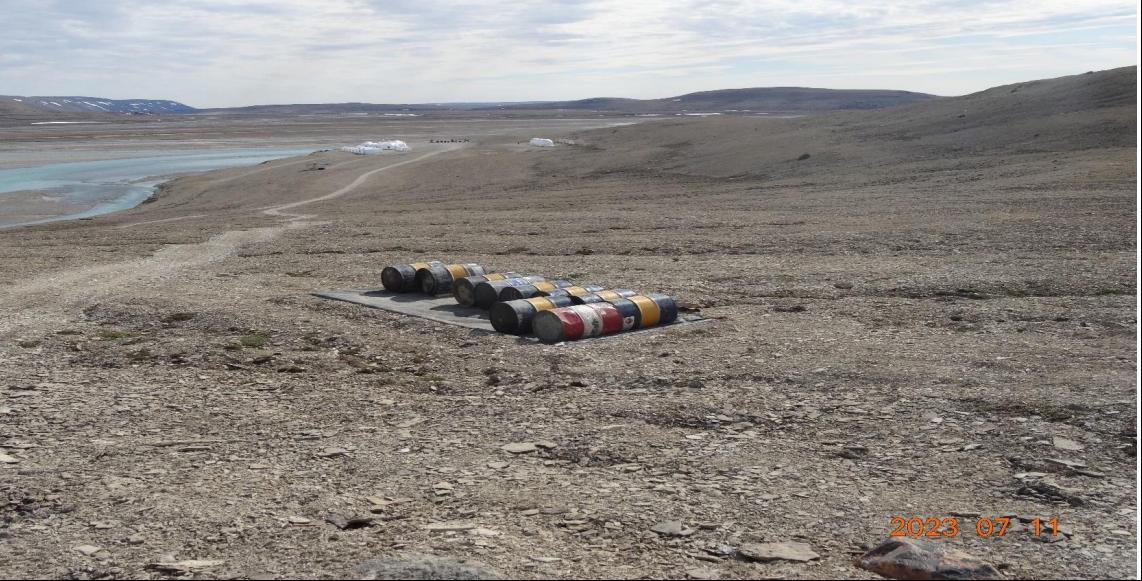
Photo Log #	Location
Photo 16	Arctic Watch Cunningham inlet

Description: Empty Waste drums on a lined pad with timbers to contain any wastes at Solid Waste Facility.

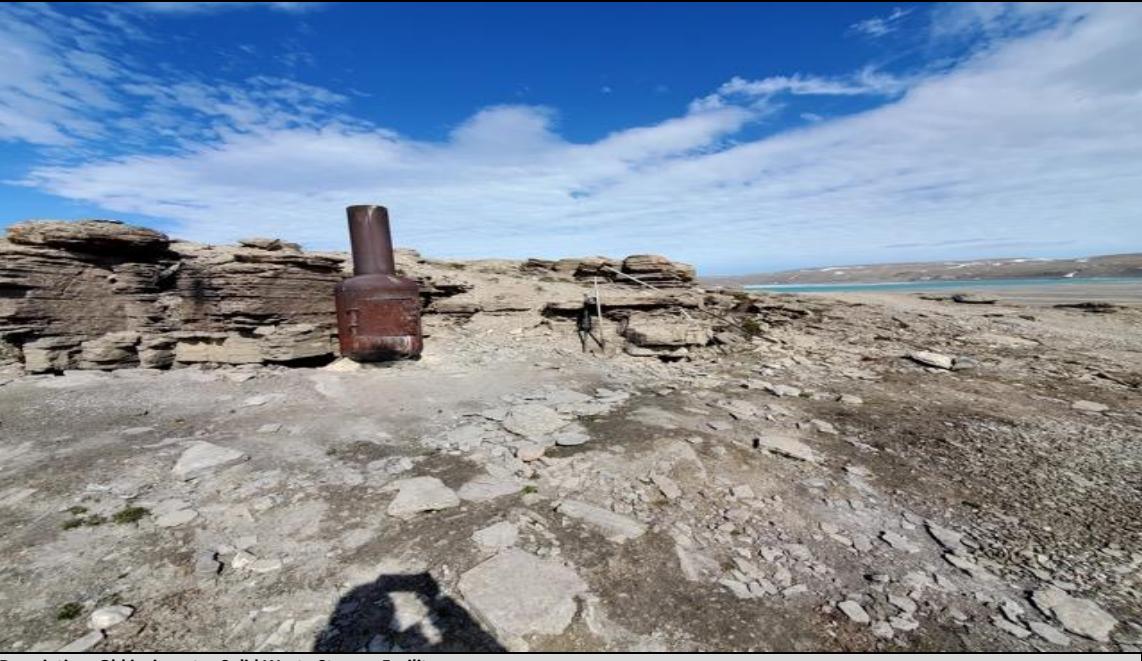
Photo Log #	Location
Photo 17	Arctic Watch Cunningham inlet

Description: Old incinerator Solid Waste Storage Facility

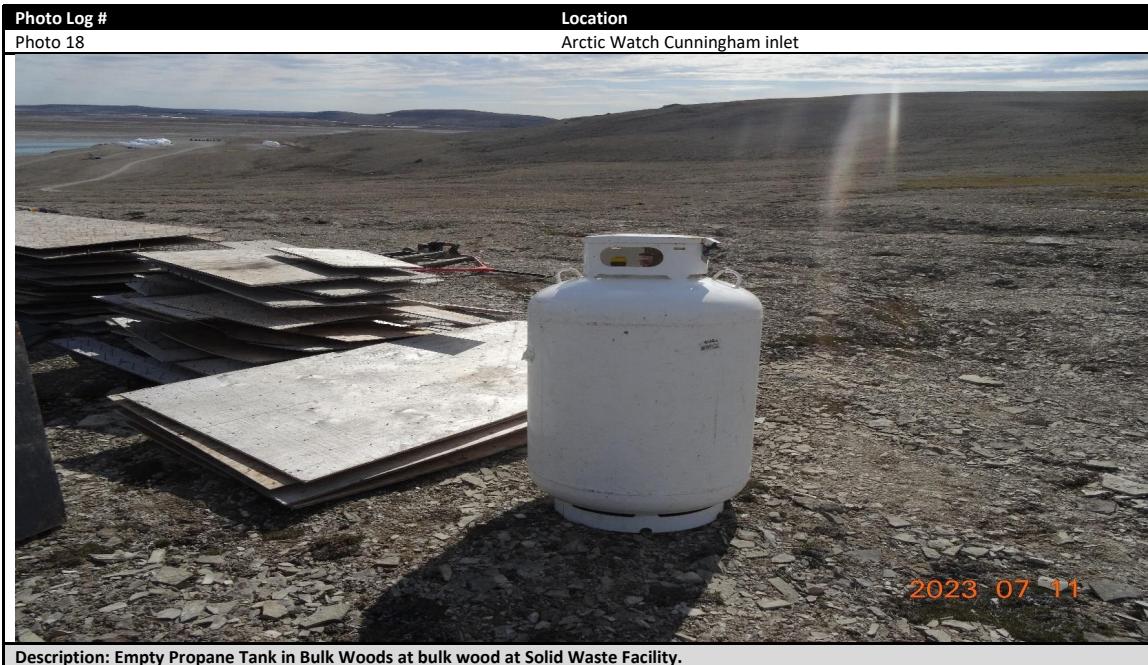
Description: Empty Propane Tank in Bulk Woods at bulk wood at Solid Waste Facility.

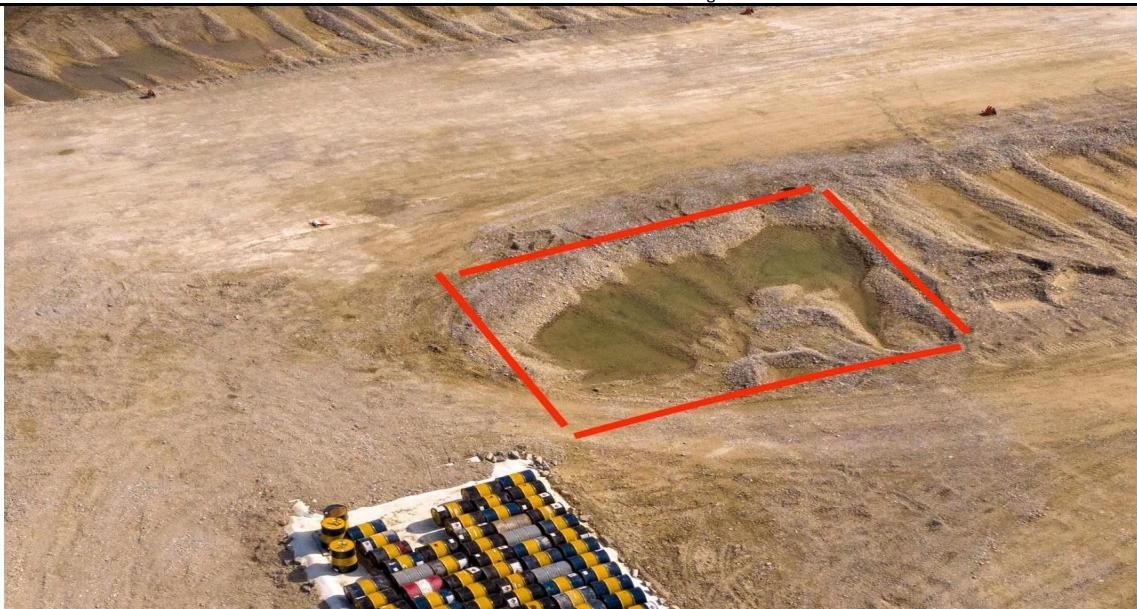
Photo Log #
Photo 20

19. Fuel Cache #1 was within 31 metres of the nearest adjacent water body. Reclamation of the drainage ditch was conducted. This is now deemed to be compliant with requirement to store fuel cache 31 metres away from the high water mark. Prior notification provided to the inspector, and the NWB on July 22, 2023.

Description: Fuel cache secondary contaminant. Drainage ditched within 31 metres of fuel cache. Photo submitted by Weber Arctic Expeditions Ltd.

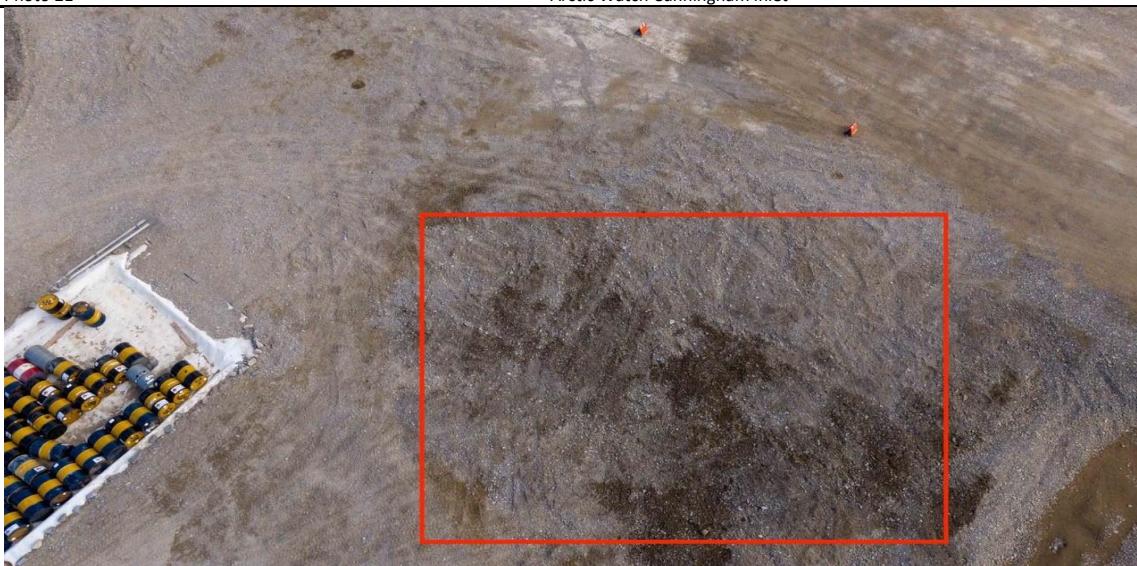
Photo Log #
Photo 21

Description: Fuel Cache secondary contaminant. Drainage ditched filled in with gravel to comply with the requirement to be 31 metres from the Ordinary High Water Mark of any adjacent water bodies.

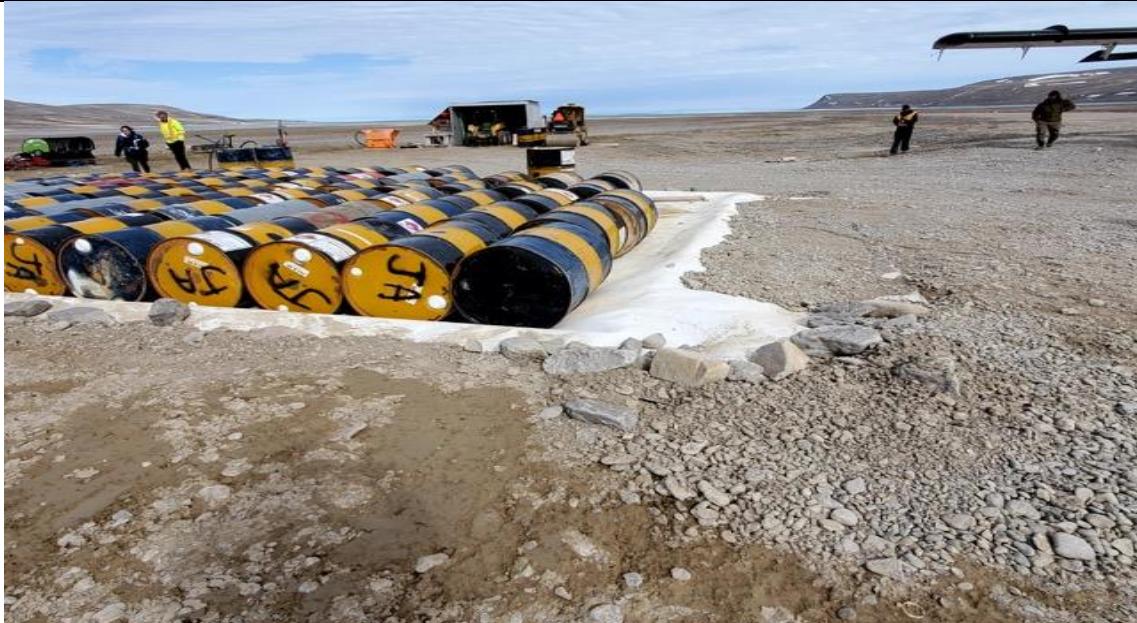
Photo Log #
Photo 22

Description: Fuel Cache secondary containment walls are flush with the surrounding landscape. 19 barrels on top of liner. Also a fuel transfer station.

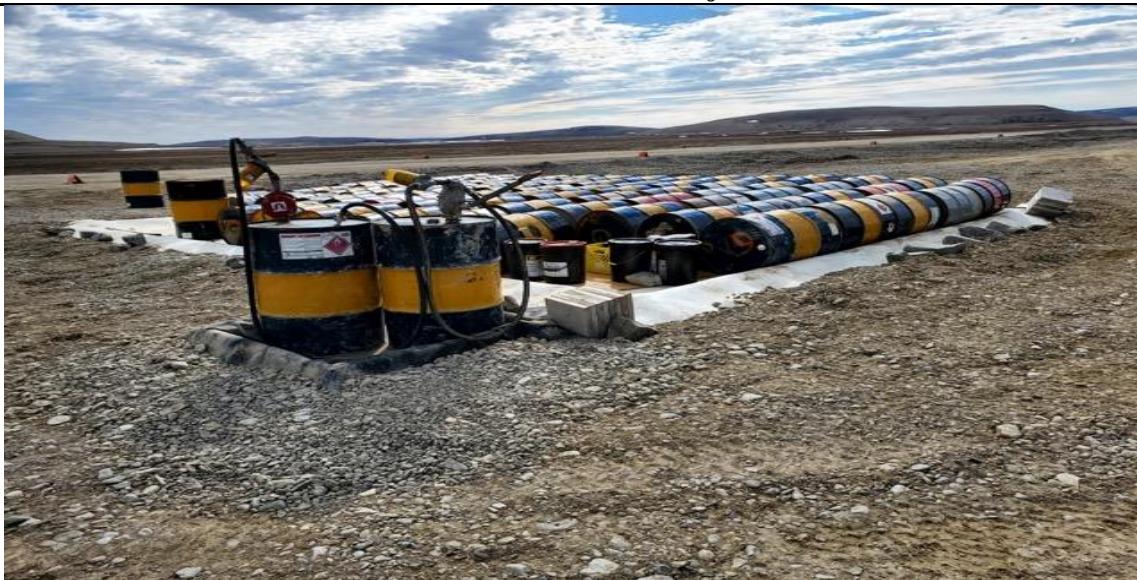
Photo Log #
Photo 23

Description: Fuel Cache in secondary containment walls are slightly elevated with the surrounding landscape. Approximately 77 barrels on top of liner. Also a fuel transfer station with two drums.

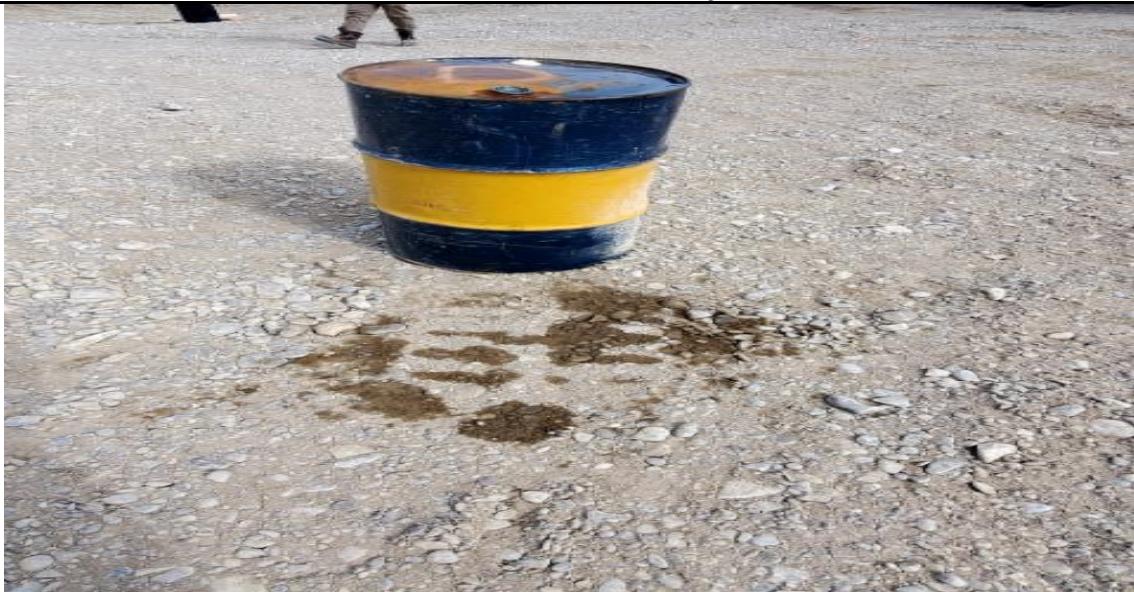
Photo Log #	Location
Photo 24	Arctic Watch Cunningham inlet

20. Drum with minor spills. Drum outside of secondary containment (photo 24).
21. 5 Propane storage tanks. 4 medium, 1 large tanks (photo 25).
22. 900 Litre Storage tank, with drip pan for secondary containment. (photo 26).

Description: Minor spill from a drum outside secondary containment.

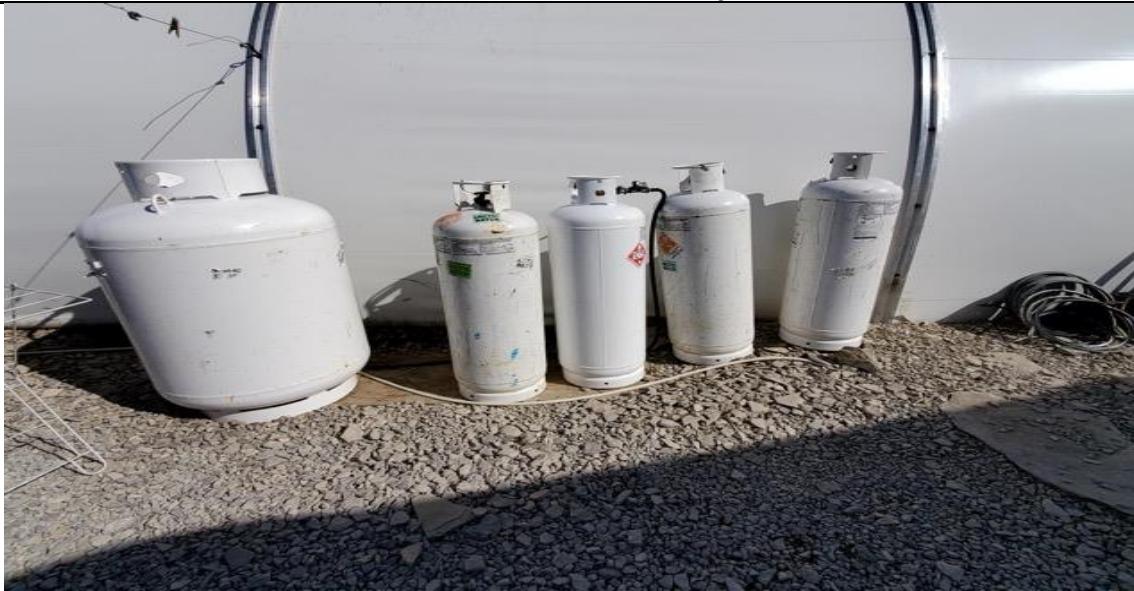
Photo Log #	Location
Photo 25	Arctic Watch - Cunningham inlet

Description: 1 large propane tank, 4 medium propane tanks.

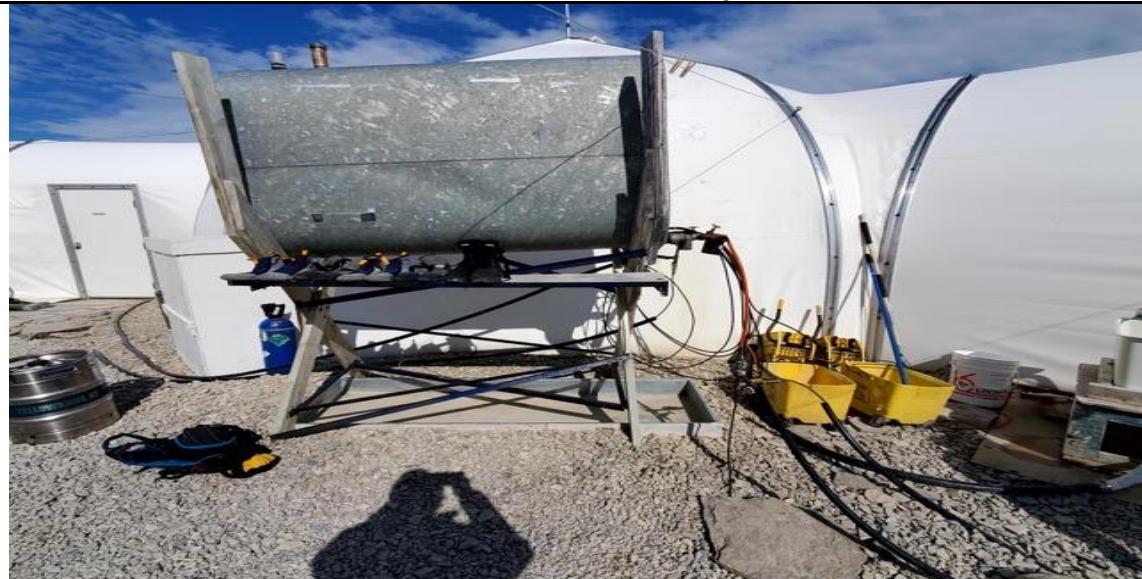
Photo 26

Description: 900 Litre Fuel Storage tank with secondary containment drip pan. Connection points outside of secondary containment

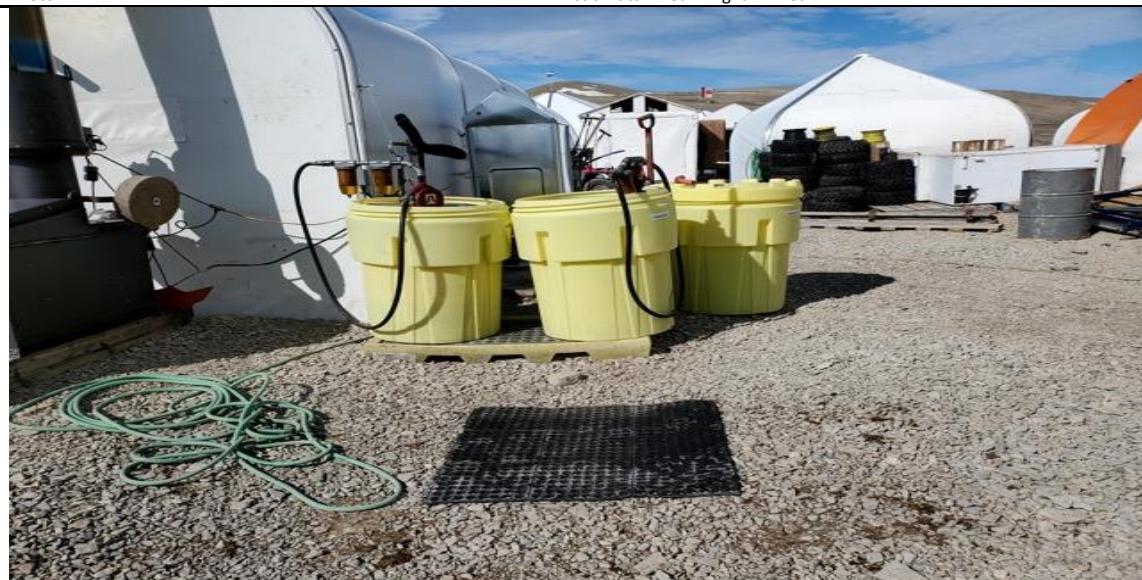
Photo 27

23. The Fuel Transfer Area, drums in secondary containment drums spill kit drums, and on top of a secondary containment pallet. Signs of minor spills. Secondary containment berm set up to capture any spills from the hose post inspection. (photos 27 and 28).

Description: Fuel Storage tank with fuel transfer equipment in spill kit containment. 2 x spill kits containment on top of secondary containment pallet. 1 x spill kit. Sign of minor spills. Photo 30 shows installation of a drip pan to capture spills from the fuel line during fuel transfer.

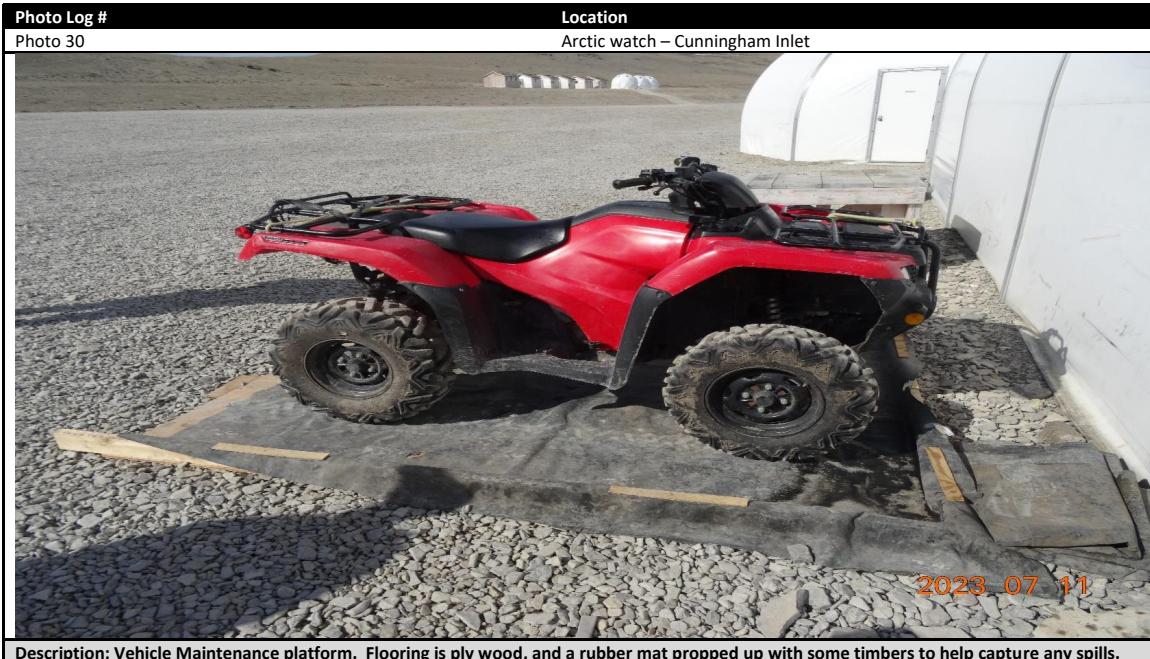
24. Double walled fuel storage tank in secondary containment (photo 29).
25. All-Terrain Vehicle(ATV) parked on the vehicle maintenance pad, rubber matting over some timbers provides secondary containment for leaks and spills while servicing (photo 30).

Description: Vehicle Maintenance platform. Flooring is ply wood, and a rubber mat propped up with some timbers to help capture any spills.
