Letter to CIRNAC regarding the Contaminated Soils Stockpile

Subject: Report on Soil Stockpile Construction During Airport Improvements at the Eureka High Arctic Weather Station (HAWS)

**PUBLIC SERVICES AND PROCUREMENT CANADA
EUREKA AIRSTRIP RECAPITALIZATION PROJECT
Contaminated Soil Stockpile - Construction Report**

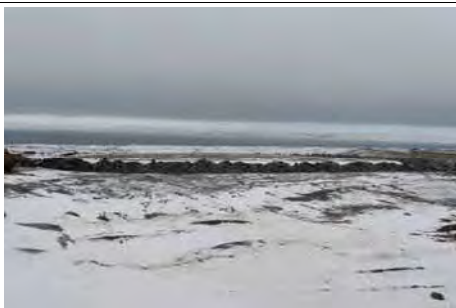
Preparing Top of Stockpile for Liner Cover

SEPTEMBER 17, 2020 - Prepared Cover and Anchor Trench

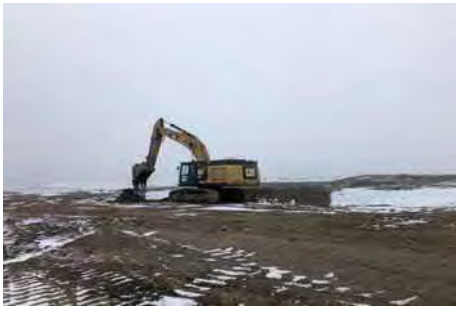
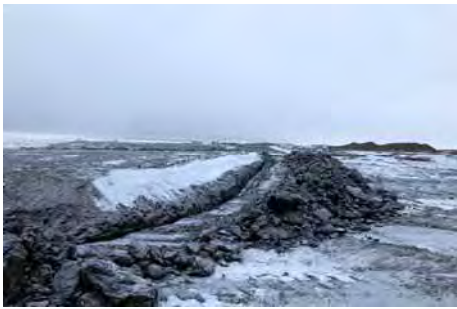
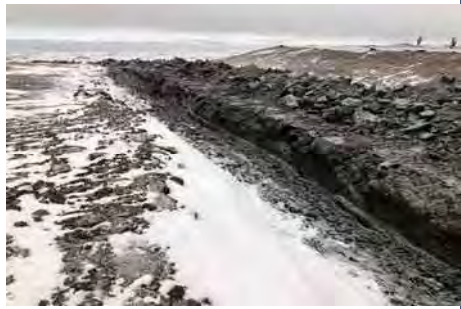
Anchor Trench Construction		
SEPTEMBER 15, 2020 - Excavation of Anchor Trench	SEPTEMBER 15, 2020 - Completed Anchor Trench	SEPTEMBER 17, 2020 - Completed Anchor Trench

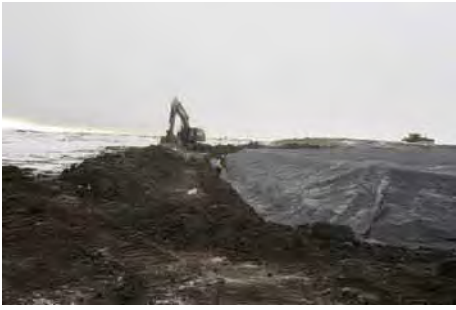
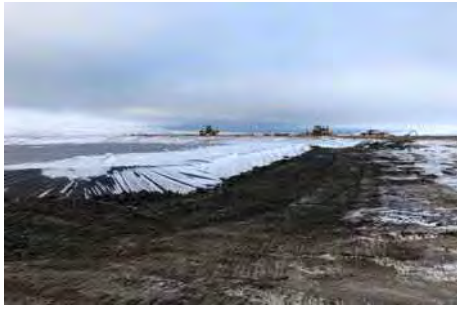
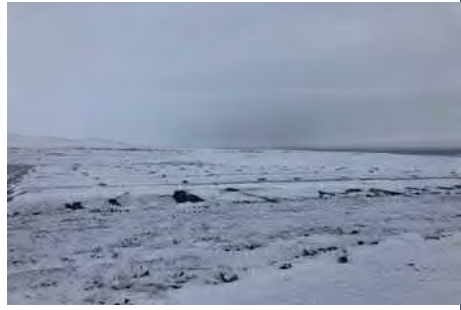
Cover Liner Installation		
SEPTEMBER 17, 2020 - Cover Liner installation	SEPTEMBER 19, 2020 - Backfilled Anchor Trench	SEPTEMBER 23, 2020 - Sandbag Placement on Cover Liner

<p>Contruction Comments:</p> <p>Ramp constructed on East side of contaminated soil stockpile</p> <p>Liner panels placement mirrored from design (overlapped West to East)</p> <p>Liner cover could not be installed immediately after contaminated soil placement is complete due to delay in delivery of liner (very poor conditions of airstrip)</p>		
Attached documents : As-builts (Stockpile Base, Berms, Contaminated Material, Base and Cover Liner)
