Nunavut Water Board

Water License 8BC-EUR1621 2020 Annual Report

Date: March 2021

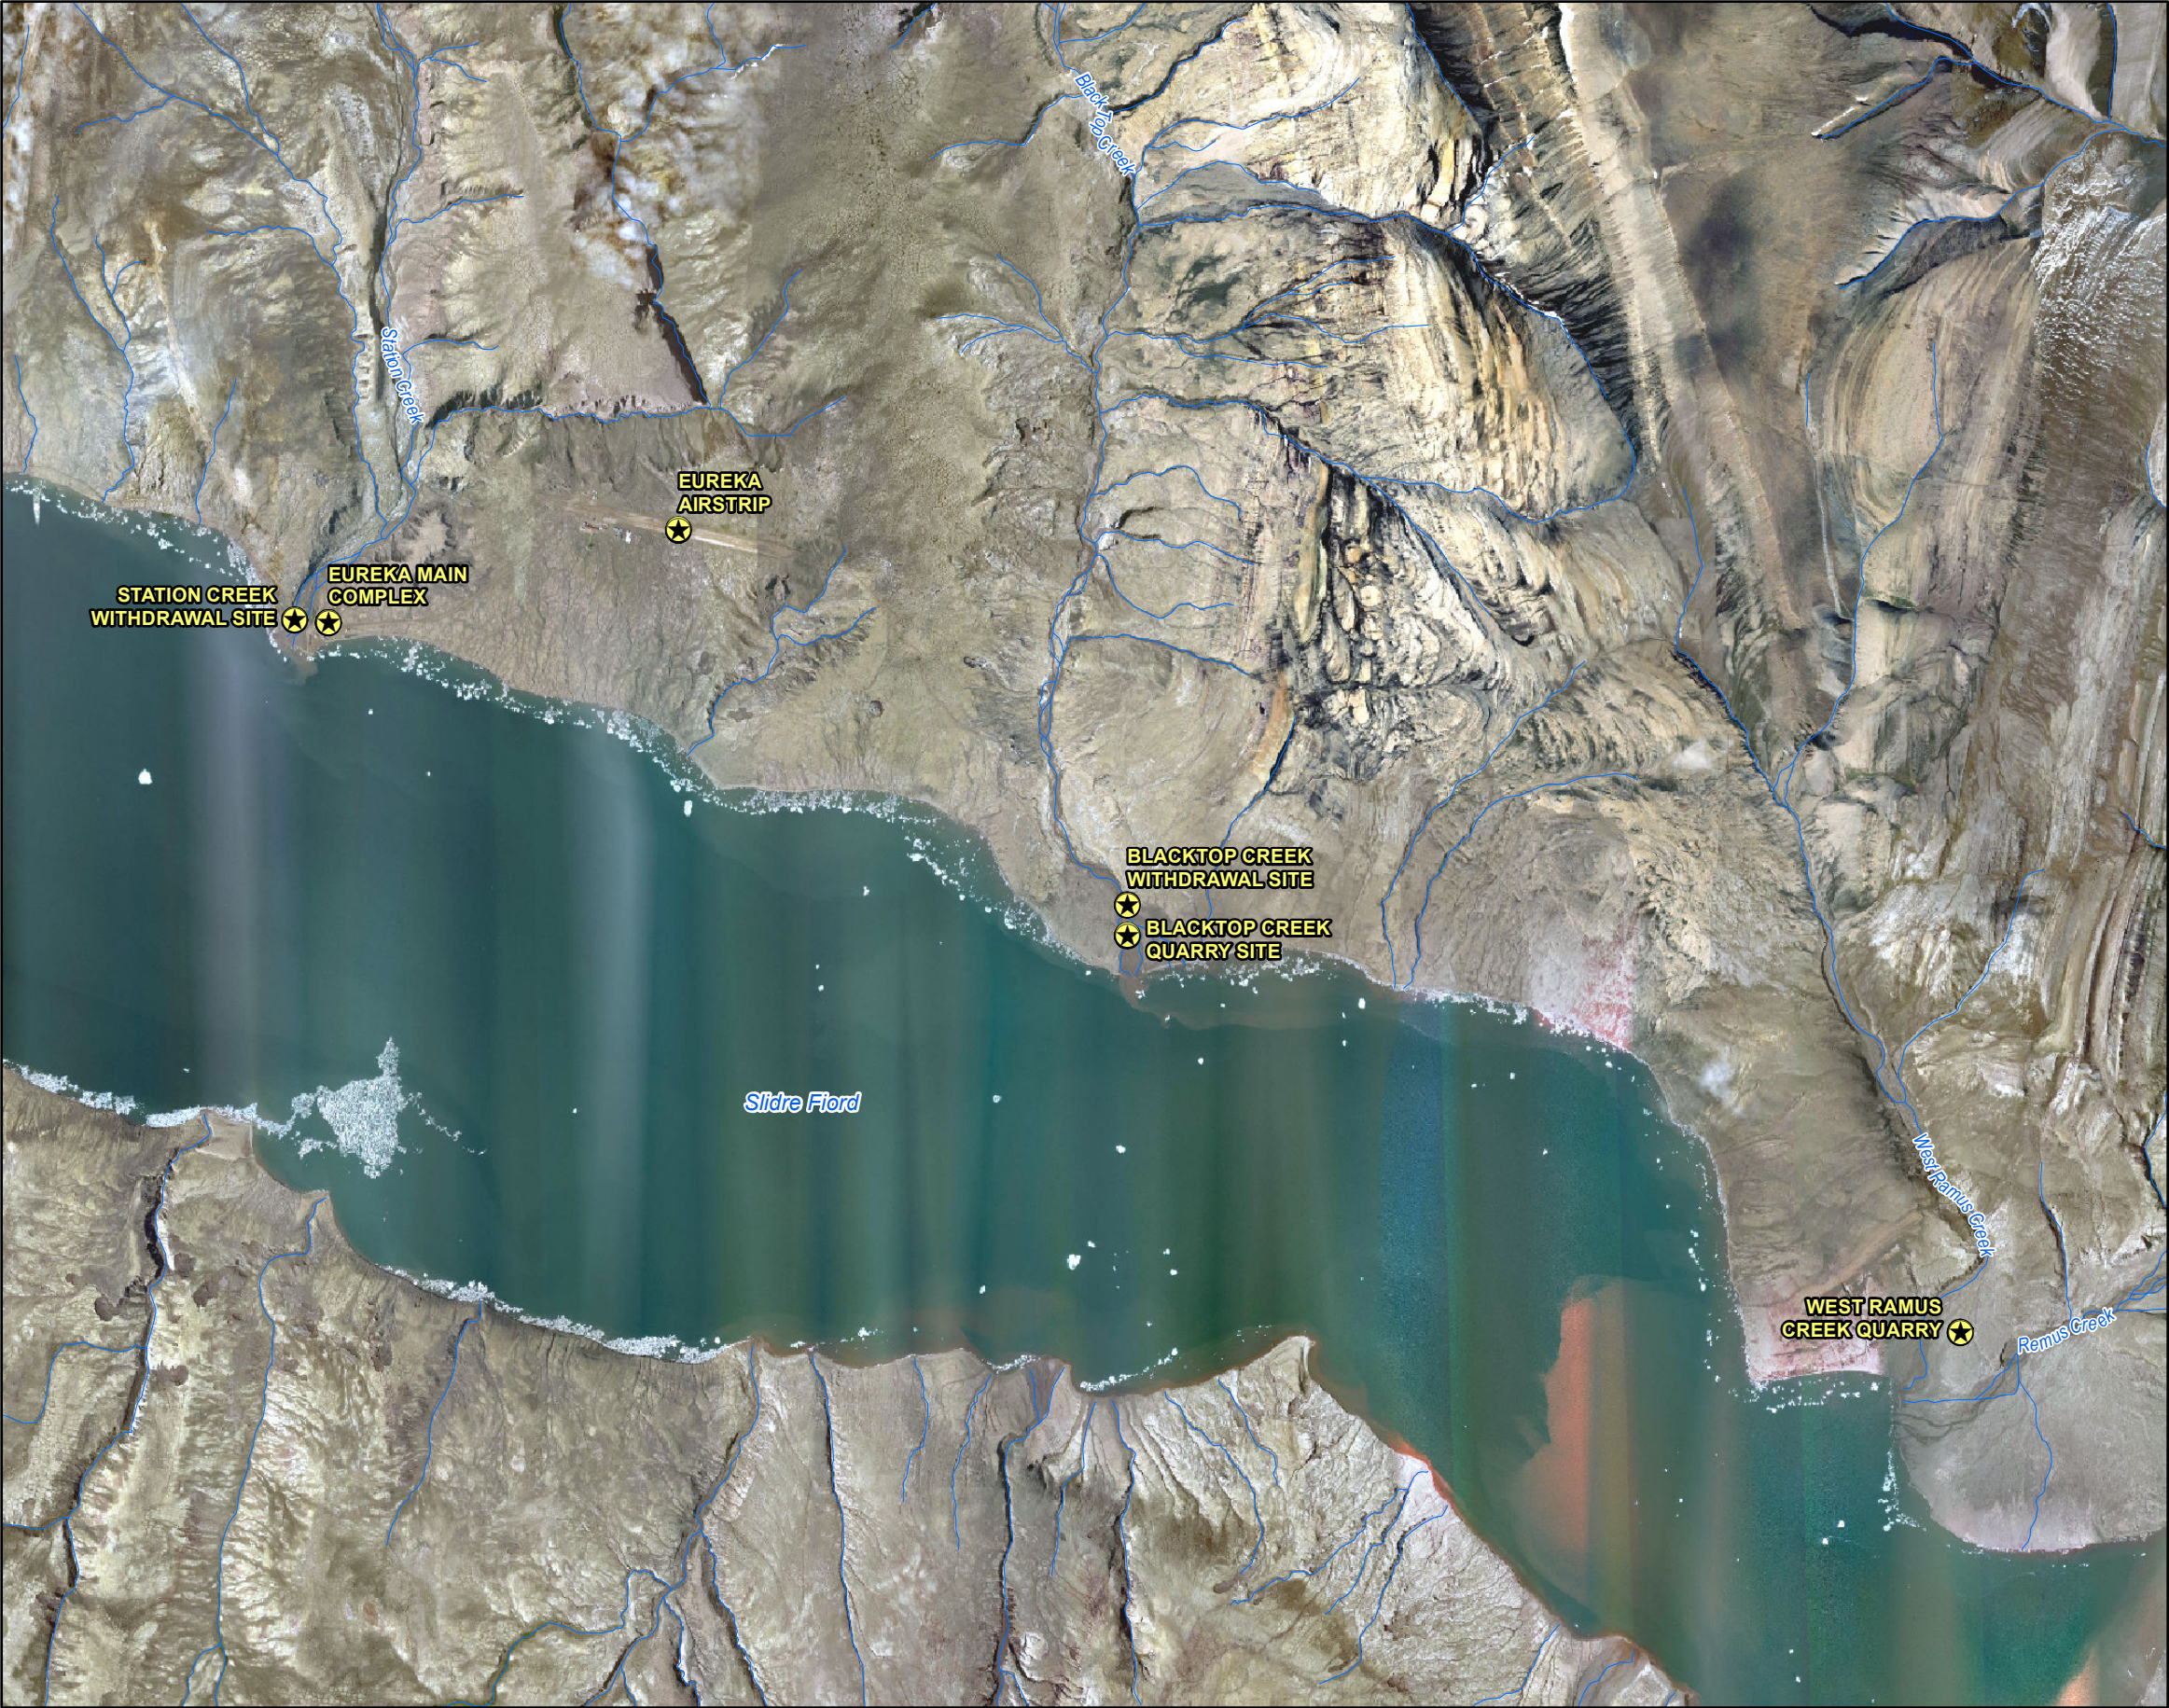
From July 10 to September 4, 2020 water was incorrectly extracted from Blacktop Creek (**Figure 1**) using a 3/8' mesh screened intake hose for dust suppression. PSPC has since advised that only West Remus Creek should be used for dust suppression purposes and the contractor has altered their procedures accordingly. The incorrect withdrawal of water from Blacktop Creek has been reported as a non-compliance to the NIRB in the 2020 NIRB Annual Report (AECOM, 2020). PSPC and their consulting team will work more closely with contractors throughout the year to ensure and improve compliance requirements.

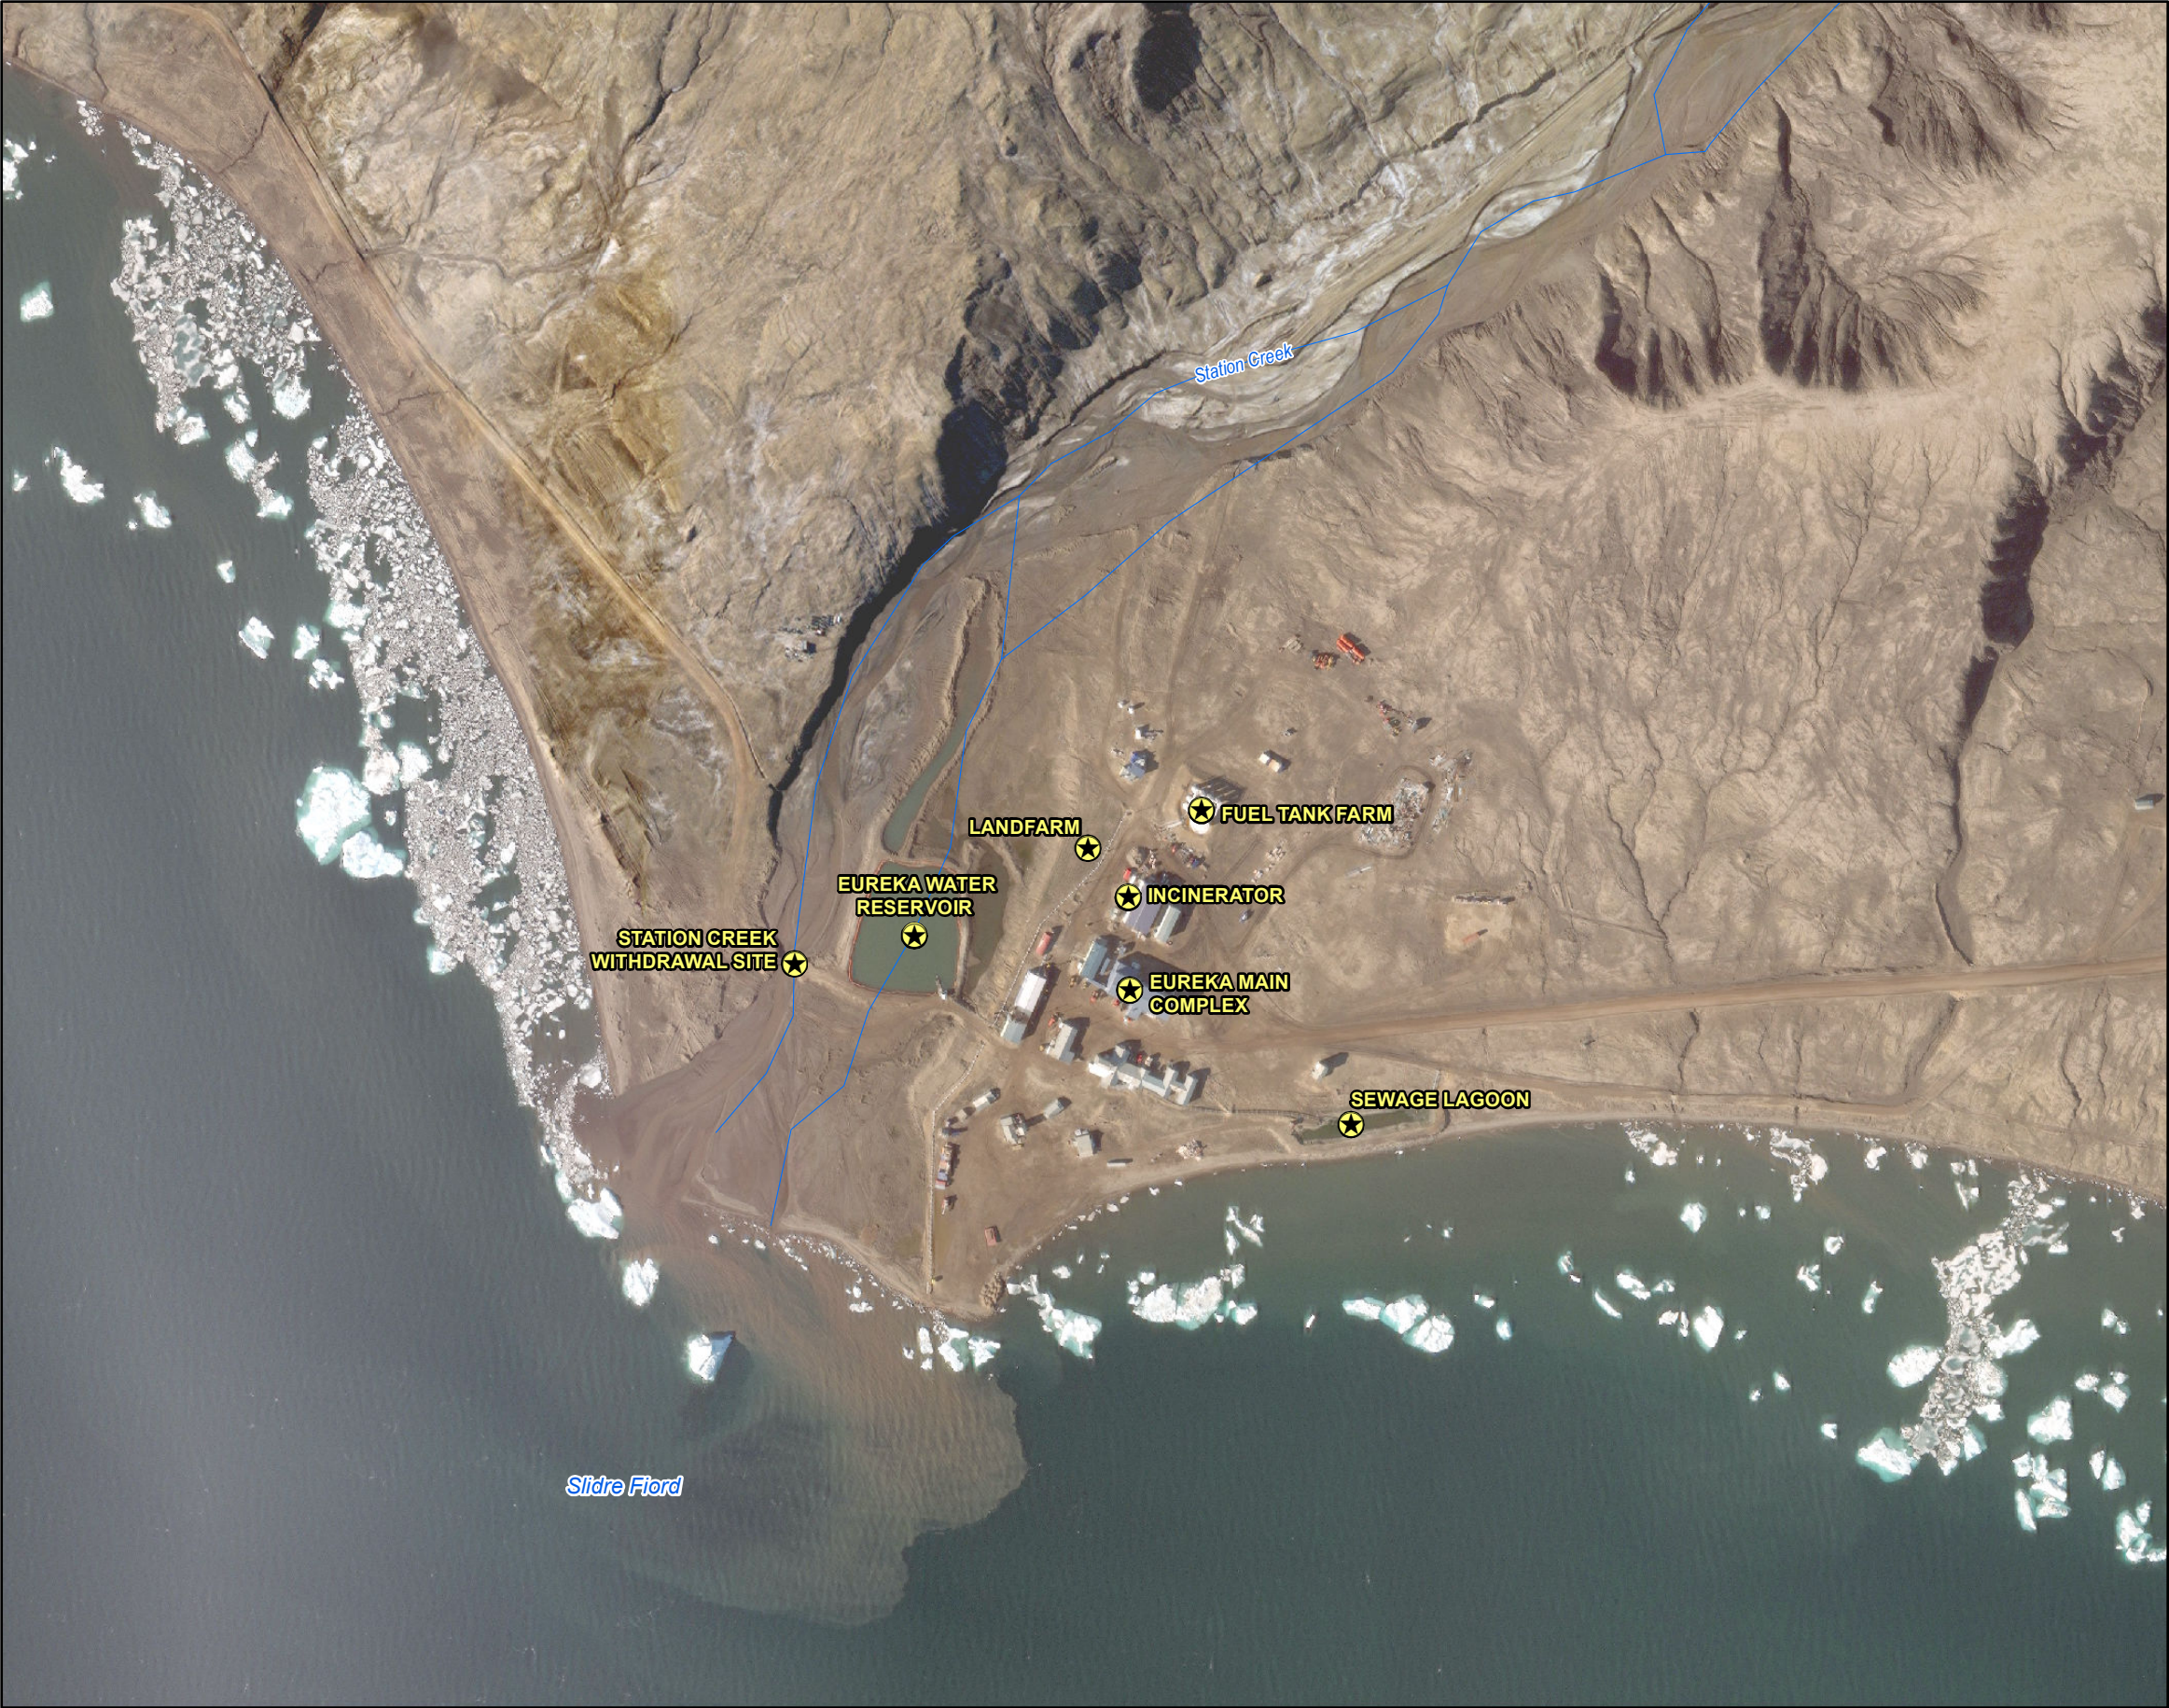
The Eureka HAWS obtains its water for domestic purposes from Station Creek (**Figure 2**). The water is pumped from Station Creek into the Eureka Water Reservoir using a Franklin Electric FLS-400 pump. Pumping occurs shortly after water starts flowing in Station Creek to maximize the amount of fresh runoff into the Eureka Water Reservoir. Station Creek eventually stops flowing until a second flow begins when the permafrost melts. At this time water is pumped again to ensure the Eureka Water Reservoir is full prior to freeze up.

Blackwater at the Eureka HAWS is collected with Pacto toilets and is then incinerated on site; whereas, greywater is pumped to the Sewage Lagoon (**Figure 2**).

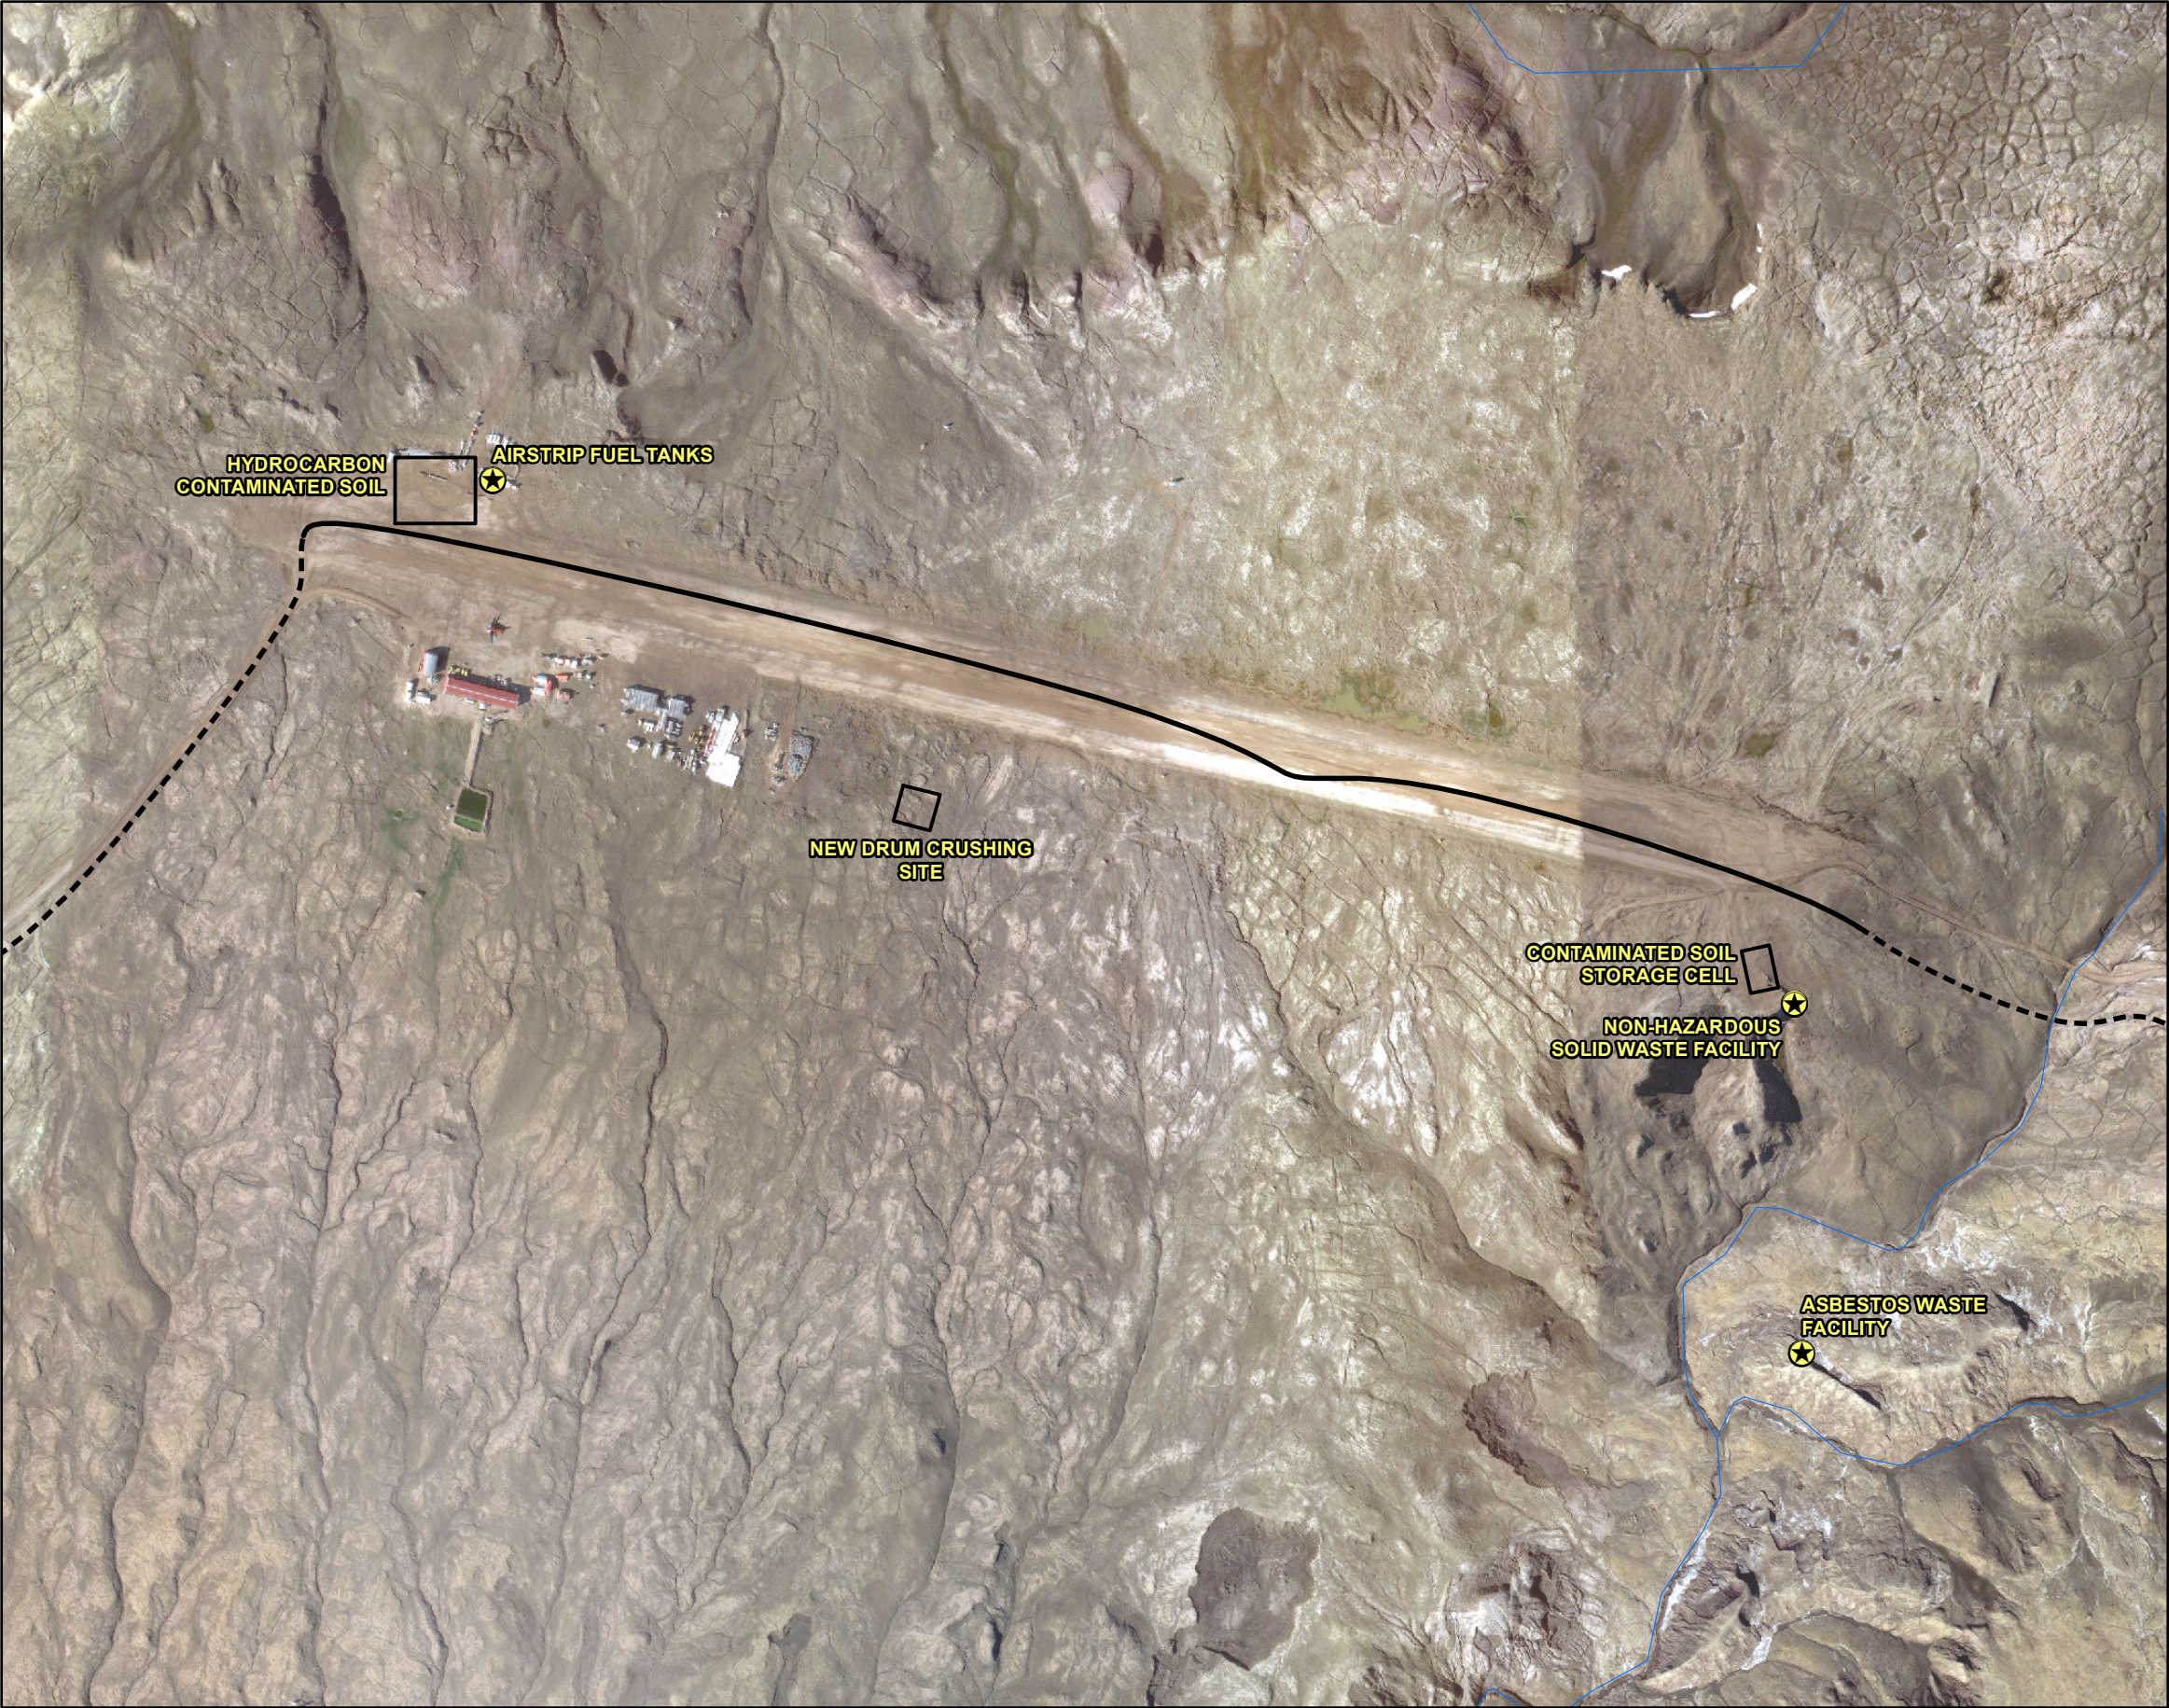
Table 2 provides locations of waste disposal sites at Eureka HAWS and **Figure 3** shows the various waste storage facilities, which includes:

The New Drum Crushing Site and Contaminated Soil Storage Cell are approximate locations

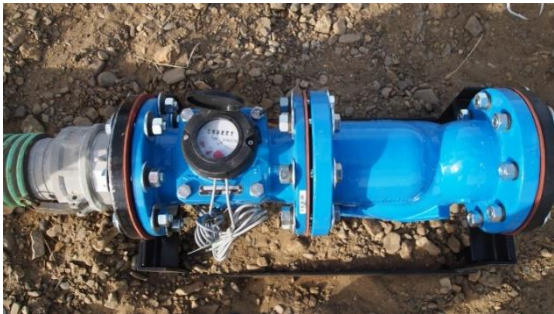
#	Non-Compliance Identified in CIRNAC Report	Water License Item Related to Identified Non-compliance	Timeline	Recommended Mitigation Measures	Status as of December 31, 2020
1	The Licensee shall install flow meters or other such devices, or implement suitable methods required for the measuring of Water volumes as required under.	Part B: Item 3; Part J: Item 2	Summer 2020 Given the current COVID-19 situation, timeline may be impacted if the contractor cannot access the site	Flow meters will be installed at the two following locations: <ul style="list-style-type: none">▪ In the raw water pump house▪ After the portable pump used to discharge the wastewater lagoon. The selection of the flow meters is ongoing and purchase order to be initiated shortly.	Flow meters have been received and are in use.

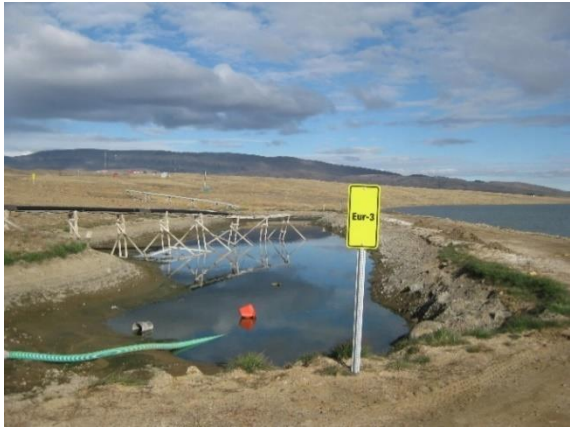
2	Freeboard of 1.0 metre, or as recommended by a qualified geotechnical Engineer and as approved by the Board, shall be maintained at all dykes and earth-fill structures associated with the Water Supply Facilities.	Part C: Item 4	Spring 2020 Given the current COVID-19 situation, timeline may be impacted if the contractor cannot access the site	Measures to monitor the level of wastewater in the lagoon will be increased to ensure that the 1.0 metre freeboard is maintained at all times. Should the wastewater level come close to the limit, ECCC management shall be notified as early as possible. ECCC is exploring the possibility of raising the dyke.	Freeboard is maintained and monitoring continues.

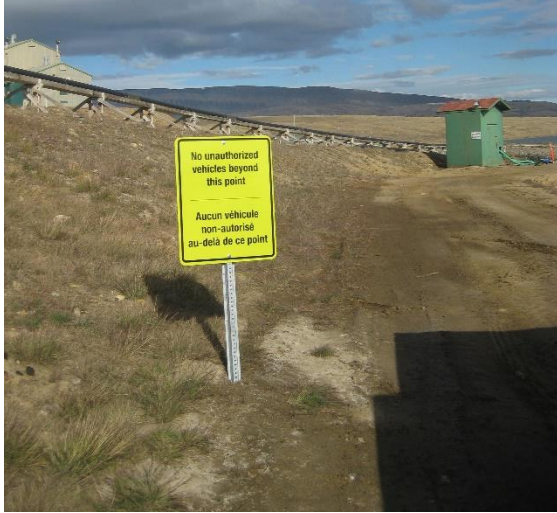
#	Non-Compliance Identified in CIRNAC Report	Water License Item Related to Identified Non-compliance	Timeline	Recommended Mitigation Measures	Status as of December 31, 2020
3	The Licensee shall not cause erosion to the banks of any body of water and shall provide necessary controls to prevent such erosion.	Part C: Item 7	Summer 2020 Given the current COVID-19 situation, timeline may be impacted if the contractor cannot access the site	Banks will be repaired. Furthermore, ECCC will establish an exclusion zone around the raw water reservoir and the wastewater lagoon to prevent erosion. Heavy vehicles will be excluded from the zone and all stakeholders will receive a written notification. In addition, high visibility signage will be installed at the boundary of the zone to warn heavy vehicles not to approach. This signage is to be clearly visible in all weather conditions. Also, Station Program Manager will brief all incoming visitors and contractors when they arrive on site about these procedures.	Signs have been installed. Banks are repaired. Directive is in effect and is being followed by station staff and visitors.

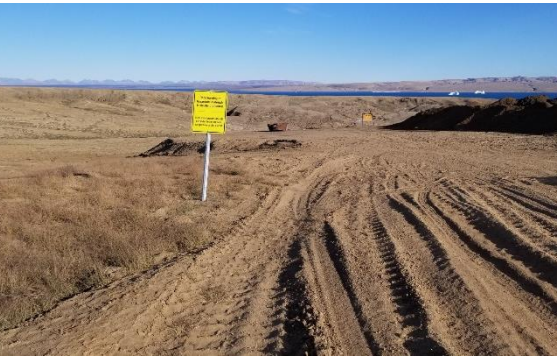
4	The Licensee shall not open burn plastics, wood treated with preservatives, electric wire, Styrofoam, asbestos or painted wood to prevent the deposition of waste materials of incomplete combustion and/or leachate from contaminated ash residual, from impacting any surrounding waters, unless otherwise approved by the Board in writing.	Part D: Item 3	2020	ECCC management will notify all station occupants (including subcontractors and other government organizations) that open burning of such materials is strictly prohibited. This directive will be written in the upcoming Standard Operating Procedures for the station. Also, Station Program Manager will brief all incoming visitors and contractors when they arrive on site about these procedures. Finally, clear signage will be installed near burning locations.

Sign has been installed next to the burning location. Directive is in effect and is being followed by station staff and visitors.
