Subject: Report on Soil Stockpile Construction During Airport Improvements at the Eureka High Arctic Weather Station (HAWS)

**PUBLIC SERVICES AND PROCUREMENT CANADA
EUREKA AIRSTRIP RECAPITALIZATION PROJECT
Contaminated Soil Stockpile - Construction Report**

PHOTO LOG

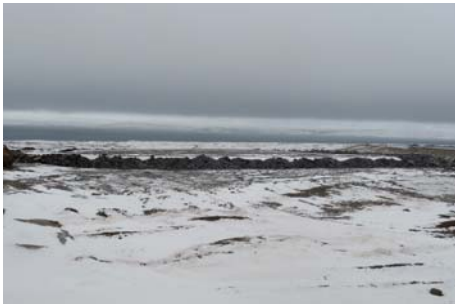
Preparing Top of Stockpile for Liner Cover

SEPTEMBER 17, 2020 - Prepared Cover and Anchor Trench

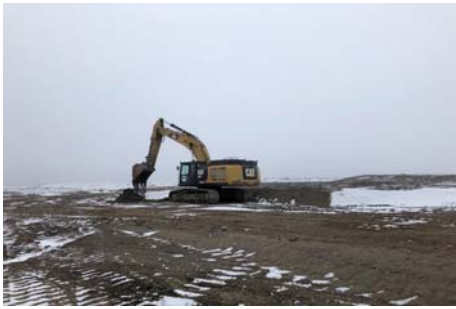
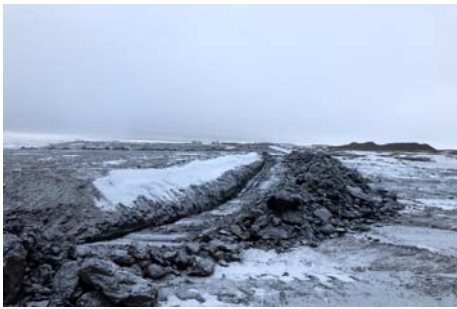
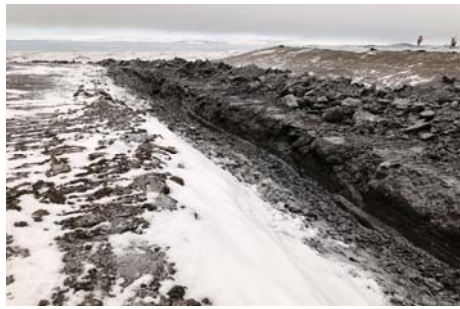
Anchor Trench Construction		
SEPTEMBER 15, 2020 - Excavation of Anchor Trench	SEPTEMBER 15, 2020 - Completed Anchor Trench	SEPTEMBER 17, 2020 - Completed Anchor Trench

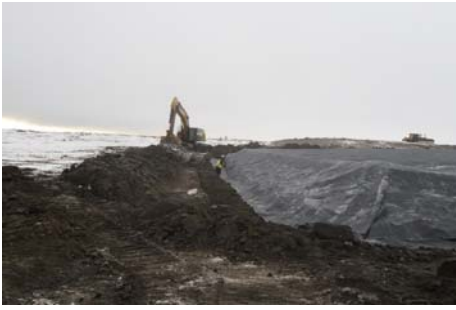
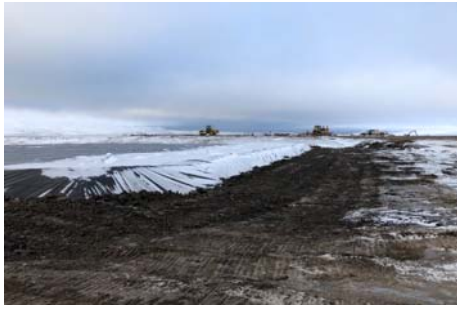
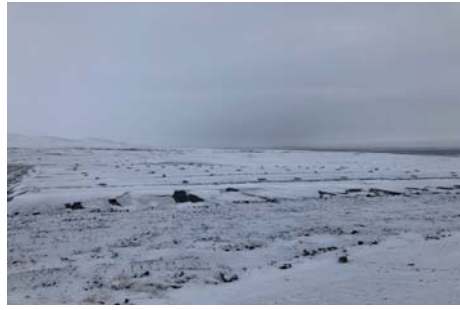
Cover Liner Installation		
SEPTEMBER 17, 2020 - Cover Liner installation	SEPTEMBER 19, 2020 - Backfilled Anchor Trench	SEPTEMBER 23, 2020 - Sandbag Placement on Cover Liner

<p>Contruction Comments:</p> <p>Ramp constructed on East side of contaminated soil stockpile</p> <p>Liner panels placement mirrored from design (overlapped West to East)</p> <p>Liner cover could not be installed immediately after contaminated soil placement is complete due to delay in delivery of liner (very poor conditions of airstrip)</p>		
Attached documents : As-builts (Stockpile Base, Berms, Contaminated Material, Base and Cover Liner)
