**2008 Annual Report
to the
Nunavut Water Board**

**Licensee: Department of National Defence,
Government of Canada**

Licence: NWB6BAF0409 - Type "B"

**Location: BAF-3 North Warning System Site,
Brevoort Island, Baffin Region, Nunavut**

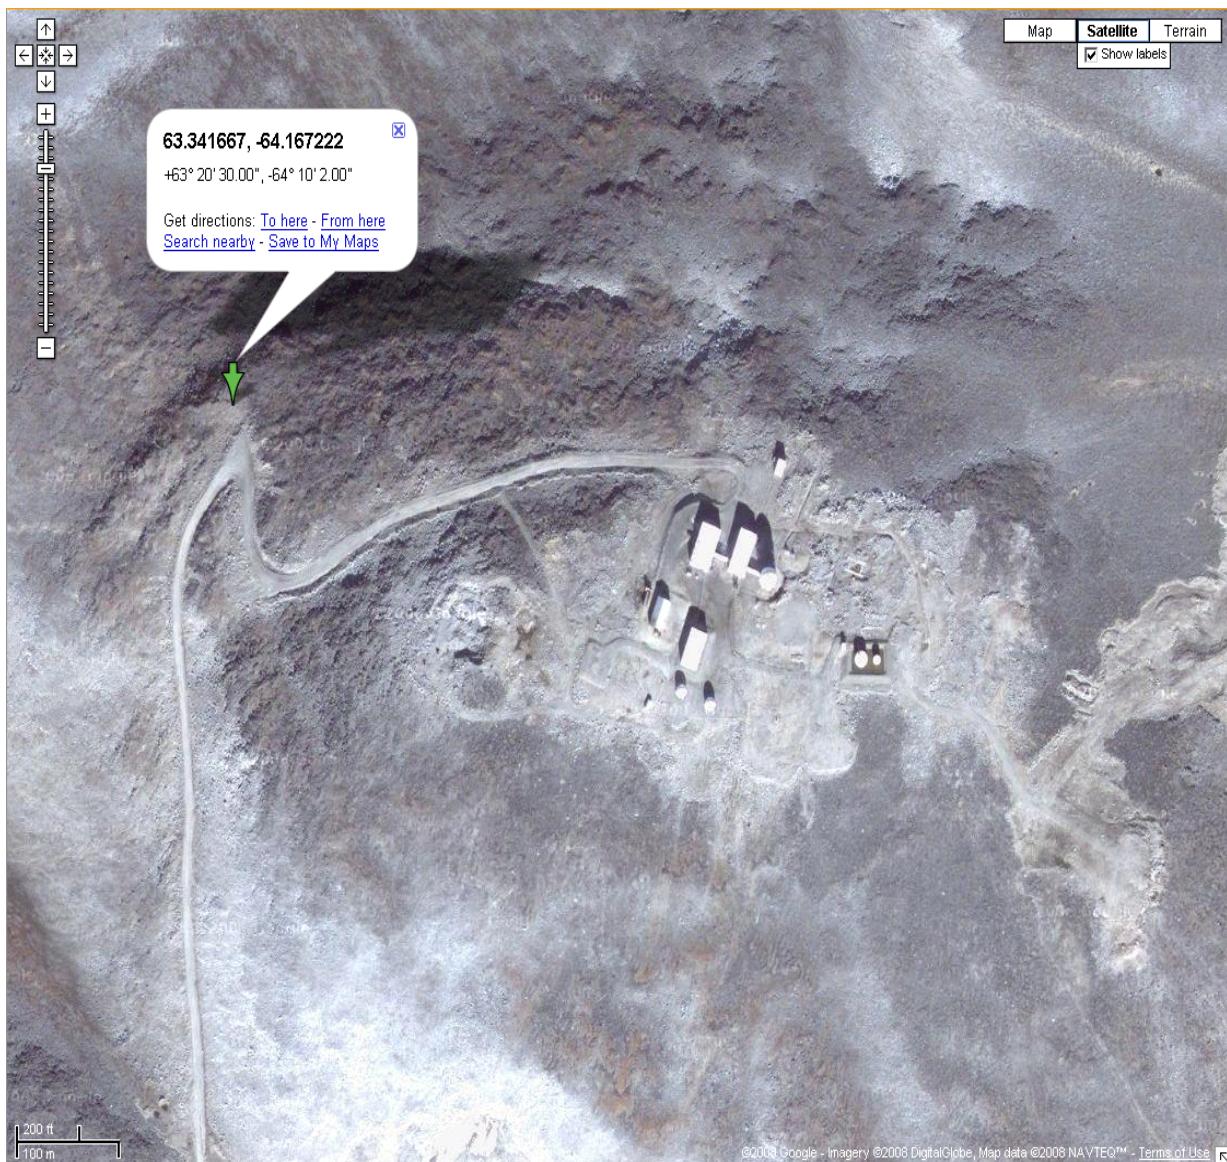
Location of Landfill at BAF-3 with GPS Co-ordinates

Nonhazardous domestic solid waste was flown out to LSS-Q and disposed of at Iqaluit's landfill. Some solid waste was deposited at the on-site landfill (see Annex C).

See Annex C for the location of the landfill.

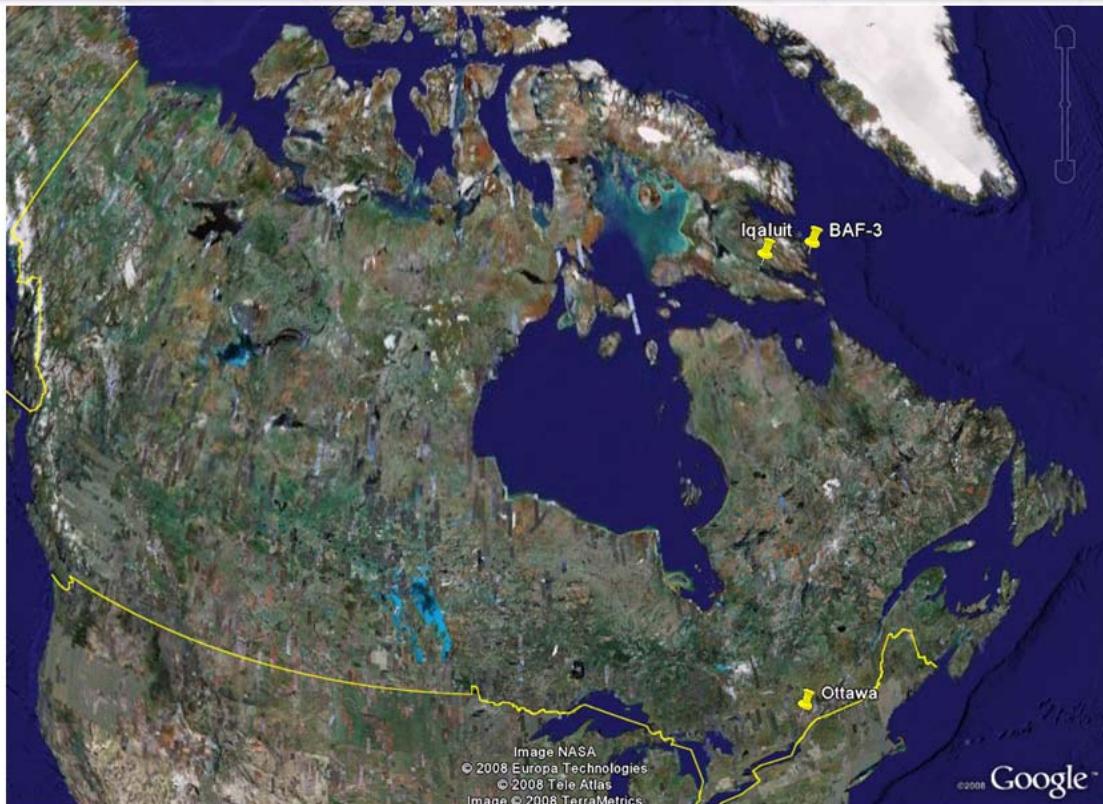
Site Location and Spill

12 Jan 2007, 150,000 L

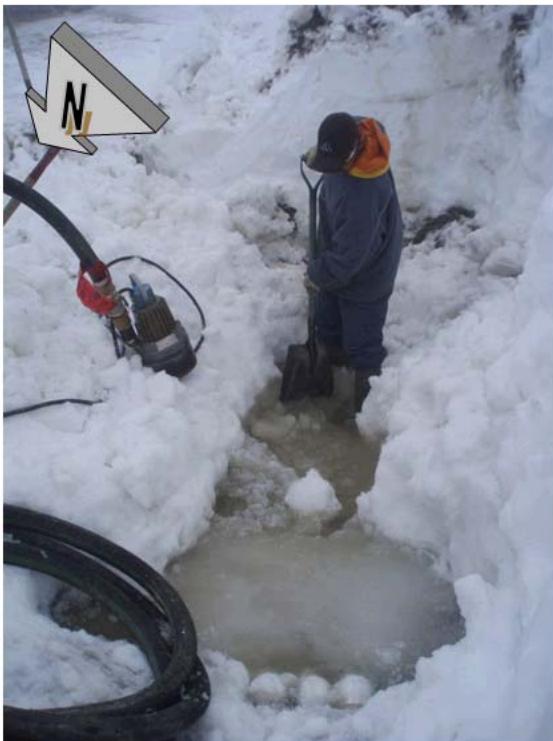
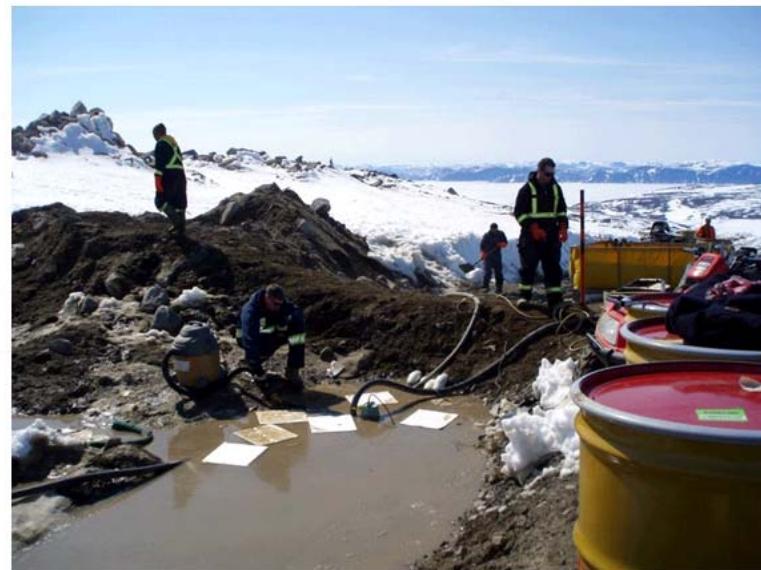
Free Product Collection

Flex Tank at CS-2

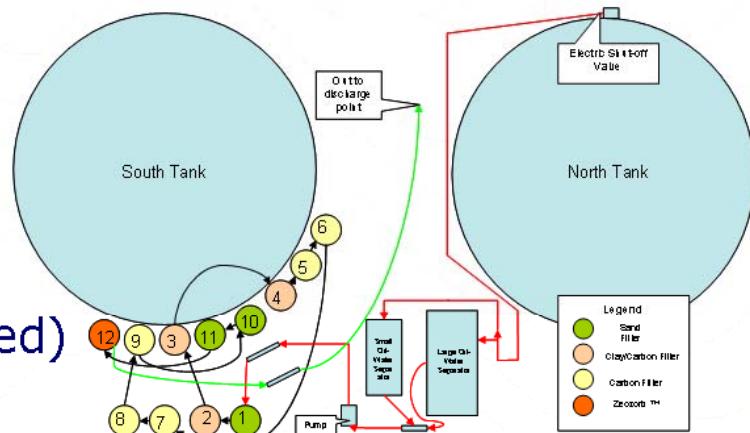
- Major tasks included:
 - Backwash and filter maintenance;
 - Fixing leaks; and
 - System adjustments
- Start- and end-season sampling of raw (untreated) water
- Regular effluent monitoring (5 events) to ensure system efficacy and satisfy regulatory requirements
 - Last round failed: likely cause sediment re-suspension, need to optimize system operation

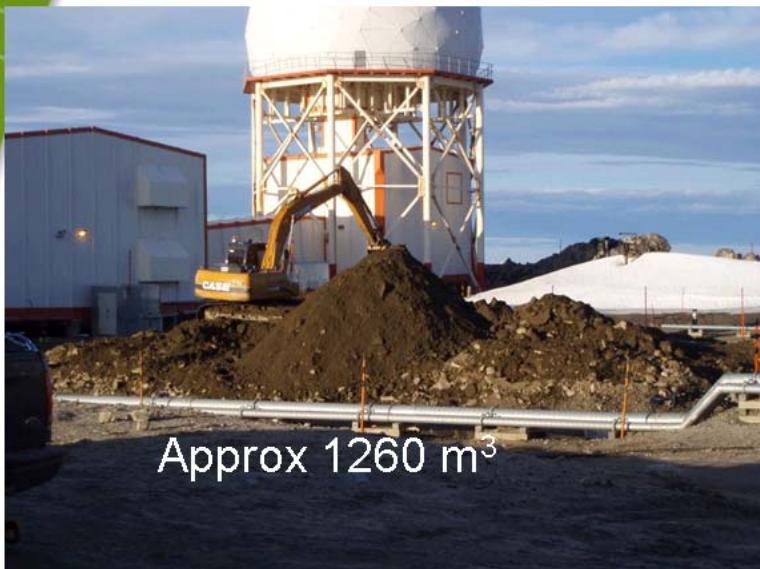
- Transport of TISSA soils (2007 excavation) to biopiles (1260 m³)
- Excavation of the 'bowl' in APEC 2 (300 m³)
- Biopile preparation, development and monitoring
 - 2007 TISSA soil concentrations 1-11x DLCC
 - 2008 TISSA soil concentrations 0.5-1x DLCC
 - 2008 biopile concentrations 0.25-1.1x DLCC

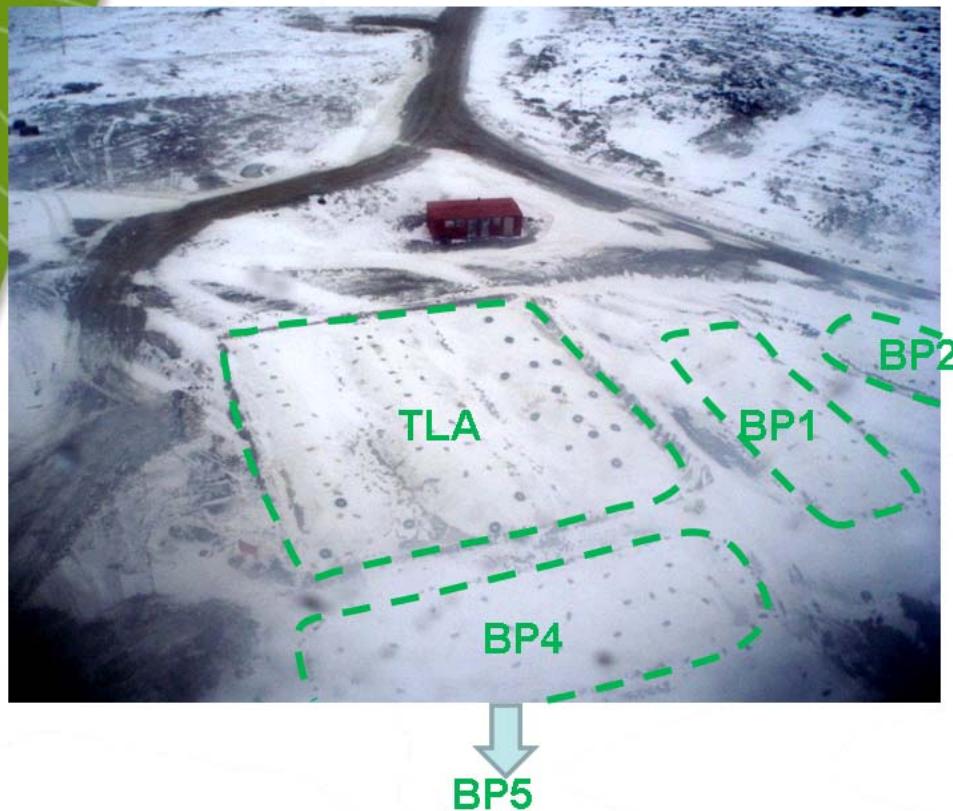
2008 Results: Biopiles

- 3 completed
- 2 started
- Temporary lay down area
- Runoff control

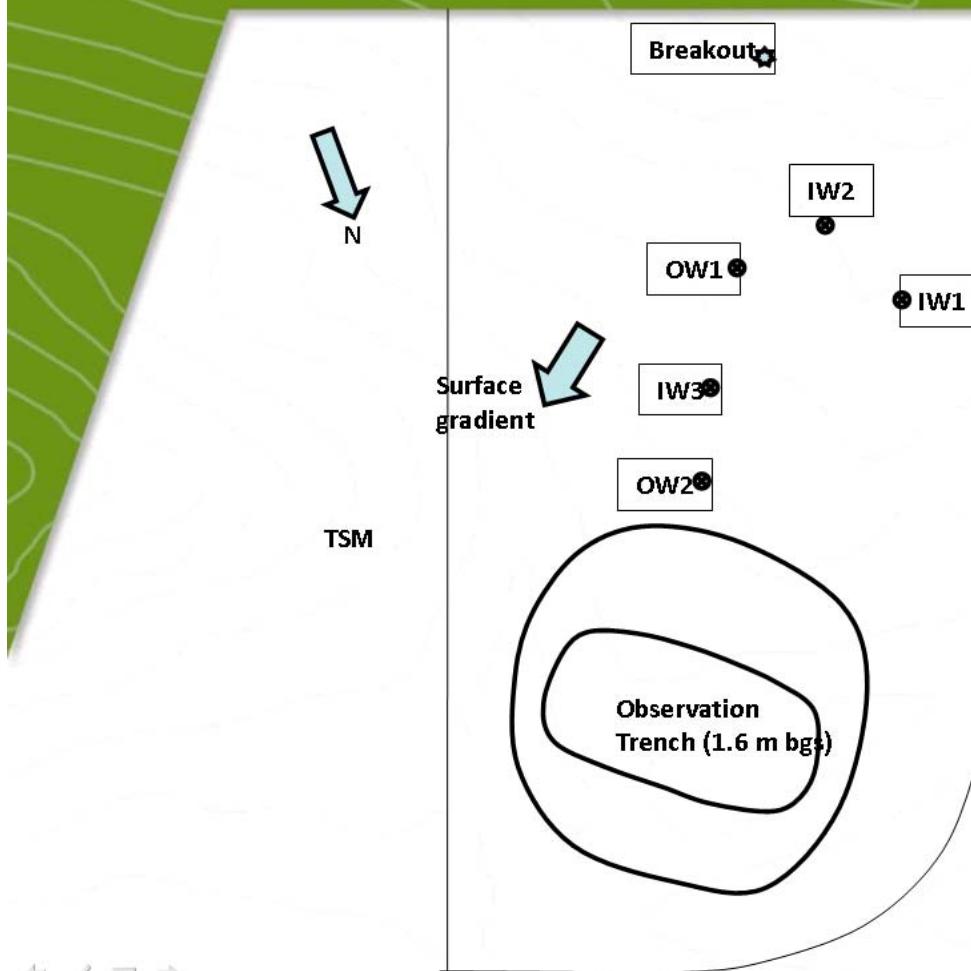
2008 Results: Soil Flushing Pilot

- Observation trench
- 2 observation wells
- 3 injection wells (1 successful)
- GW seepage at 100x un-forced

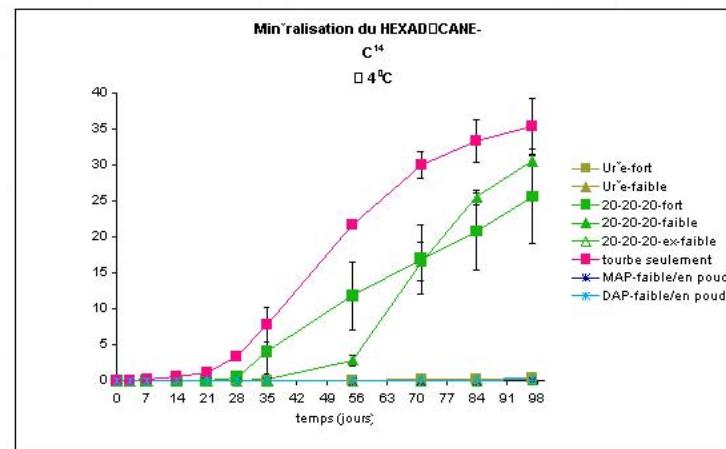
- NRC-BRI:
 - Initial results from mesocosm very positive
- Utility Locates:
 - USL on-site, plan produced by NJW

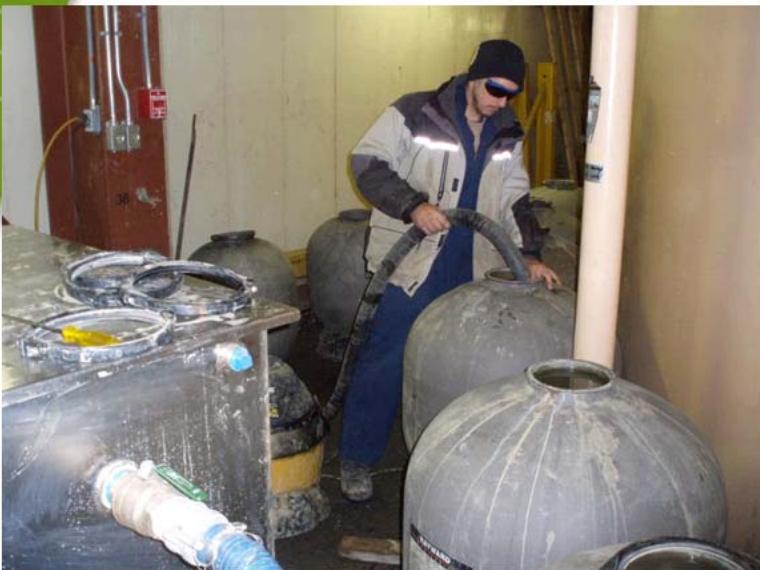
WTS

2008 Workplan: Winterization and Site-Shutdown
