2016 ANNUAL NUNAVUT WATER BOARD

REPORT FOR BAF-3

North Warning System

BAF-3 Jet Fuel Release 2016 Project Update

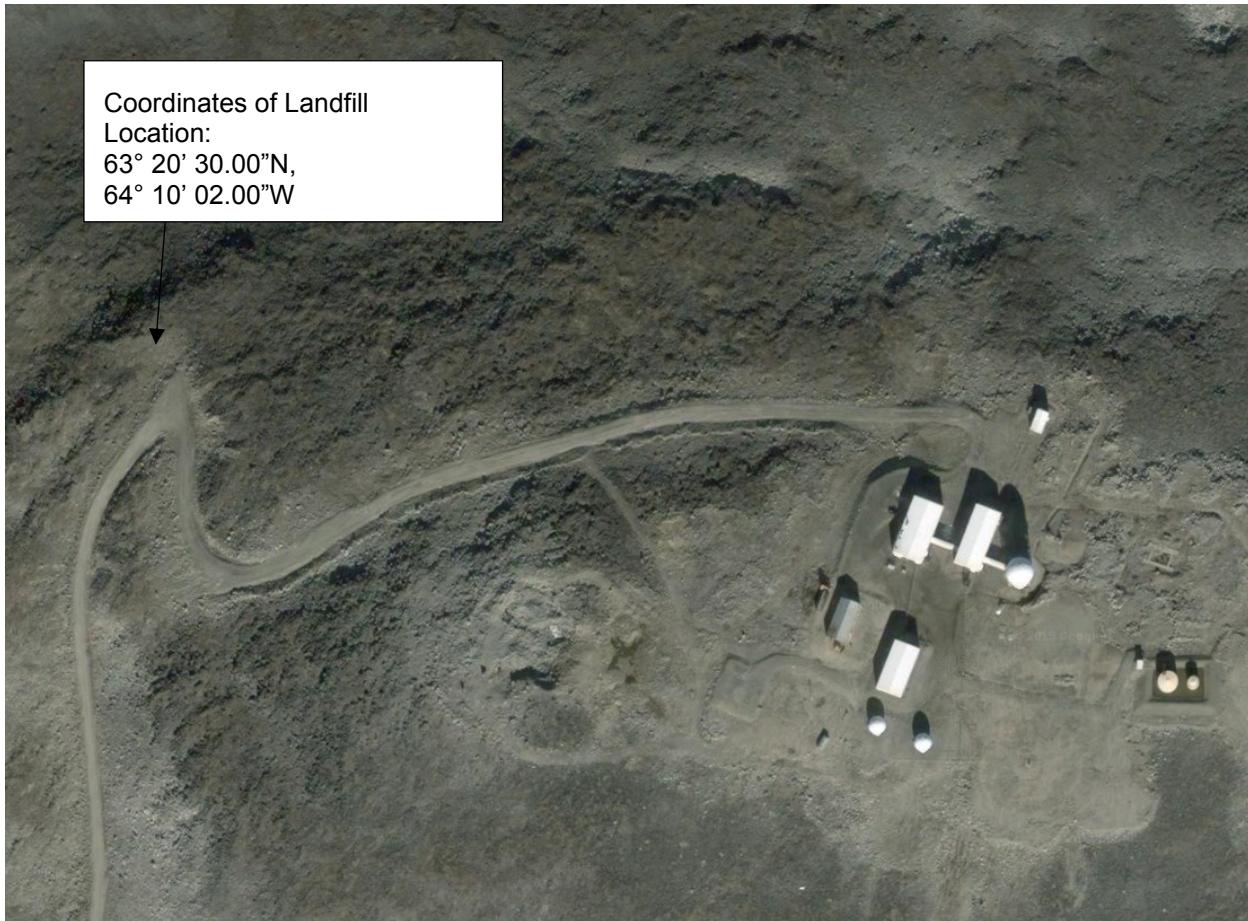
ANNEX B: LOCATION OF LANDFILL WITH COORDINATES

Coordinates of Landfill Location: 63° 20' 30.00"N, 64° 10' 02.00"W

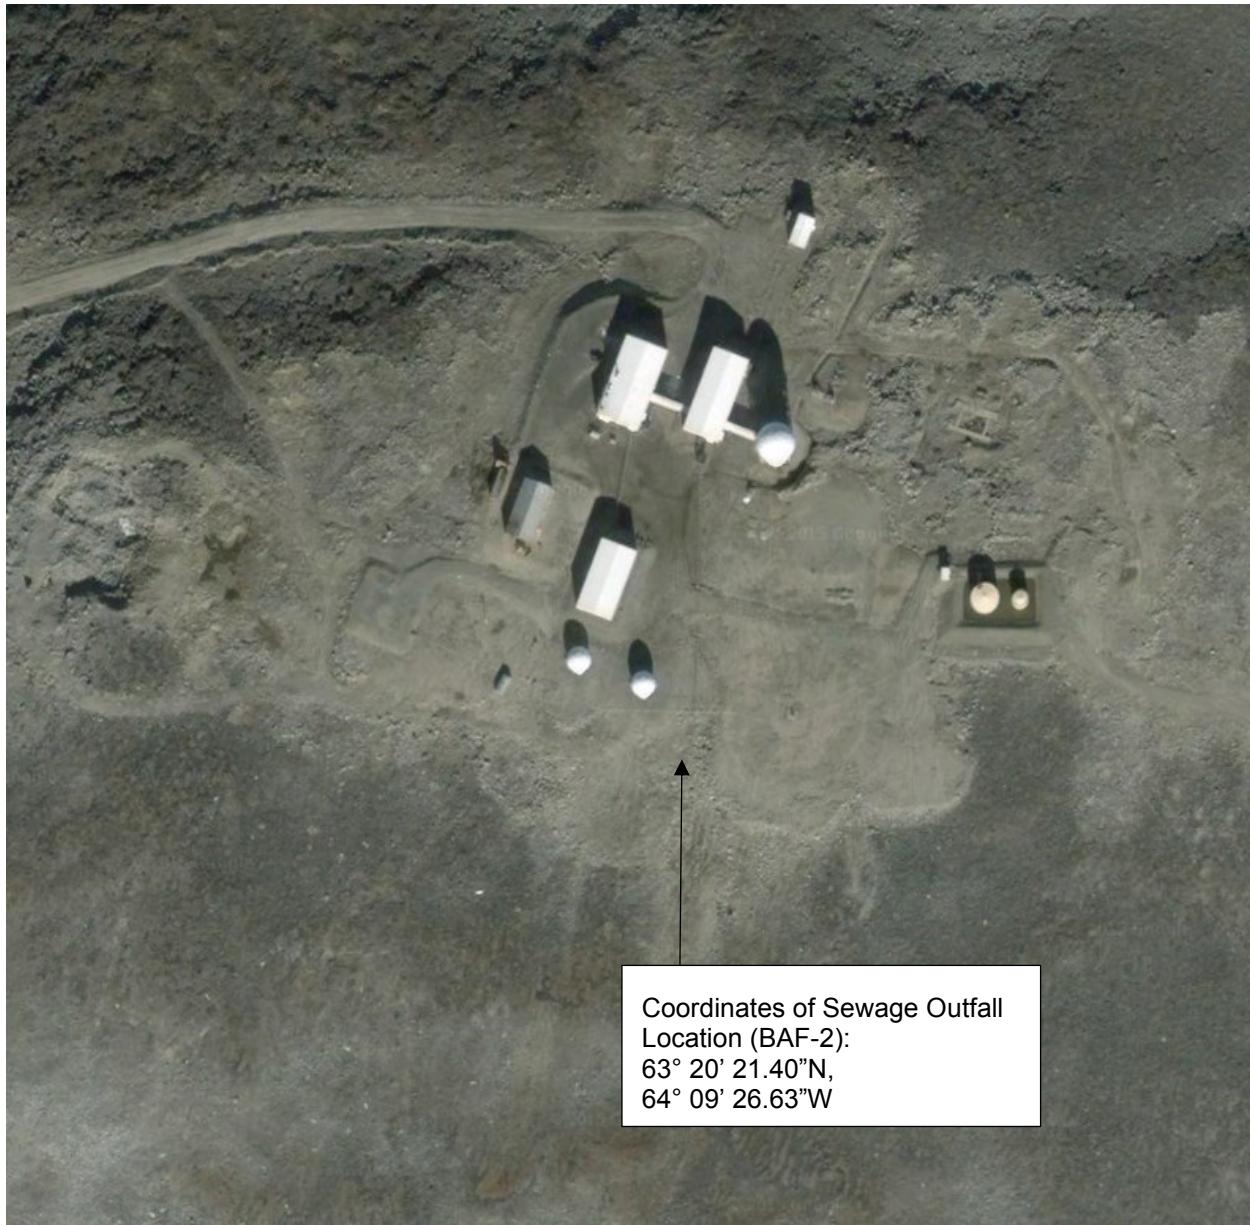
ANNEX C: SEWAGE EFFLUENT OUTFALL (BAF-2) LOCATION WITH COORDINATES

Coordinates of Sewage Outfall Location (BAF-2): 63° 20' 21.40"N, 64° 09' 26.63"W

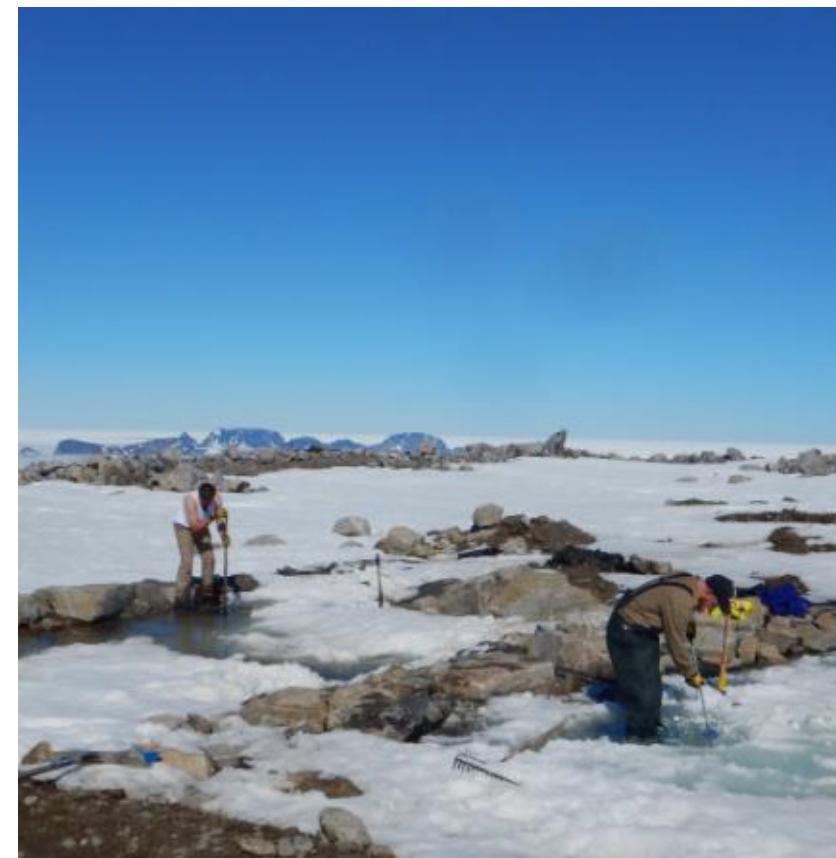
Monitor and Control Fuel Migration

- Environmental staff arrived on site June 13, focuses on assessing site conditions and preparing to reconnect water treatment system
- Freshet was occurring, but there was no evidence of fuel migration
- Team cleared ice from coffer dams, laid out hose and electrical between recovery area and treatment, transferred water from recovery area to coffer dams
- Treatment re-started July 3

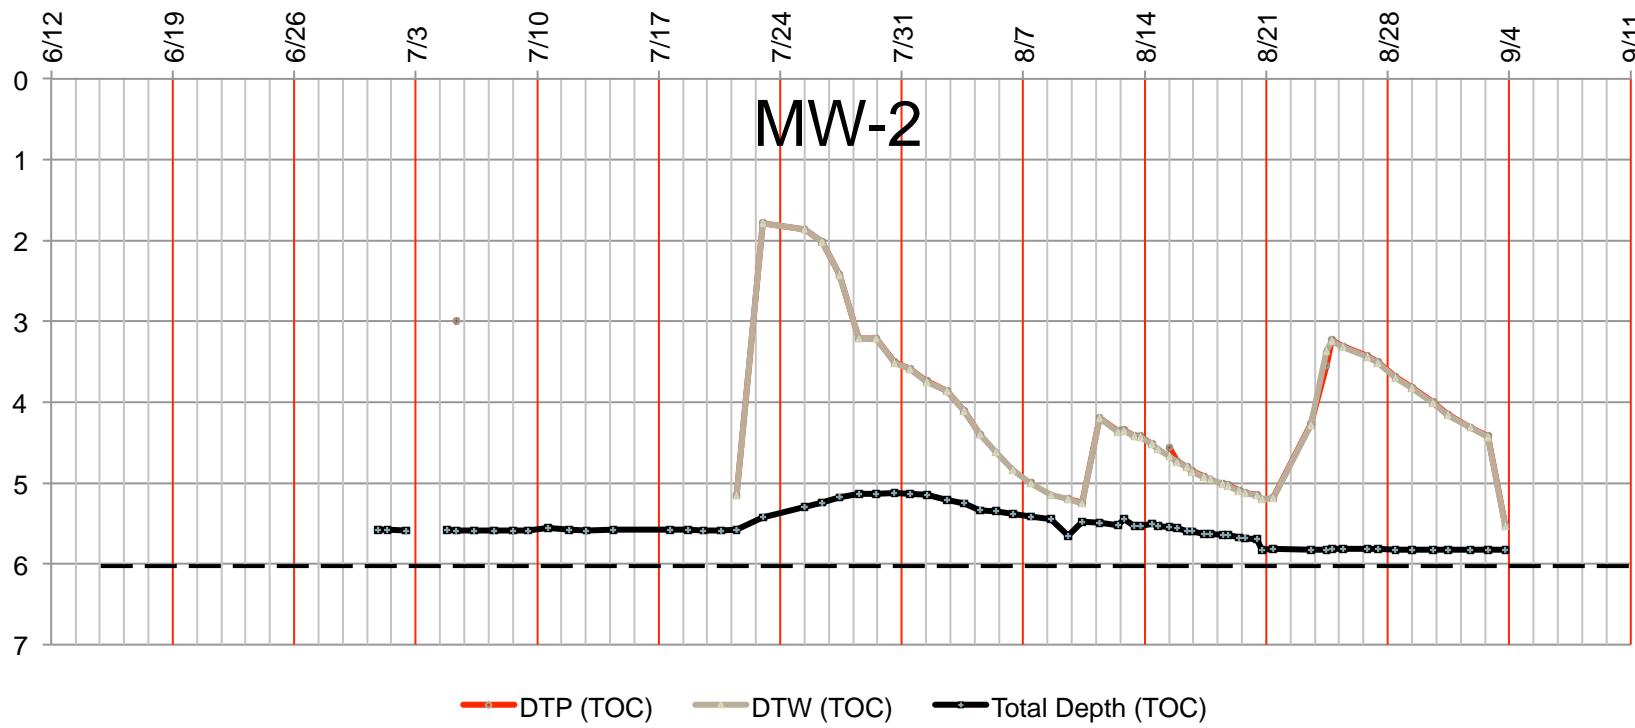
Monitor and Control Fuel Migration

- Wells were cleared of snow to allow for monitoring of fuel levels, water levels, and total depths of each well
- Monitoring total depths provided significant insight to thawing of the permafrost and mobilization of subsurface fuel

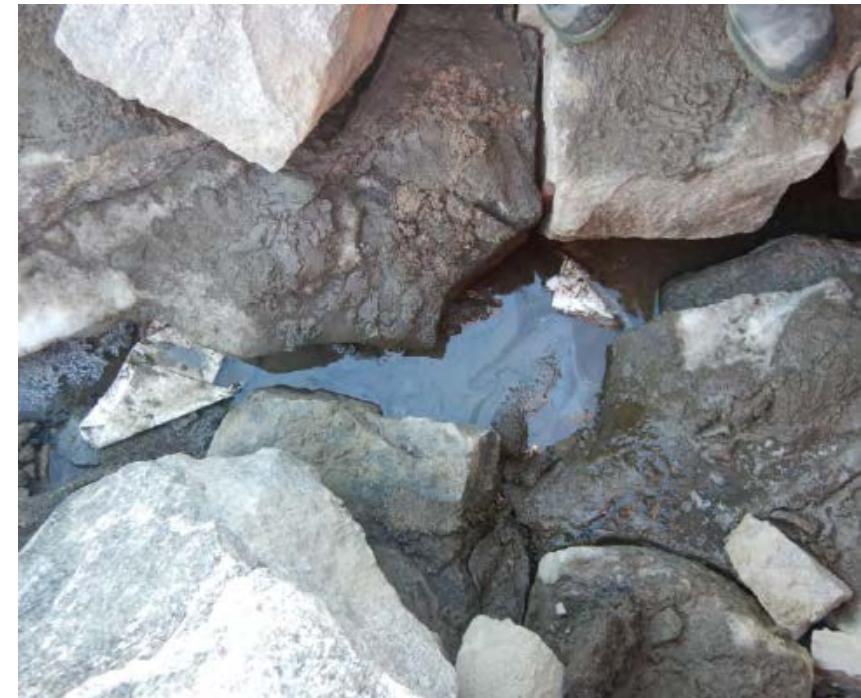
Monitor and Control Fuel Migration

- Coffer dams in the north drainage exhibited little evidence of fuel migration throughout the summer
 - Minor sheens were detected on the surface of intermittent stream flow
- There was sheen observed in the south drainage warranting installation of an oil water trap
- No NAPL accumulation was observed to the South until a late season (Aug 23) major rain event changed conditions, warranting installation of an additional coffer dam and booms

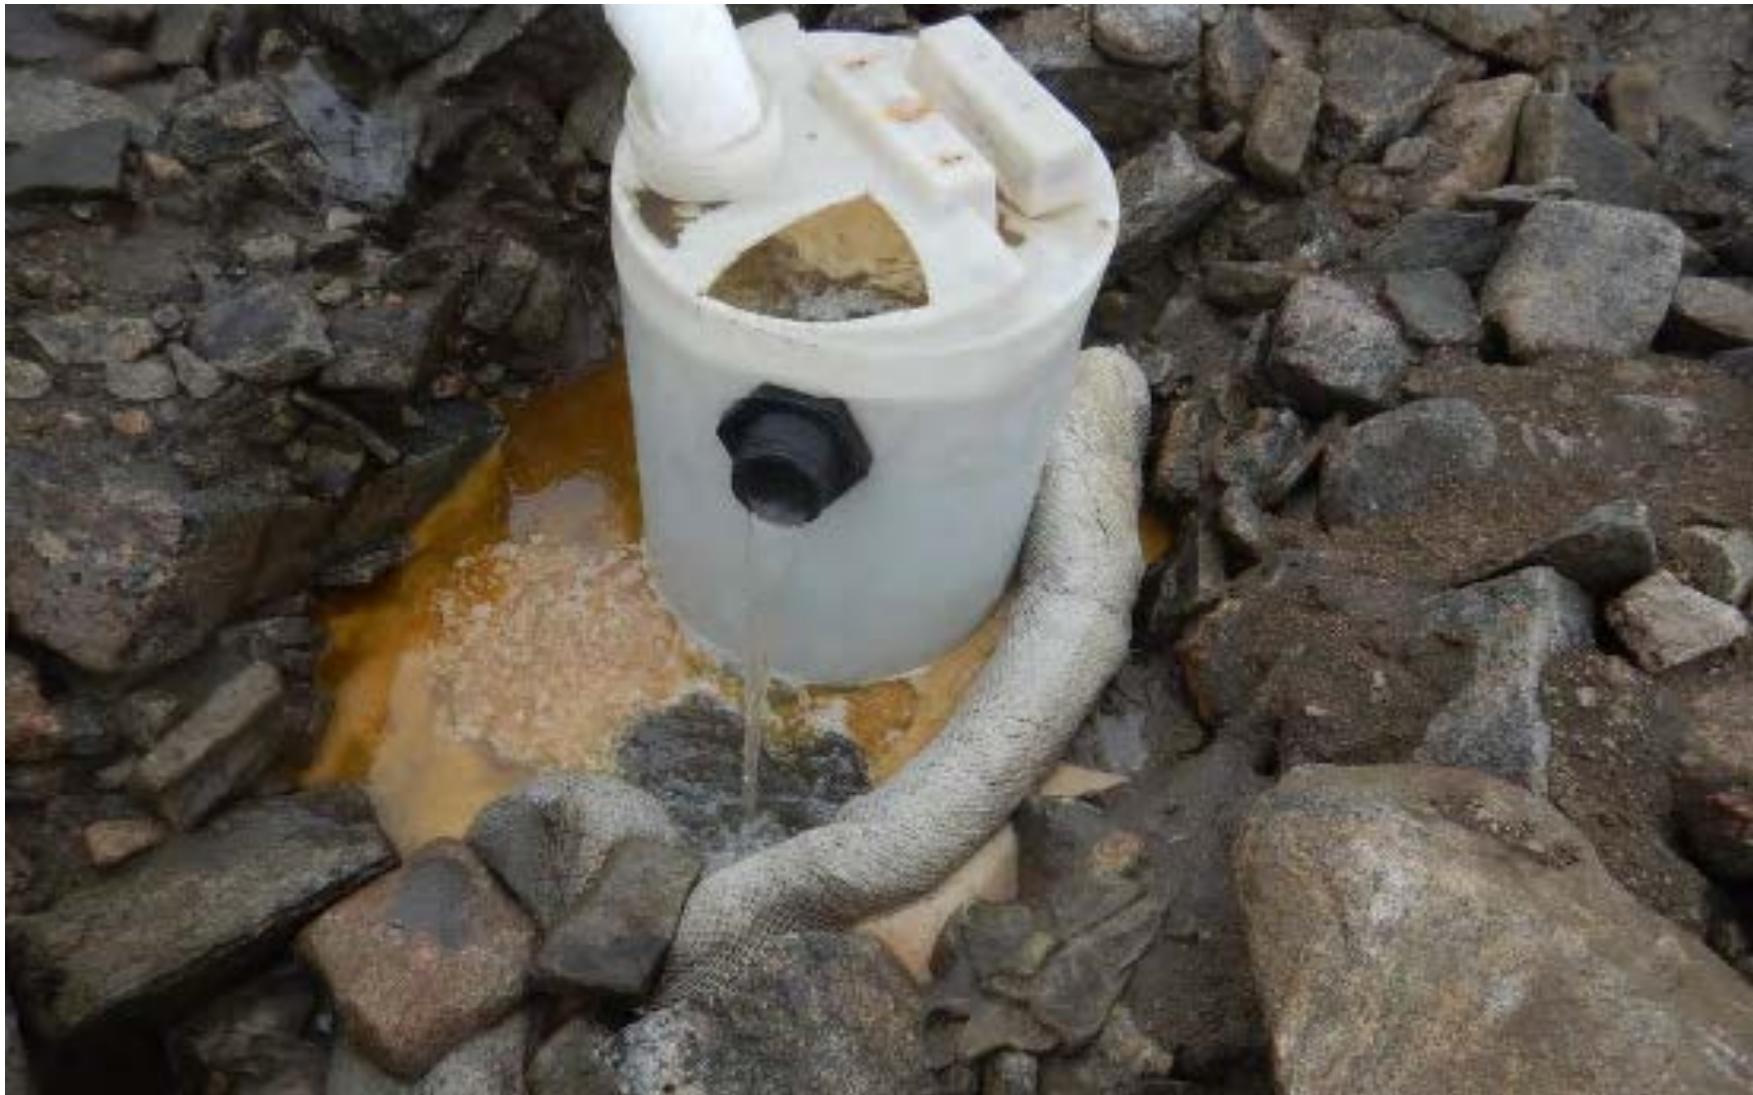
Typical Flow Conditions

Fresh Storm Flushed NAPL

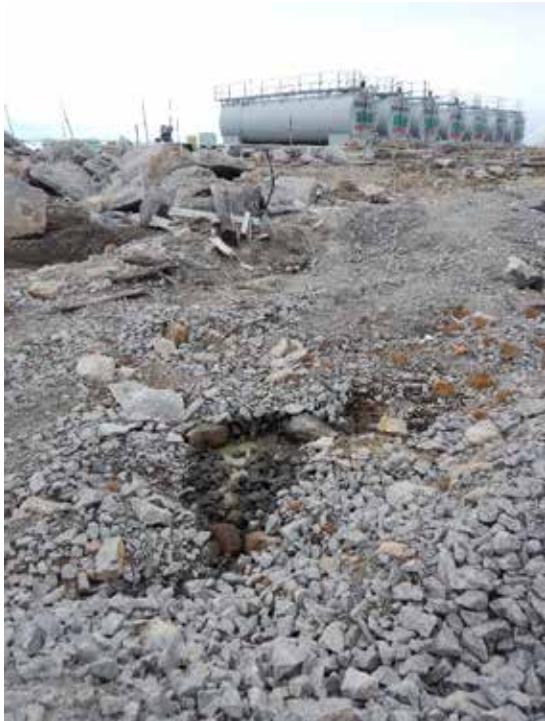
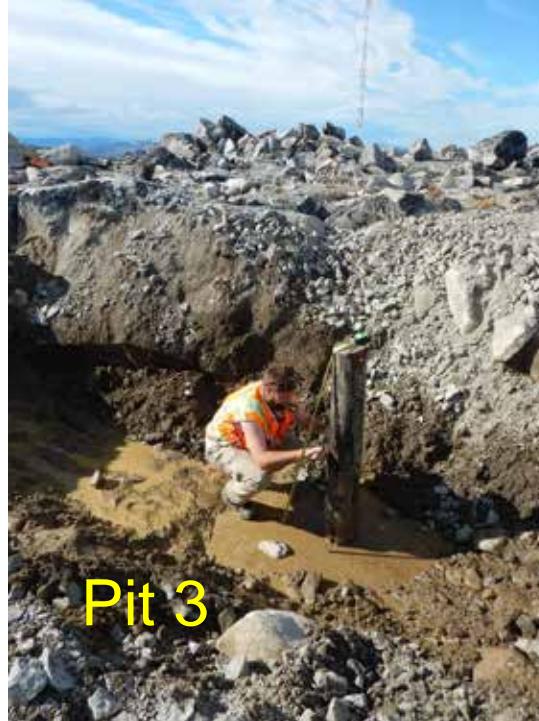
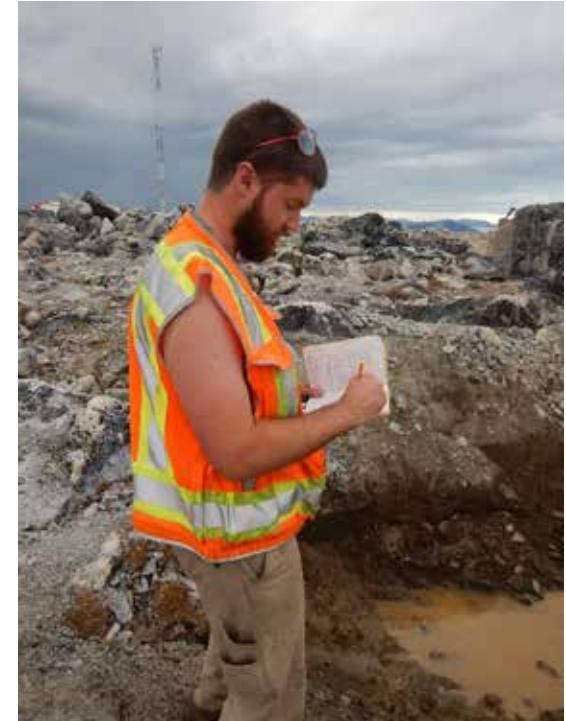
Pit Installation

- Three investigation pits have been installed in areas immediately downgradient of the release area
- Little to no recoverable NAPL existed even after induced drawdown of the water table

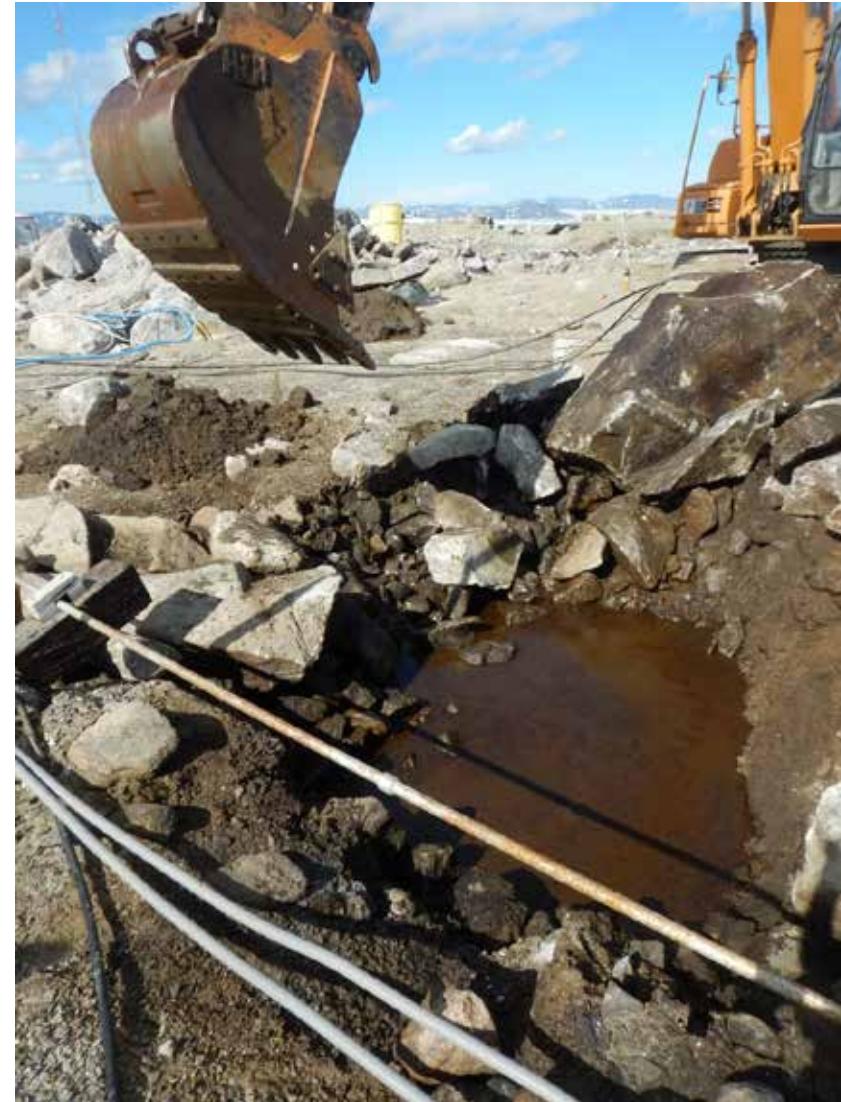
Fuel Recovery Efforts (GW)

- Pit 3 is located north of the POL line and east of the release
- The Pit was installed in a boulder area where NAPL recovery occurred during 2015
- Limited NAPL recovery from the newly installed Pit during 2016
 - Two distinctly different NAPLs were recovered
 - One an amber colored fresh NAPL
 - One black weathered and viscous NAPL

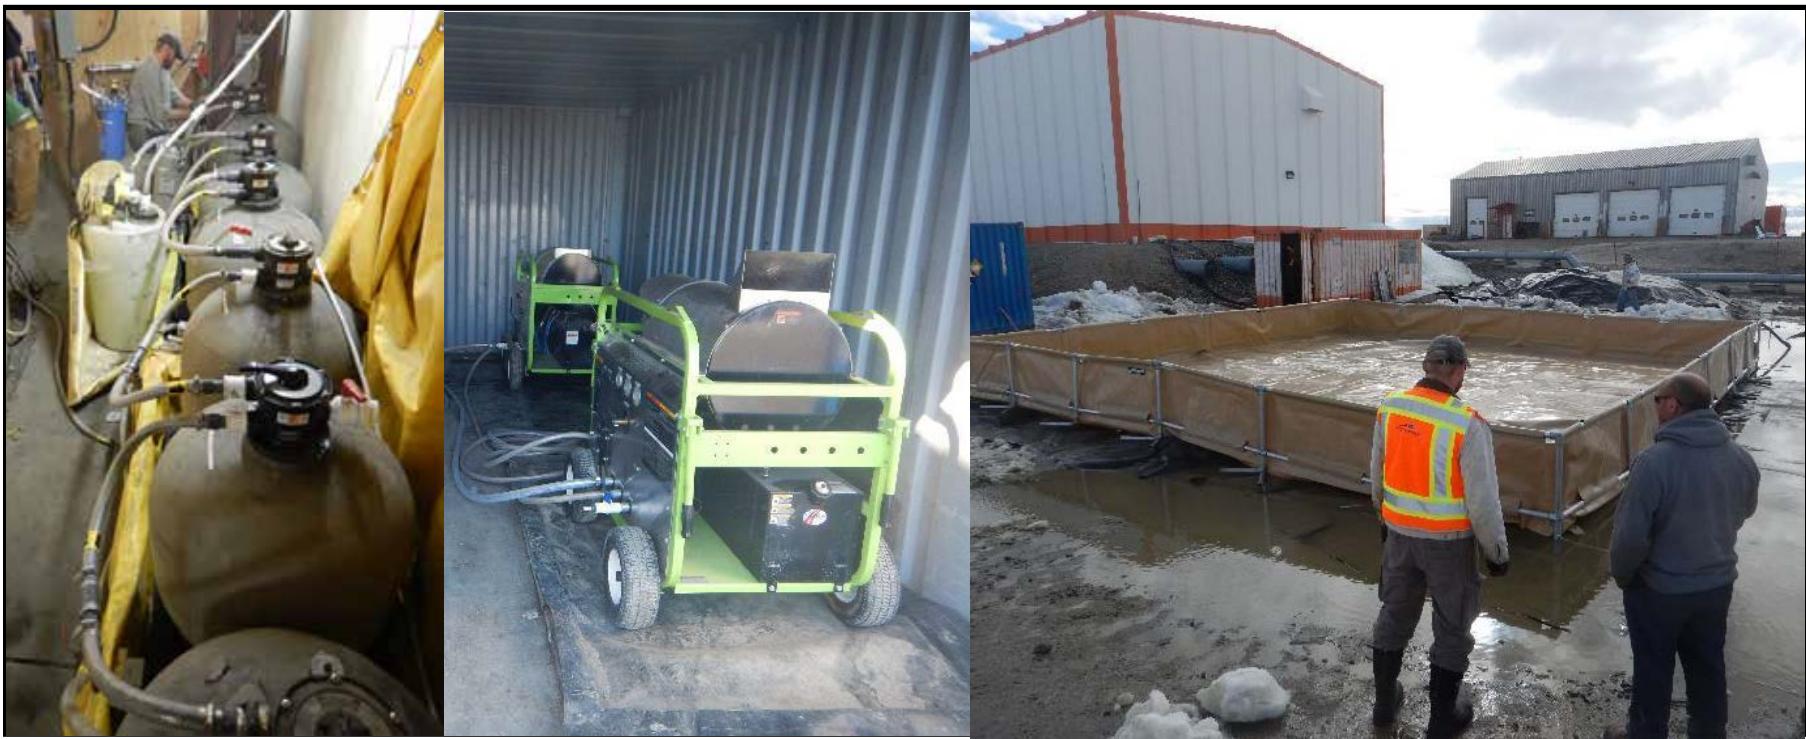
Fuel Recovery Efforts (GW)

- Groundwater depression was reactivated in the recovery trench after the water treatment became operational July 3
- To address phenol exceedances observed in 2015, RCL increased temperature through the air stripper and added H_2O_2 chemical feed and UV activation

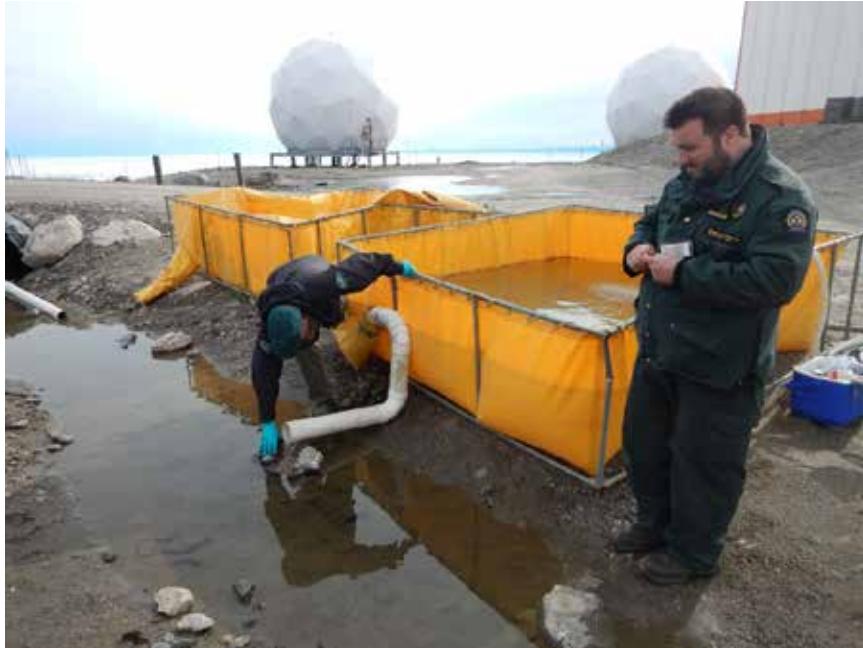
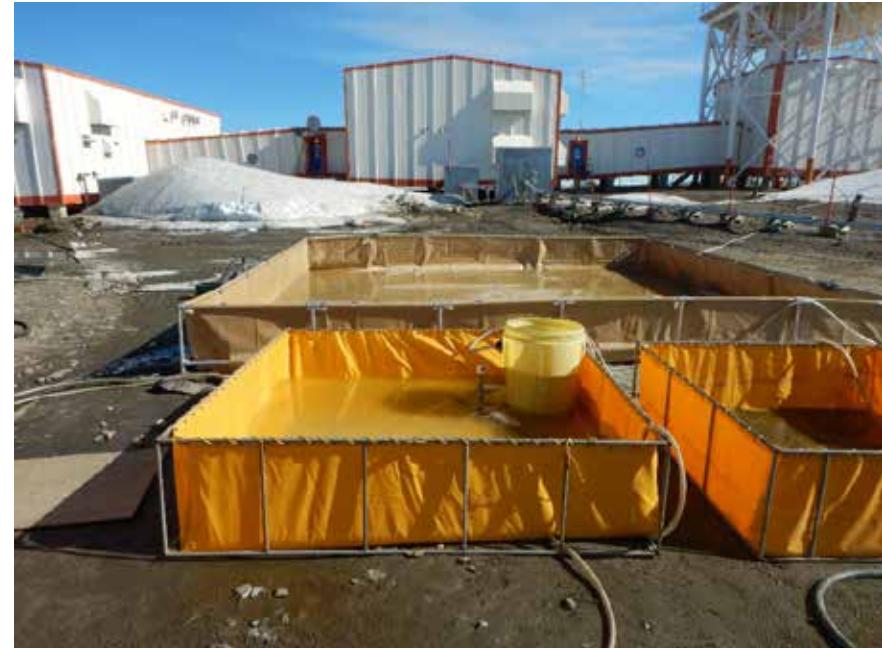
Compliance Sampling

- Original layout used a 1,000 gallon berm for the effluent outfall before discharge
- Modified discharge of outfall to a large berms allowed for more conservative monitoring of effluent prior to discharge

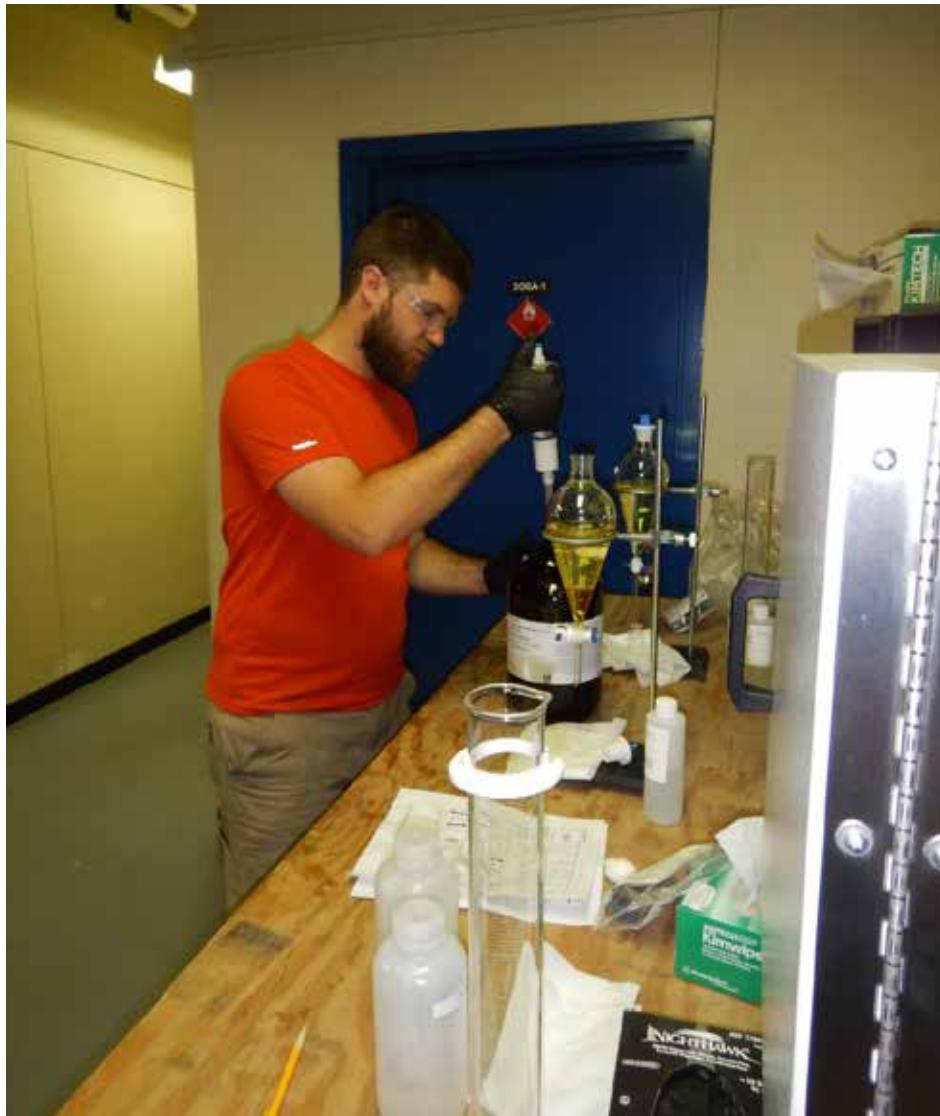
2016 On-site Analytical

- Addition of on-site analytical capabilities to analyze for phenols and H_2O_2
 - field test kits for higher concentrations
 - wet chemical technique for lower concentrations
- 2016 efforts resulted in compliant results for phenols
- Phenols appear related to dissolution of treated wood preservatives

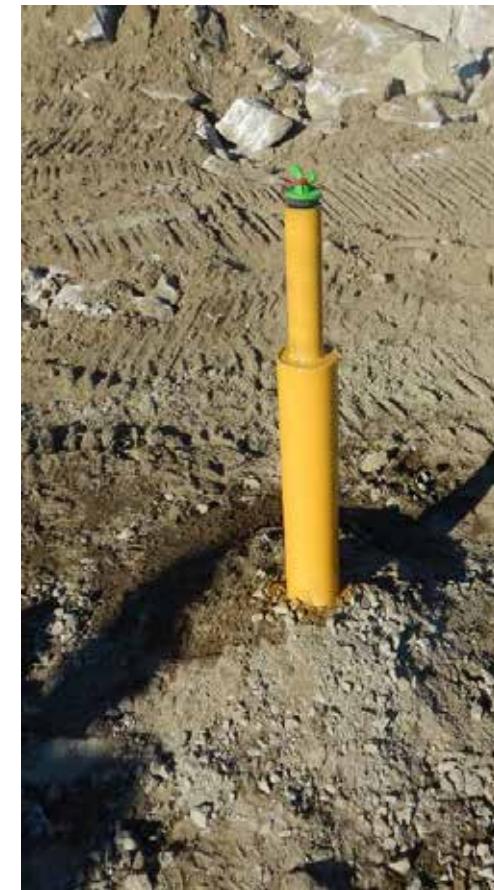
Additional Site Investigation

- 64 soil samples were collected from the investigation area
- Three new wells were installed to better define the horizontal extent of impact
 - All wells were sampled and analyzed in the laboratory
- Installed two additional Petroleum Investigation Trenches (PITs)
 - One just north of the recovery trench area, one north of MW-4
 - Limited product was visible at all three PITs
- Completed a soil vapor survey north and south of area of release

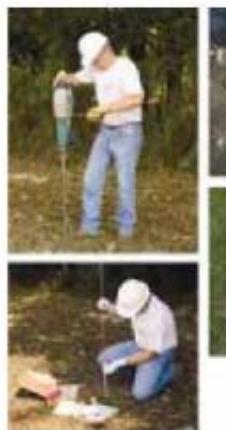
■ Soil vapor survey

- Used to further delineate nature and extent of soil and water impacts
- Process
 - Sample
 - Analyze
 - Report
- Works in: air, soil-gas, water, sediment
- Sampling for VOCs/SVOCs, target petroleum hydrocarbons
- Aid in identification of high petroleum hydrocarbon concentration areas

- Soil vapor survey results compared to soil vapor extraction area indicates much lower petroleum hydrocarbon concentrations are observed in effective treatment area

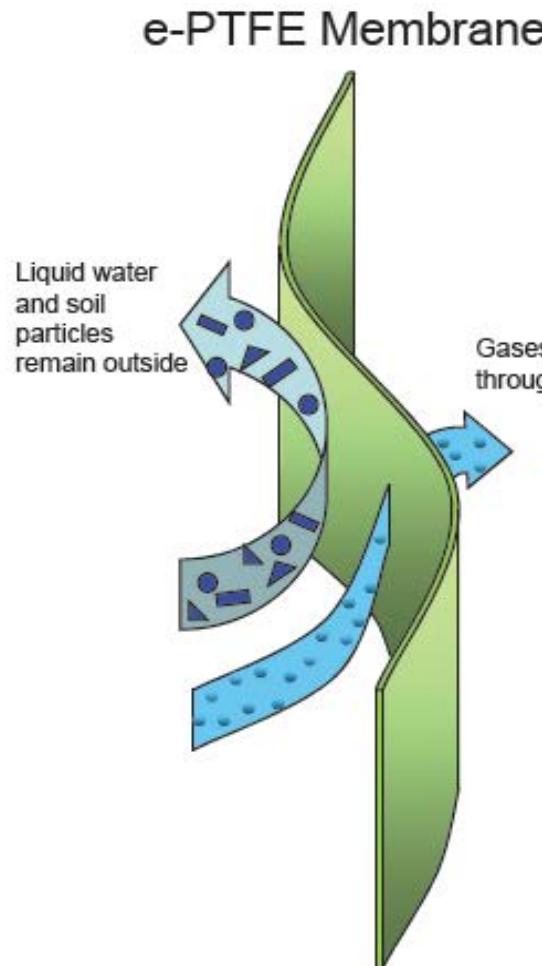
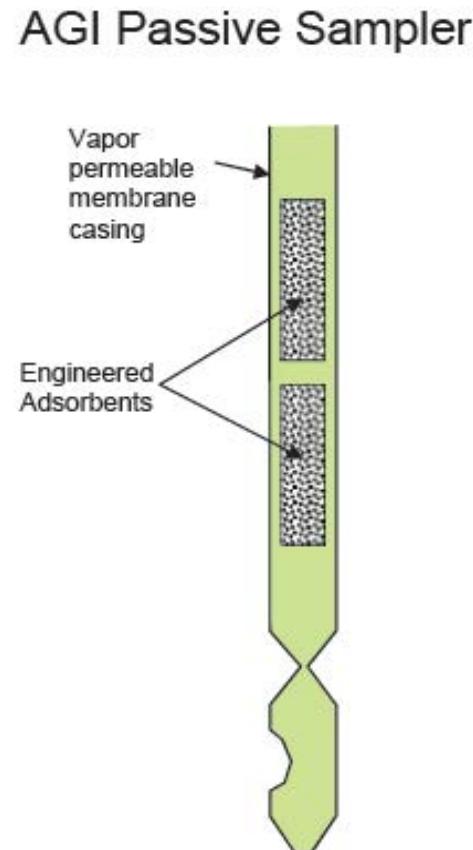
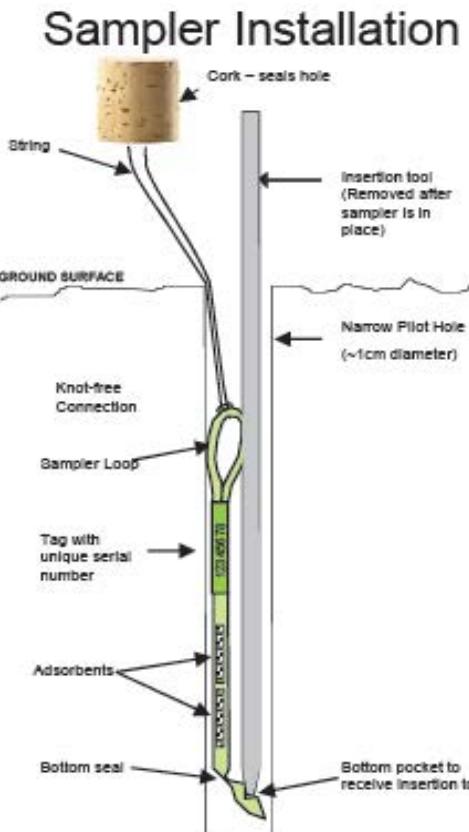
Additional Investigation

- Soil vapor survey sampling process

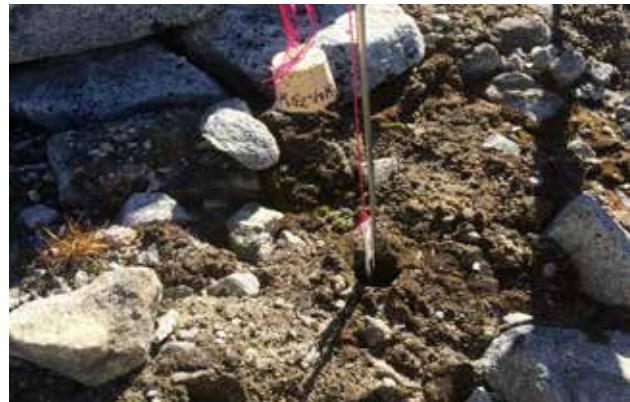
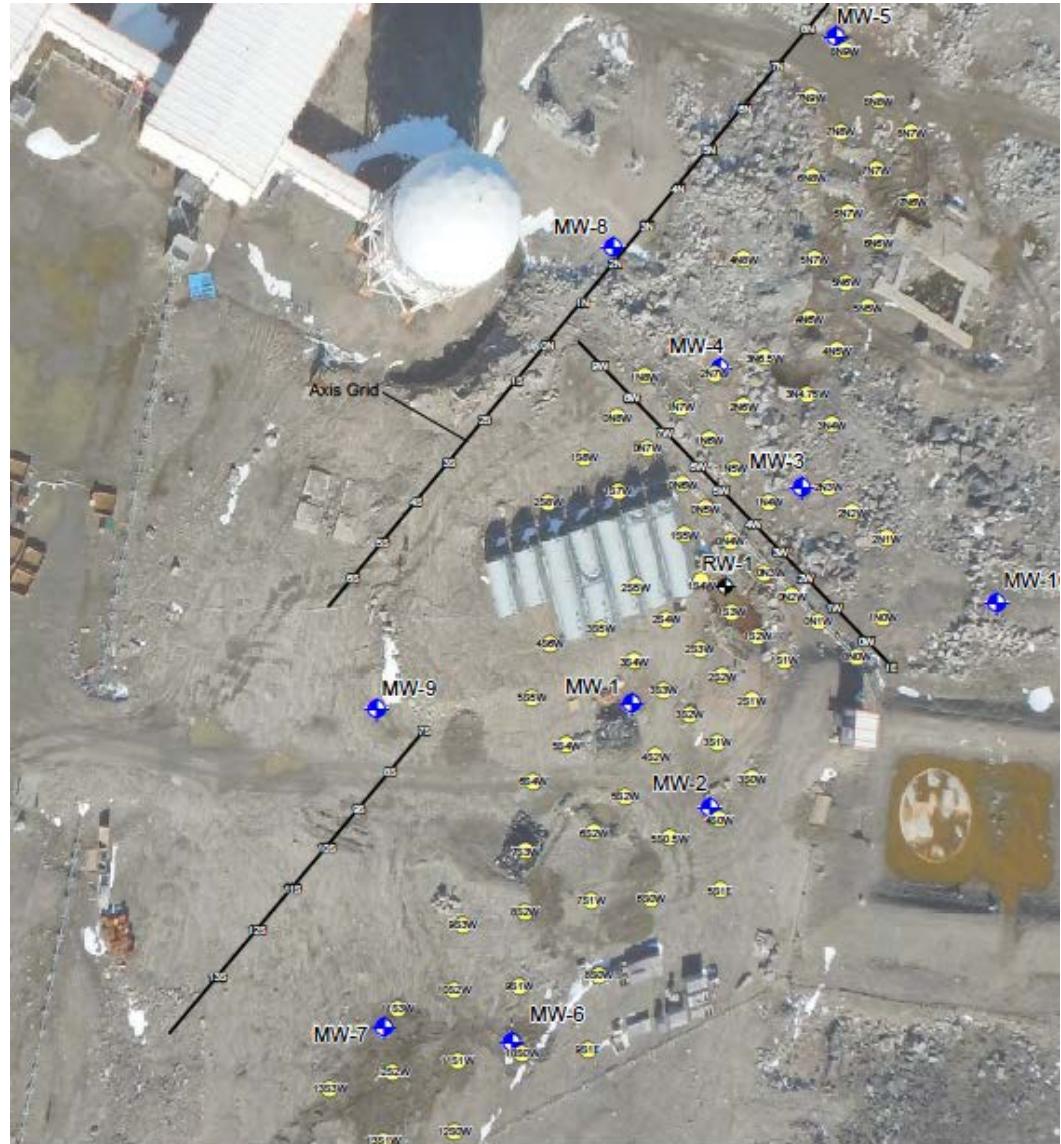
Additional Investigation

- Soil vapor survey sampling grid
 - 84 passive soil vapor sampler locations
 - Locations spaced on 6 m (20 ft) to 10 m (32 ft) centers
 - Samplers installed approximately 0.5 m (18 in) below ground surface

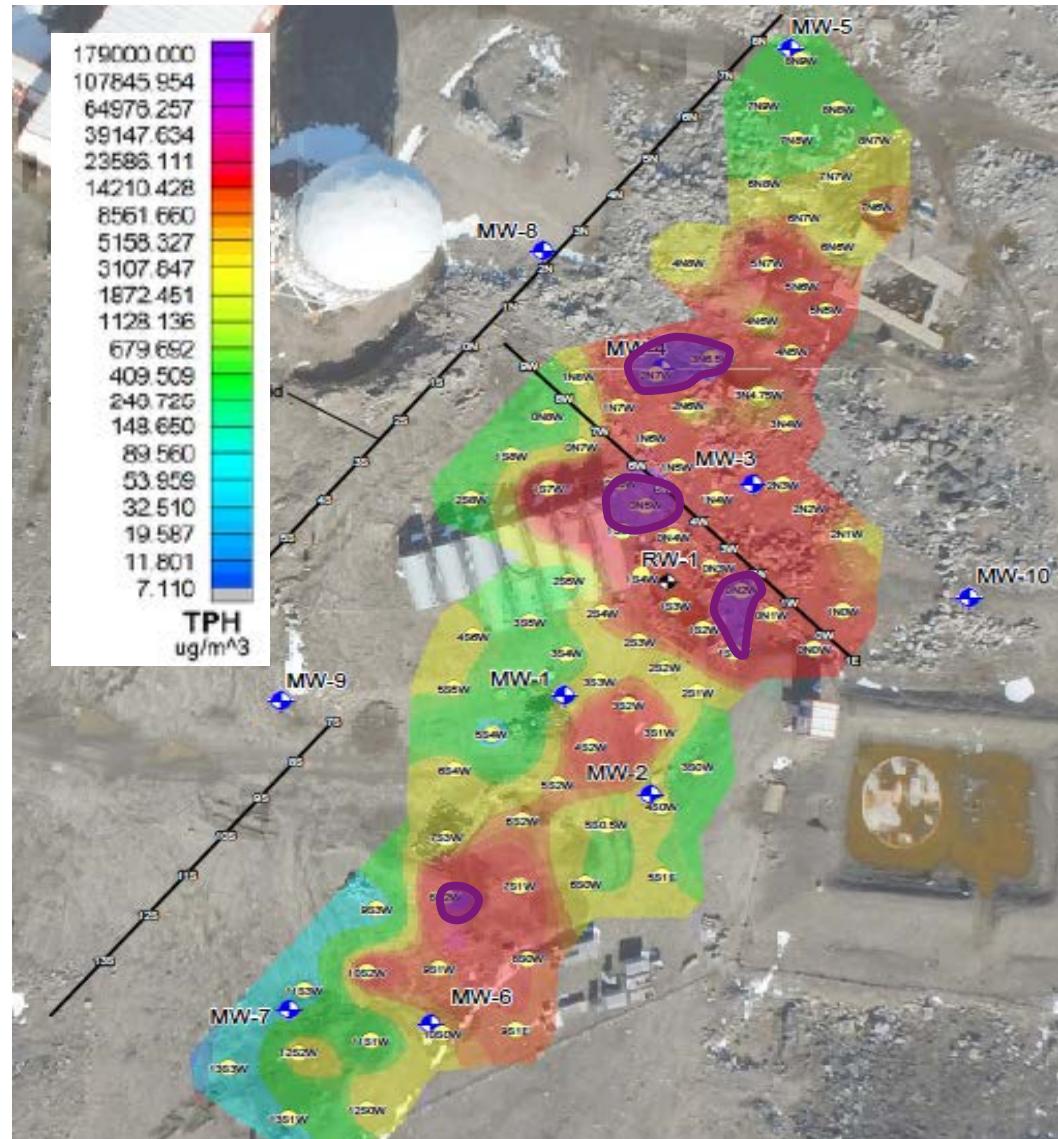
Additional Investigation

- Soil vapor survey results
 - Identification of petroleum hydrocarbon areas
 - Results indicate high concentrations reside in pocketed locations
 - Purple color represents higher total petroleum hydrocarbon concentrations
 - Identification of migration pathways
 - Petroleum hydrocarbon soil impacts primary reside in proximity of spill area

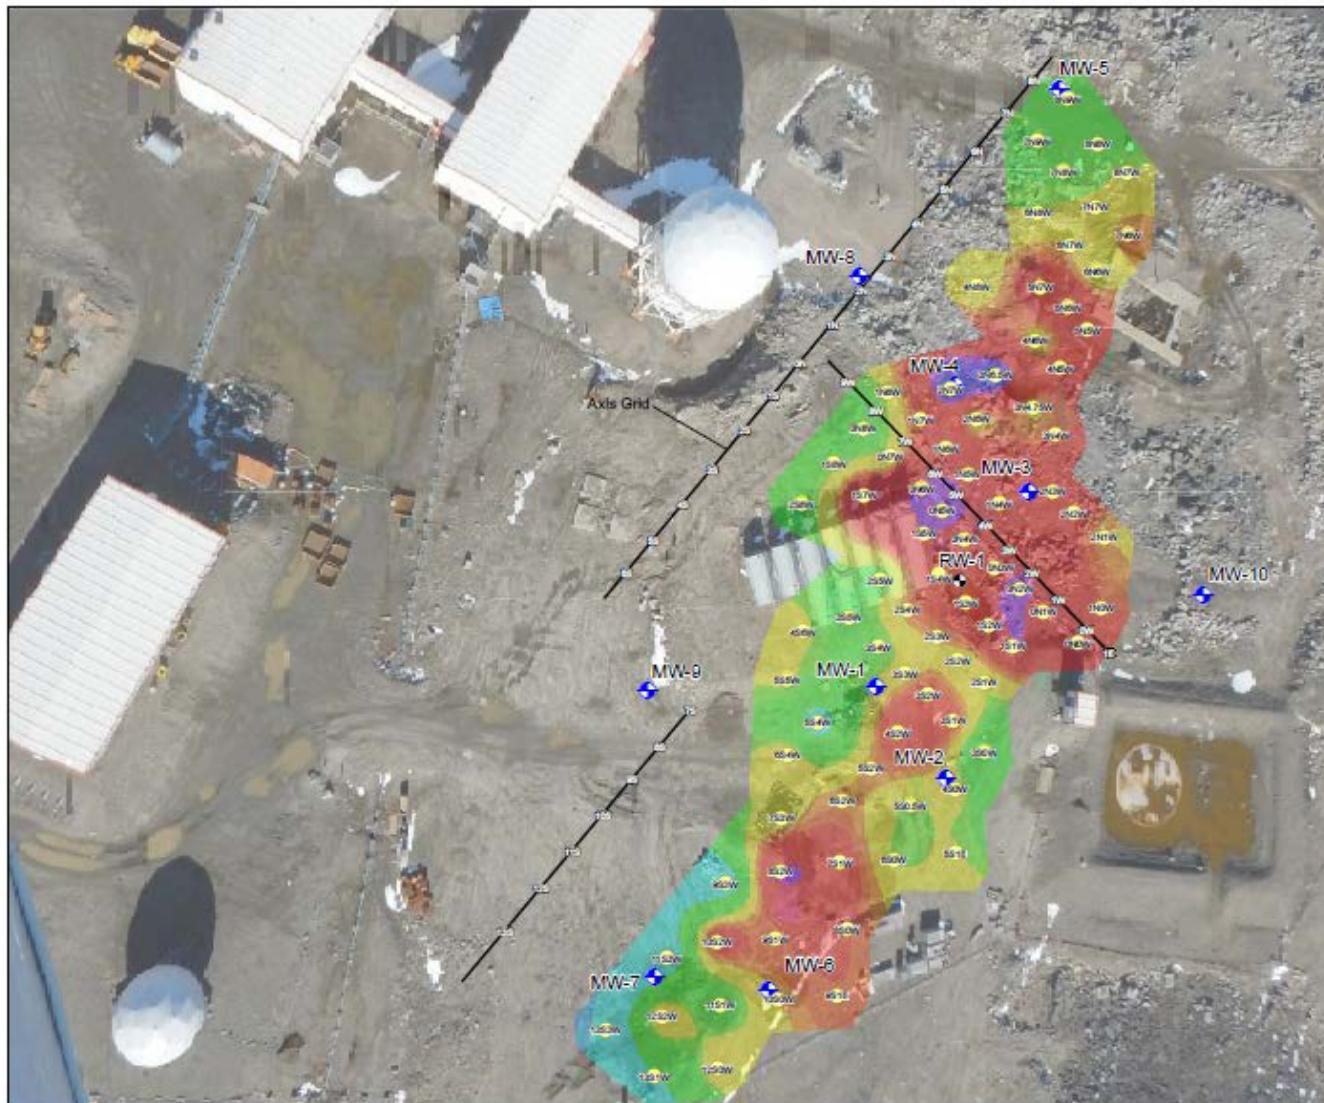
TPH Soil Vapors

Figure 11
Soil Vapor Survey
Total Petroleum Hydrocarbon
Concentration Map
BAF-3

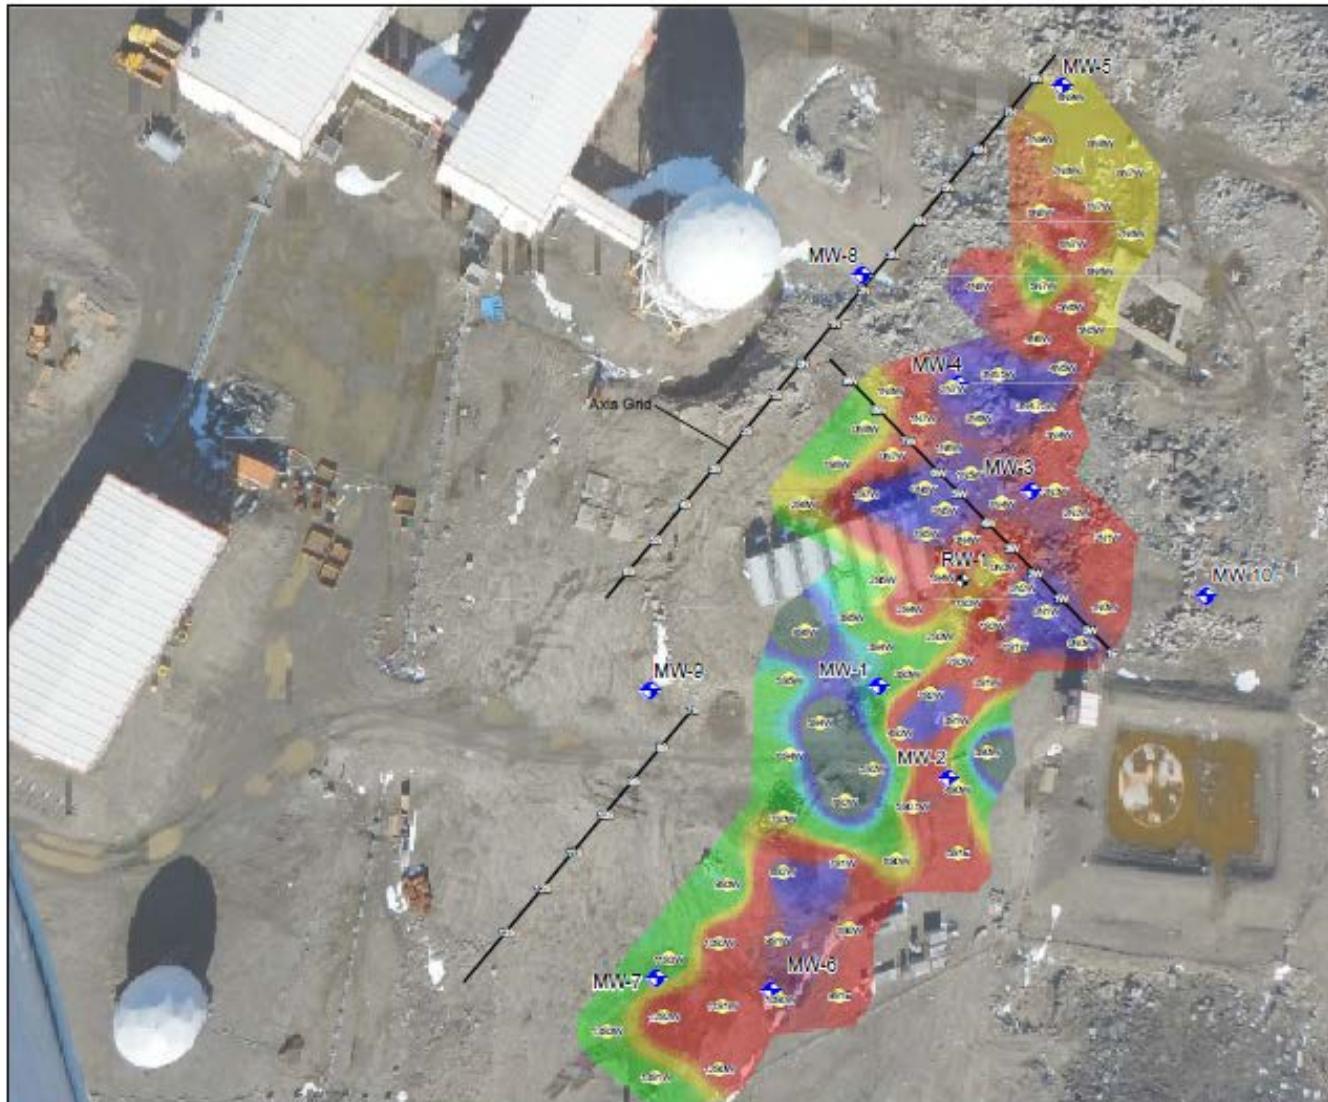
BTEX Soil Vapors

Figure 13

**Soil Vapor Survey
Total BTEX (benzene / toluene / ethylbenzene / m,p-xylene / o-xylene) Concentration Map**

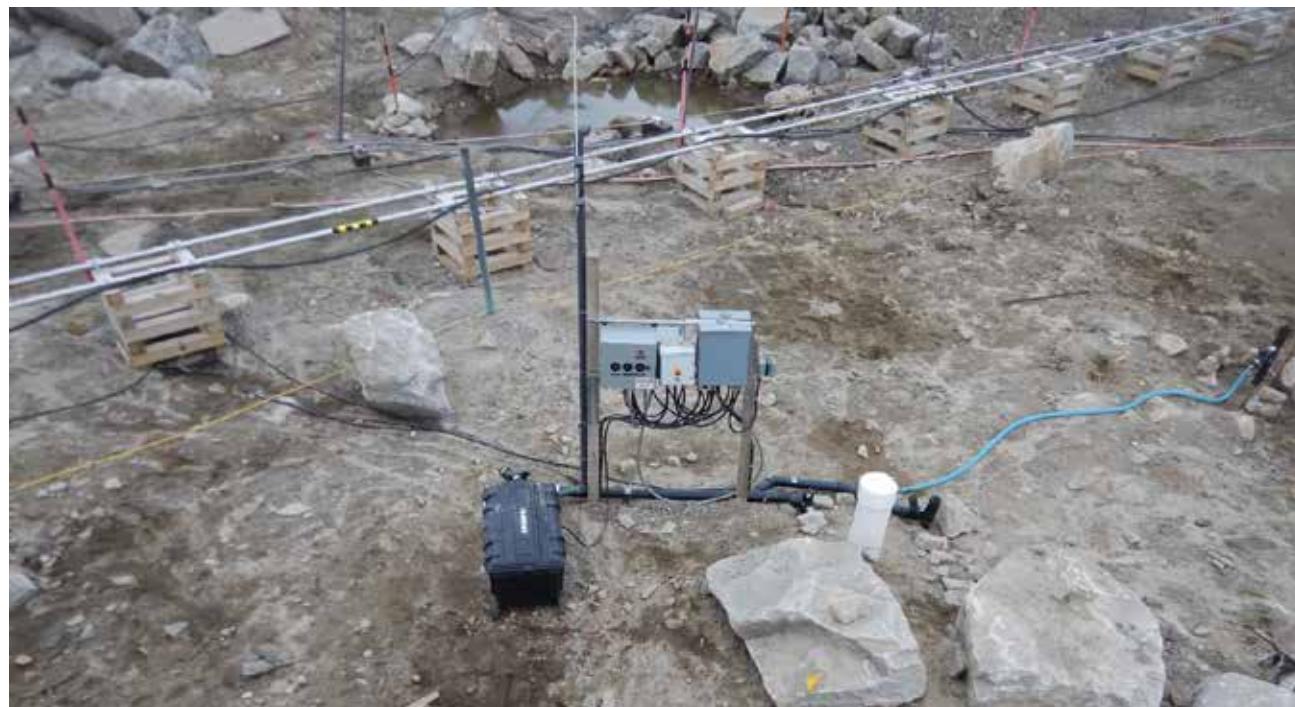
Fuel Recovery Efforts (SVE)

- Soil vapor extraction was initiated by installing a blower pump in the recovery trench area using the connector pipes installed during 2015
- SVE proved very effective removing volatile hydrocarbon compounds from the recovery trench area
