2016 ANNUAL NUNAVUT WATER BOARD

REPORT FOR BAF-3

North Warning System

BAF-3 Jet Fuel Release 2016 Project Update

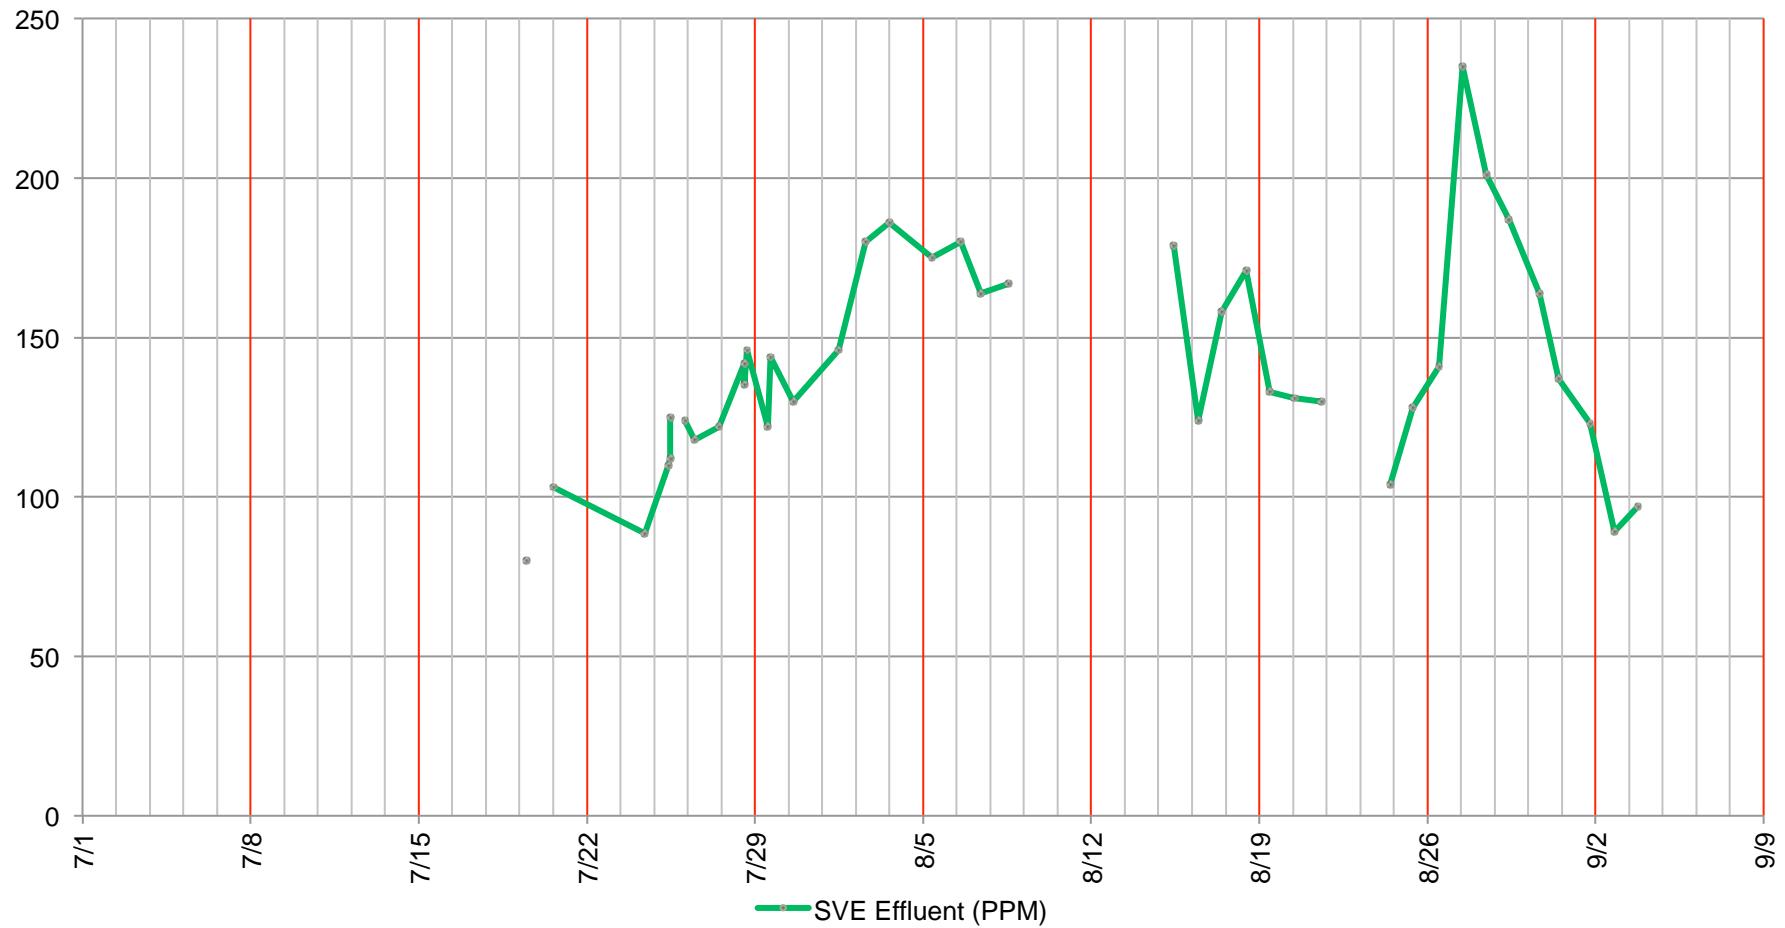
Fuel Recovery Efforts (SVE)

SVE Effluent (PPM)

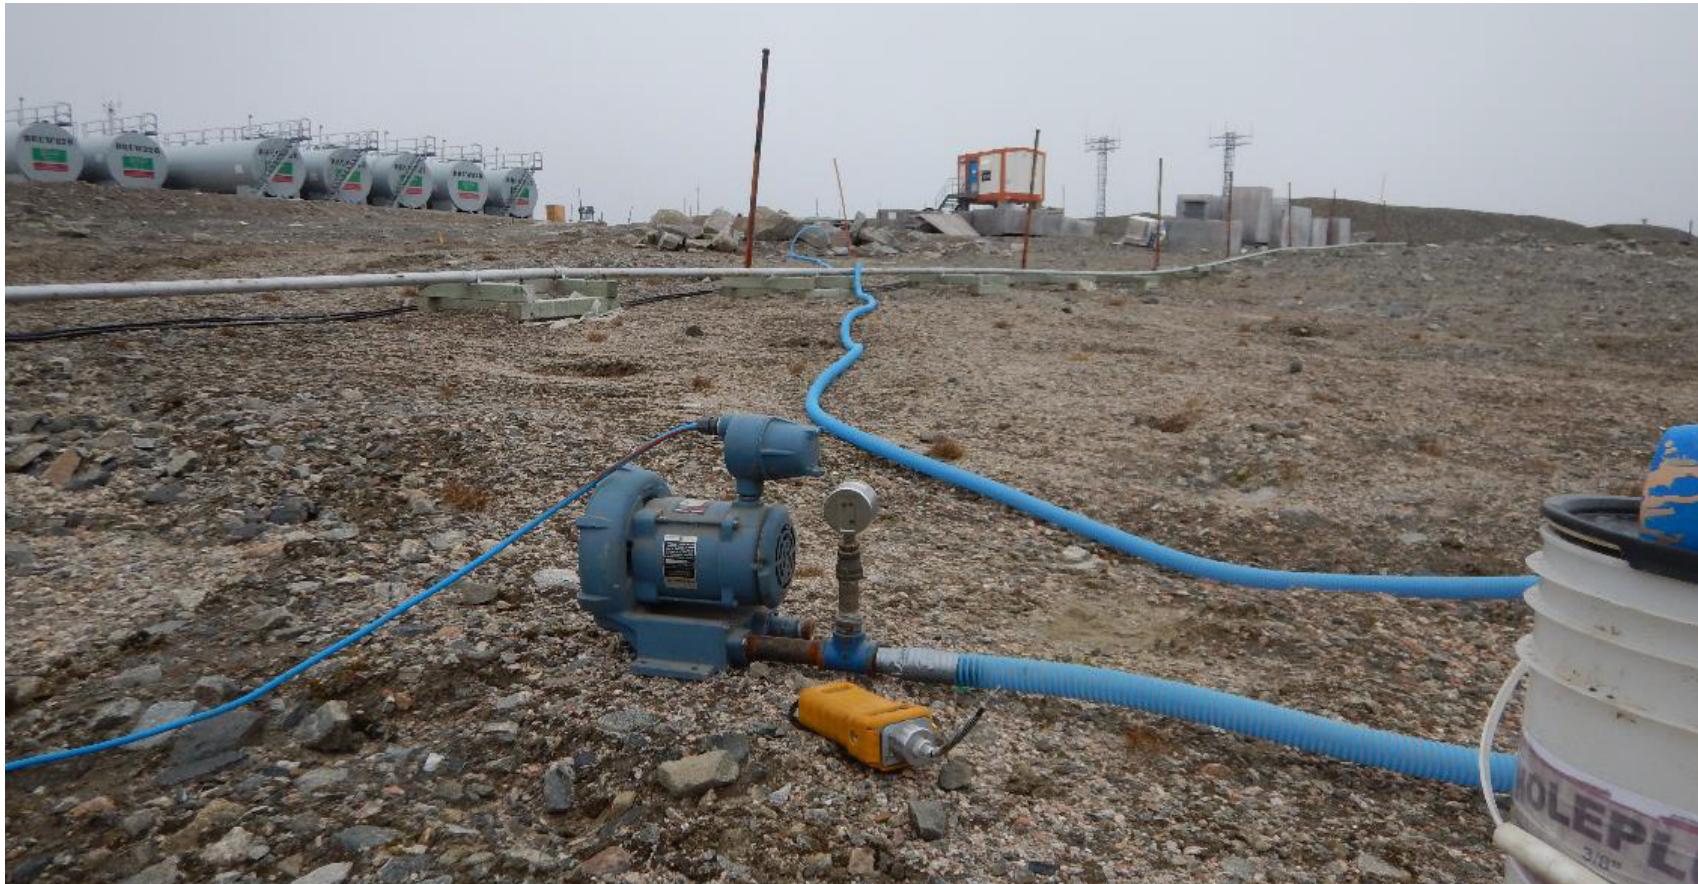
Fuel Recovery Efforts (SVE)

- Based on the successful SVE from the recovery area, RCL completed testing of SVE from several wells and subsurface access points in the area

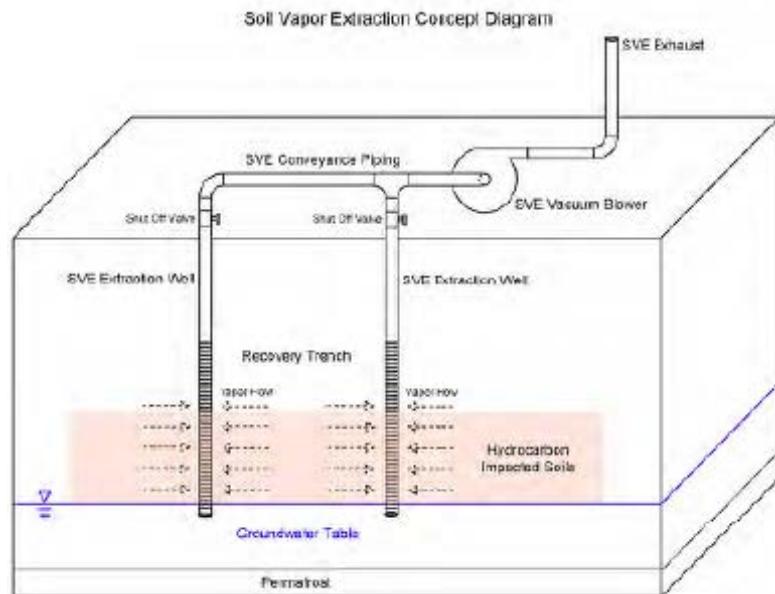
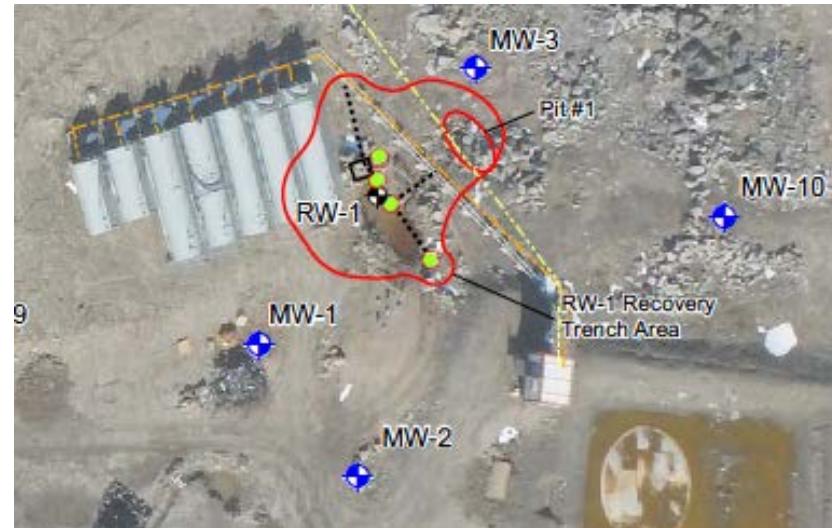
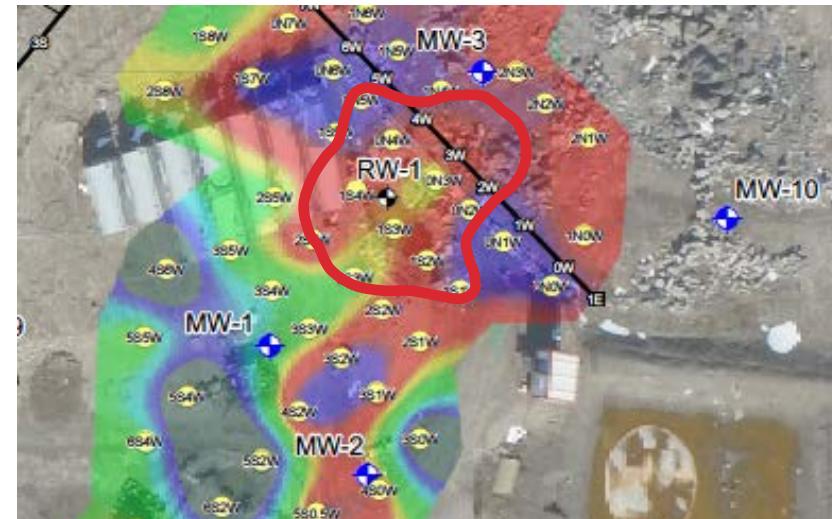
Soil Vapor Extraction

- Soil vapor survey results compared to soil vapor extraction area indicates much lower petroleum hydrocarbon concentrations are observed in effective treatment area

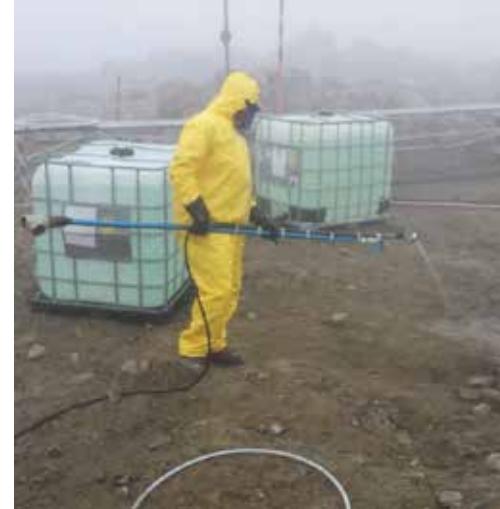
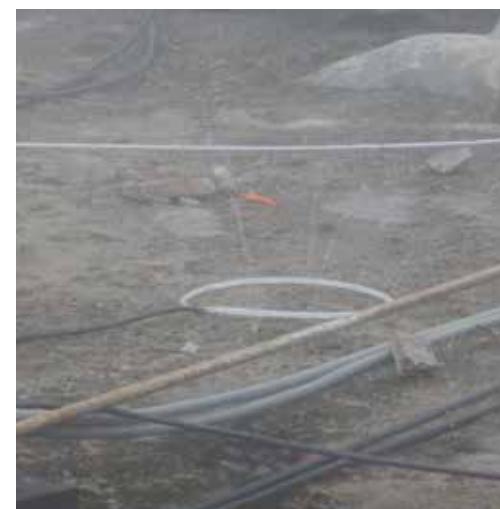
Surficial Soil Treatment

- 2½ totes of hydrogen peroxide were transferred from interior storage to the recovery trench area
- The H_2O_2 was diluted to 5 totes of 20% solution for application to the Jet A1 impacted areas
- Soil samples were collected before and after the application of the H_2O_2
- Sample results confirm effectiveness
- Initial penetration of the H_2O_2 appeared minimal; however, after application water from the recovery trench was recorded with detections of H_2O_2

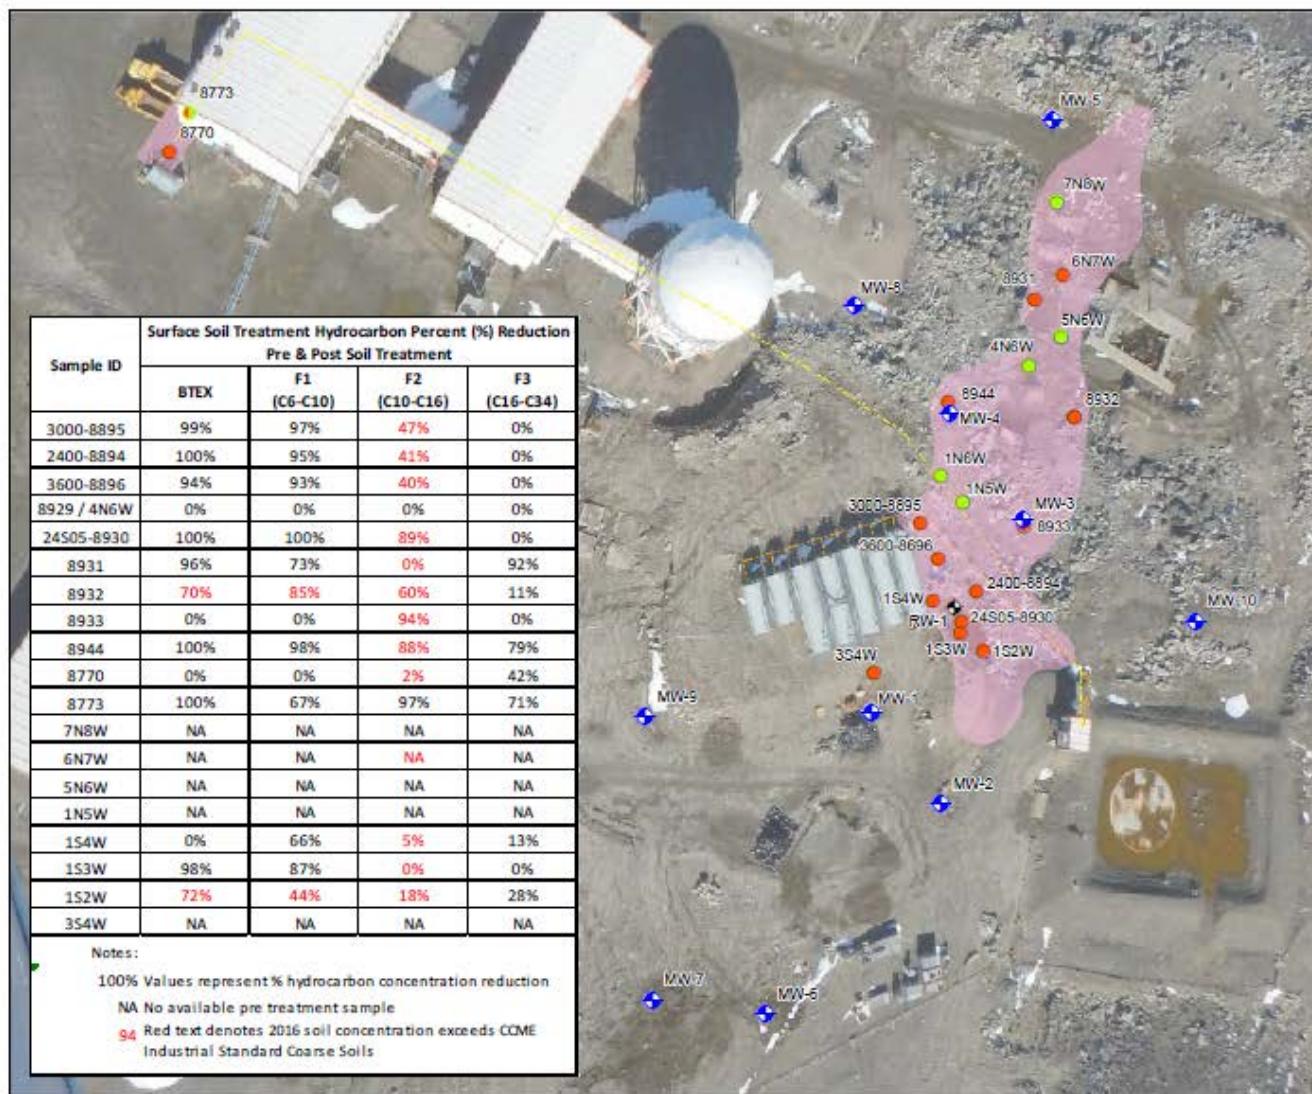
Peroxide Treatment of Soils

Figure 8
Surface Soil Treatment
Hydrocarbon Concentration
Reduction and Sampling Map
BAF-3
