Conseil national
de recherches Canada
Institut de recherche
en biotechnologie

DETAILED CHARACTERIZATION AND ECONET UPDATE OF MULTIPLE SITES AT CFS-EUREKA AND CFS-ALERT, NUNAVUT Volume I : CFS-ALERT

Final Report 2007/08

March 31, 2008

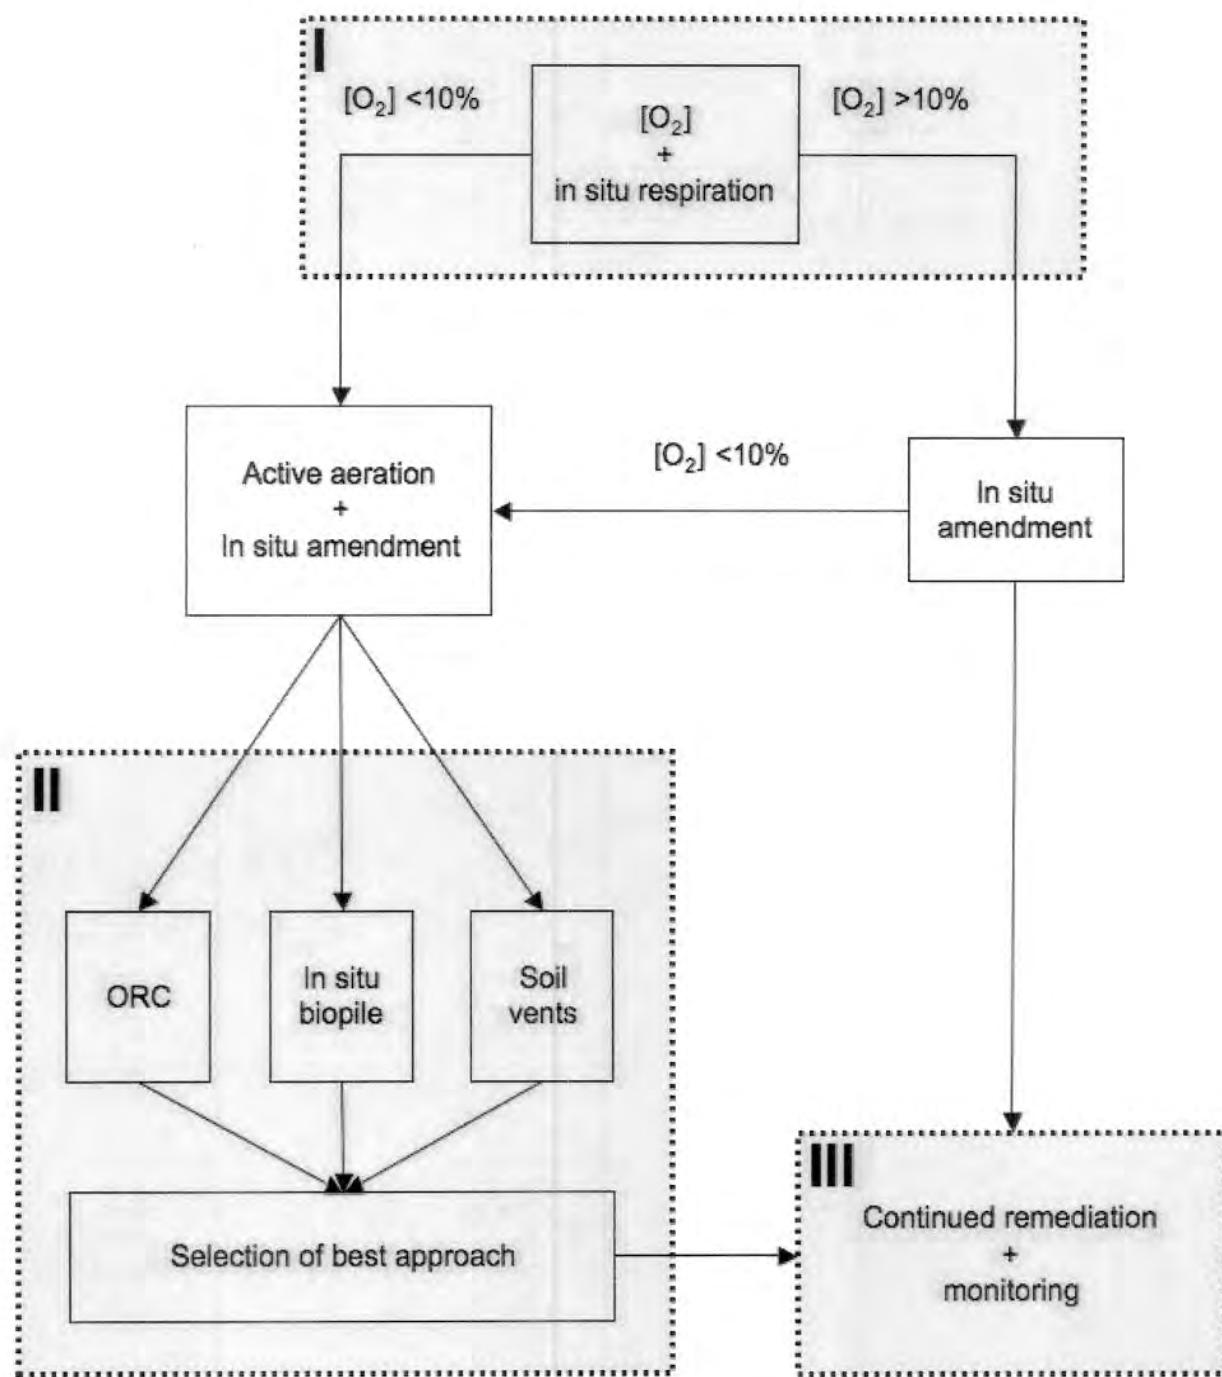
The proposed experimental program will be performed initially at 2 representative sites: S-349 Oxidator Building and S-10216 Baker's Dozen. This experimental program is aimed at identifying and validating the most appropriate conditions for successful *in situ* bioremediation. Once the optimal conditions for the 2 sites are determined, this information will be used to address the TPH contamination at the remaining (and future) contaminated sites. The work can be broken down into 3 distinct phases, to be carried out simultaneously at the two sites (Figure 75).

Figure 75. Flow chart for experimental work designed to establish and validate the most appropriate conditions for successful in situ bioremediation.

Phase 1 is to determine the current level of subsurface aeration and *in situ* microbial respiration. To achieve these goals, filter points will be installed at several locations within each site and oxygen concentrations measured in the subsurface. These values will be used as a baseline to determine whether additional aeration needs to be provided (minimum 10% O₂ desired), the concentration of oxygen during bioremediation, and if necessary, whether implemented aeration systems are providing adequate subsurface aeration. Once the base line subsurface oxygen concentrations are established, *in situ* respiration will be examined using the same filter points. Air will be pumped down the sealed filter points for 24-48 hours, after which the concentration of O₂ and CO₂ will be regularly measured for approximately 24-48 hours. This data will provide an indication of the current microbial aerobic respiration rates (i.e. baseline rates) at each site by comparing the consumption of O₂ and production of CO₂. If sufficient O₂ is present in the subsurface, a nutrient amendment program will be developed to accelerate the *in situ* biodegradation of TPH contamination. Based on previous work by this lab, the suggested nutrient amendment is monoammonium phosphate (MAP) at a final concentration of 250 mg/kg.
