WATER LICENCE INSPECTION FORM

Licensee	Licensee Representative				
Department of National Defense – Eureka Station	No DND Representative on Site				
Licence No. / Expiry	Representative's Title				
8BC-ERK1621/ 2021					
Date of Inspection	Inspector				
July 11 2019	Jeremy FRASER				
Activities Inspected					
<input type="checkbox"/> Camp	<input type="checkbox"/> Drilling	<input type="checkbox"/> Mining	<input type="checkbox"/> Construction	<input type="checkbox"/> Reclamation	<input type="checkbox"/> Fuel Storage
<input type="checkbox"/> Roads/Hauling	<input checked="" type="checkbox"/> Other: depositions of waste on site	<input type="checkbox"/> Other:

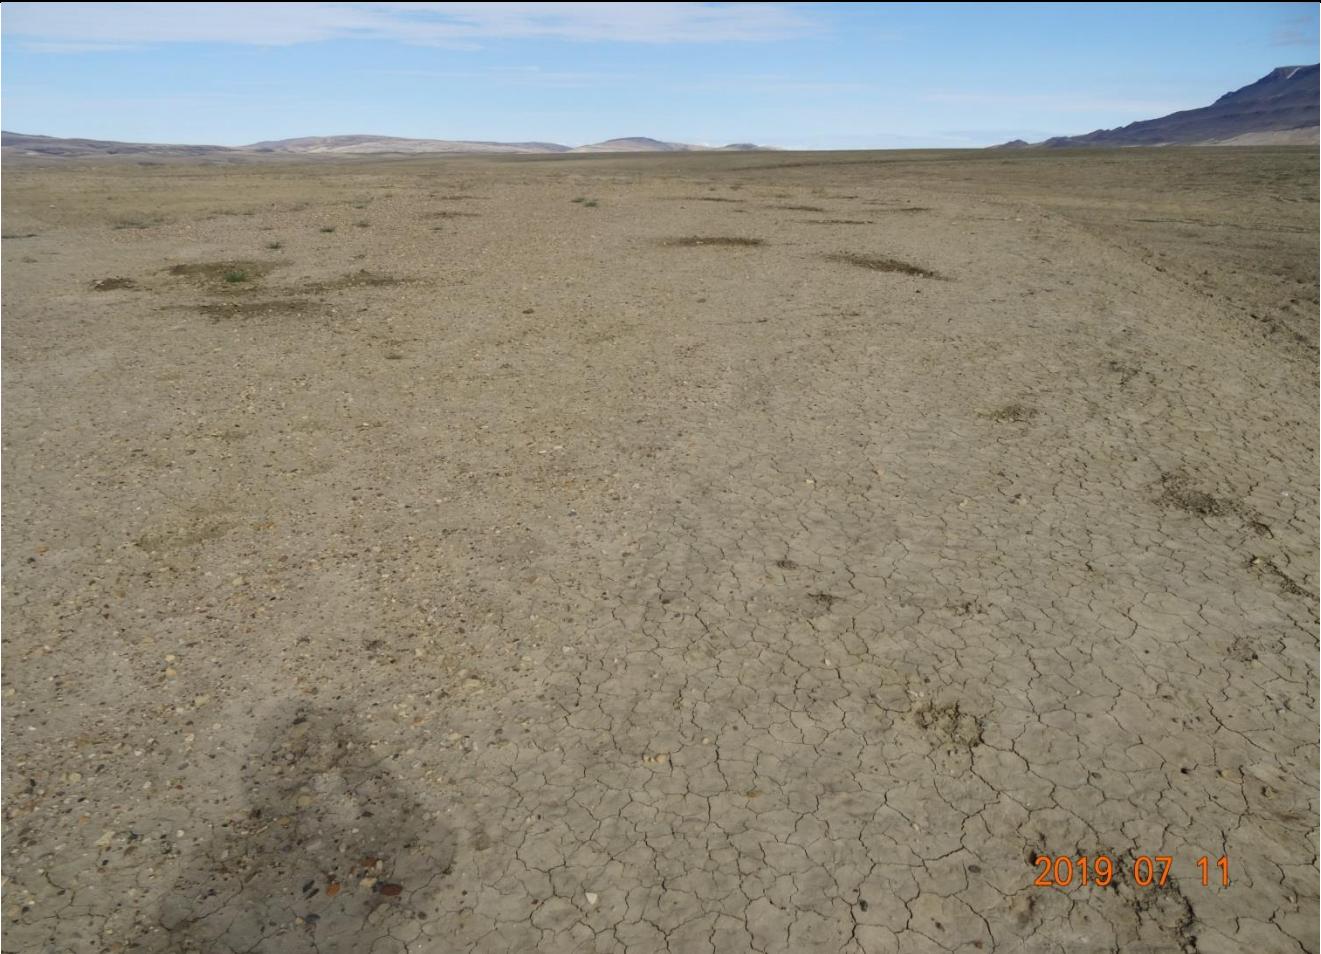
Photo #2

Description: Battery Dump – Capped appears to be in good order

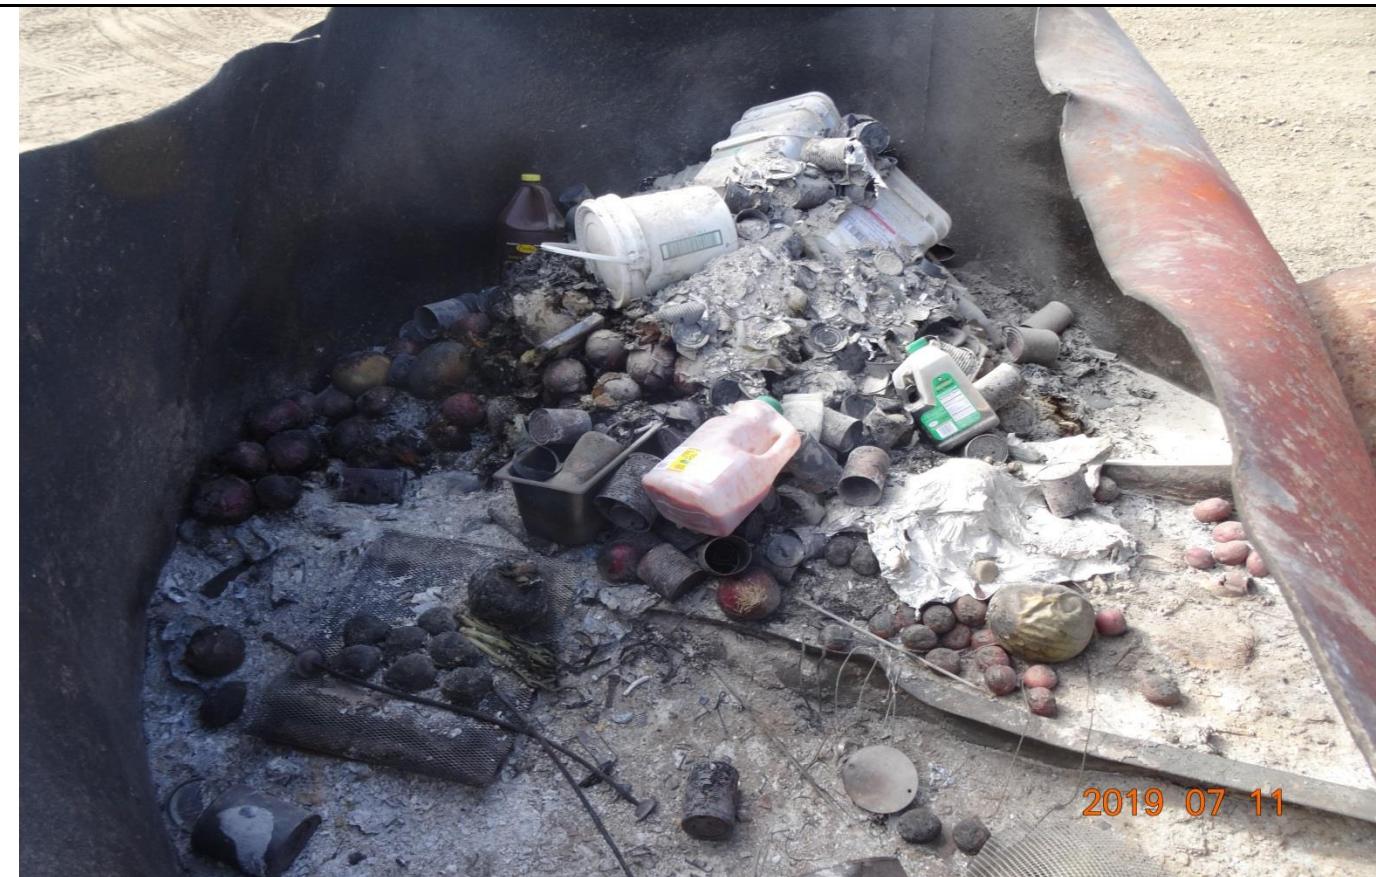
Description: Burn pan containing non-burnable material such as plastics and metals

<p>Landfill DND eureka station is authorized by the water licence to operate a landfill including a burn pan authorizing open burning of food waste, non-treated wood, and cardboard. The landfill appears to be operating as intended, however it was noted that plastics and metals were in the burn pan mixed with ash and food waste (see photo 3). This is a violation of the Water Licence Part D Item 4</p>			
SECTION 2	<input type="checkbox"/> Comments	<input checked="" type="checkbox"/> Non-Compliance with Act or Licence	<input checked="" type="checkbox"/> Action Required
<p>It was noted during this inspection that DND Eureka Station is burning plastic and metals in the burn pan as seen in the photos. This act is in violation of the Water Licence Part D Item 4.</p> <ul style="list-style-type: none"> • The inspector is requesting that DND remove all non-burnable material immediately prior to further burning of material in the facility.

<p>Part D Item 4 <i>"The Licensee shall not open burn plastics, wood treated with preservatives, electric wire, Styrofoam, asbestos or painted wood to prevent the deposition of waste materials of incomplete combustion and/or leachate from contaminated ash residual, from impacting any surrounding waters, unless otherwise approved by the board in writing".</i></p>
