**DETAILED CHARACTERIZATION AND ECONET UPDATE  
OF MULTIPLE SITES AT CFS-EUREKA AND CFS-ALERT, NUNAVUT  
Volume III – CFS-EUREKA**

**Final Report 2007/08**

## **4.6 S-10527 NORTH AIRSTRIP APRON**

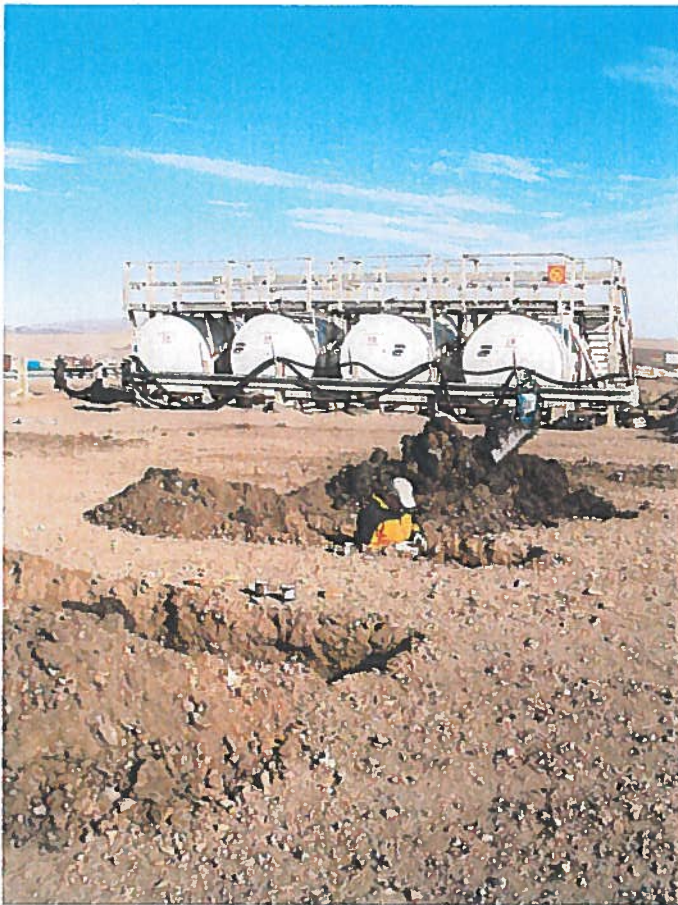
Photograph 15. (North Airstrip Apron, S-10527) Trenches dug in front of the refuelling tanks.

During the 2006/07 campaign, several trenches were noted on site, suggesting that soil samples were recently collected. Also, during this campaign, the bladders appeared to be in active use as transfer hoses were seen to be attached. DND has indicated that the location of the 4 diesel fuel storage tanks is likely to change in the near future.

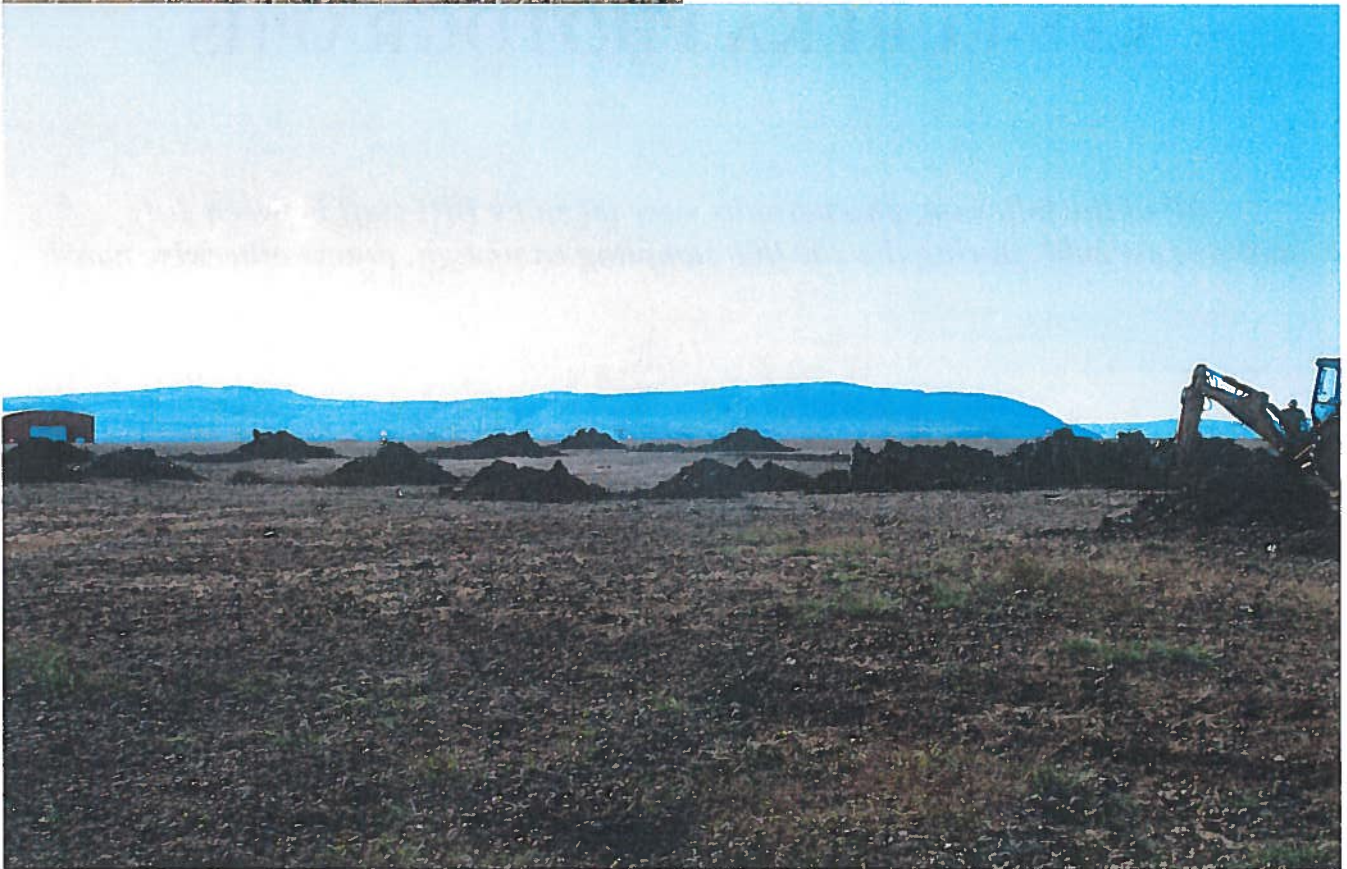
Photograph 16. (North Airstrip Apron, S-10527) Delineated area located south of the 4 tanks.

In 2007/08, 25 subsurface soil samples, including 1 duplicate pair, were collected and analyzed for TPH, BTEX and PAHs (Table 13) (Photographs 16 to 18, Appendix A). TPH Fractions 1, 2 and 3 at concentrations above the CCME guidelines were measured in 12, 11 and 1 soil sample, respectively. Benzene, toluene, ethylbenzene and total xylene concentrations exceeding the CCME guidelines were detected in 5, 3, 10 and 5 soil samples, respectively. PAHs were detected in 10 soil samples, but only naphthalene in one sample was above the CCME guidelines. The results indicated the presence of 2 to 3 hydrocarbon contaminated areas. These areas were located between the 4 diesel fuel storage tanks and the airstrip.

The FCSAP classification based on the above results classifies the North Airstrip Apron as a Class 1 site with a score of 80.5. The estimated volume of contaminated soil is 1,755 m<sup>3</sup>. This indicates that action is required to address the contamination on site.
