WATER LICENCE INSPECTION FORM

Licensee	Licensee Representative
Department of National Defence	Don Beattie
Licence No. / Expiry	Representative's Title
3BC-FOH0919	Environmental Officer
Land / Other Authorizations	Land / Other Authorizations
Date of Inspection	Inspector
July 11, 2018	Joseph Monteith & Jonathan Mesher
Activities Inspected	
<input type="checkbox"/> Camp	<input type="checkbox"/> Drilling
<input type="checkbox"/> Roads/Hauling	<input type="checkbox"/> Mining
	<input checked="" type="checkbox"/> Other: Potable Water Source, Solid Waste Facility, Sewage Disposal Facility
	<input type="checkbox"/> Construction
	<input type="checkbox"/> Reclamation
	<input type="checkbox"/> Fuel Storage
	<input type="checkbox"/> Other:

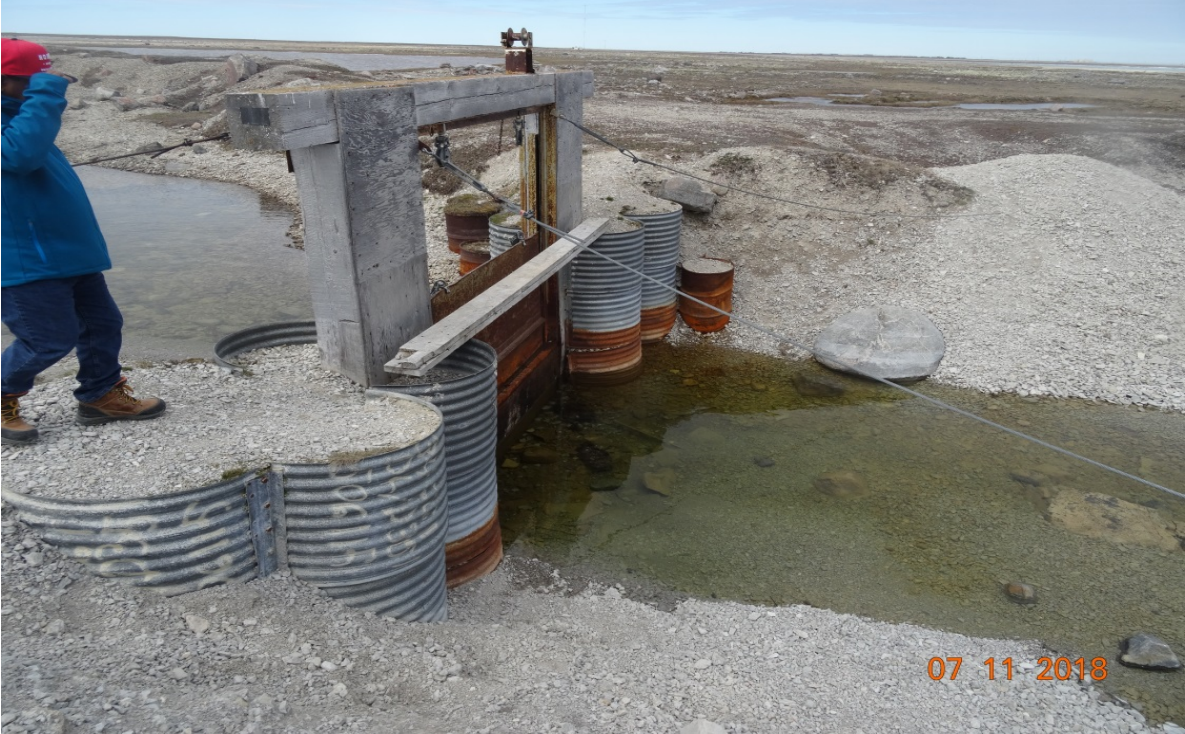
Date	Camera	Inspector
July 11, 2018	Nikon Coolpix	Joseph Monteith
Photo Log #1		Location
Photo 1		Hall Beach - North Warning Site FOX-M

Description: South Lake in the background, with the pump house in the mid ground, and piping in the foreground

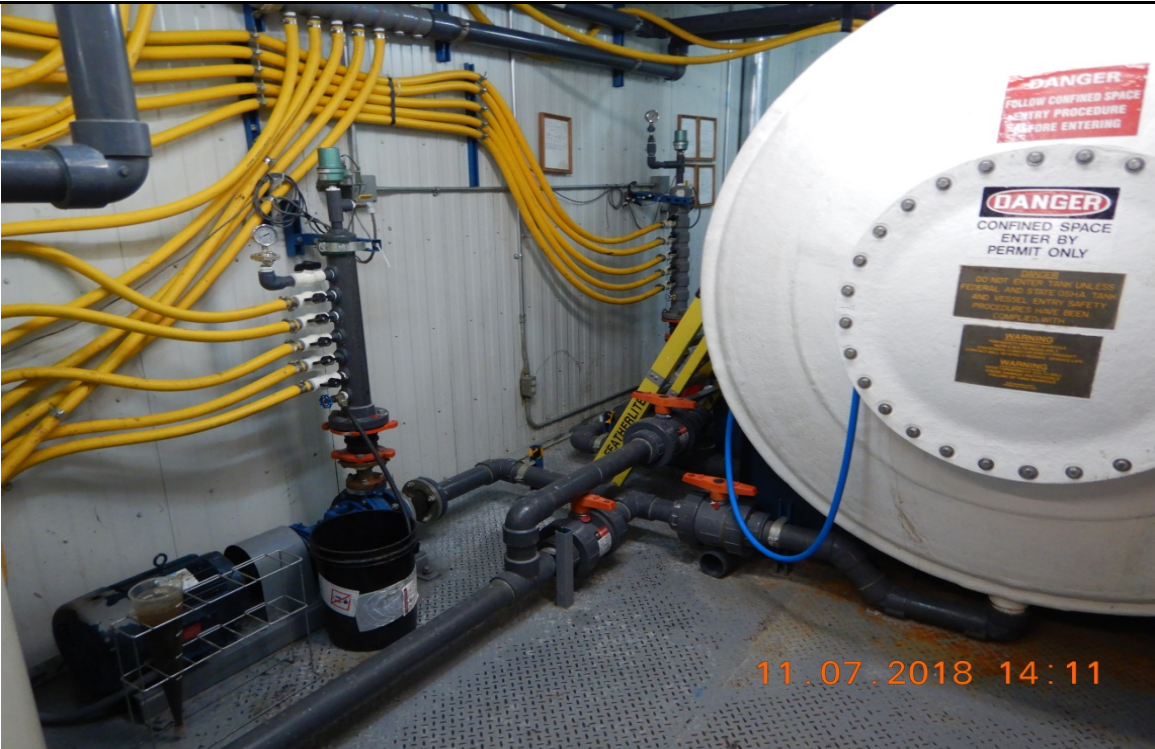
Photo Log #  
Photo 8

9. Sewage Waste is treated on site using a bio-reactor, sodium hydroxide injection system, membranes, and processing pumps, and activated carbon absorbers to remove color. This is all to recycle water for use in toilets and urinals (see photo 8 & 9).
10. After the waste water is treated it is used as toilet water. The excess treated water due to the input of showers, kitchens, wash basins, toilets and urinals, is discharged to the receiving environment (see photo 10).

Description: Bio Reactor

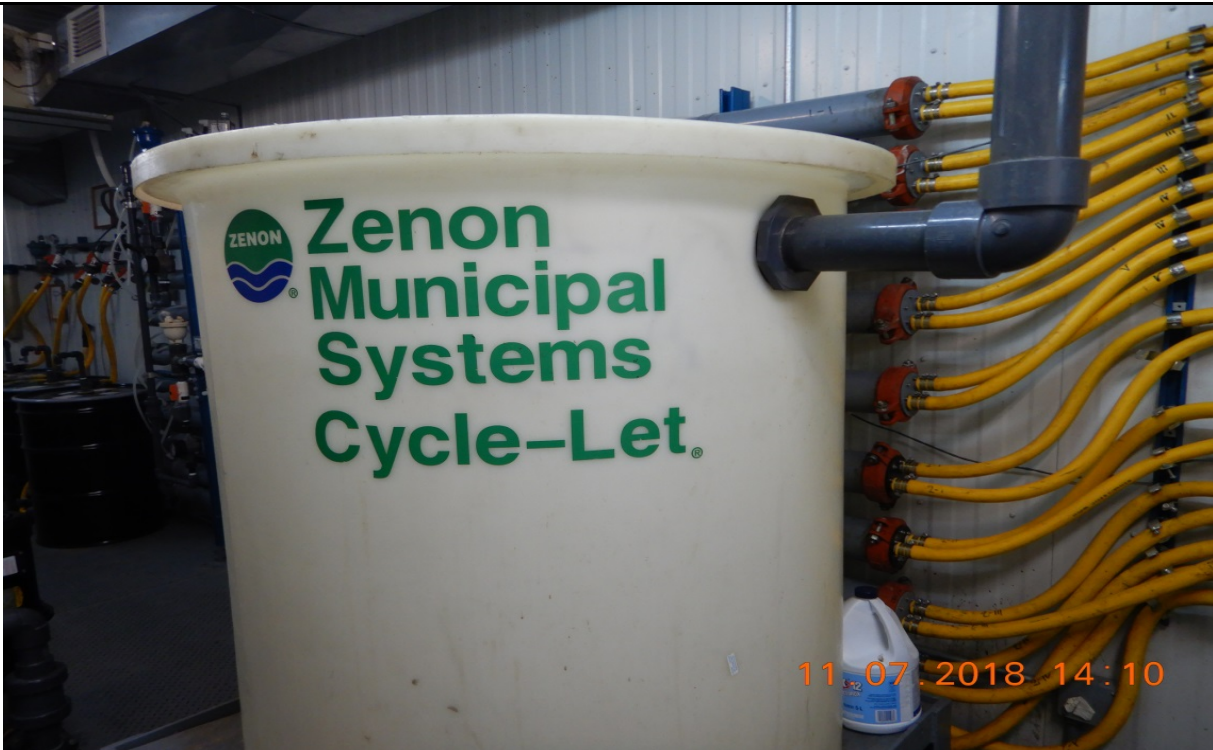
Photo Log #	Location
Photo 9	FOX-M

Description: Cycle-Let Sump contain for excess treated waste water
