WATER LICENCE INSPECTION FORM

Licensee	Licensee Representative				
Department of National Defence	William Wyman				
Licence No. / Expiry	Representative's Title				
8BC-FOH1929	Environmental Officer				
Land / Other Authorizations	Land / Other Authorizations				
Date of Inspection	Inspector				
September 8, 2021	Joseph Monteith				
Activities Inspected					
<input type="checkbox"/> Camp <input type="checkbox"/> Drilling <input type="checkbox"/> Mining <input type="checkbox"/> Construction <input type="checkbox"/> Reclamation <input type="checkbox"/> Fuel Storage <input type="checkbox"/> Roads/Hauling <input checked="" type="checkbox"/> Other: Potable Water Source, Solid Waste Facility, Sewage Disposal Facility, Hazardous materials, and waste <input type="checkbox"/> Other:

On September 8, 2021, a water licence inspection was conducted on was conducted by Water Resource Officer (WRO) Joseph Monteith at 8BC-FOH1929, also known as the North Warning Site (NWS), FOX-M in Hall Beach, Qikiqtani Region, Nunavut.

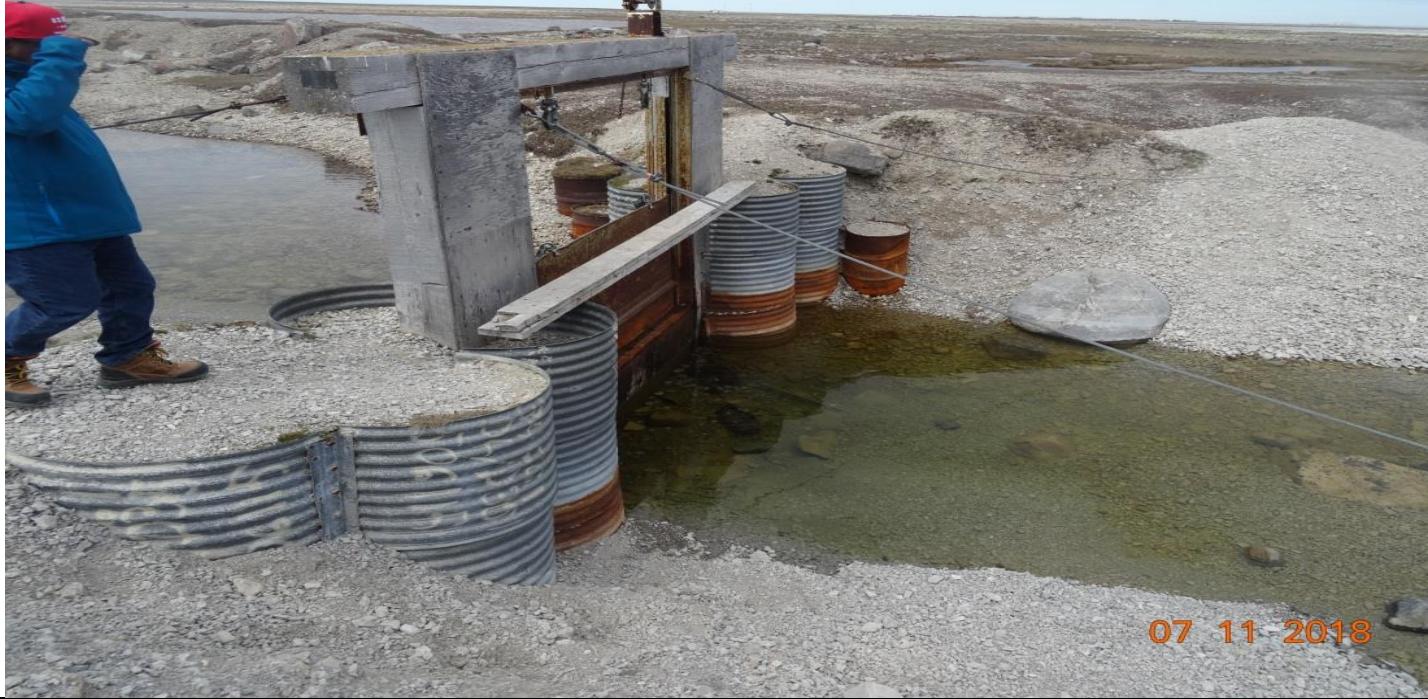
Date	Camera	Inspector		
September 8, 2021	Nikon Coolpix	Joseph Monteith		
Photo Log #1	Location			
Photo 1	Hall Beach - North Warning Site FOX-M

07 11 2018				
Description: South Lake in the background, with the pump house in the mid ground, and piping in the foreground. Photo from July 11, 2018.

2. Water withdrawal is conducted from South Lake (photo 1) to the Water Storage Reservoir(Photo 2). The Water from South Lake is recharged by opening up a gate on a dyke which is also a man-made reservoir. The lined Storage Reservoir has a capacity of 60,000m³ (Photo 2).
3. The pipe that historically delivered metered water to the NWS facility was damaged. Consequently the NWS has installed a truck pipe connector, and hose to withdraw water from the reservoir (Photo 3).
4. During the inspection their logs showed total of 35m³ withdrawn from trucked service (Photo 4).
5. Fox-M treats water through granular carbon filter, a multimedia filter and two UV filter lamps (see photo 5).

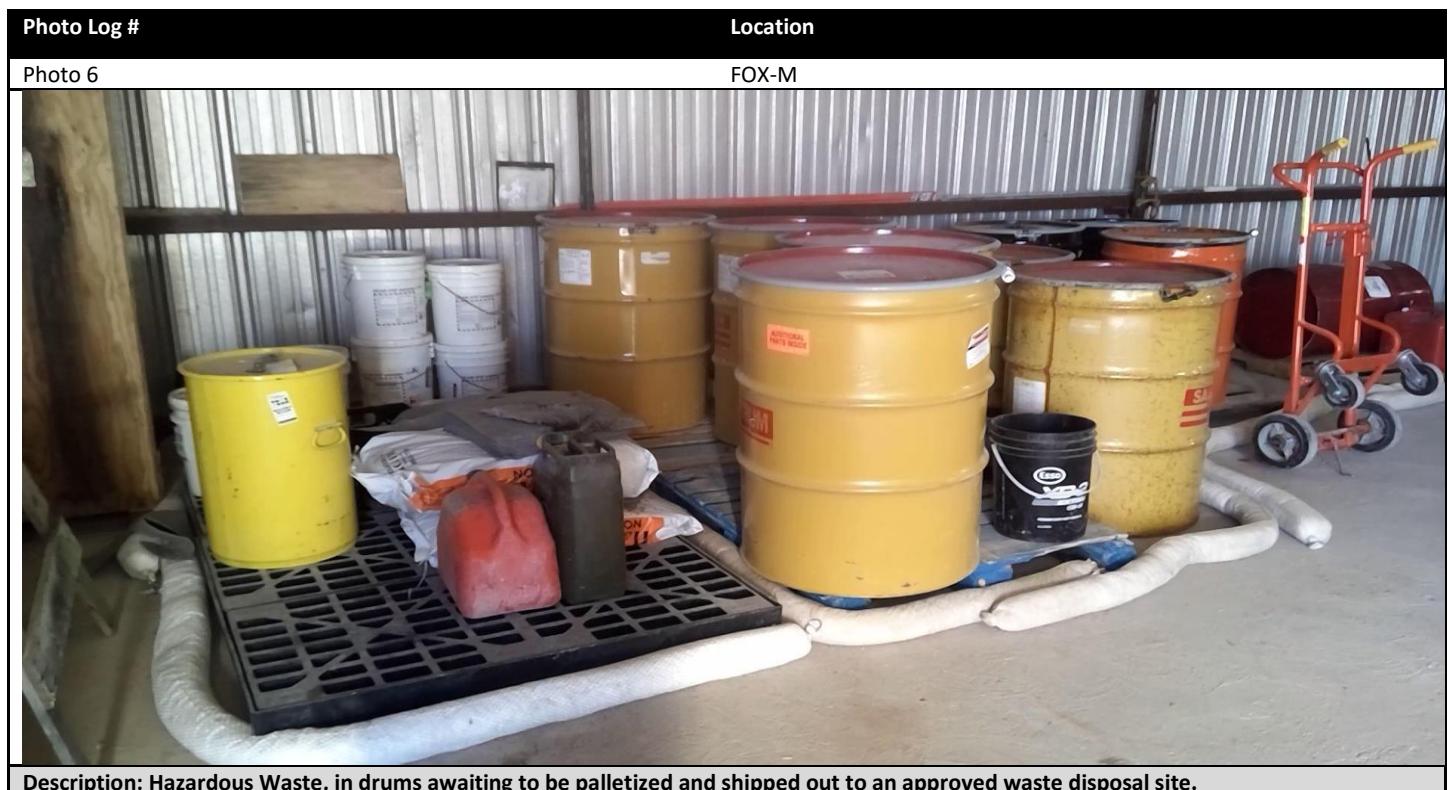
Photo 7

Description: Movement Document/ Manifest – Hazardous Waste Manifest

6. Solid waste is disposed of at the Hamlet of Hall Beach's Land Fill.
7. Hazardous Waste is disposed of by palletizing the waste, store them in a warehouse to backhaul them to an approved hazardous waste Disposal Facility (Photo 6).
8. Copies of Hazardous Waste Manifest observed on site (Photo 7).

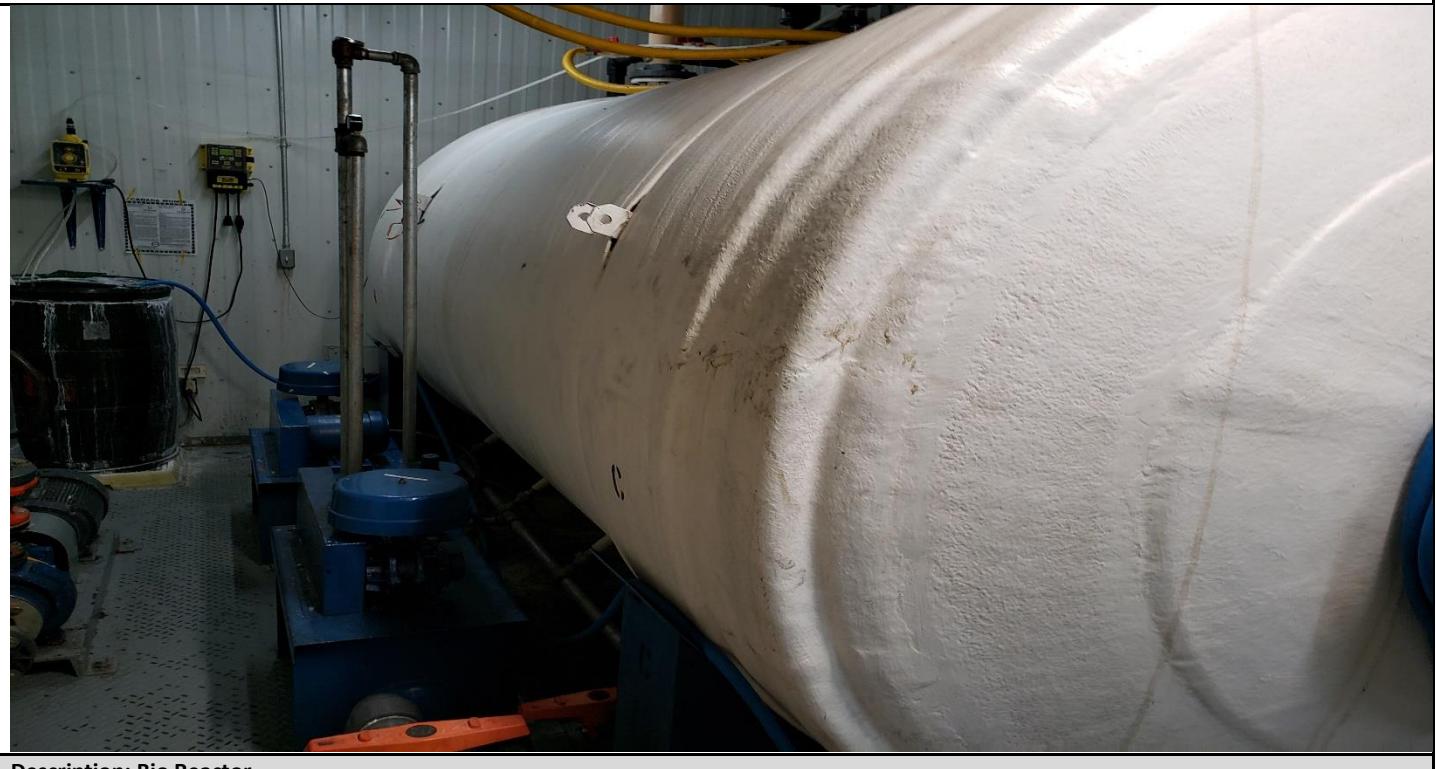
Photo 8

Description: Bio Reactor

9. Sewage Waste is treated on site using a bio-reactor, sodium hydroxide injection system, membranes, and processing pumps, and activated carbon absorbers to remove color. This is all to recycle water for use in toilets and urinals (see photo 8 & 9).
10. After the waste water is treated it is used as toilet water. The excess treated water due to the input of showers, kitchens, wash basins, toilets and urinals, is discharged to the receiving environment (see photo 10).
